LMB GEOSOLUTIONS LTD

GROUND INVESTIGATION & ASSESSMENT

11-12 INGESTRE ROAD, LONDON NW5

July 2021

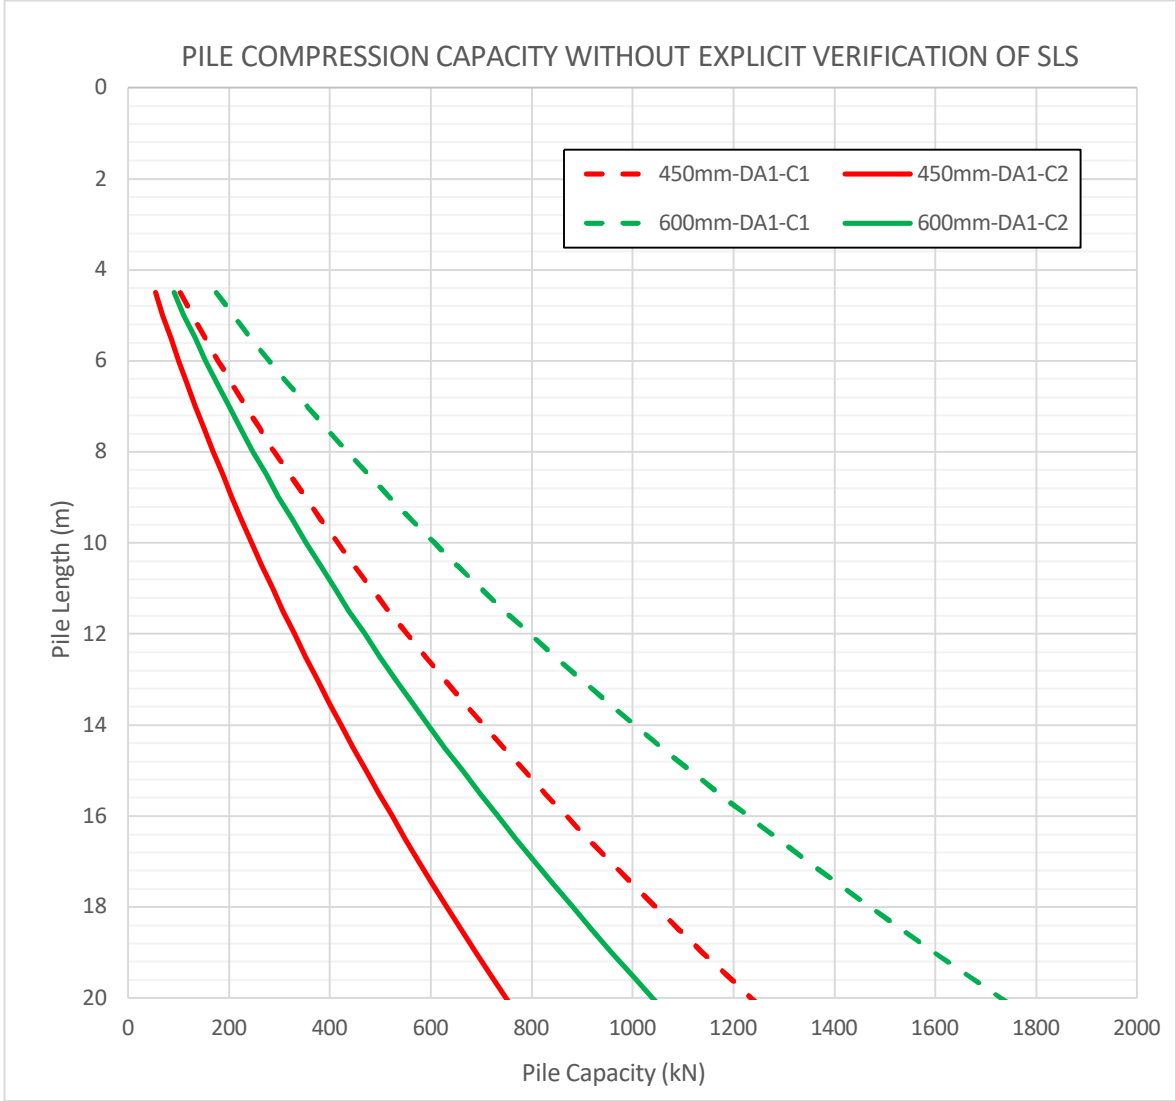
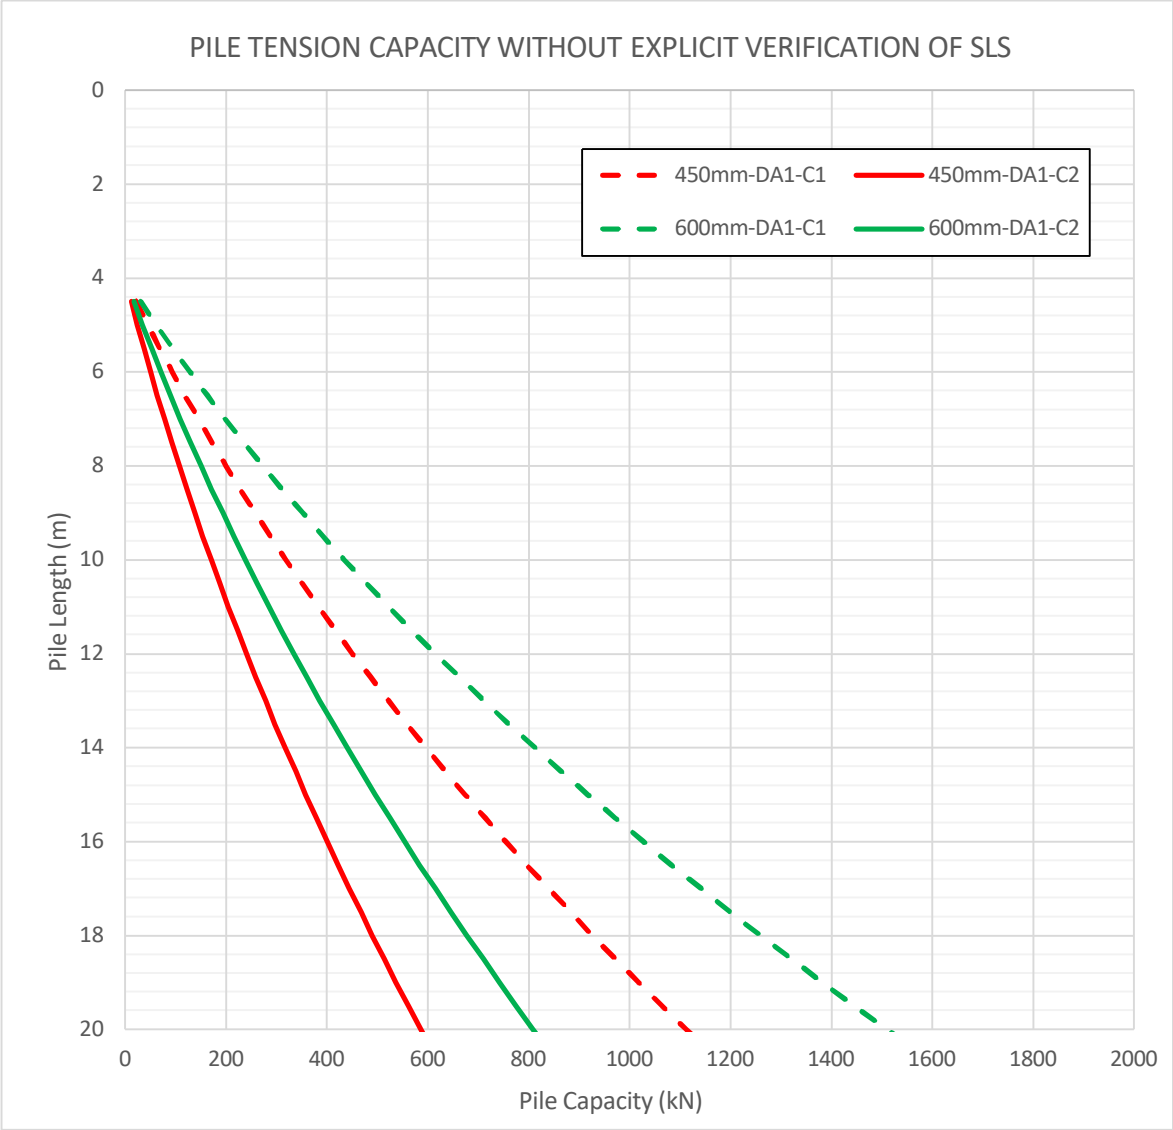
EUROCODE 7			
		Compression Capacity		Tension Capacity	
Pile Length	Pile Diameter	Rcd (M1+R1)	Rcd (M1+R4)	Rtd (M1+R1)	Rtd (M1+R4)
(m)	(mm)	(kN)	(kN)	(kN)	(kN)
6	600	279	154	127	70
8	600	434	248	272	150
10	600	606	352	435	238
12	600	796	468	614	334
14	600	1004	595	812	440
16	600	1229	733	1027	554
18	600	1471	881	1259	677
20	600	1731	1041	1509	809

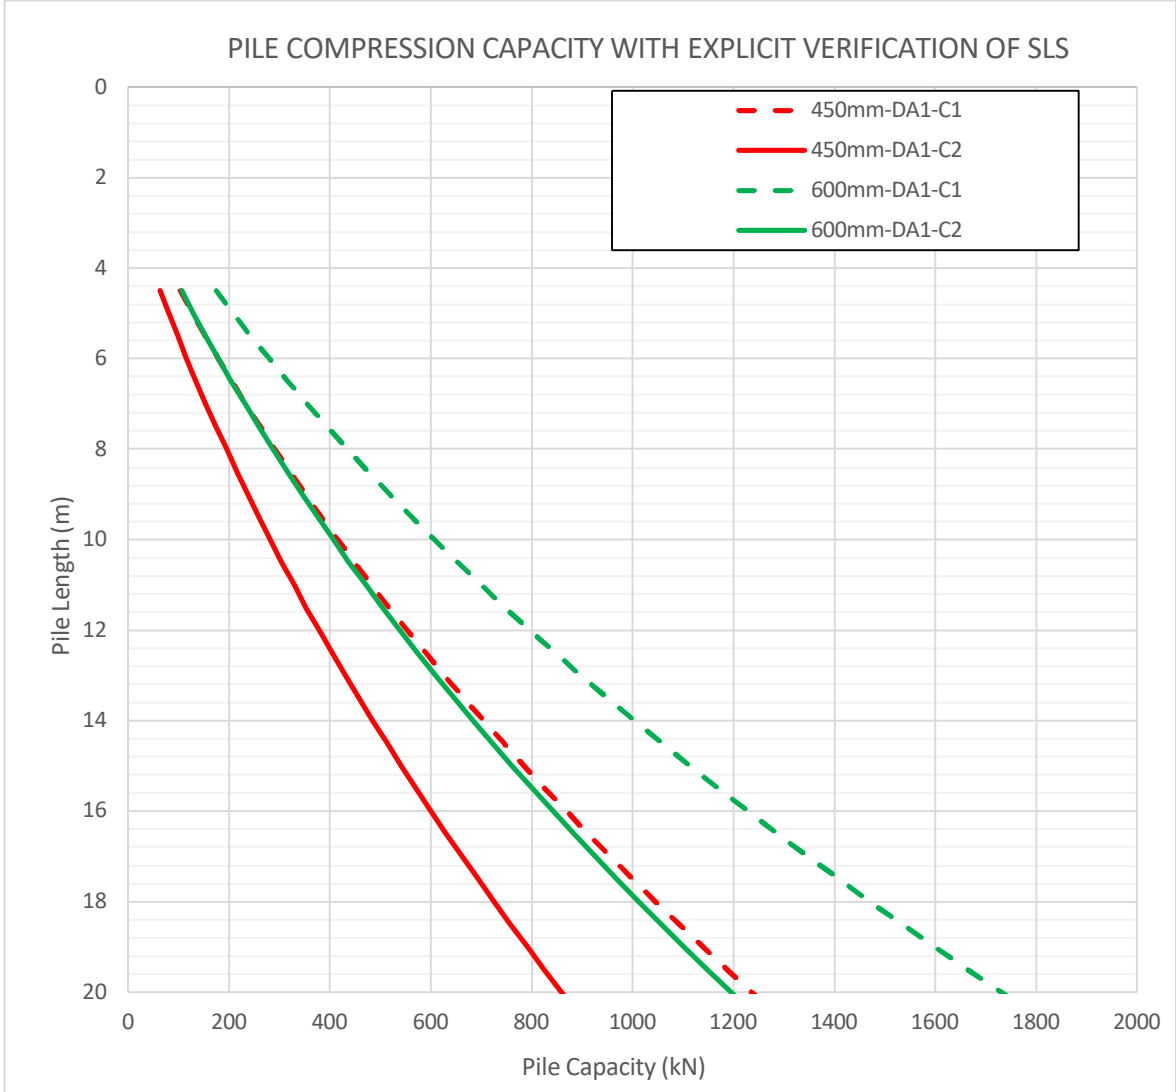
EUROCODE 7			
		Compression Capacity		Tension Capacity	
Pile Length	Pile Diameter	Rcd (M1+R1)	Rcd (M1+R4)	Rtd (M1+R1)	Rtd (M1+R4)
(m)	(mm)	(kN)	(kN)	(kN)	(kN)
6	600	279	179	127	80
8	600	434	286	272	171
10	600	606	406	435	272
12	600	796	539	614	384
14	600	1004	684	812	505
16	600	1229	842	1027	637
18	600	1471	1012	1259	780
20	600	1731	1195	1509	932

- All piles lengths have been measured from ground level.
- Resistance of top 4.0m of soil has not been considered due to the basement excavation.
- Design undertaken to BS-EN-1997-1:2004 and relevant UK-NA using partial factors for CFA/bored piles.
- Pile diameters of 450mm and 600mm have been considered.
- Pile axial capacity is provided both with and without explicit verification of SLS (i.e. assuming pile load testing would/would not be undertaken).
- Pile group effect has not been considered.

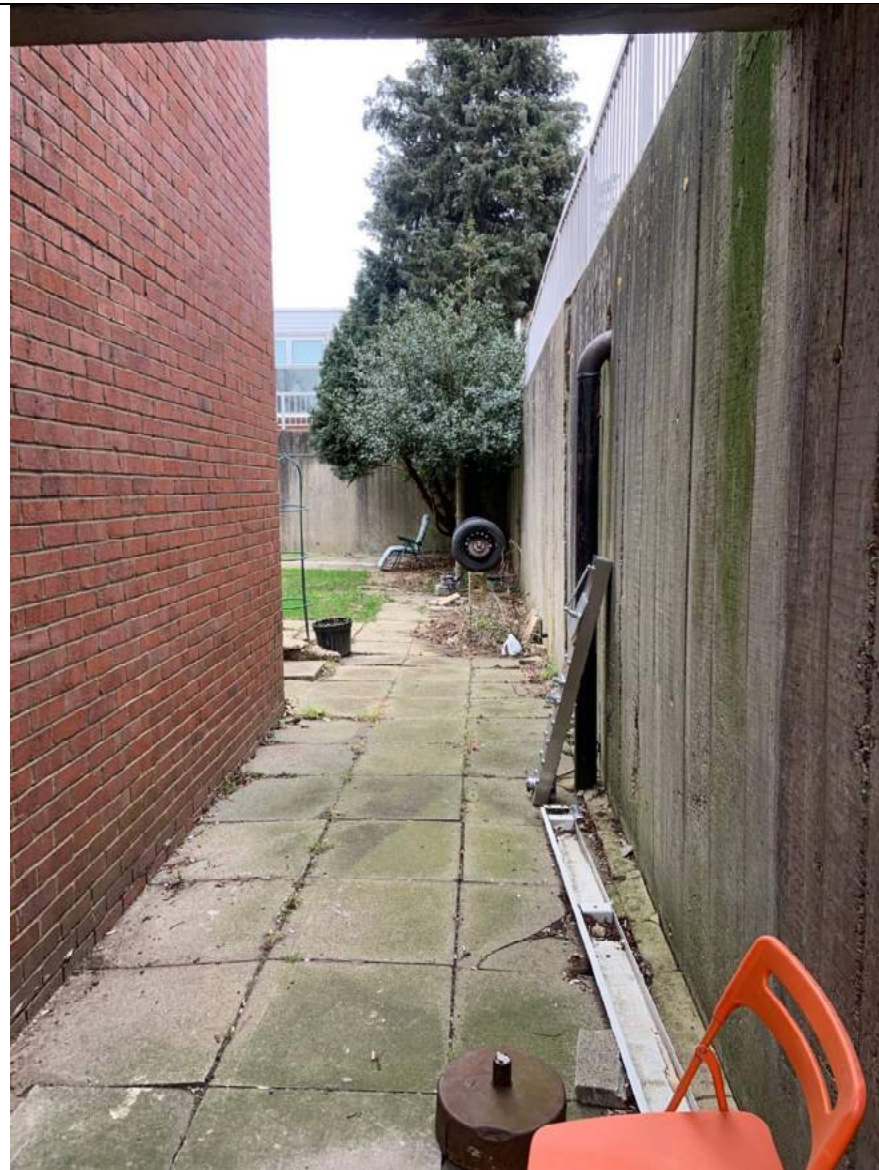
Photo 4 – Retaining wall along southern boundary.

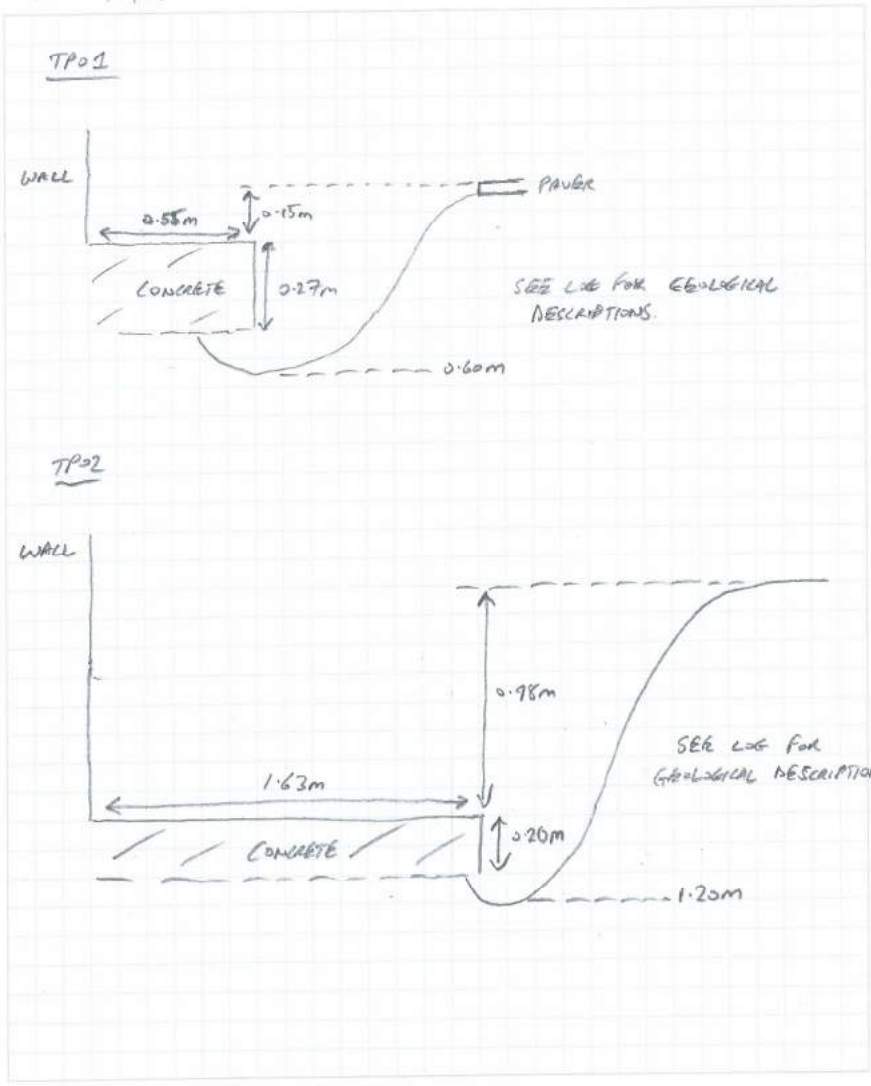
Project: INGESTRE ROAD
Description: HAND EXCAVATED TRIAL PIT SECTIONS
Drawn by: PL
Date: 26/2/21

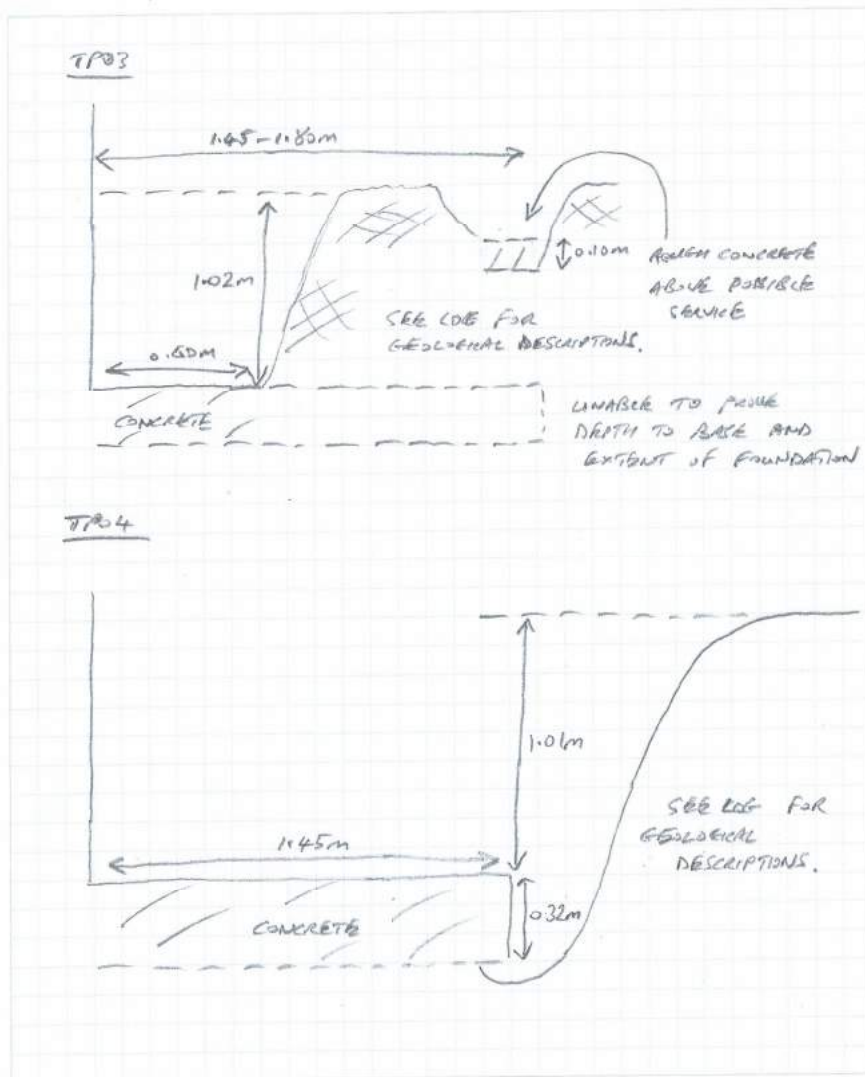
Project: INGESTRE ROAD
Description: MAIN EXCAVATED TRIAL PIT SECTIONS
Drawn by: PCC
Date: 26/3/21

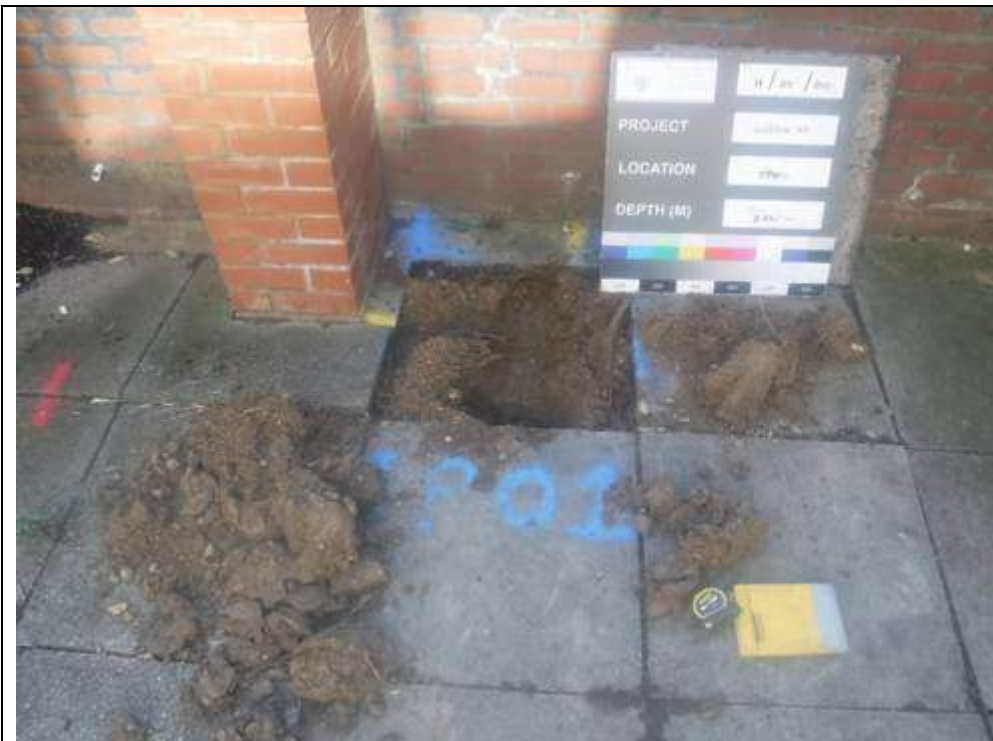
Photo 1 - TP01 arisings

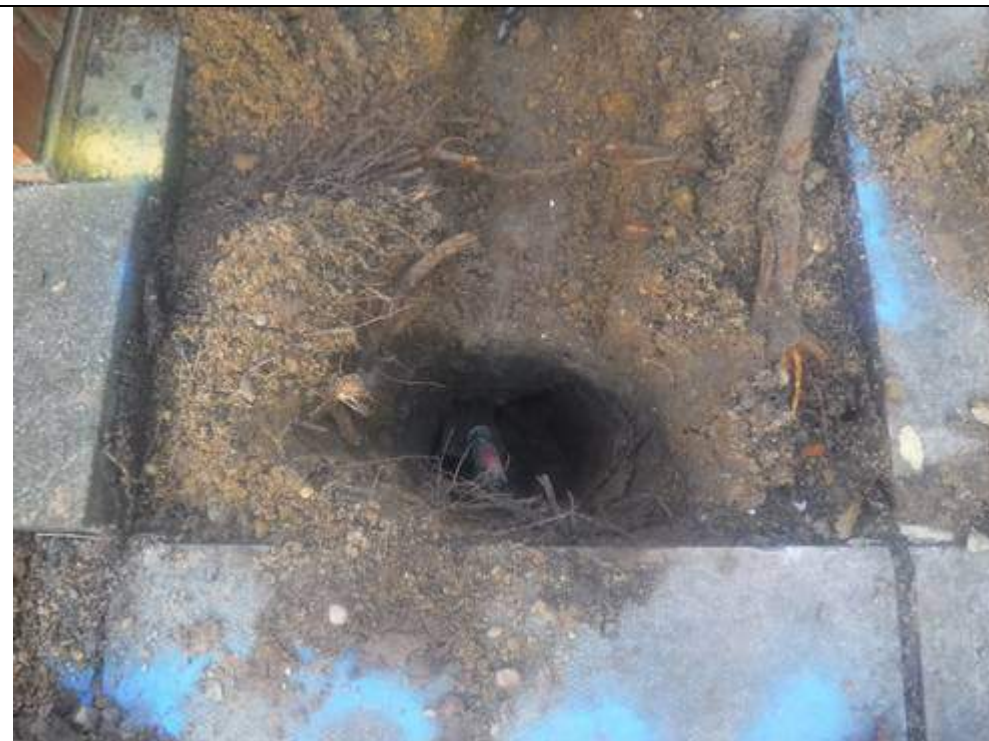
Photo 2 - TP01 excavation

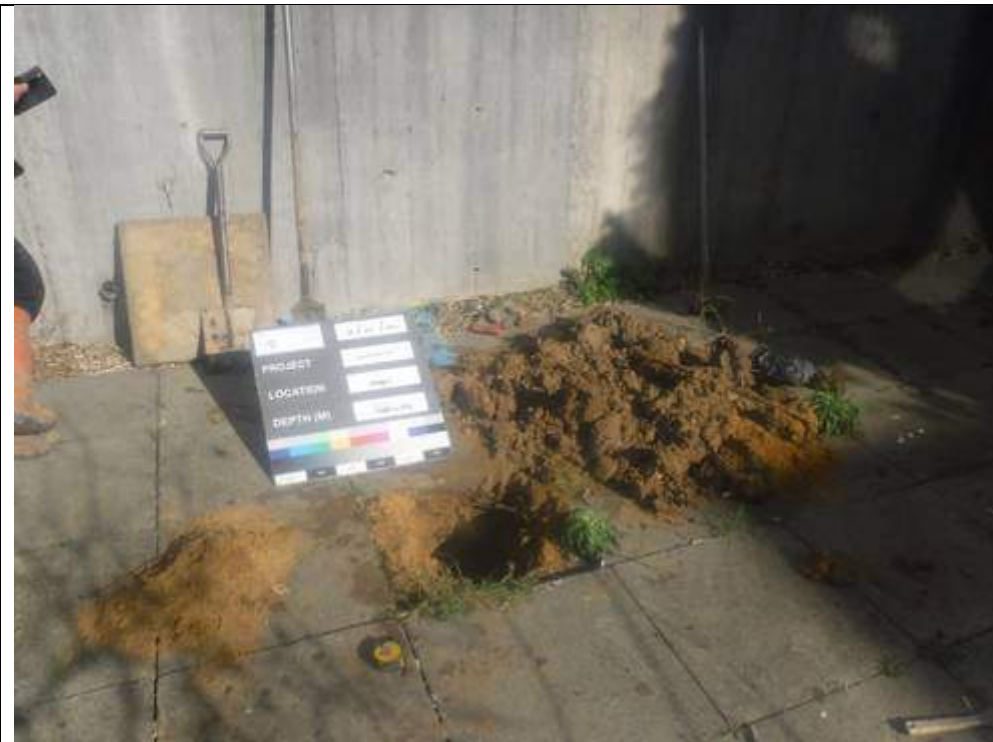
Photo 3 – TP02 arisings.

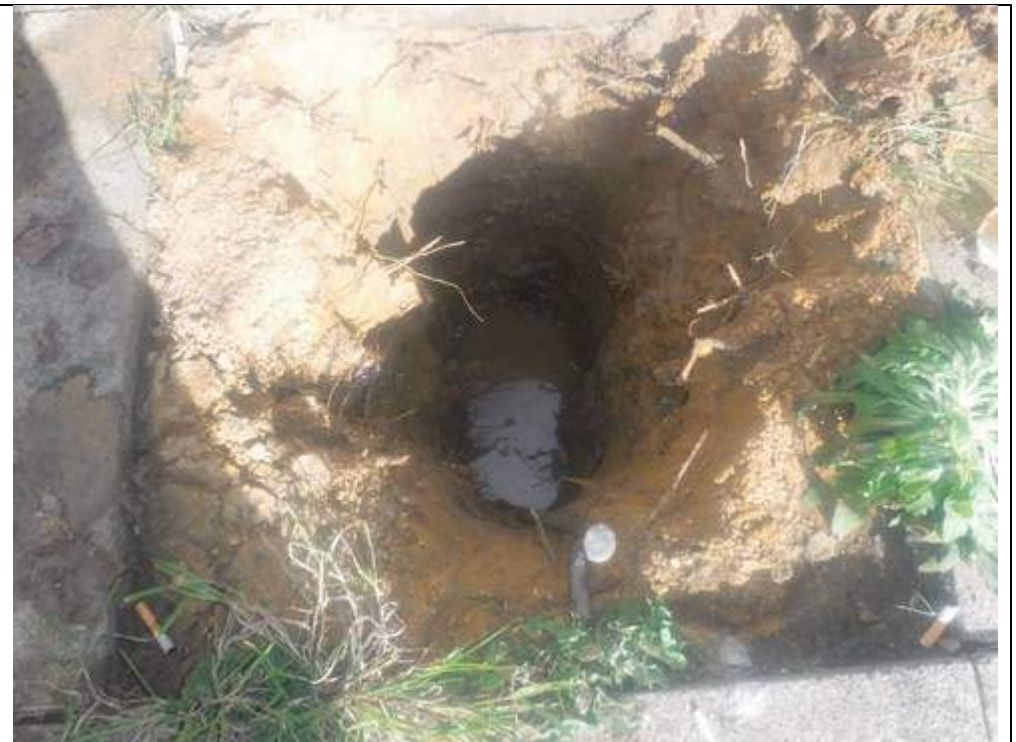
Photo 4 – TP02 excavation.

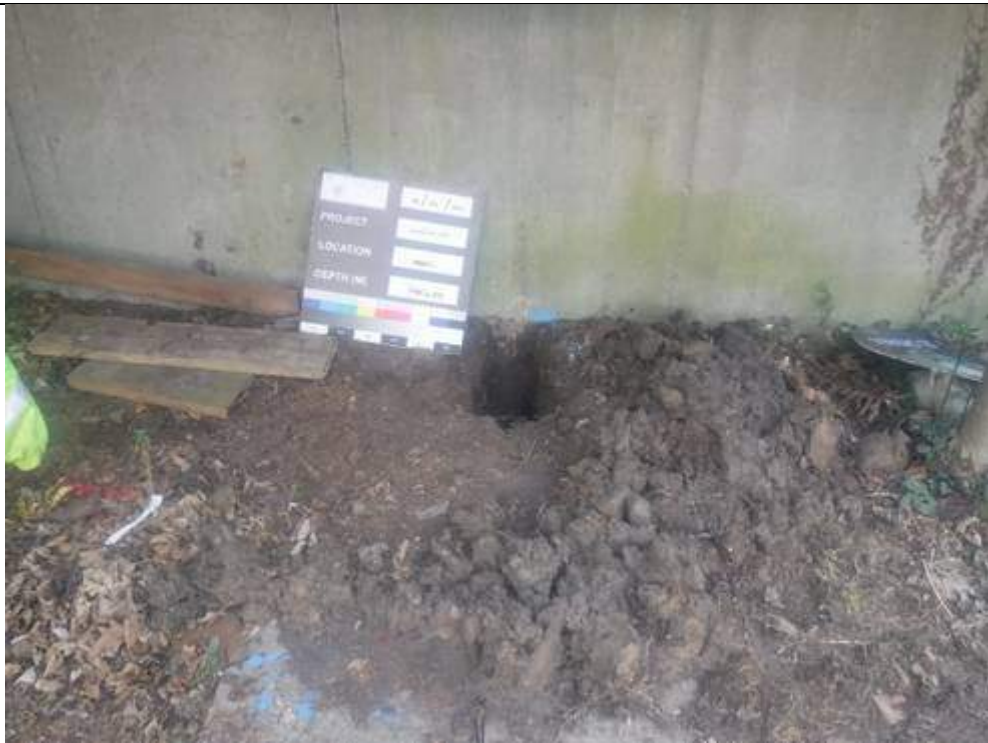
Photo 5 – TP03 arisings.

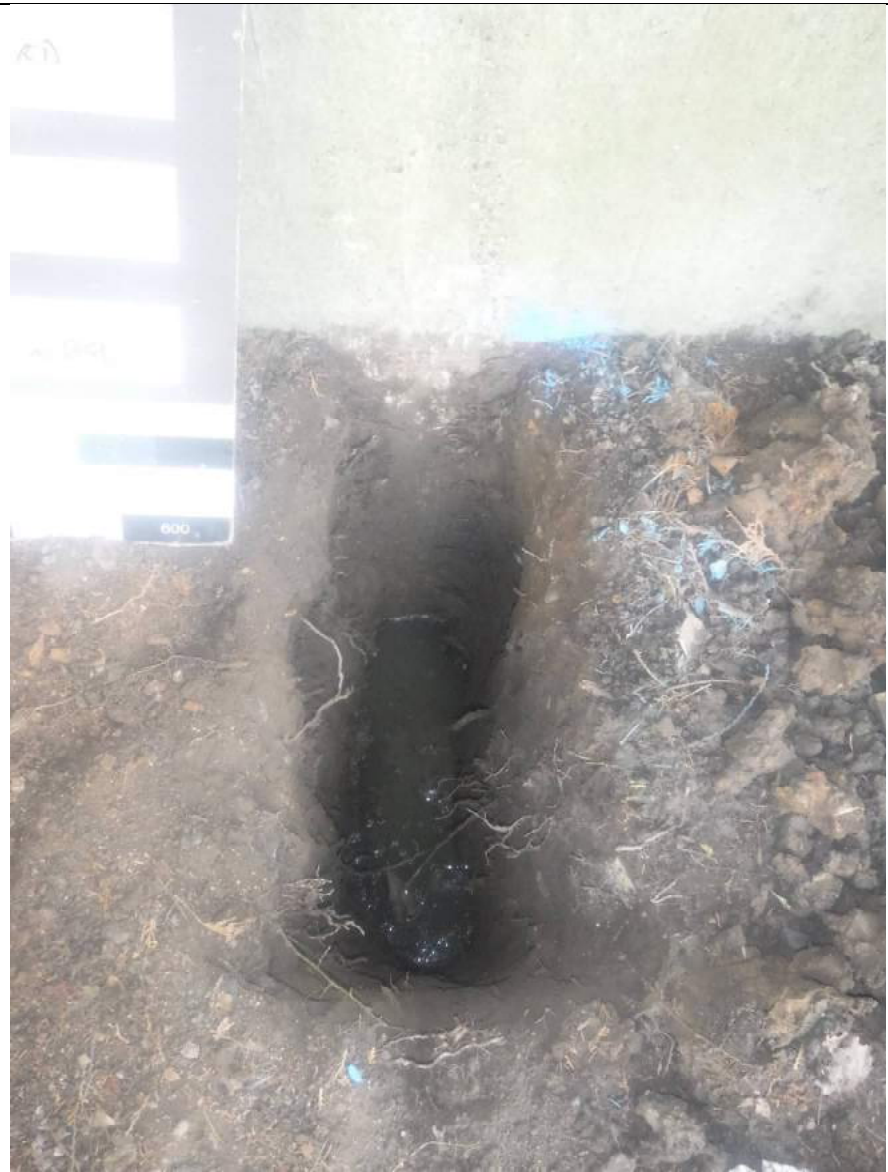
Photo 6 – TP03 excavation.

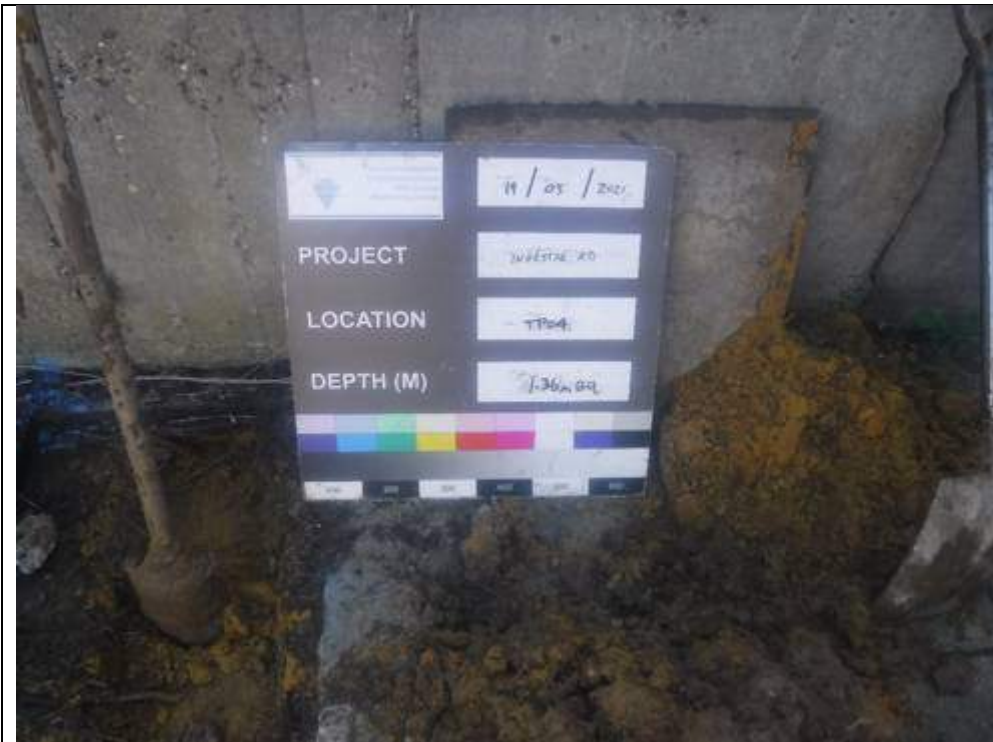
Photo 7 – TP04 arisings.

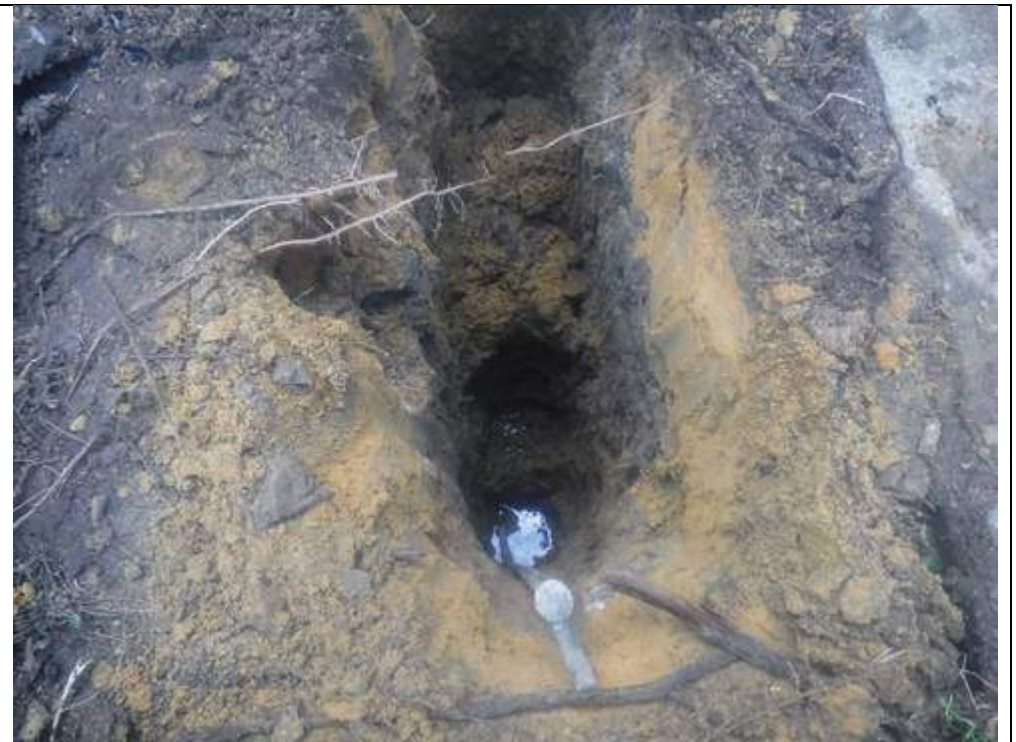
Photo 8 – TP04 excavation.
