bere:architects

8 VILLAGE CLOSE **BELSIZE LANE** LONDON NW3 5AH

DEMOLITION SOUTH WEST ELEVATION

A.G11.E02

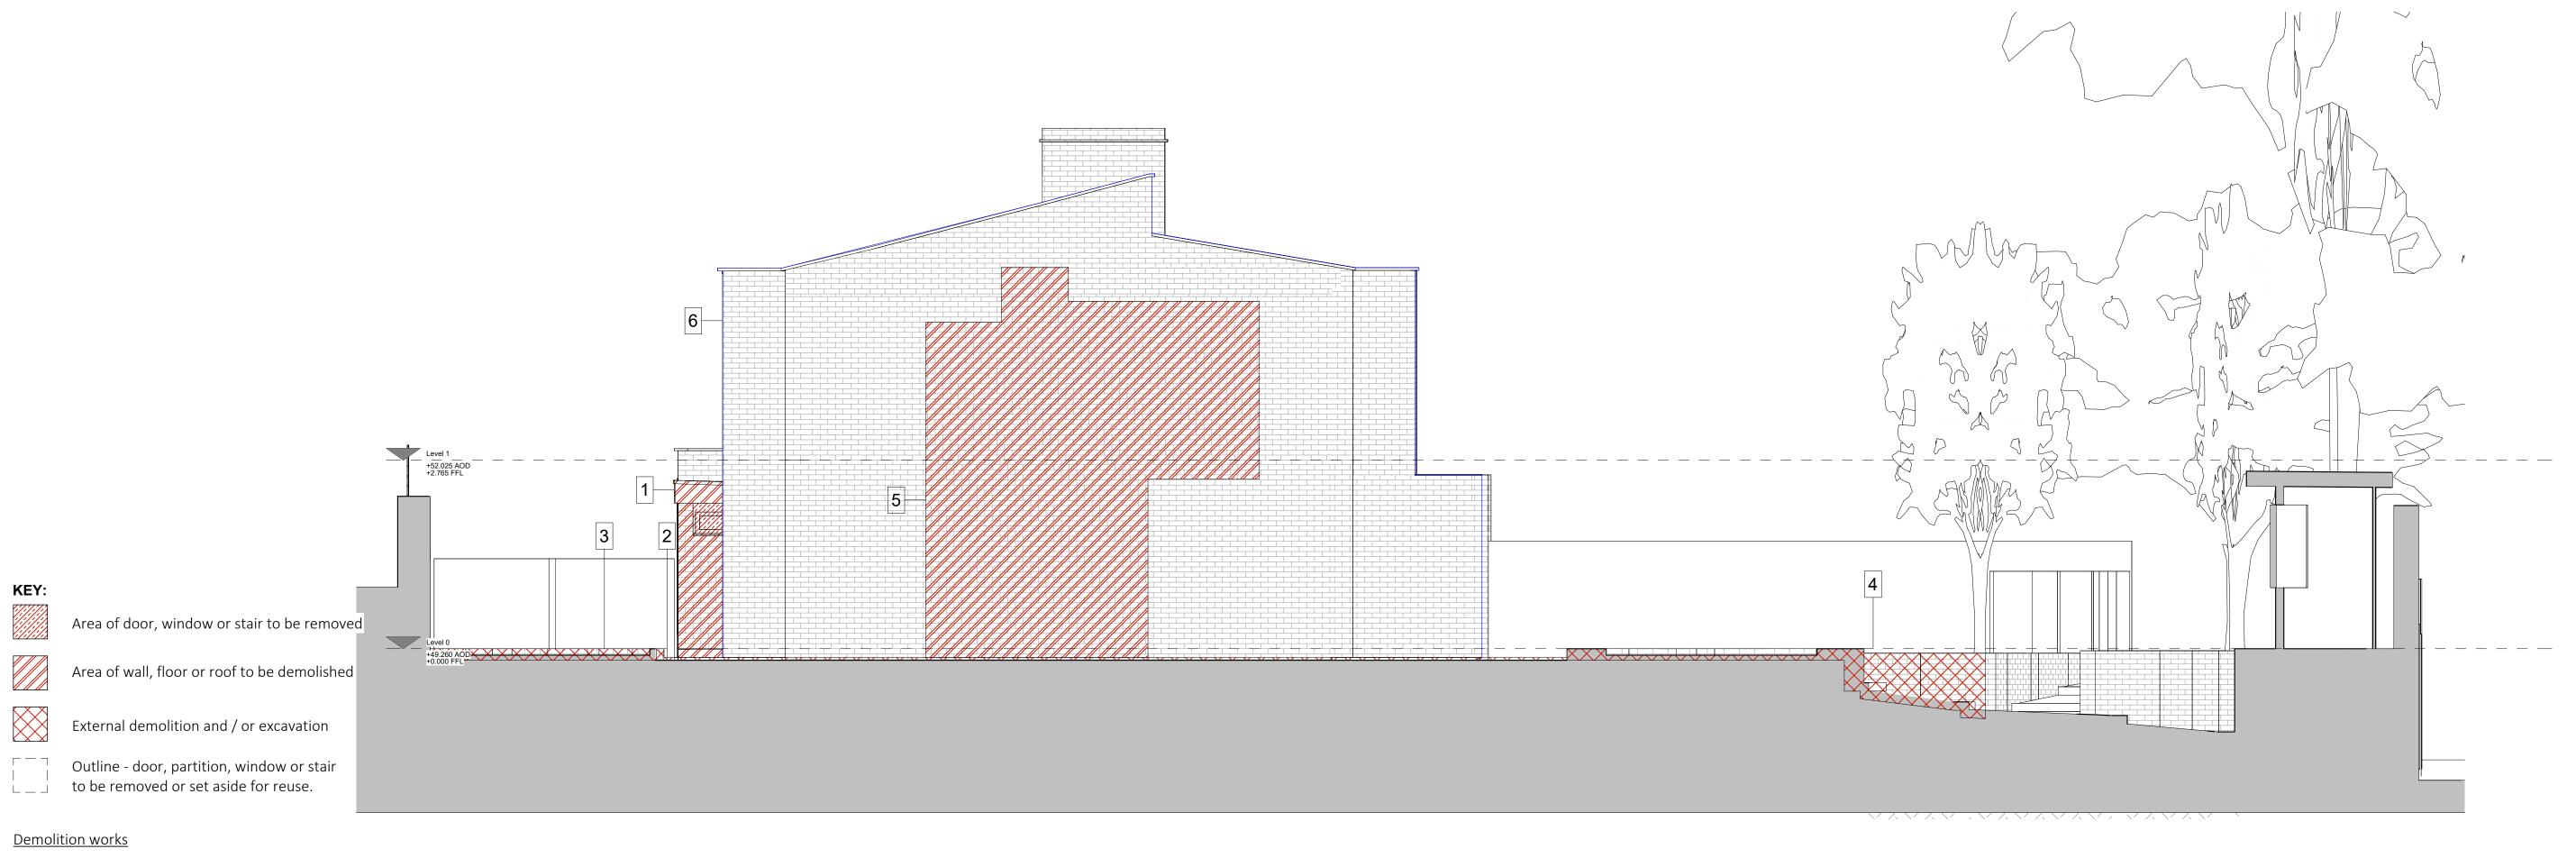
Walls and porch of North West Elevation to be demolished, windows and doors to be removed

2 Paving to be removed

3 Low wall to be demolished

Steps and low walls to be demolished and rebuilt

5 New opening made in existing end terrace wall

6 Outline of existing end terrace wall marked in blue
