GODWIN AND CROWNDALE ESTATE

PHASE II GEOTECHNICAL AND GEO-ENVIRONMENTAL INVESTIGATION *LONDON BOROUGH OF CAMDEN* 03/05/2024

Project: **CONSTRUCTION OF 10NO. RESIDENTIAL DWELLINGS**

Reference: LS 4257

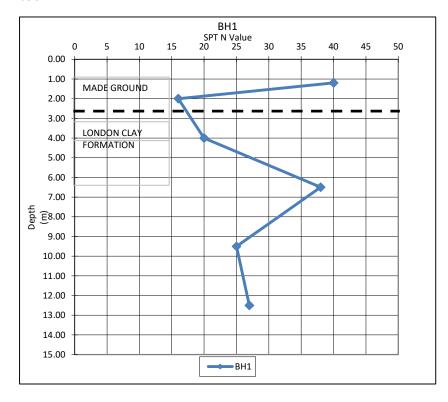
5.1 Standard Penetration Testing (SPT's)

In-situ standard penetration tests (SPT's) were undertaken within CP1, in order to assess the relative density of the materials encountered. The blow count (N) to drive the cone 300mm after any seating blows is recorded, and is used as a measure of the relative density of granular soils (as defined in BS5930:2015). The results may also be used to estimate the consistency of cohesive soils, using an empirical correlation. The results are summarised below.

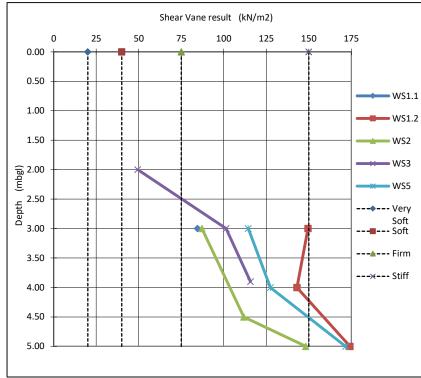
5.2 Shear Vanes

Laboratory shear vane tests were performed on samples of cohesive materials recovered within the boreholes. The test provides a direct estimate of undrained shear strength, and in turn may be used to give an indication of consistency as defined in BS5930. The results are summarised below.

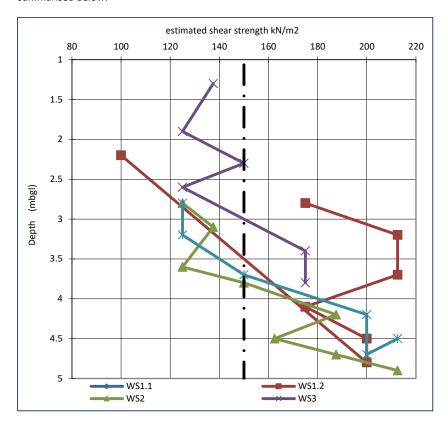
5.3 Penetrometers

Hand penetrometer tests were performed on samples of cohesive materials recovered within the boreholes. The test is used to approximate undrained shear strength and in turn has been used to give an indication of consistency as defined in BS5930. The results are summarised below.
