1, 4 & 7 Triton Square Isolations

Date: 1st March 2018

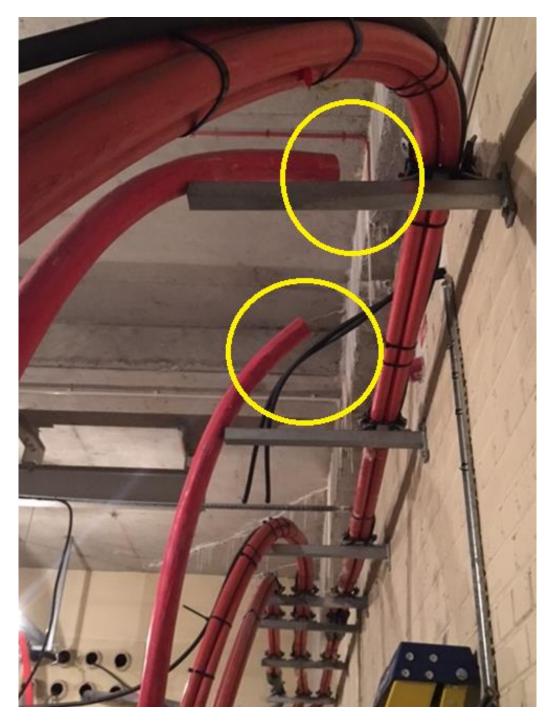
1. The two High Voltage (HV) JP Morgan supplies were disconnected and the cables cut from within the UKPN sub-station and in the switch rooms.

JP Morgan HV cables cut from within the UKPN switch room.

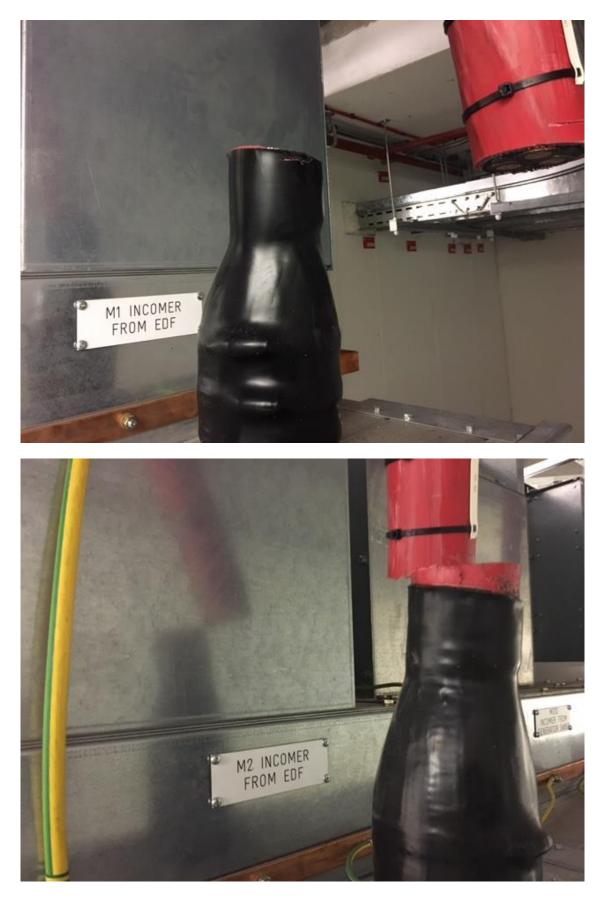
JP Morgan HV cables cut from within the two switch rooms.

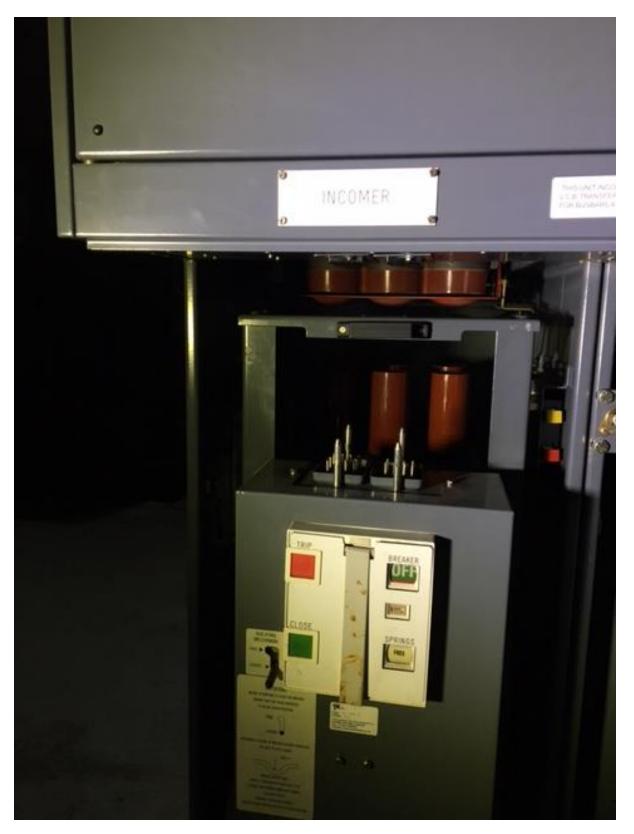
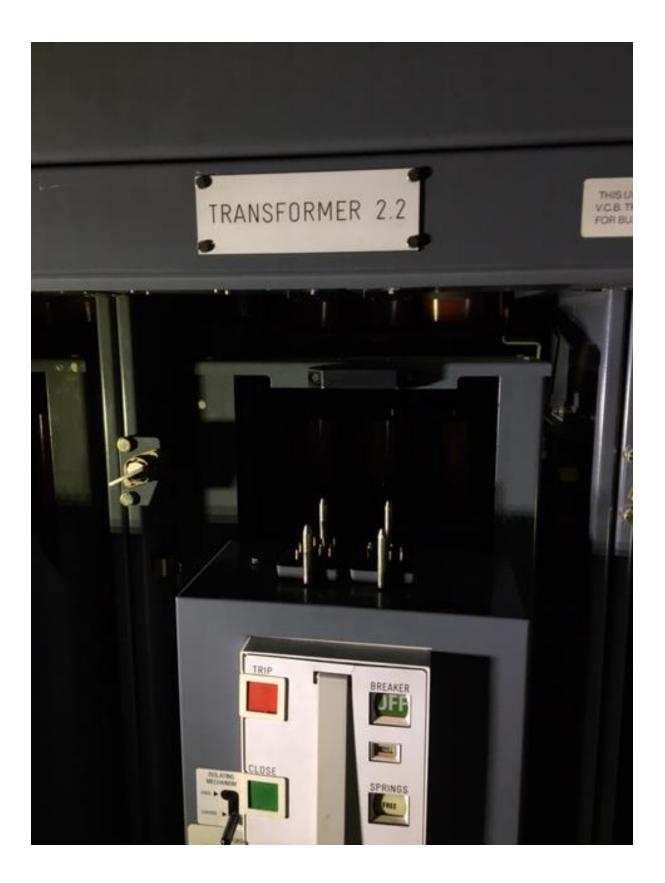
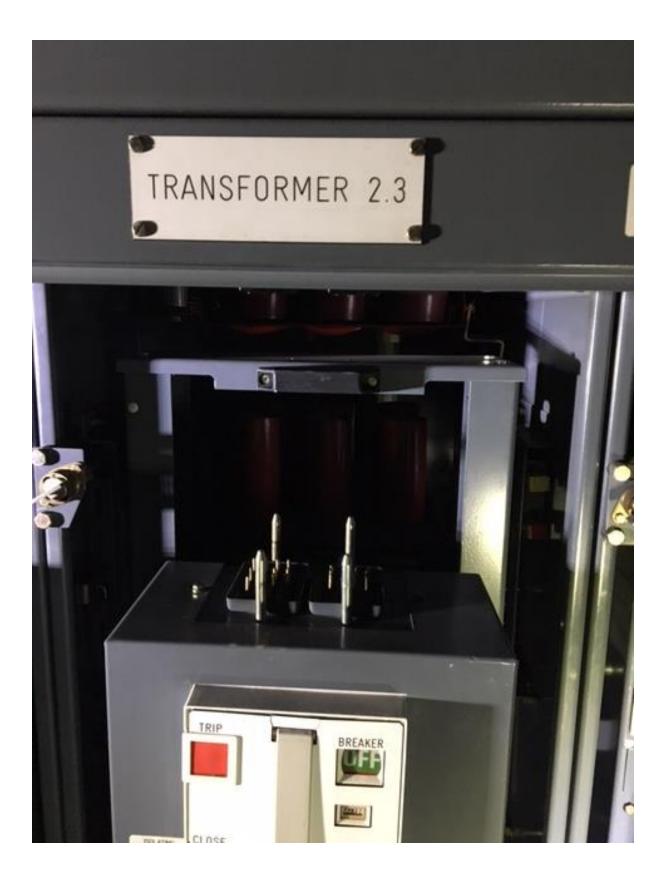
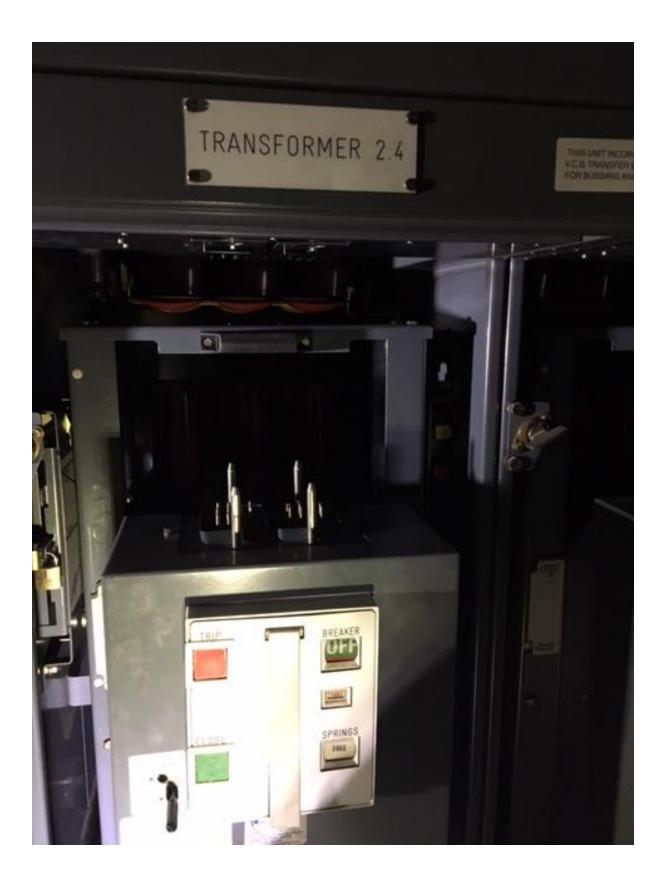
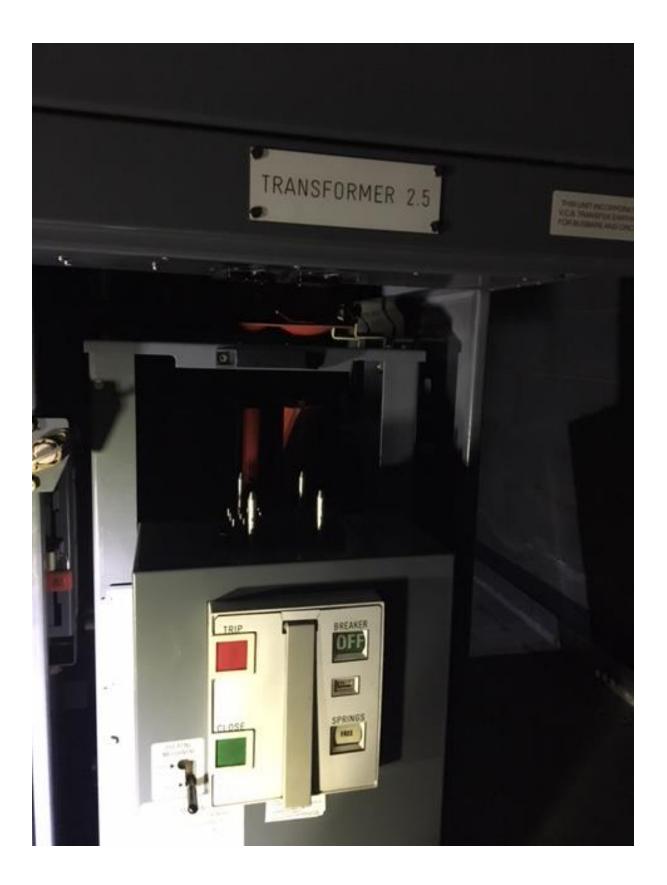
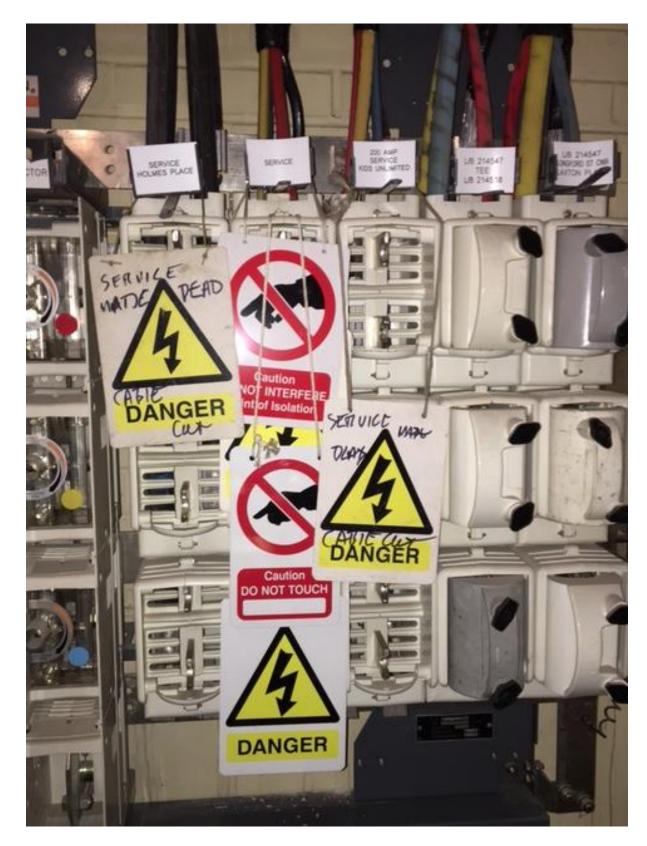
2. The Landlords HV supplies were racked out and the EPO pushed to isolate power back to the UKPN substation.

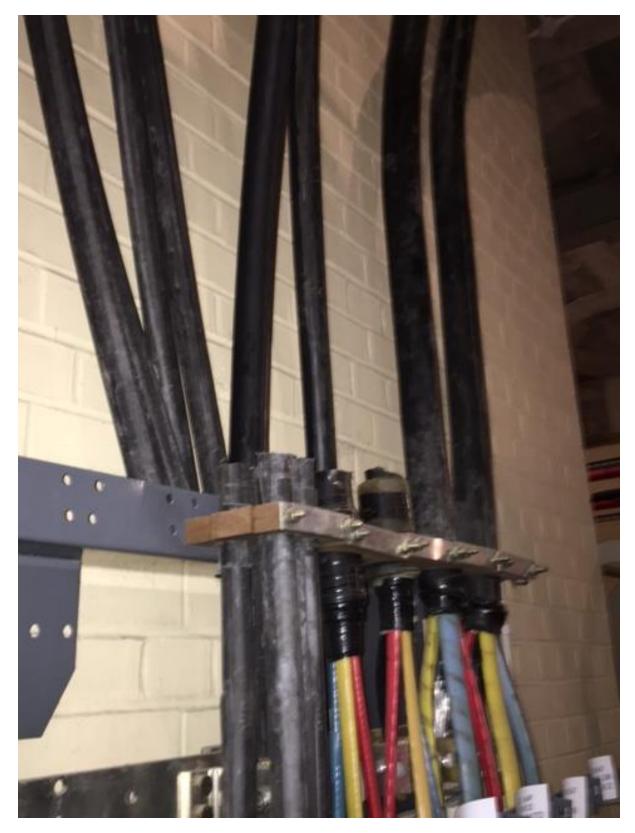
3. The three Low Voltage supplies to the Gym, Nursery and Service (unknown supply) were disconnected and the cables cut from within the UKPN substation and within the retail unit.

The Gym (Homes Place), Nursery (Kids Unlimited) and Service (Unknown) supplies cut within the UKPN sub-station.

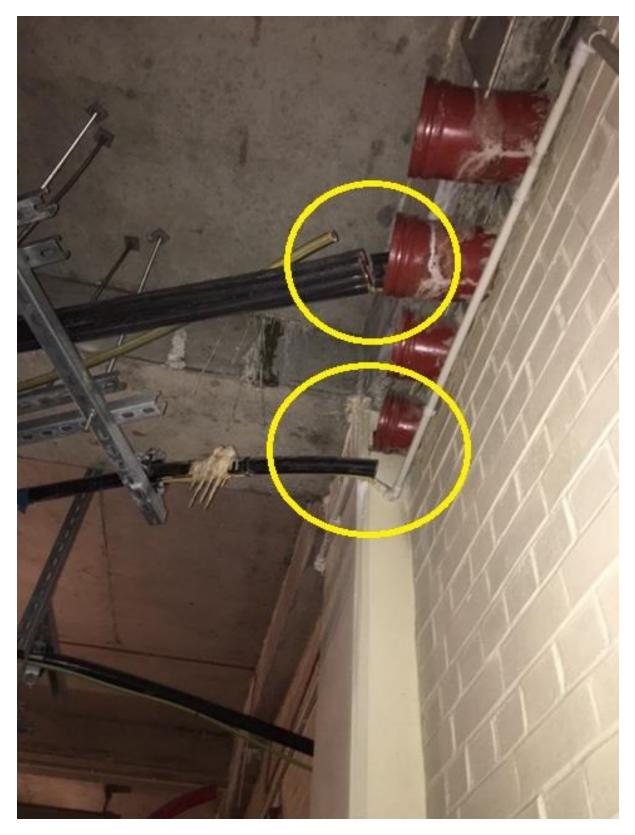
Gym (Homes Place) and Nursery (Kids Unlimited) supply cut with in UKPN sub-station.

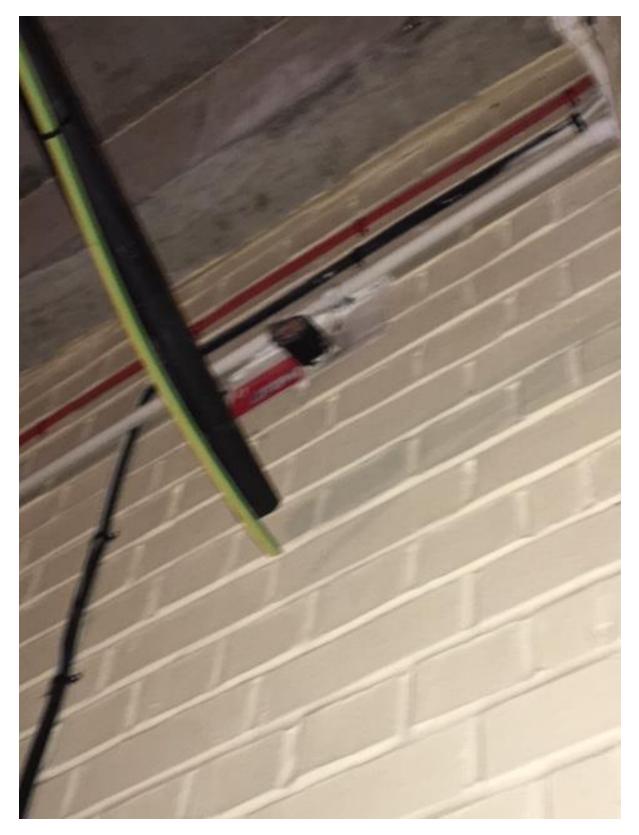
Service (unknown) supply cut within UKPN sub-station.

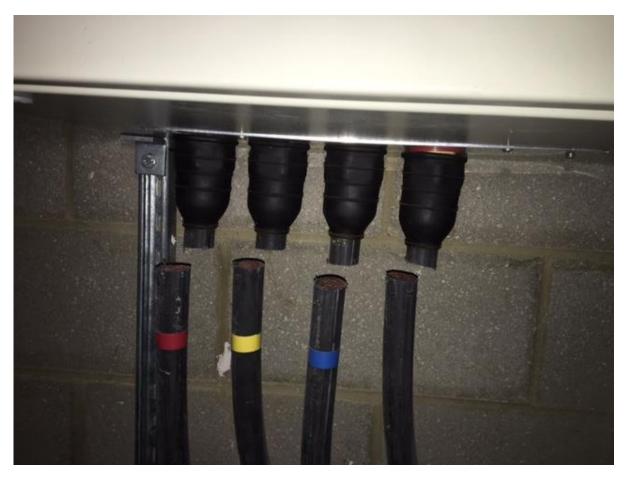
LV Supply cut from within the gym (Homes Place).

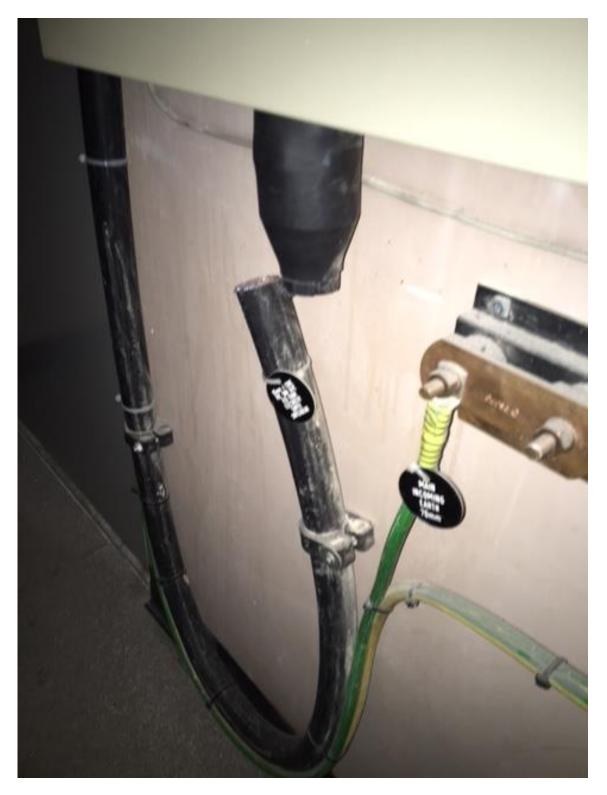
LV supply cut from within the Nursery (Kids Unlimited)

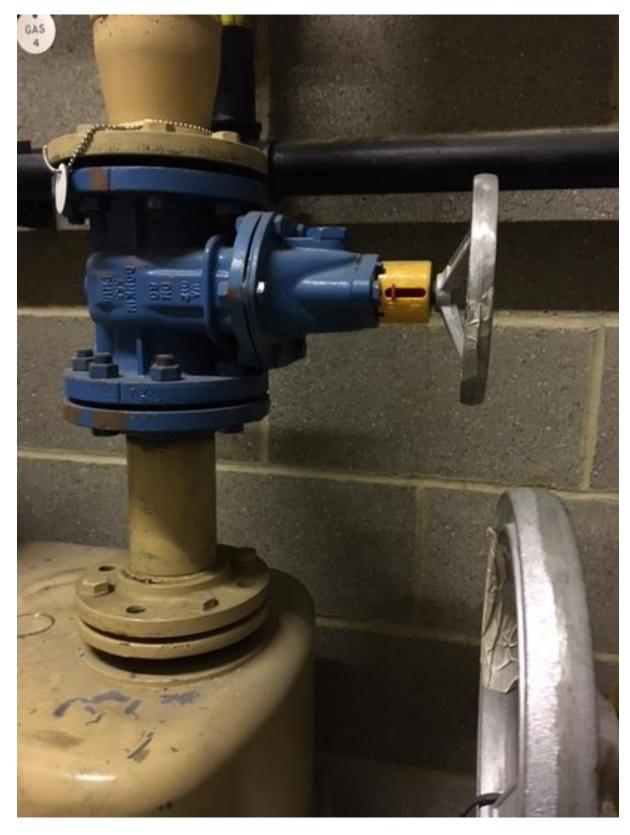
4. The gas supplies to the Landlords Boilers and Gym were shut off and a gas tightness test was carried out to prove the valves hold.

Landlords gas supply isolated

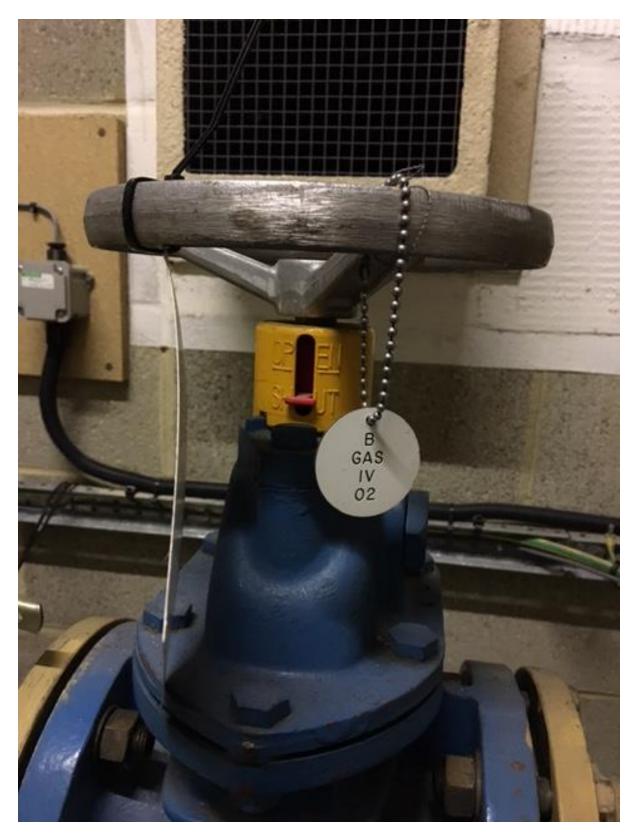
Gym Gas supply isolated

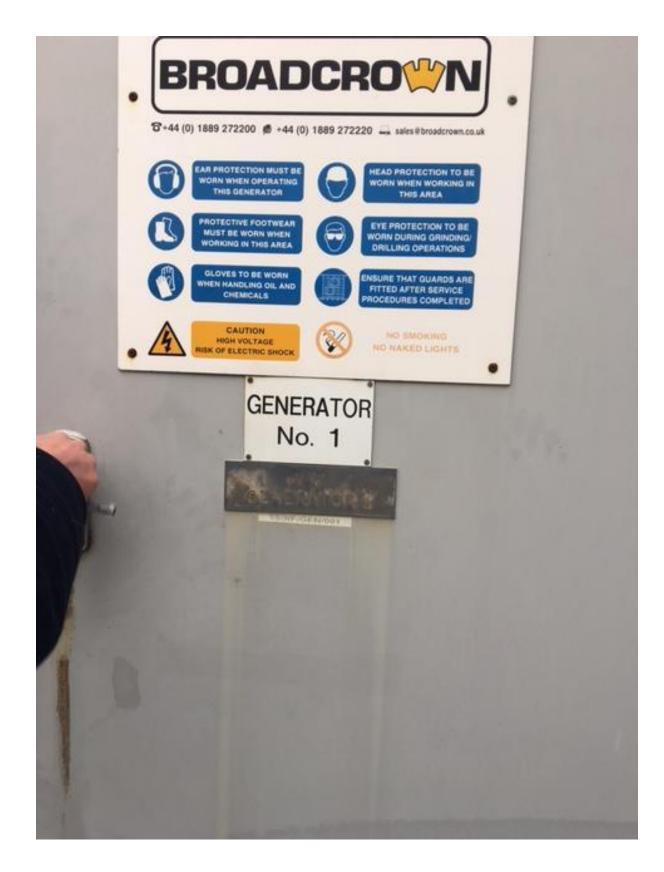
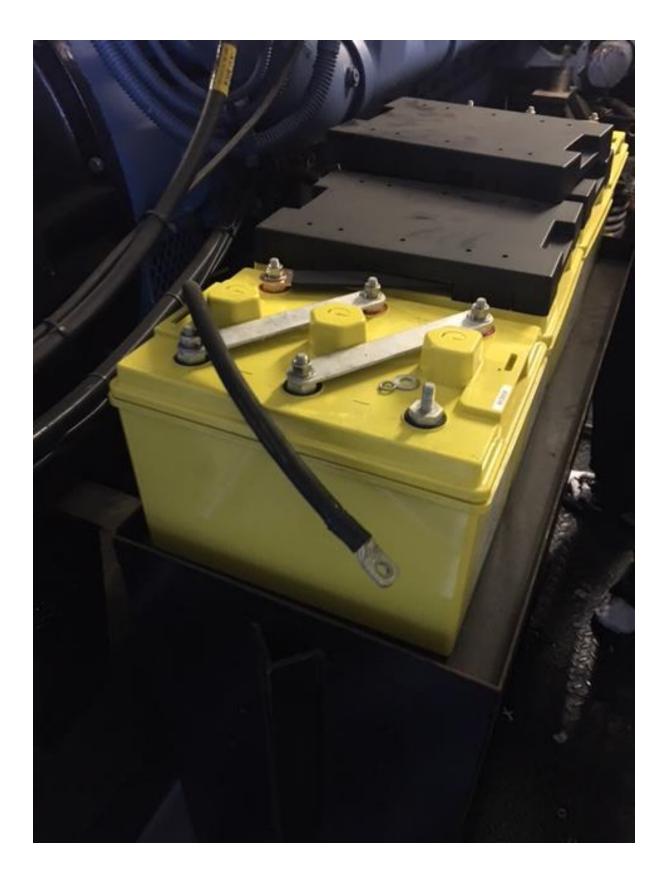
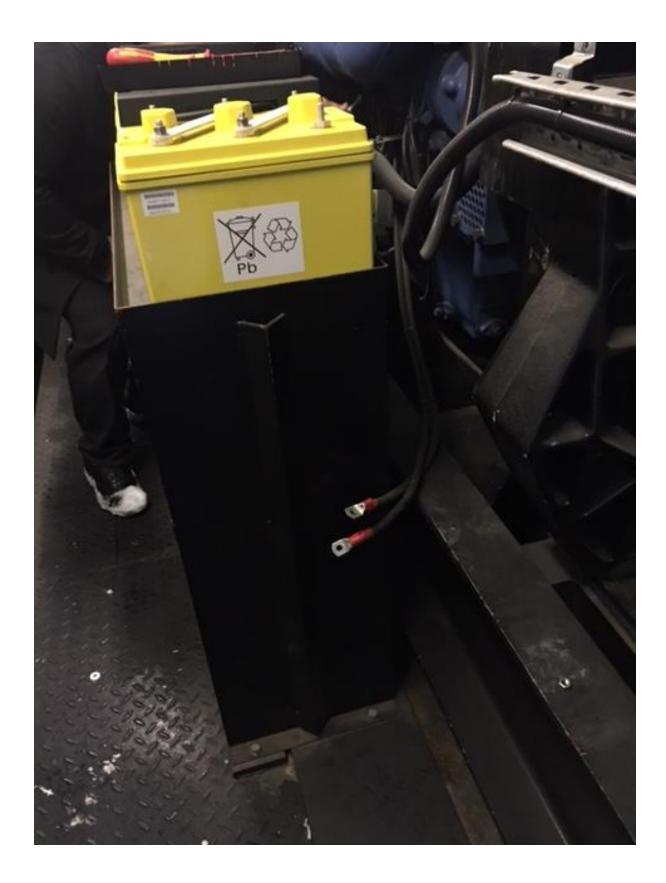
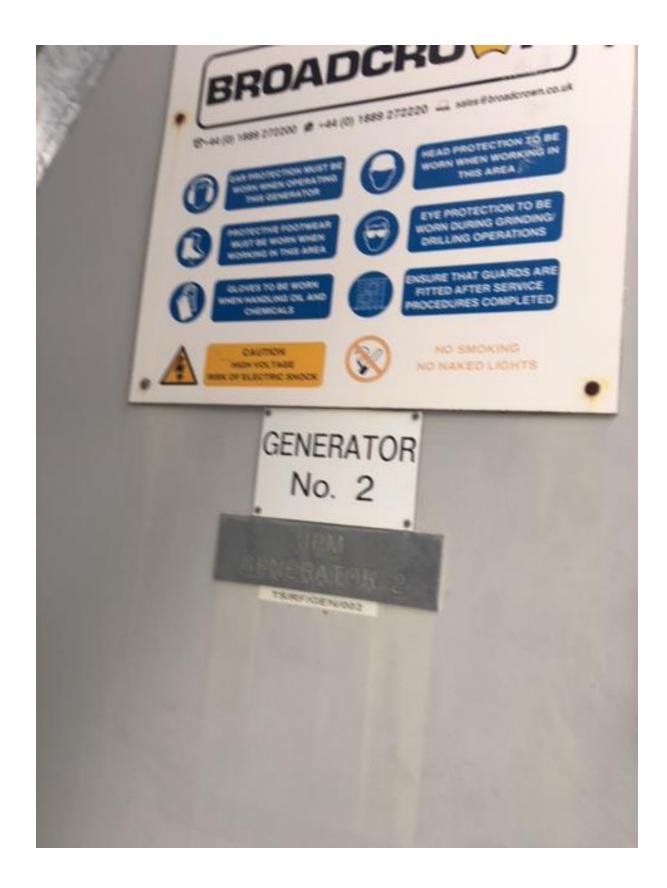
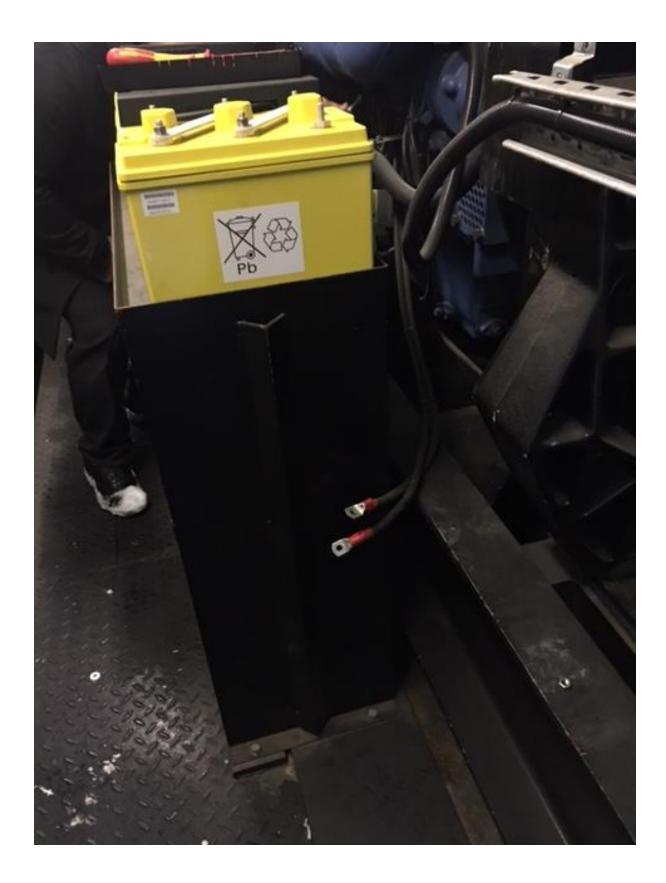
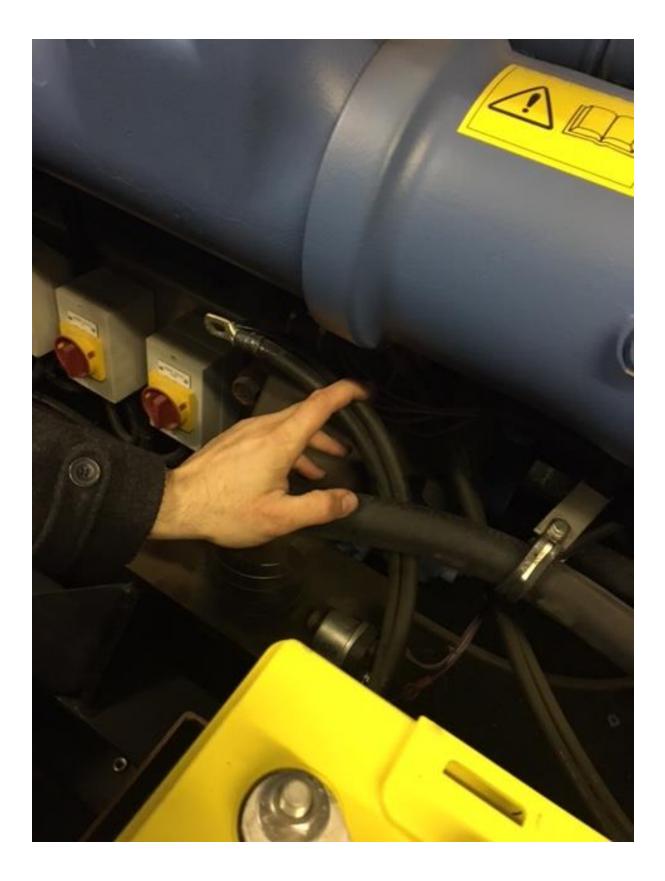
JP Morgan

5. All Generator starting batteries were disconnected.
