# **12 PARK VILLAGE WEST** **London NW1 4AE**

Historic Fabric Assessment

March 2024

## **Historic Fabric Assessment**

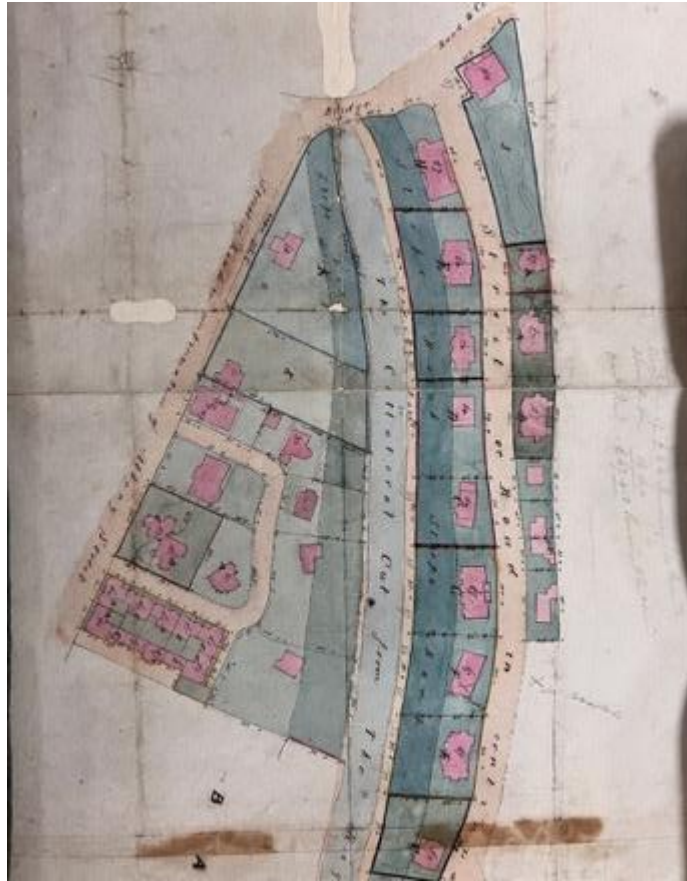
Figure 5. Plan of Village Land in the Regents Park belonging to John Nash, probably 1833 (National Archive ref MR 1/1905)

- 2.1.3 *Plan of Village Land in the Regents Park let to John Nash*, (National Archive ref: MR 1/1905) shows No. 12 Park Village West with a proposed rent fee of £2 (Figure 5). The map is undated. However, annotations suggest it was drawn in the early 1830s, likely 1833. This map also confirms that the land of Park Village West and East was leased to John Nash for 99 years from 5<sup>th</sup> January 1824. The outbuilding occupies the northwest corner of the garden of No. 12. However, the position of the Tower House is slightly different from the current position of the building, suggesting that the map presents the proposal rather than the existing buildings. Thus, the position and size of the coach house (outbuilding), which are drawn on this map, are also a proposal rather than the survey of the existing building.

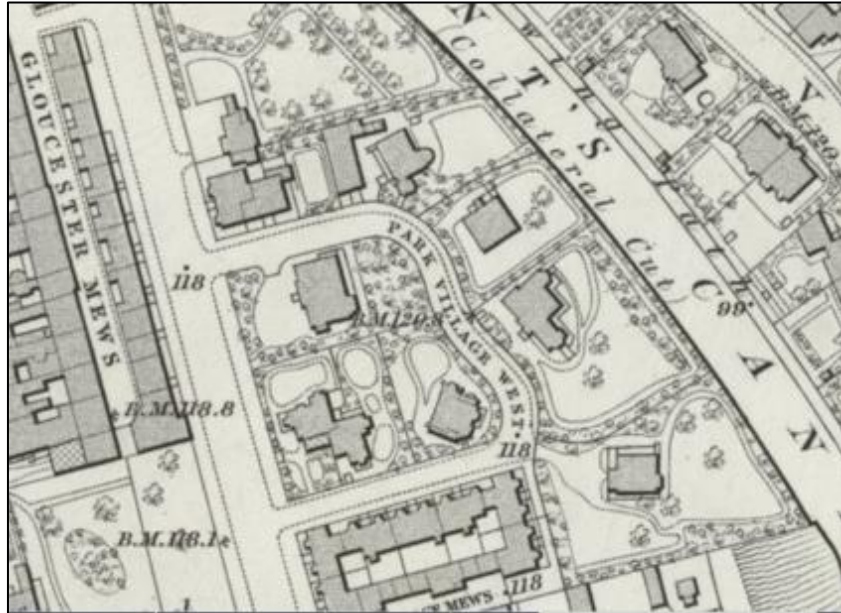
Figure 8. OS Map of 1870 (National Library of Scotland)

- 2.1.9 There are no maps illustrating the details of the tower house and coach house before 1870. The site and buildings' layout is well depicted on the Ordnance Survey Map of 1870 (Figure 8). The footprint of the coach house is different to now in that it is seen as extending as far as the northern boundary wall, rather than its current setback position, and its southern elevation was set at an oblique angle. It is also worth noting that it had a relatively narrow access path set slightly to the right of the centre.
- 2.1.10 There was also a small outhouse to the north of the house, apparently connected to the coach house by a wall. This has been replaced by the current link containing the gym (Dollamore and Collins, 2022).

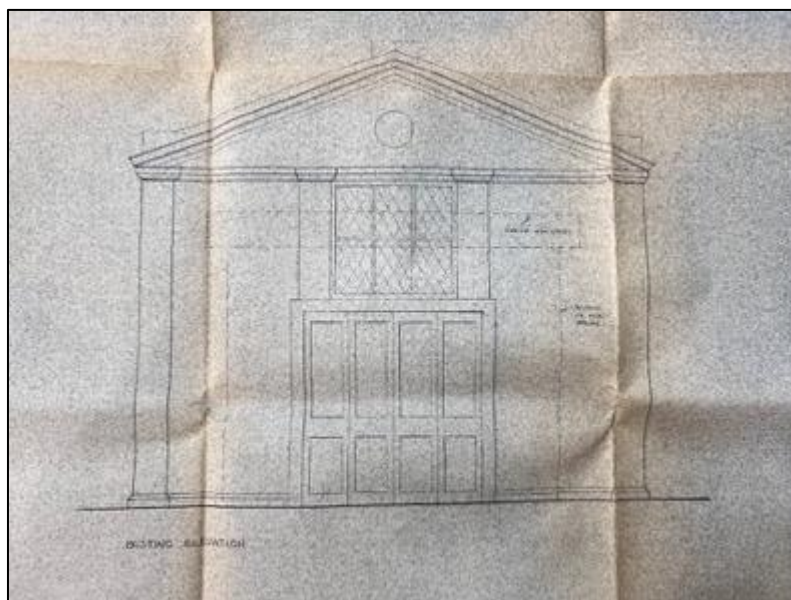
Figure 25. Existing south elevation of 12A park Village West as per drawing 40/10 by John Burkett ARIBA, 1958 (National Archive Ref CRES 35/3545)

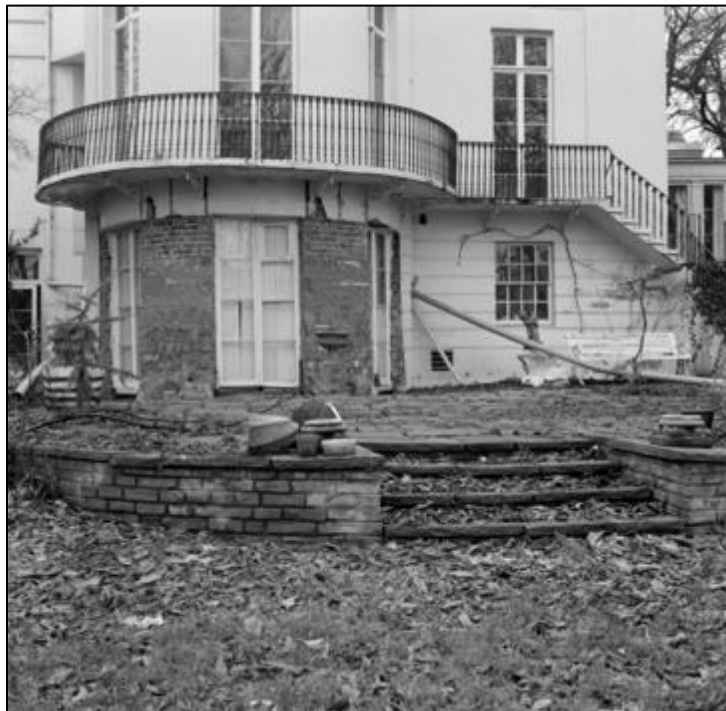
1976 (Figure 28). It is evident that the Tower House's north elevation was in rather bad condition at this time (Figure 29).

Figure 29. 12 Park Village West in 1976. Photo by John Donat (RIBA Pictures Collection)

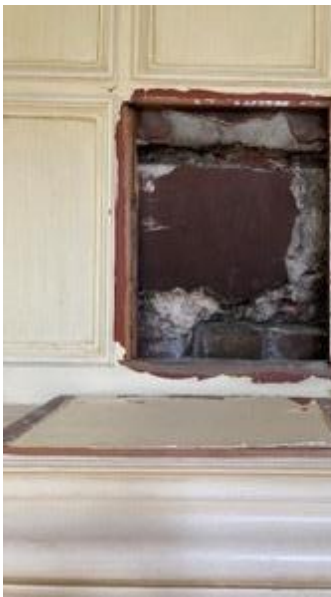
*Figure 40 Main house dining room: area of original fabric exposed above the mantelpiece on the south wall*

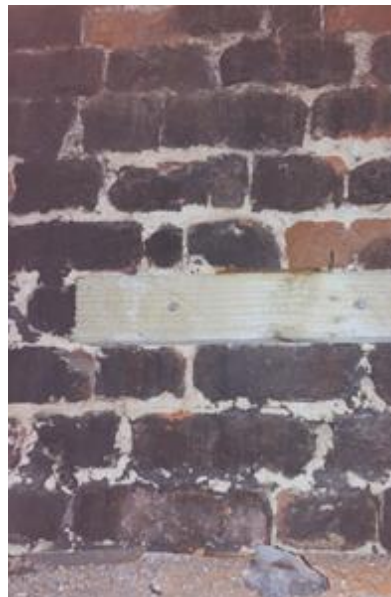
*Figure 41 Area of exposed original fabric observed in the attic space above the main house first floor landing*

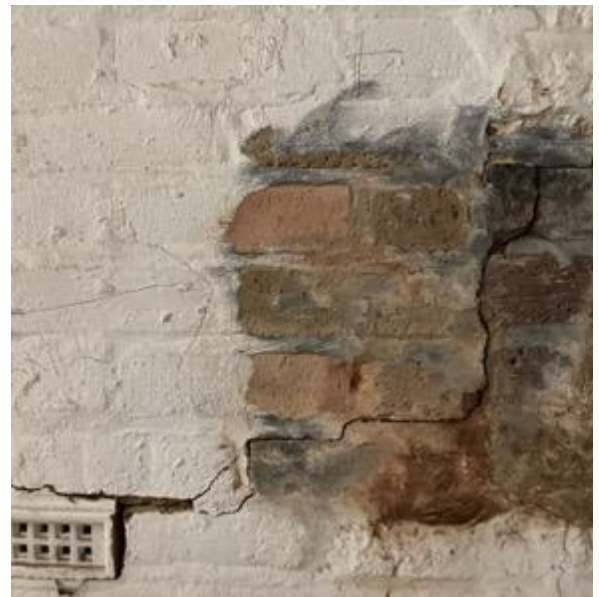
*Figure 42 Area of fabric exposed through paint stripping on the fireplace on the ground floor of the coach house*

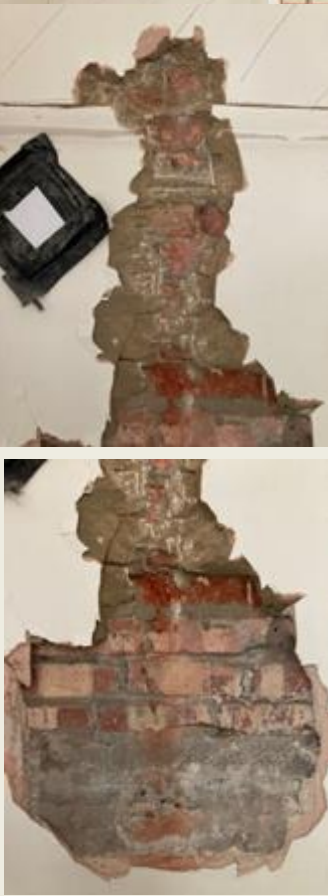
**Basement Kitchen - OU2: was the original fabric in the south-east corner of the basement kitchen ever altered?**

<p data-bbox="651 1234 933 1339">Three views of the fabric exposed in the kitchen</p>

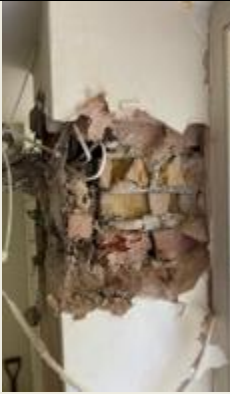
<p>Pier between the central and western windows</p>

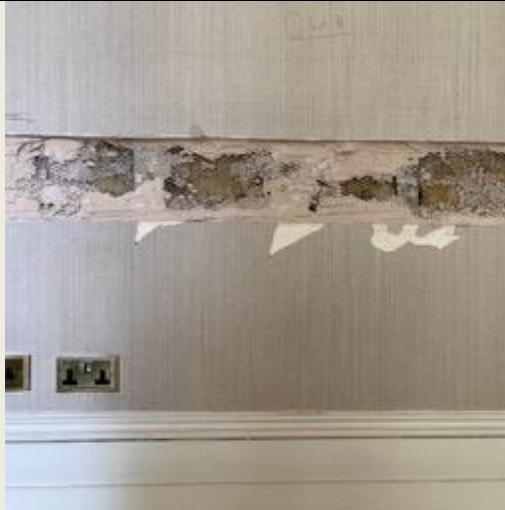
<p data-bbox="539 790 1046 869">View of the east elevation of the Reception Room west wall</p>

<p data-bbox="1058 768 1476 846">Central heating layout, 1968 (Nat. Arch. CRES38/1540)</p>
<p>Following the removal of plaster, it became evident that the partition forming the west wall of the Reception Room is completely modern. Sources from the 1960s show the partition in its current form, however, the thickness of the wall and the use of wire mesh and yellow stock bricks has been observed in interventions dating to the 1980s and confirmed the age of this structure.</p>

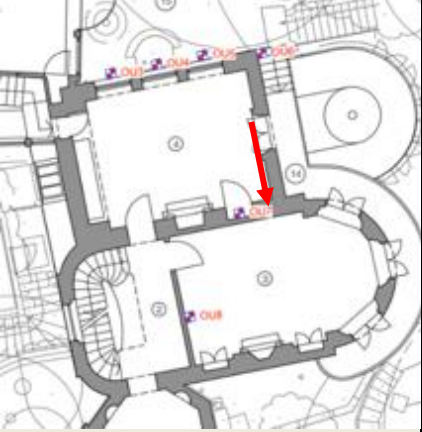
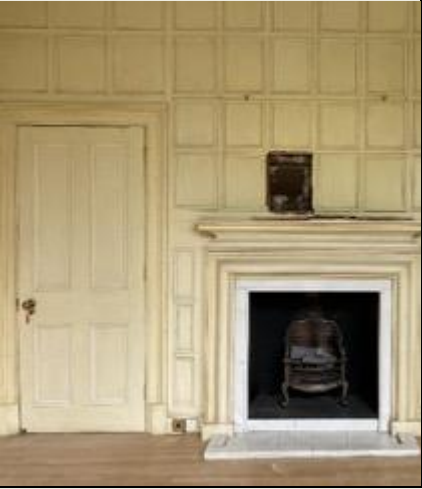
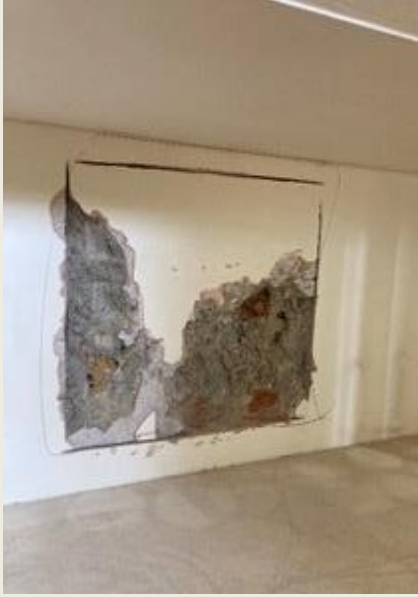
**Main house ground floor - OU7: is the fabric inside the easternmost cupboard of the Dining Room original?**

<p data-bbox="595 875 954 981">View of the interior of the cupboard to the east of the fireplace</p>

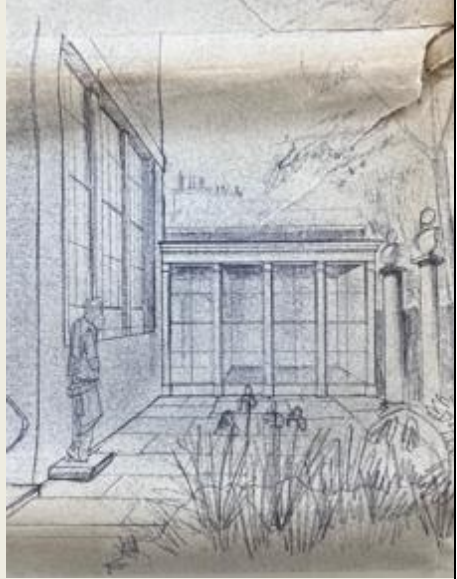
<p data-bbox="1018 884 1476 958">Drawing dating to 1958 (Nat. Arch. CRES/3545)</p>

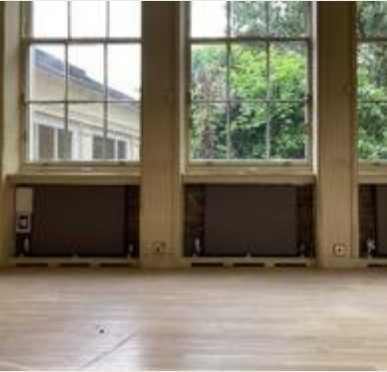
<p data-bbox="539 1184 764 1279">Area of brickwork under central window</p>

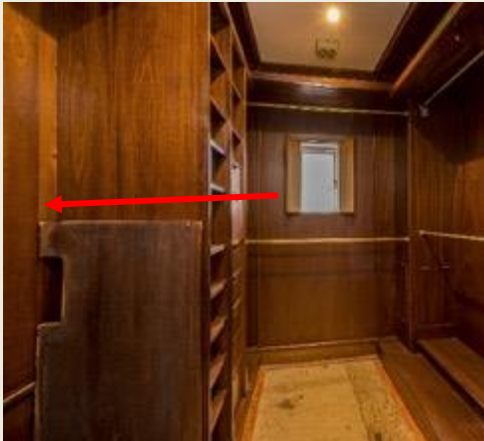
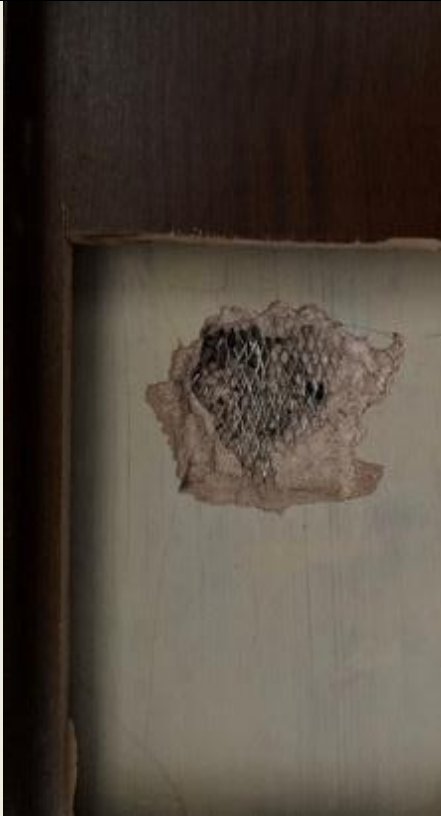
**Main house first floor - OU9: was there an additional opening on the first-floor landing?**

<p data-bbox="644 1090 1062 1196">View of the inspection of the fabric behind the wooden panel of the wardrobe</p>

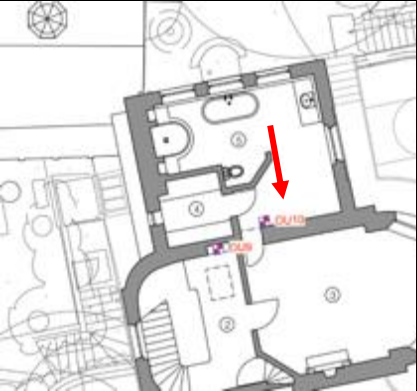
**Main house ground floor - OU10: was there a fireplace on the south wall of the large bathroom on the First- Floor?**

<p data-bbox="1110 891 1469 969">Plan of the First-Floor dating to 1958</p>
<p>The removal of wall paper and plaster from the south wall of the large bathroom on the first-floor of the main house revealed the former presence of a fireplace. The recess has been blocked with yellow stock bricks keyed into the pre-existing original wall. The existence of the fireplace was known from historic drawings.</p>

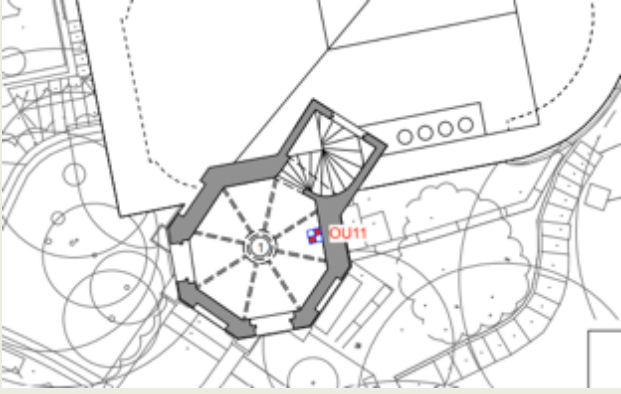
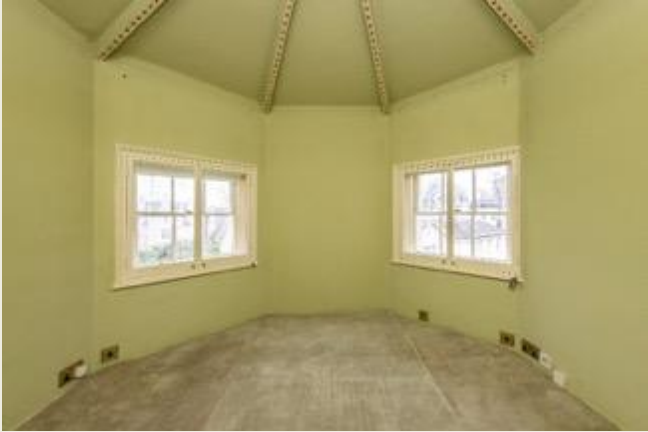
**Main house second floor - OU11: is the flooring on the second floor of the tower original?**

<p data-bbox="818 1014 1385 1120">View of the double layer of wooden boards forming the floor on the top level of the tower</p>	<p data-bbox="1417 291 1540 436">No evidence was found</p>
<p data-bbox="135 1137 1540 1279">A few timber boards were removed close to the edge of the step in the floor of the top of the tower in the main house. The removal of the modern boards revealed a lower level floor, of likely 20th century creation. On close inspection, the joists supporting the currently concealed floor appear to be original however this will need confirmed by a more extensive exposure of the timbers.</p>

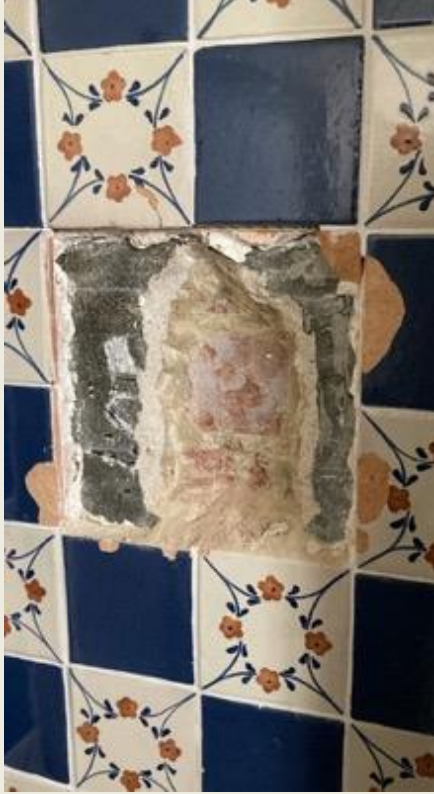
### Coach house ground floor: how much of the original middle wall of the Coach House survives?

<p data-bbox="619 1070 1023 1182">View of the inspection area in the ground floor bathroom of the coach house</p>

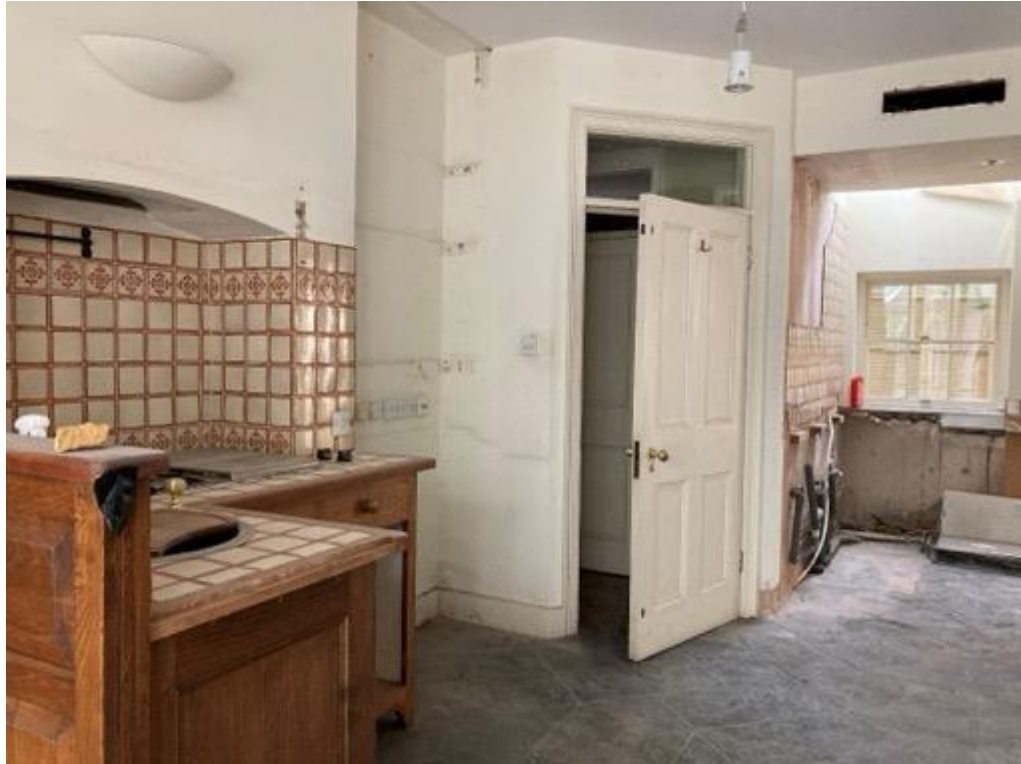
*View of the bathroom formed in the original kitchen space*

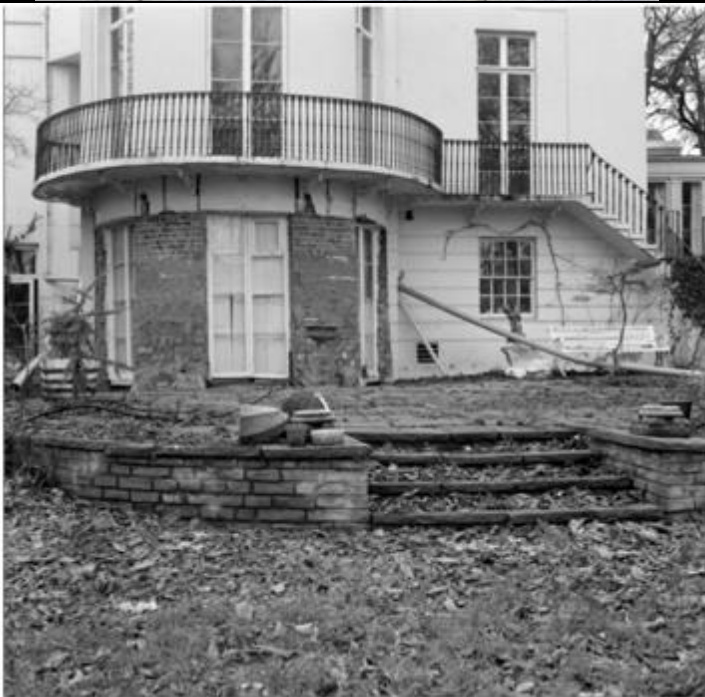
<p>RIBA photograph of garden side, 1976, the plaster of the lower ground floor had been removed, probably to address issues of damp.</p>
1987	<p>Plan from Camden Archives showing interventions undertaken in 1987. The plan shows three windows on the kitchen north wall. A label pointing to the left window says "HIGH LEVEL WINDOW REMAINS". A label on a sectional elevation through the kitchen points towards the central window and says "EXTENDED WINDOW" and "NEW EXTENDED WINDOW".</p>

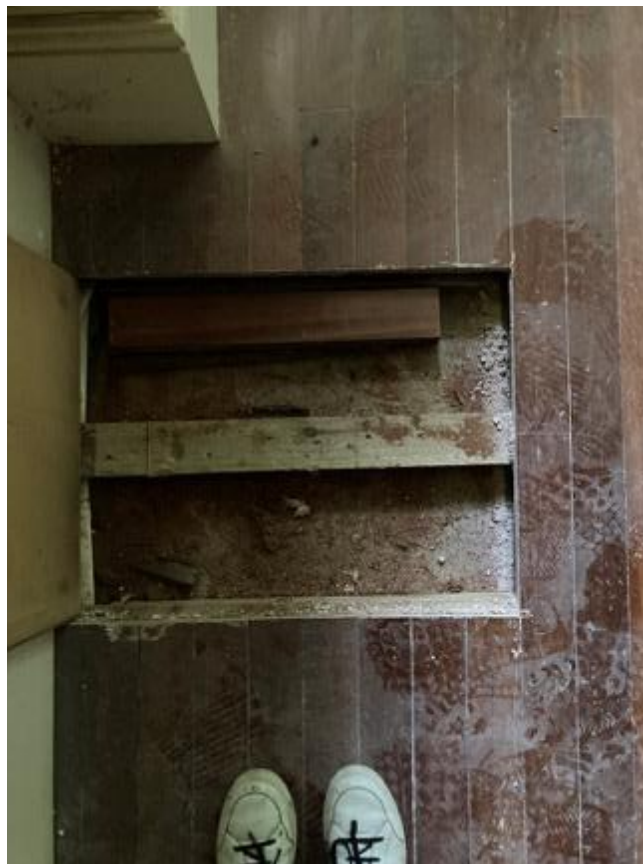
- 8.1.4 The sitting room in the basement area was altered considerably in the second half of the 20th century. The original floor appears to have been removed and a concrete slab replaced the void present in the original layout while hardwood flooring was installed in 1987. Ducts were created leading from the bay windows into the kitchen, this entailed loss of fabric in the wall adjoining the kitchen too.
- 8.1.5 The sitting room ceiling was replaced in the bay area where a concrete slab is now. It is possible that the intervention was necessary due to the failure of the bay window ceiling, which supports the weight of the balcony.

*View of the replaced wooden floor and concrete base*

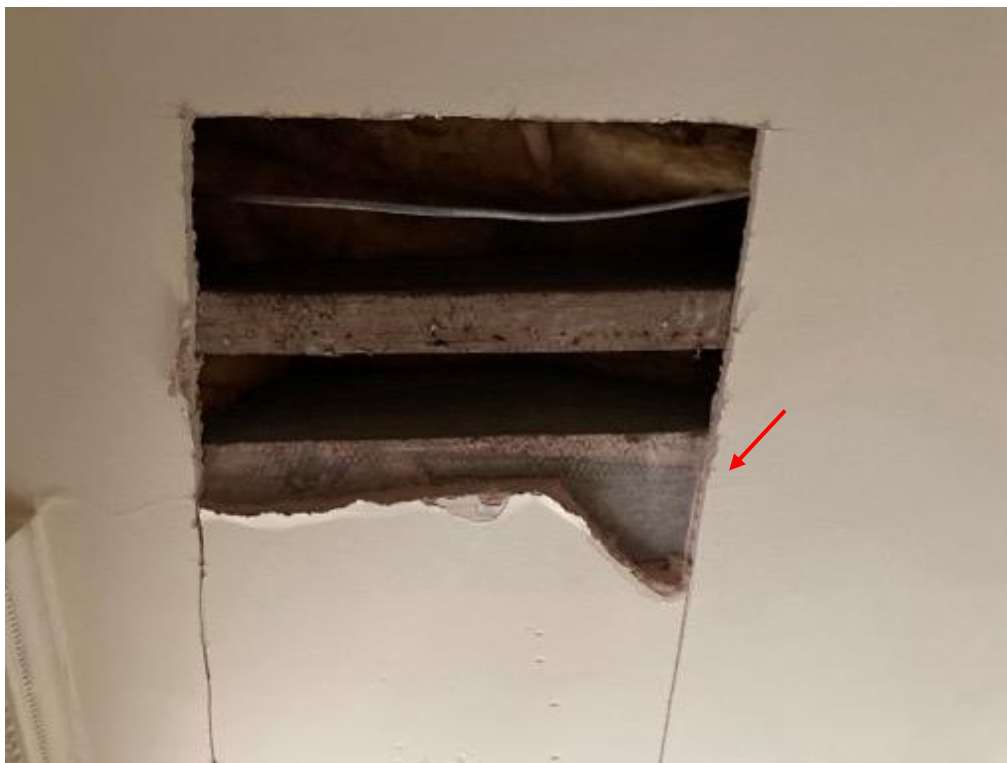
- 8.1.6 As part of the alterations to the sitting room in the basement, it was observed that the bay window ceiling was replaced with a concrete slab supported on lateral posts. The intervention was probably necessary due to structural failures caused by the prolonged weight of the balcony on the basement structure. The slab replaced a structure of original joists.

View of the ceiling concrete slab in the Basement sitting room

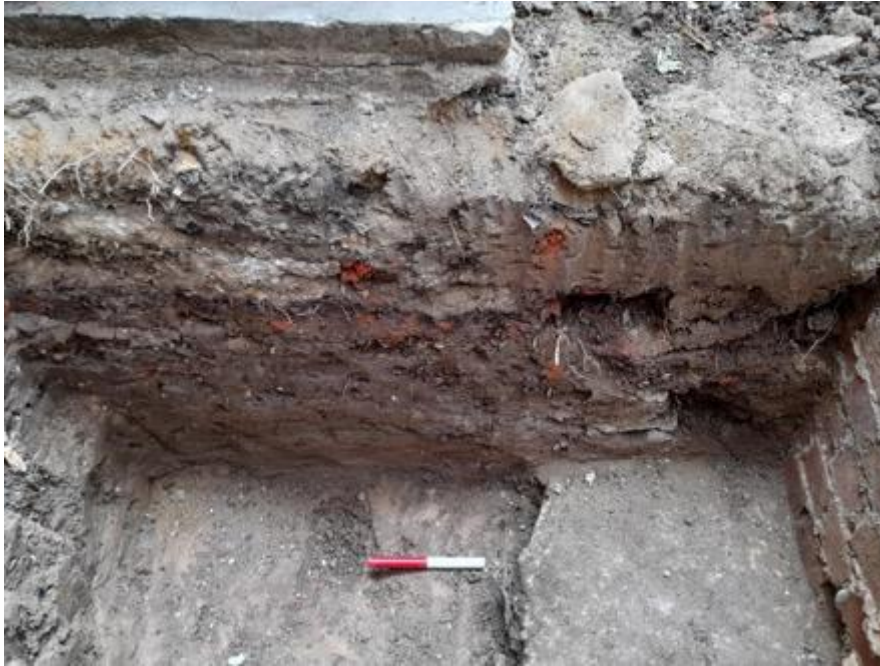
*North facing view of TR1*

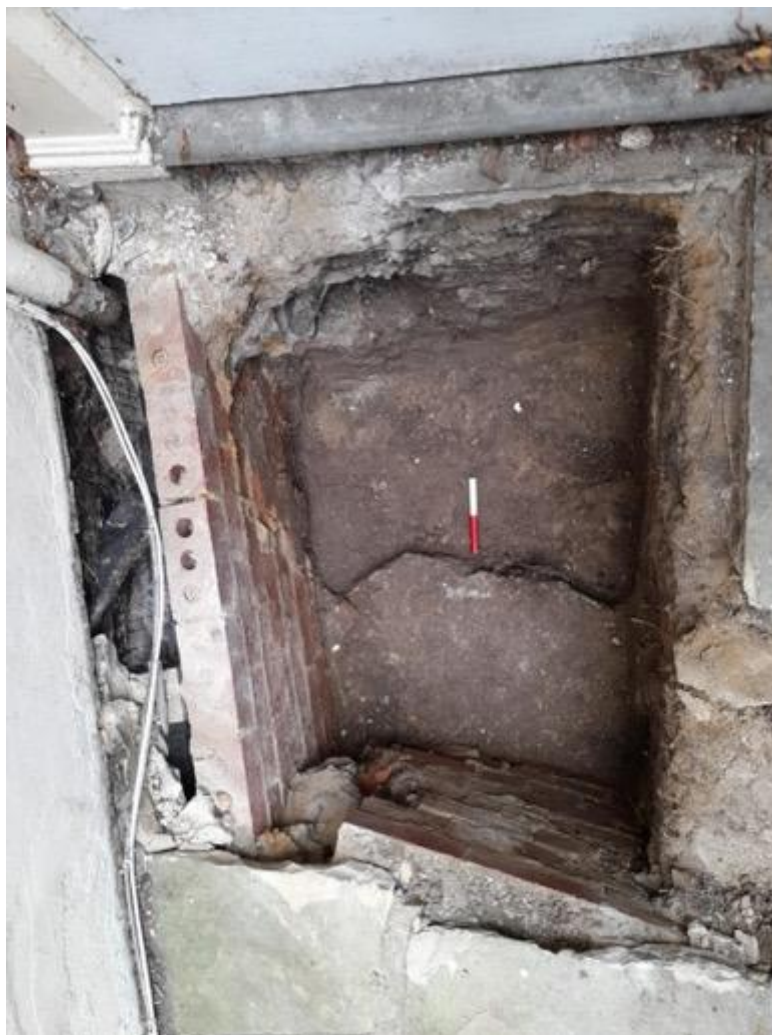
*West facing view of TR1*

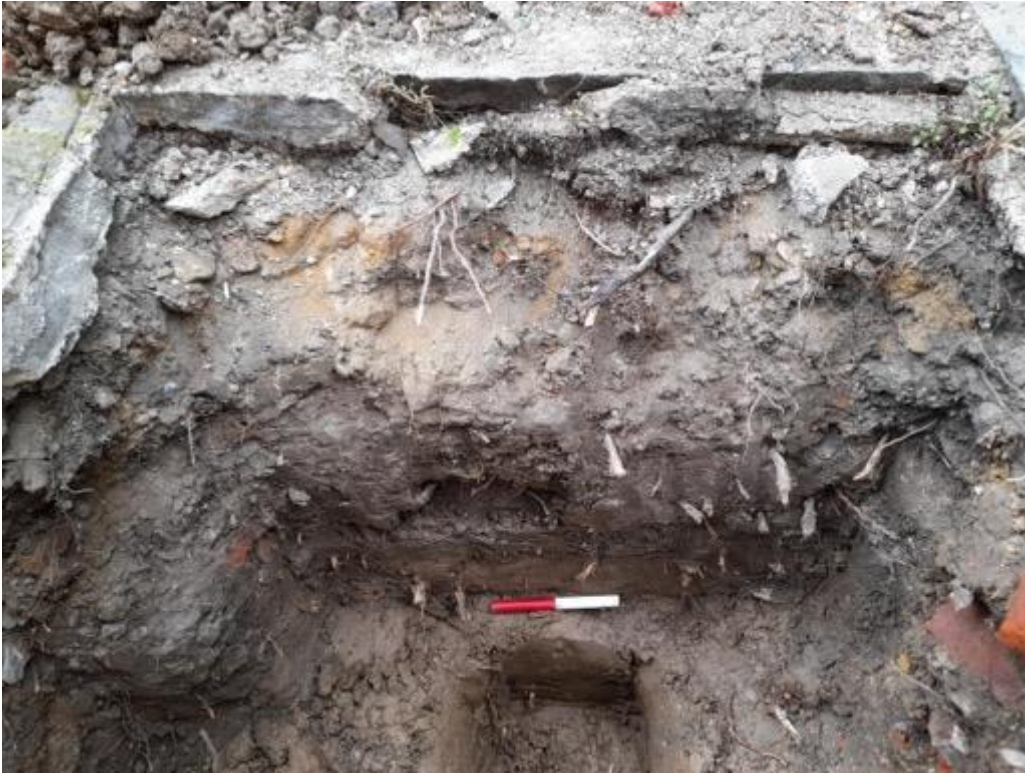
*North facing view of TR2*

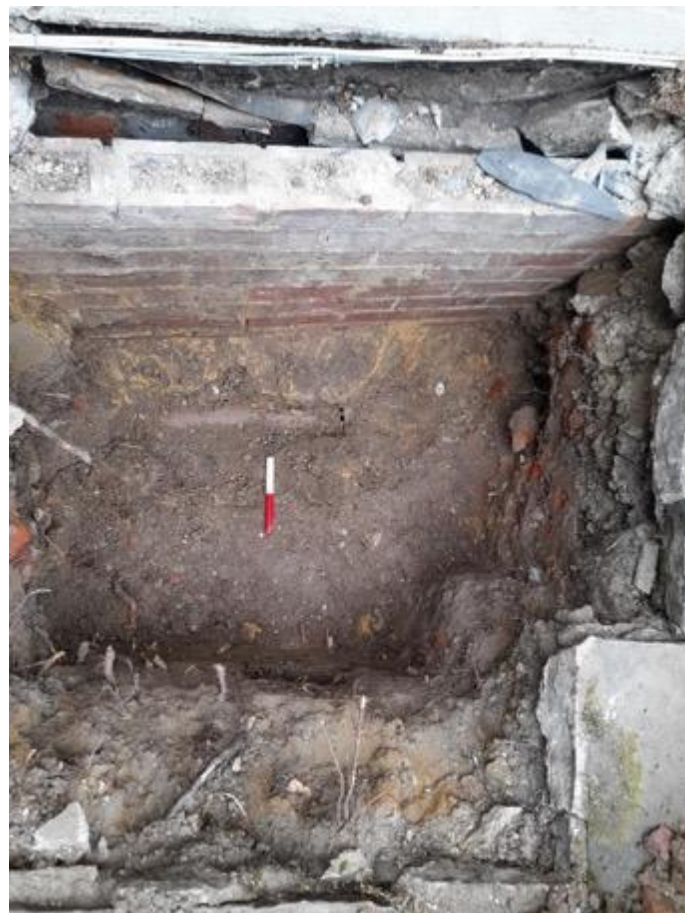
*South facing view of TR2*
