## Site Investigation Report

WHC reference [REDACTED]

Address: 49 & 49a Gloucester Crescent, London, NW1 7EG

William Hunt Consulting were commissioned by Crawford & Company to undertake a site investigation within the area of concern, located at the front elevation of the property. Site Investigations to consist of 1No. Borehole together with 1No. Trial Pit alongside Moisture contents and Atterberg limit laboratory testing, Root identification and a CCTV Drainage Layout.

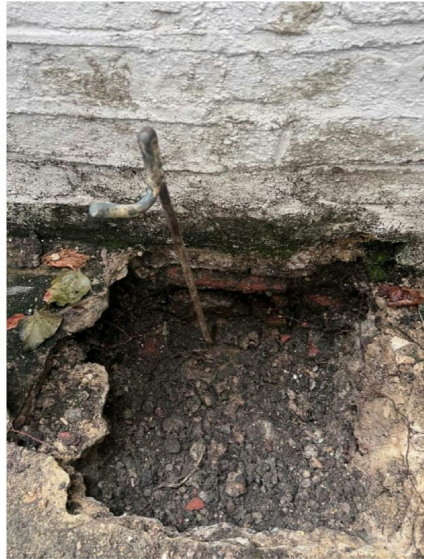
**Photo 2 – Trial Pit 1**

Trial Pit Details can be found in Appendix C where in trial pit 1, no foundation or projection were found to be present, with the retaining wall extending 0.31m below ground level.

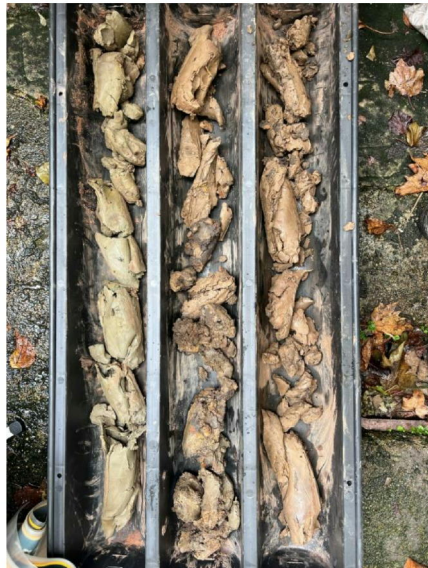
**Photo 4 – BH1 Cores (0.00m – 1.50m)**

Borehole Findings can be found in Appendix A, where in borehole 1, Concrete was found present from ground level to 0.15m below ground level, followed by Soft to Firm Clay to a depth of 0.31mbgl. Firm dark brown Clay was then recorded to a depth of 1.31mbgl, becoming light brown at 0.81m. Below this, light brown/grey firm Clay was then encountered to a depth of 1.81m below ground level, followed by stiff to very stiff light brown Clay to 2.31mbgl. Very stiff dark brown Clay was found to be present to a depth of 3.31m below ground level, at which point the borehole was terminated. Borehole did not encounter groundwater.

Root Identification Results can be found in Appendix B, where in borehole 1, multiple TILIA (Lime) roots were found at depths 0.65m – 0.80m and 1.00m – 1.20m. Further roots were found at 0.65m – 0.80m and 1.00m – 1.20m, being identified as either the subfamily POMOIDEAE or PRUNUS.

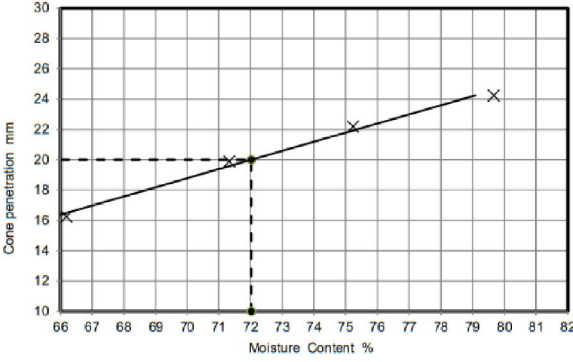
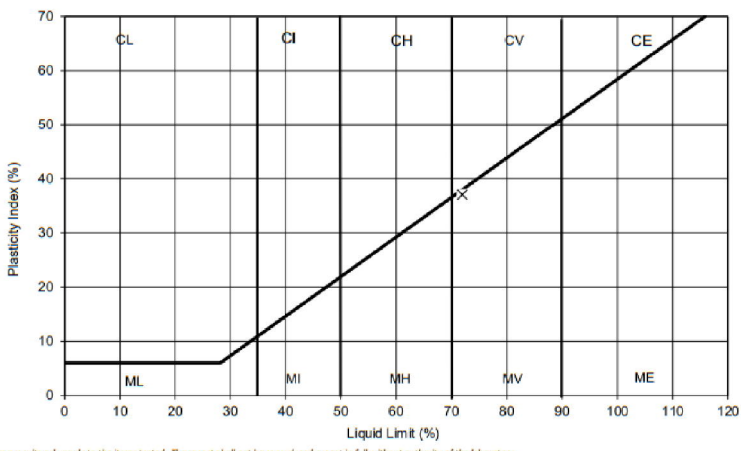
<b>LIQUID LIMIT, PLASTIC LIMIT AND PLASTICITY INDEX</b>		Job No.			
		Borehole/Pit No.	BH1		
Site Name	49 & 49a Gloucester Crescent, London NW1 7EG		Sample No.	-	
Project No.		Client	William Hunt Consulting	Depth Top	0.50 m
Soil Description	Orangish brown slightly mottled dark grey slightly gravelly silty CLAY (gravel is fm and sub-angular to rounded)		Depth Base	1.00 m	
			Sample Type	D	
			Samples received	06/11/2023	
			Schedules received	06/11/2023	
			Project Started	07/11/2023	
		Date Tested	18/11/2023

NATURAL MOISTURE CONTENT	35	%
% PASSING 425µm SIEVE	96	%
LIQUID LIMIT	72	%
PLASTIC LIMIT	35	%
PLASTICITY INDEX	37	%

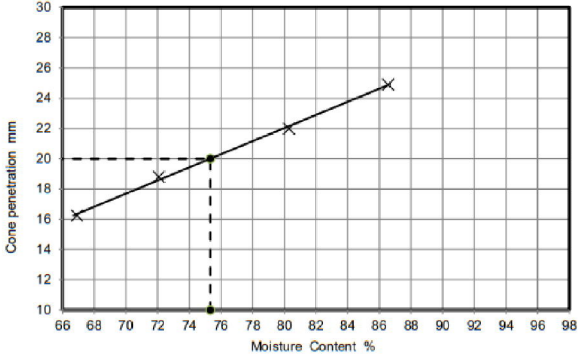
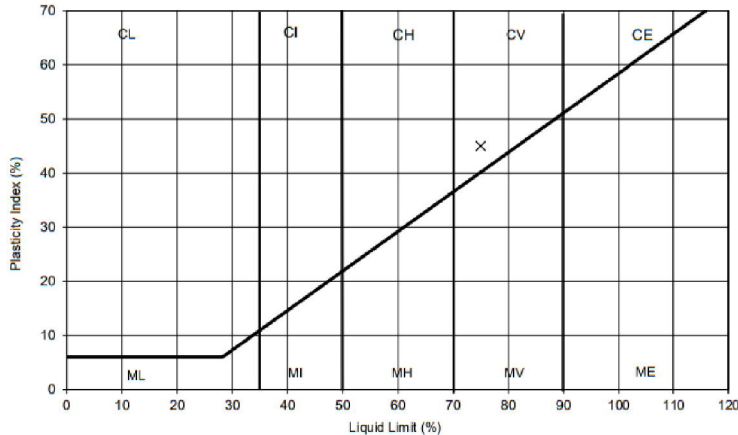
<b>LIQUID LIMIT, PLASTIC LIMIT AND PLASTICITY INDEX</b>		Job No.	
Site Name		Borehole/Pit No.	
49 & 49a Gloucester Crescent, London NW1 7EG		BH1	
Project No.		Sample No.	
Client		-	
William Hunt Consulting		Depth Top	
		1.50 m	
		Depth Base	
		2.00 m	
		Sample Type	
		D	
Soil Description		Samples received	
		06/11/2023	
		Schedules received	
		06/11/2023	
		Project Started	
		07/11/2023	
		Date Tested	
		18/11/2023

NATURAL MOISTURE CONTENT	33	%
% PASSING 425µm SIEVE	100	%
LIQUID LIMIT	75	%
PLASTIC LIMIT	30	%
PLASTICITY INDEX	45	%

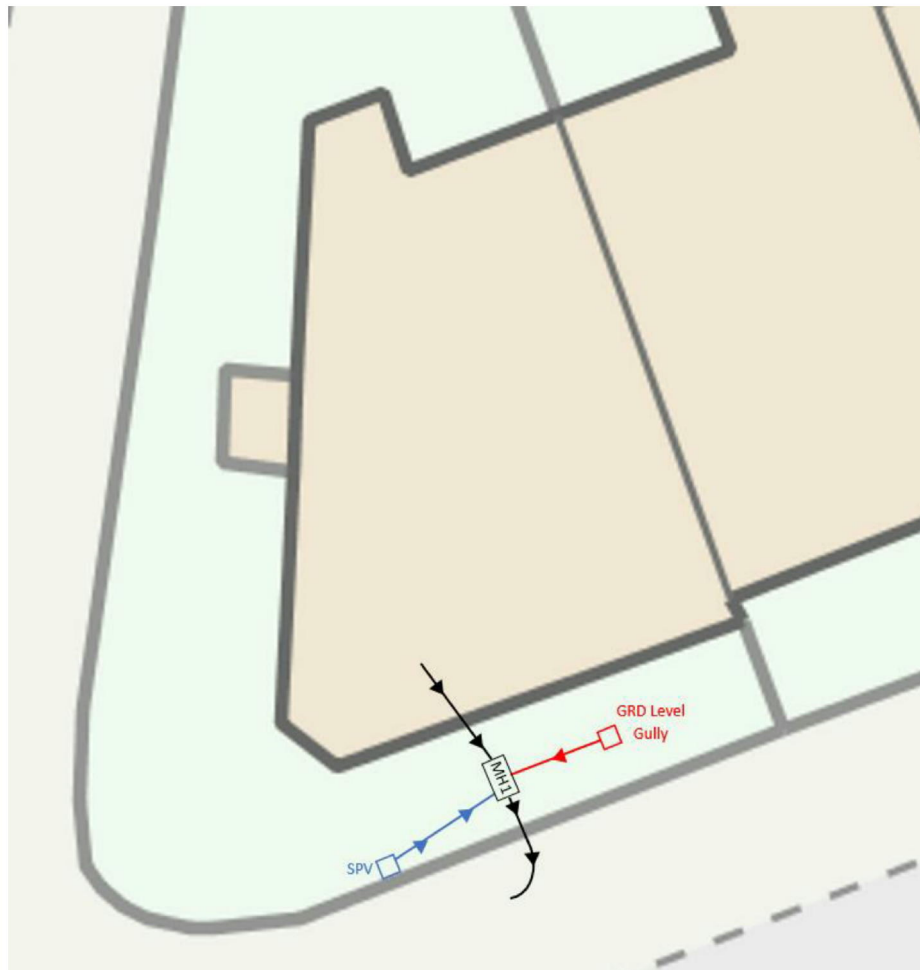
## Appendix E – CCTV Drainage Layout

CCTV Drainage Layout can be found in Appendix E.
