ACLAND BURGHLEY SCHOOL ASSEMBLY HALL REFURBISHMENT

Design and Access Statement
Heritage Statement
Statement of Community Involvement

March 2021

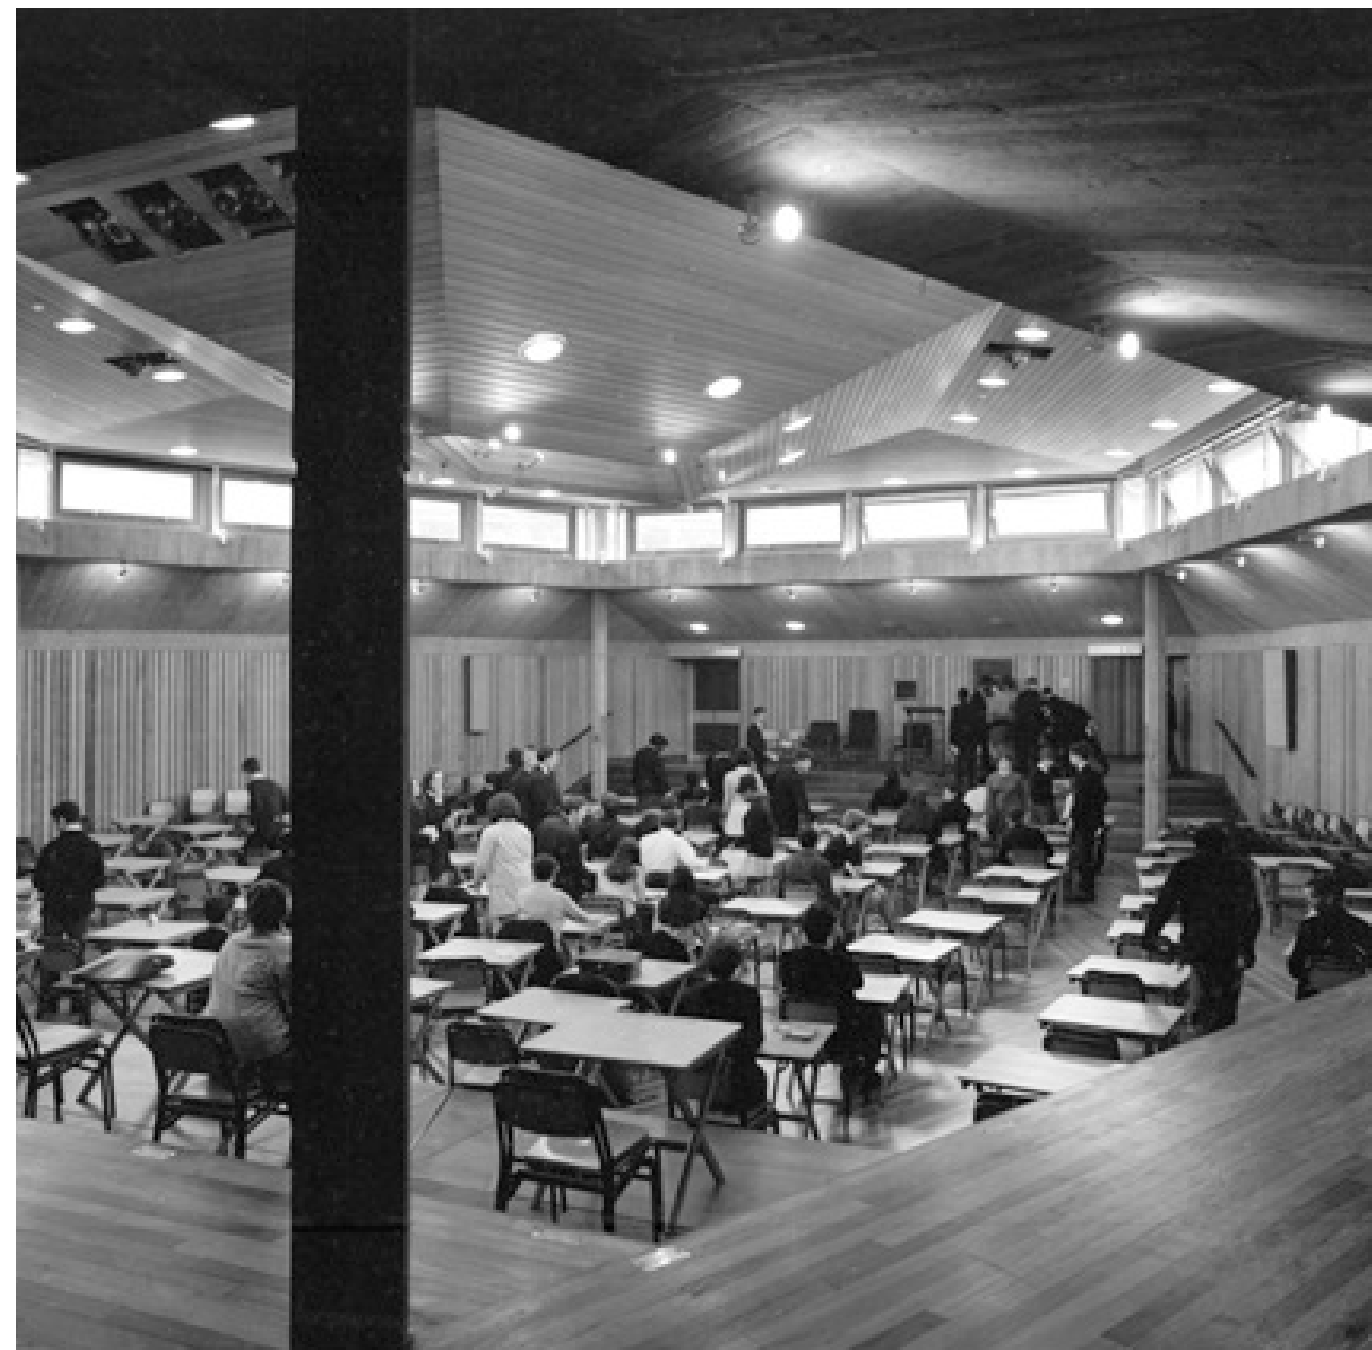
Archive photograph of the hall soon after its completion, taken from one side of the stage looking towards the entrance. As today, the main hall was designed as a multi-use space, shown here set up as an exam hall.

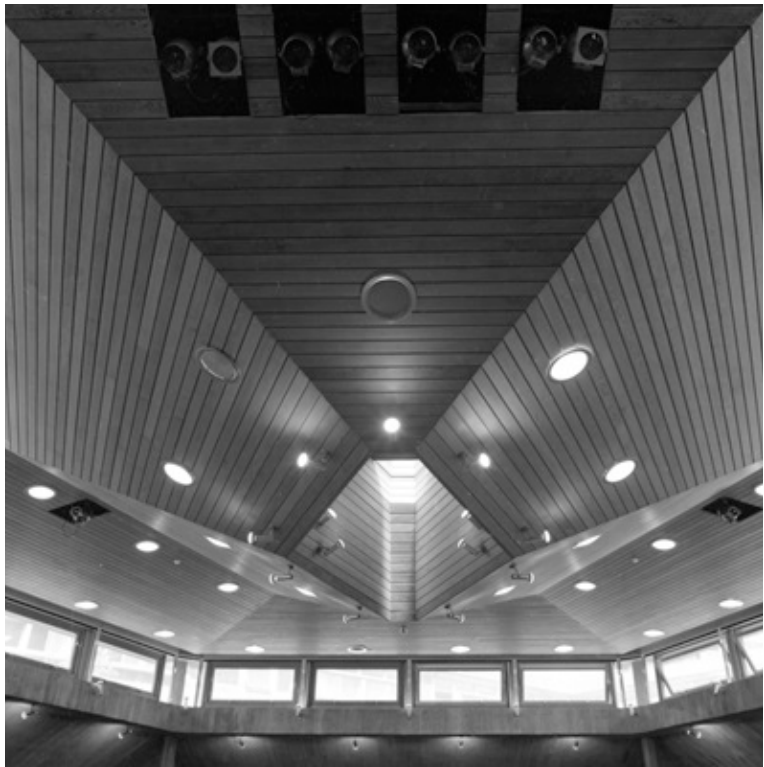
Timber-clad lantern

The single storey hexagonal assembly hall is double-ended to allow multi-functional use. A central, timber-clad lantern with a lower horizontal band of glazing is elevated above the concrete external wall; there are double-door entrances to the east and south. The internal walls to the hall are clad in timber, with an exposed concrete structure. It has a small fly tower at the western end. Although largely true to its original design, the building has seen a number of alterations over the years, most notably the ‘Super Classroom’ changes which caused significant harm to the interior of the hall (see page 7).

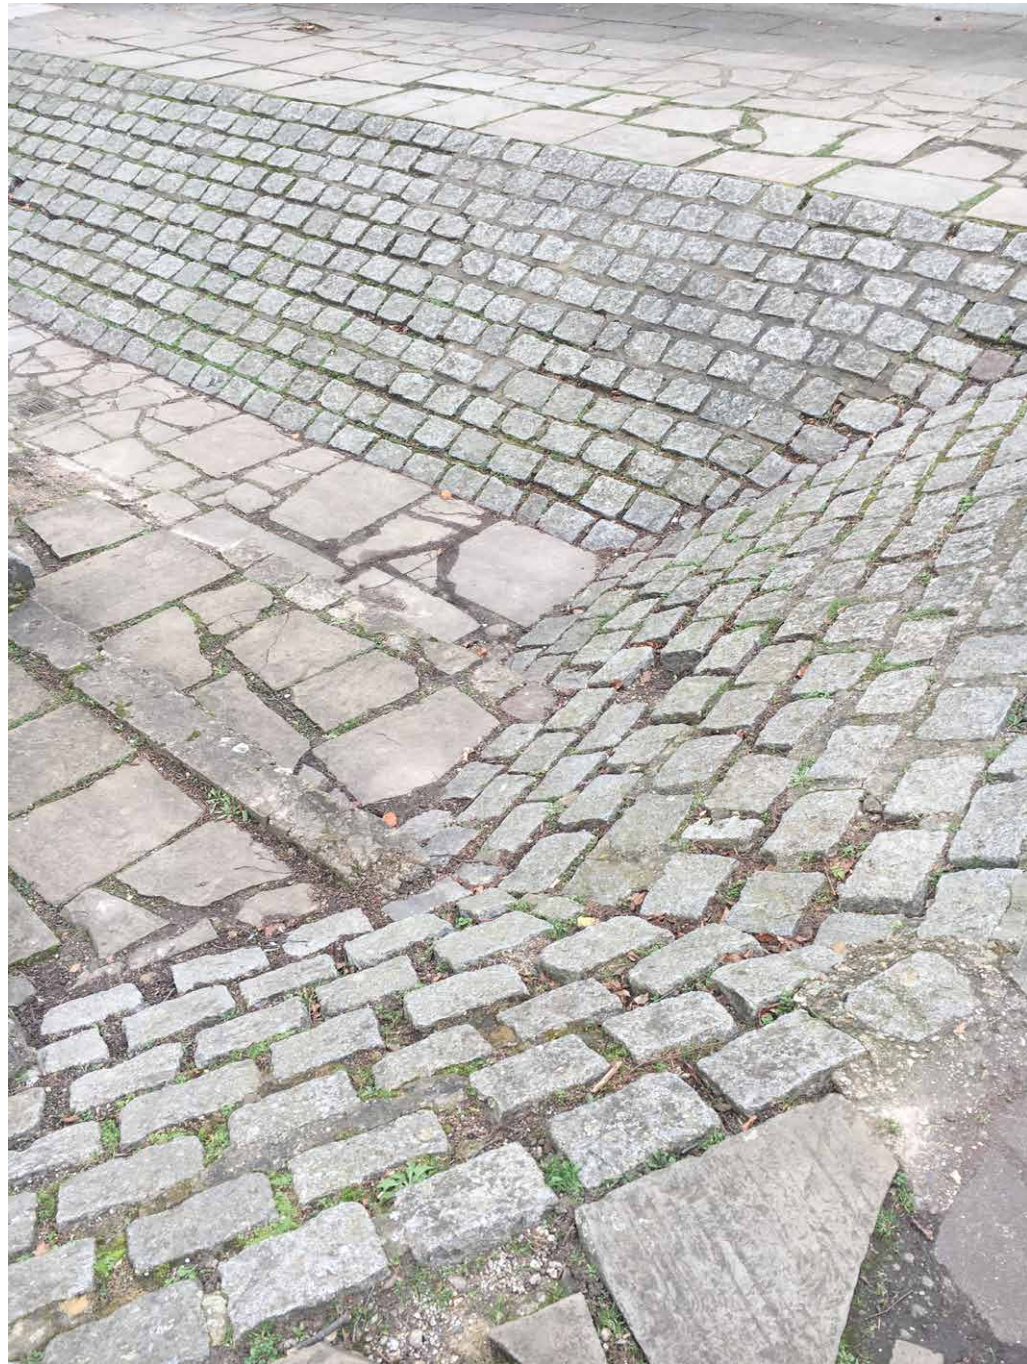
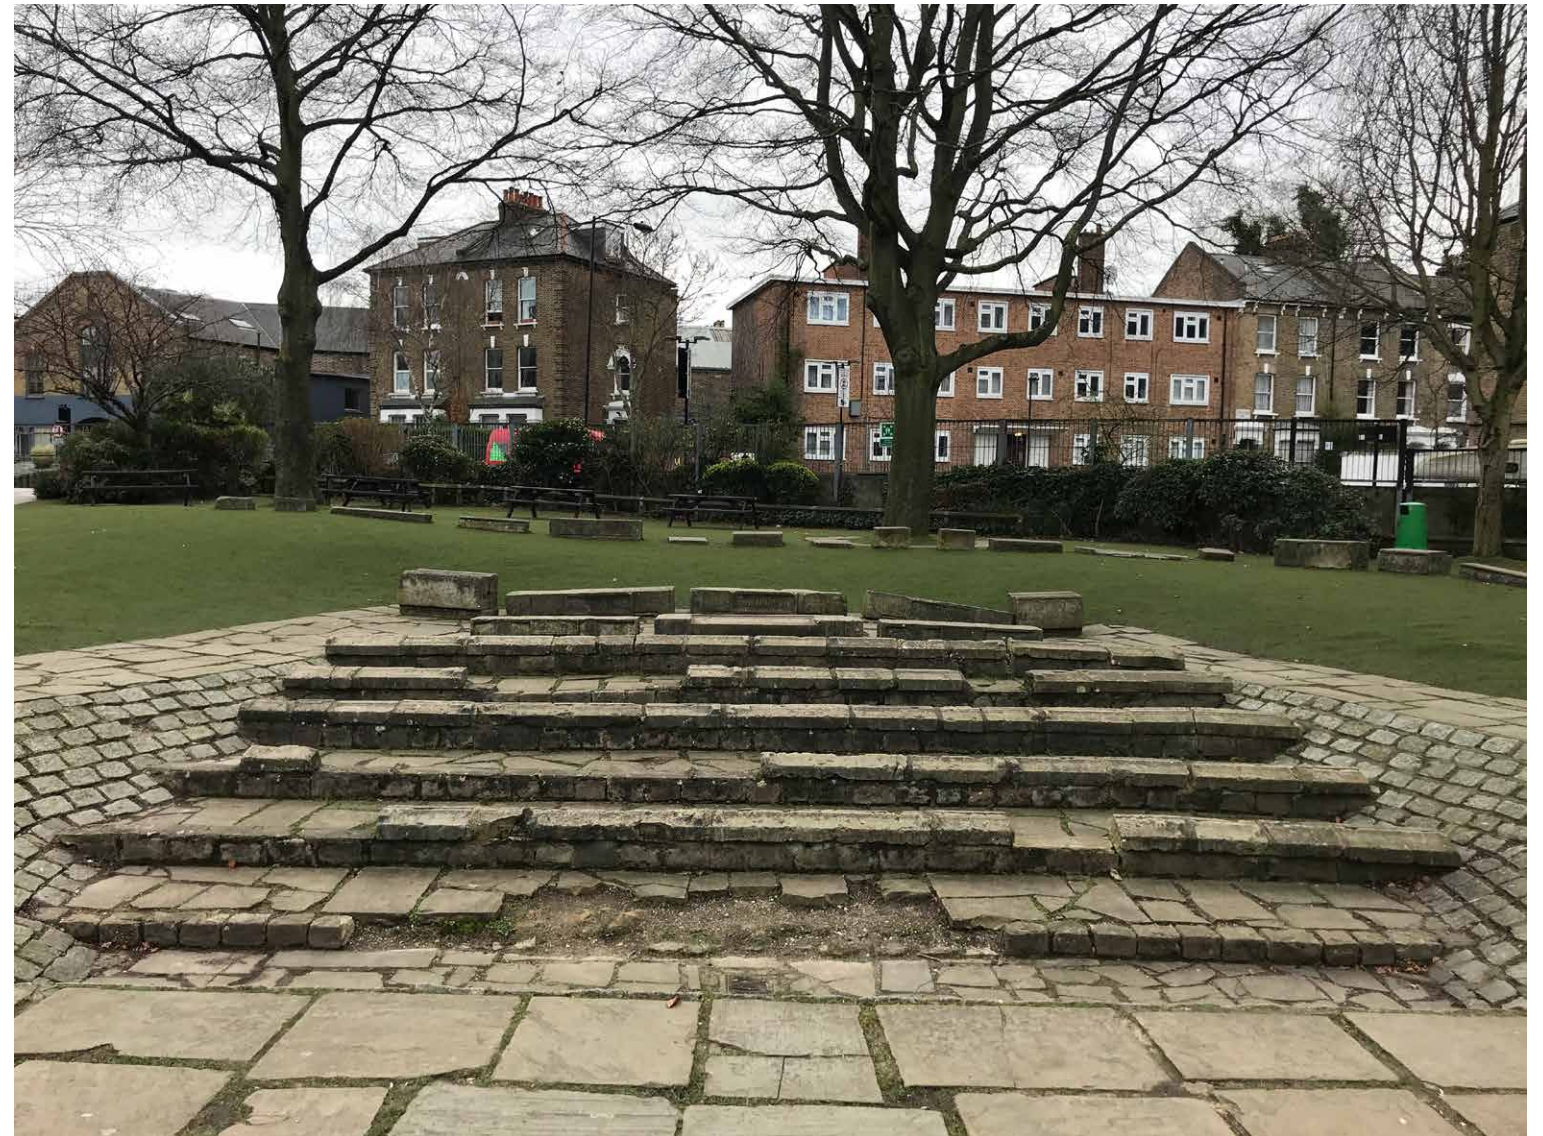
Externally, a number of the now mature trees contribute to the setting of the Assembly Hall within the school grounds. The originally fair faced concrete was painted externally prior to being listed, and has been repainted recently. Removing this paint is beyond the scope of the project, and carrying out this work is not critical to ensuring that the building can be widely used by the school can community alike.

A number of the stone sets and flagstones are missing, but the amphitheatre remains a key part of the school grounds, and is used by the school for context specific drama assignments, and outdoor summer events. There is no current provision for lighting and sound for outdoor performances.

External works include replacement of a tree (to enable ventilation works), stabilising loose paving in the amphitheatre and external building mounted signage.

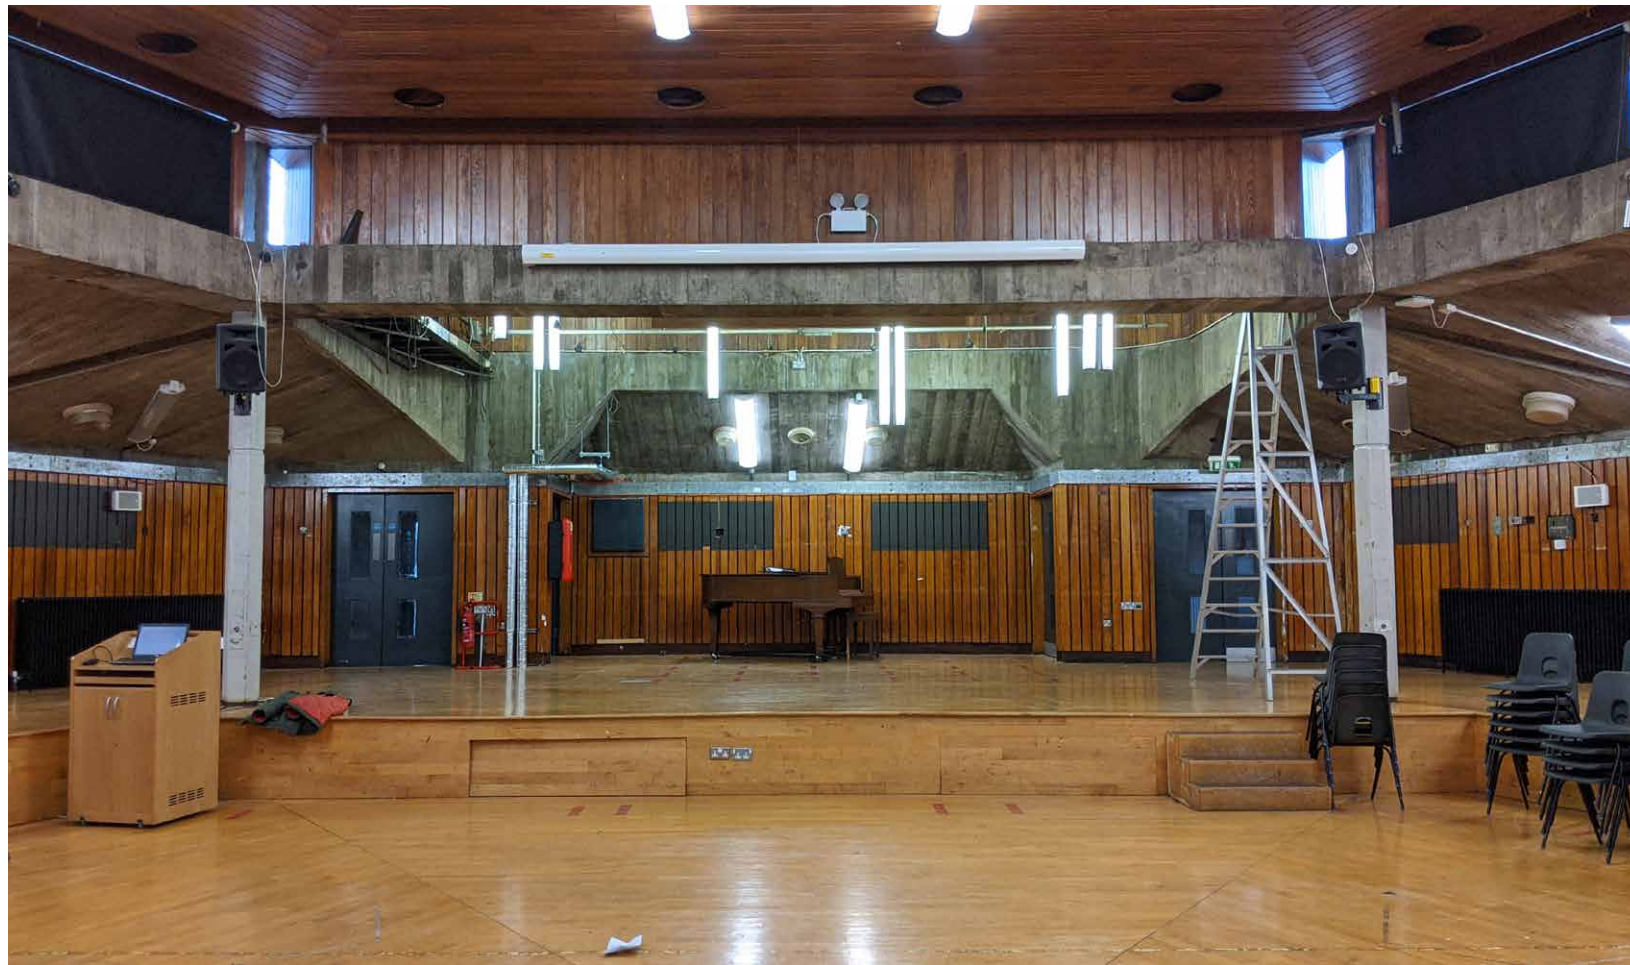
The form of the building is clearly read, and many of the original materials remain key features of the space. Several more recent additions, including yellow-toned floor pictured, painted columns, and strip lighting interfere with the original design intent. Newer, functionally important but poorly located equipment such as the projector detract from the simple expressed structure of the original building. Similarly, lagged pipework and pendant lights above the stage detract from the original building.

Repairs and new lighting installations have been added to the auditorium over the years. This is intended to be stripped out, and circular luminaires as seen in original photographs used as house lighting in place of the current strip lights fixed to the concrete soffits and timber ceiling of the auditorium.

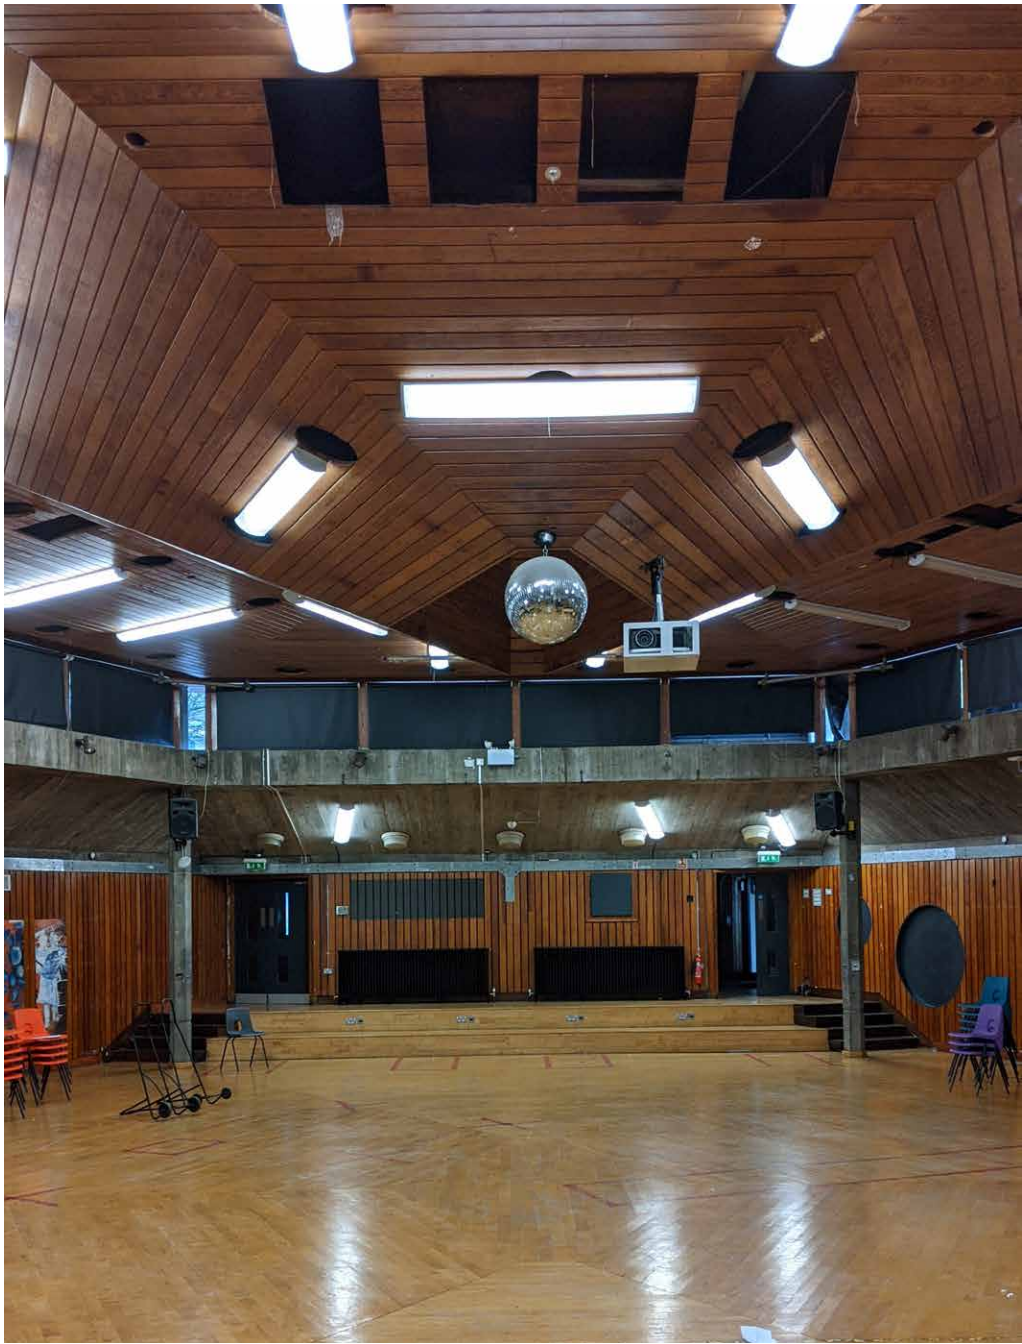
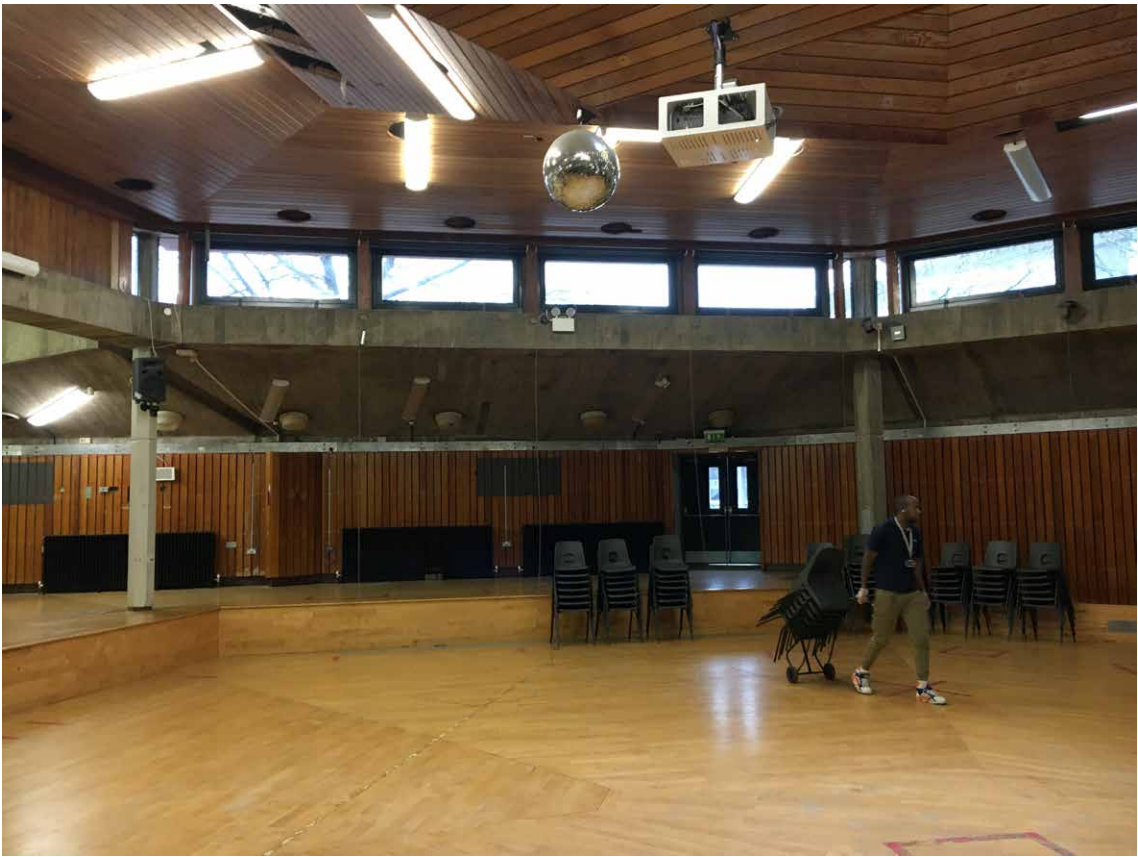
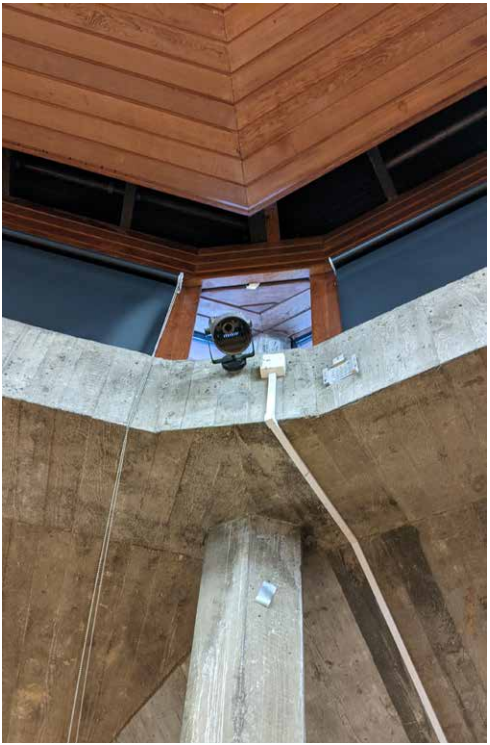
The Assembly Hall's top-lighting via a ring of clerestory windows is fundamental to the original design intent, but is in practice not experienced as often as it could be, due to the time taken to manually open and close the blinds. This results in the hall often being artificially and over-lit in the day time, and the some of the qualities of the materials are under-appreciated as a result.

Since the only ventilation is via opening windows, it is not possible to simultaneously achieve black out and sufficiently ventilate the space.

There are missing blinds in the chamfered corners of the ring of clerestory windows, so full darkness is not achievable. The blind to the central roof light has been recently repaired.

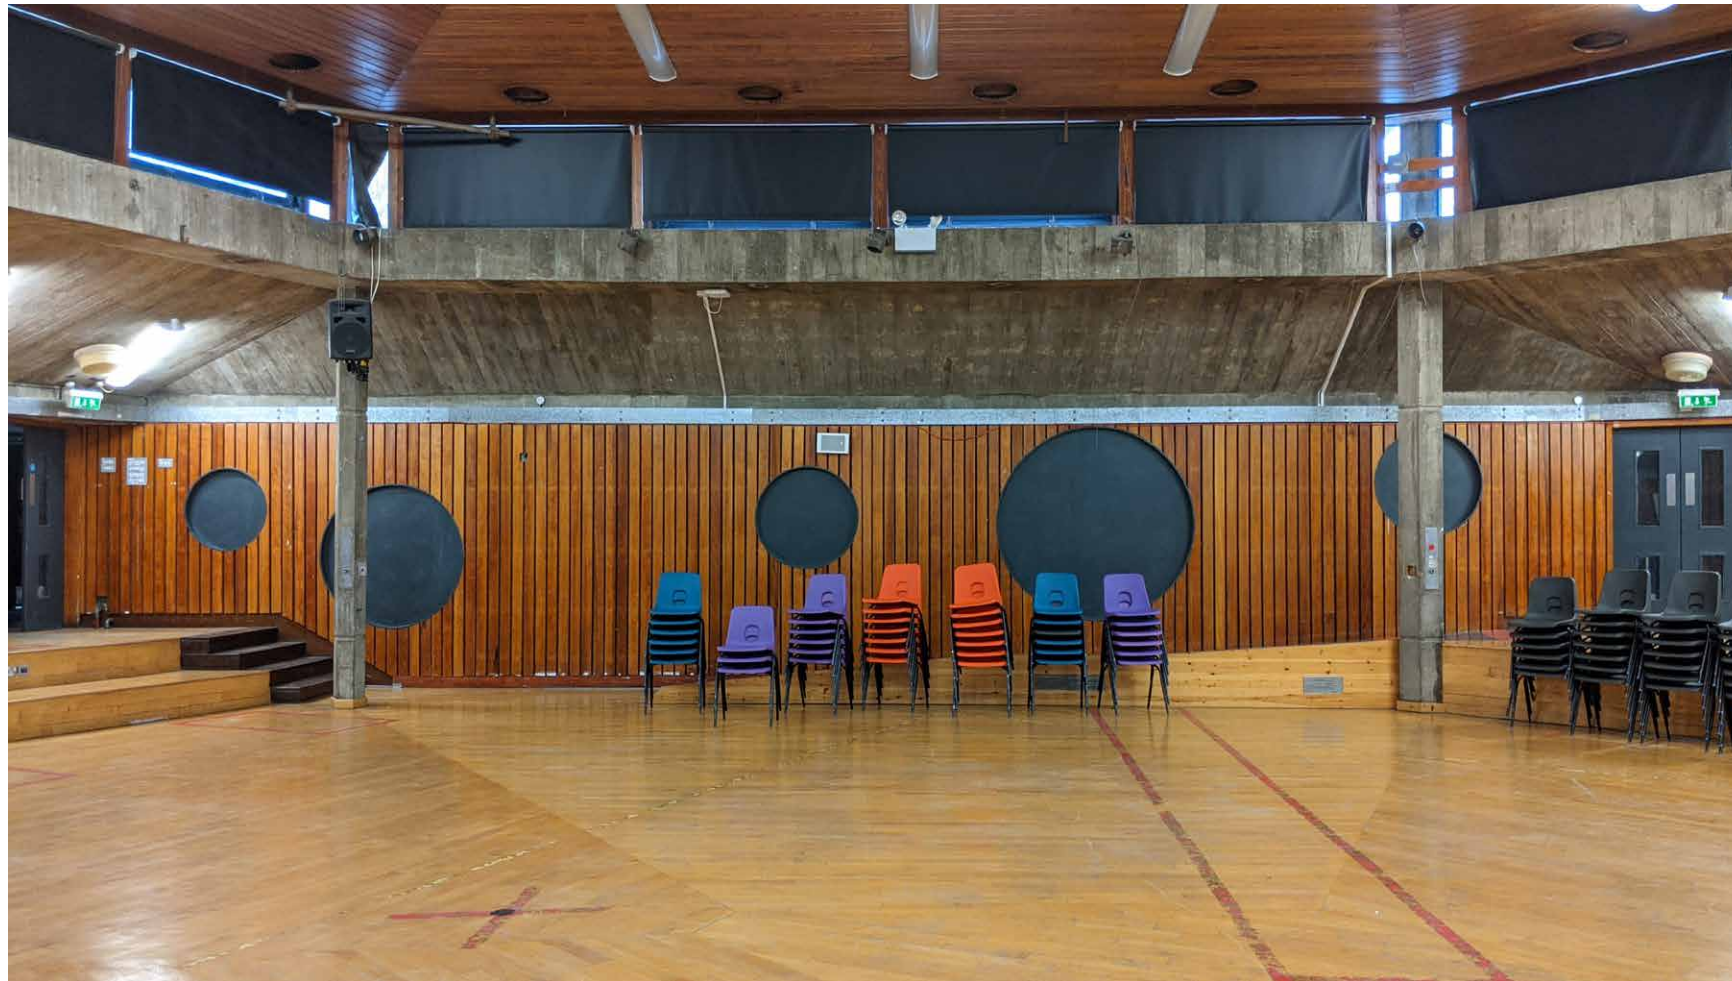
The circular holes pictured, cut into the existing walls prior to the building's listing and later in infilled, cause considerable harm to the building in heritage terms, damaging both the structure and the timber linings to the auditorium, and detracting from the building's material strategy. In functional terms, they detract from the acoustics of the building allowing sound bleed into the corridor, and removing absorbency provided by the original wood wool and timber strip wall linings.

In 2009-10 SCABAL Architects* transformed the assembly hall into a 'Superclass', as part of the Building Schools for the Future initiative. The team cut circular openings into the internal concrete walls and painted the fare faced concrete yellow to create a large classroom to accommodate up to 90 children. Although the colour and lighting have now gone, the holes remain and are noted in the heritage report as regrettable.

This includes repairing circular holes cut into the walls in 2010 prior to the building's listing, the installation of a new passive ventilation system to enable adequate cooling for summer performances, and the reconfiguration of the current, non-original floor incorporating simple staging modules that can be reconfigured to suit a range of activities.

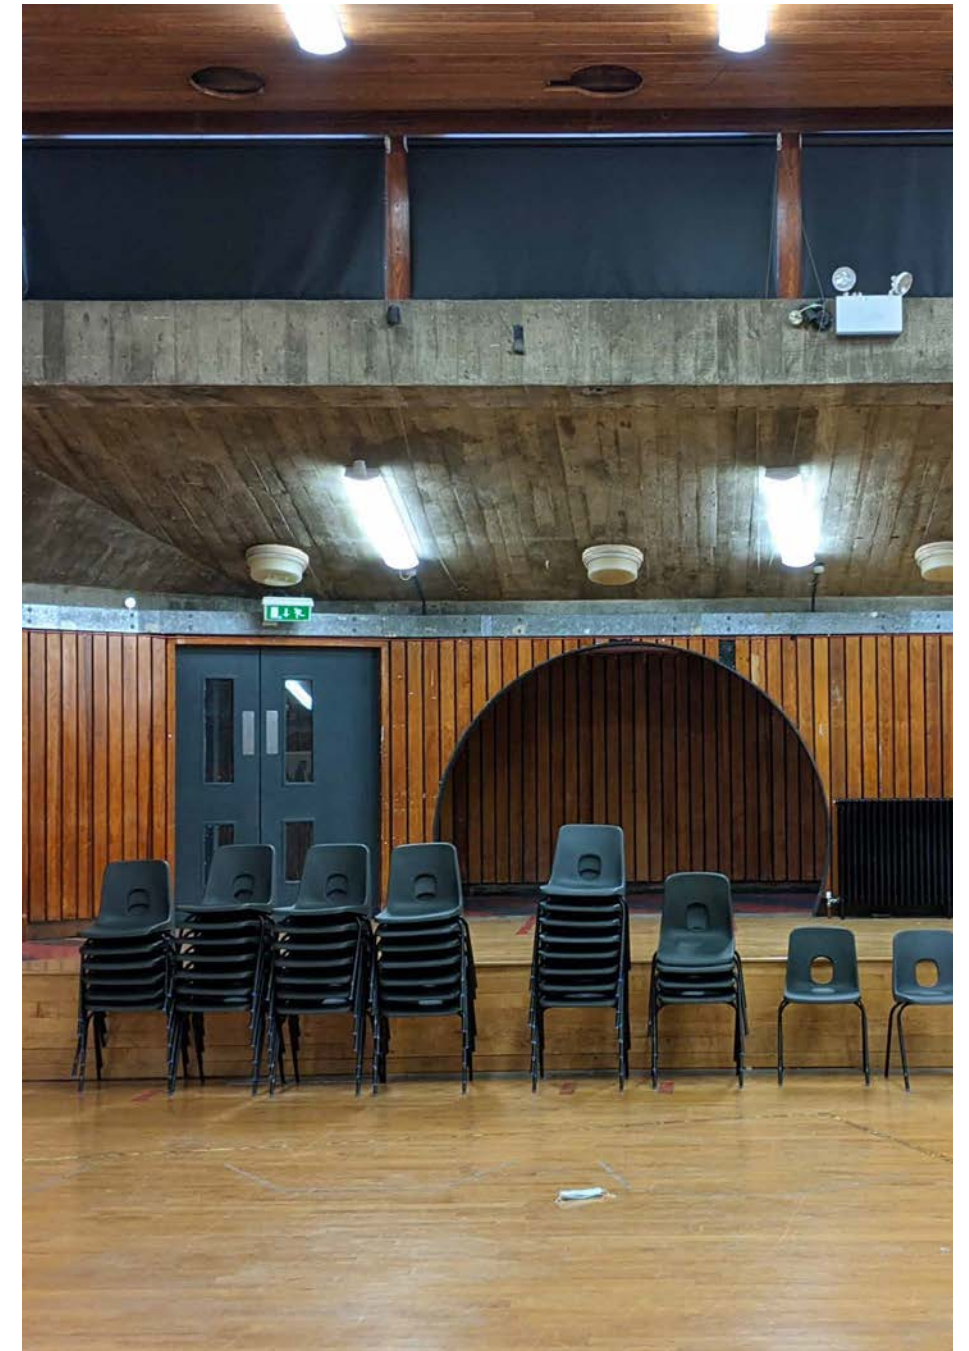
One large opening remains, making the door beside it redundant, and meaning that the hall cannot be separated from the corridor.

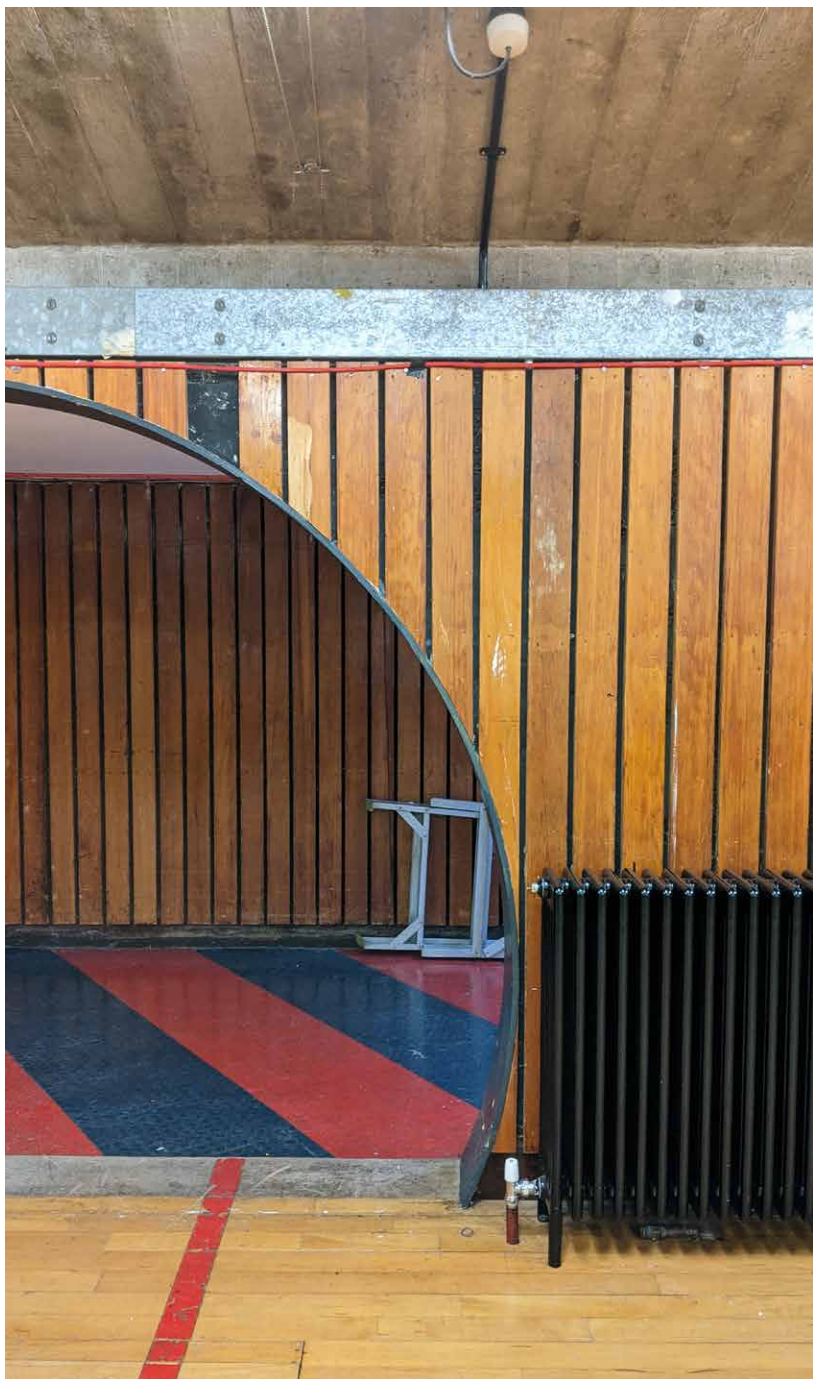
The flooring to the corridor, visible through the opening above was laid prior to the building's listing. The perimeter galvanised trunking detracts from the otherwise simple palate timber against concrete.

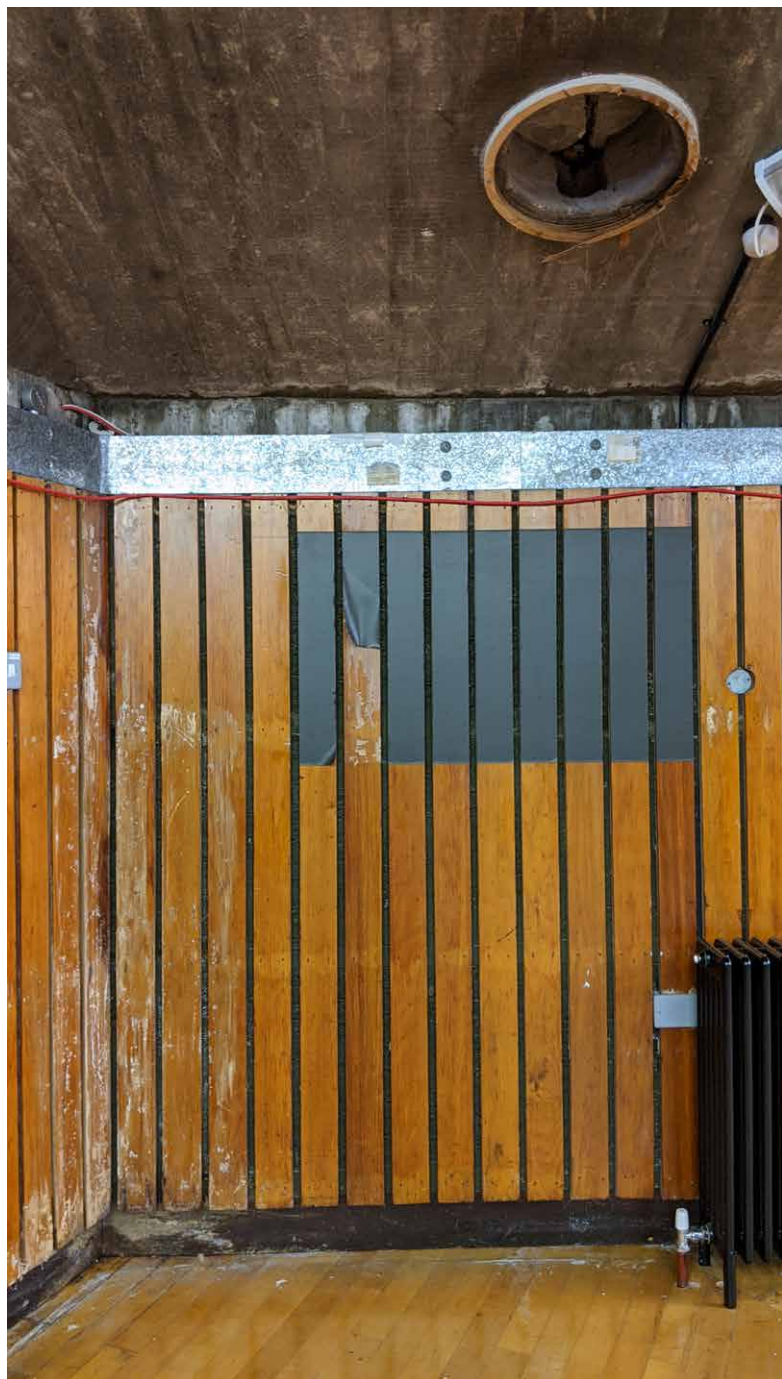
Several areas of the timber lining are marked from water damage that is thought to be historical. Adhesive magnetic strips applied to the timber lining are thought to be easily removable. Original light fittings are missing, and original concealed conduit routes are generally blocked.

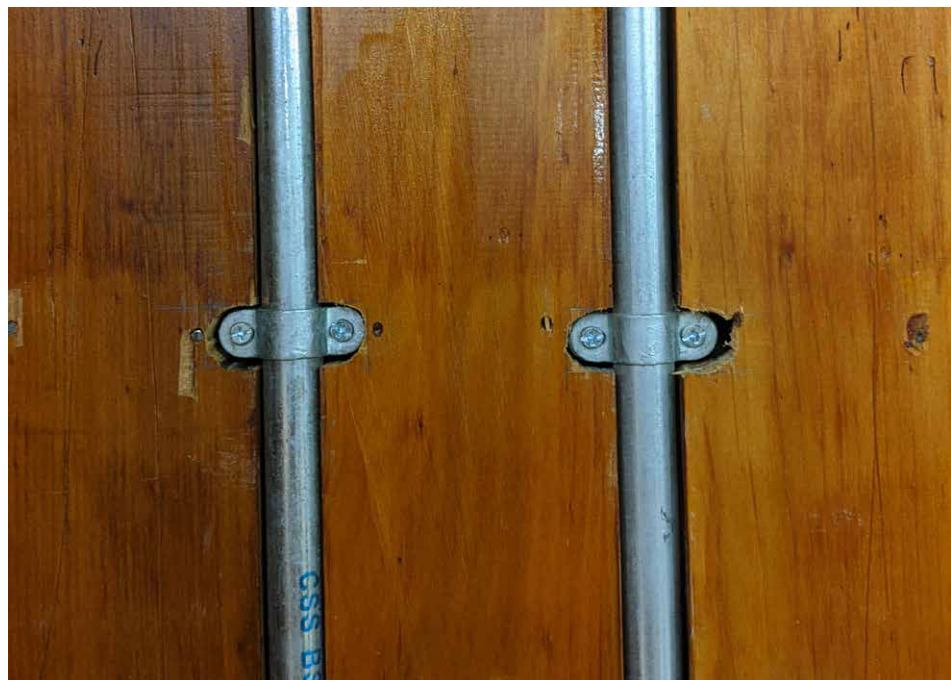
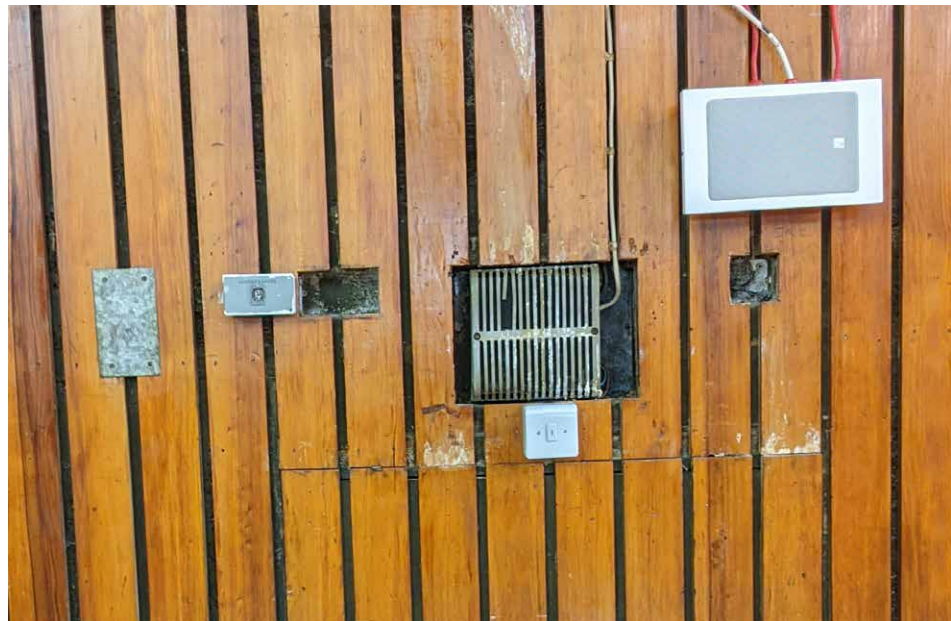
In general, redundant services installations remain in place, and have damaged small but numerous areas of the timber lining.

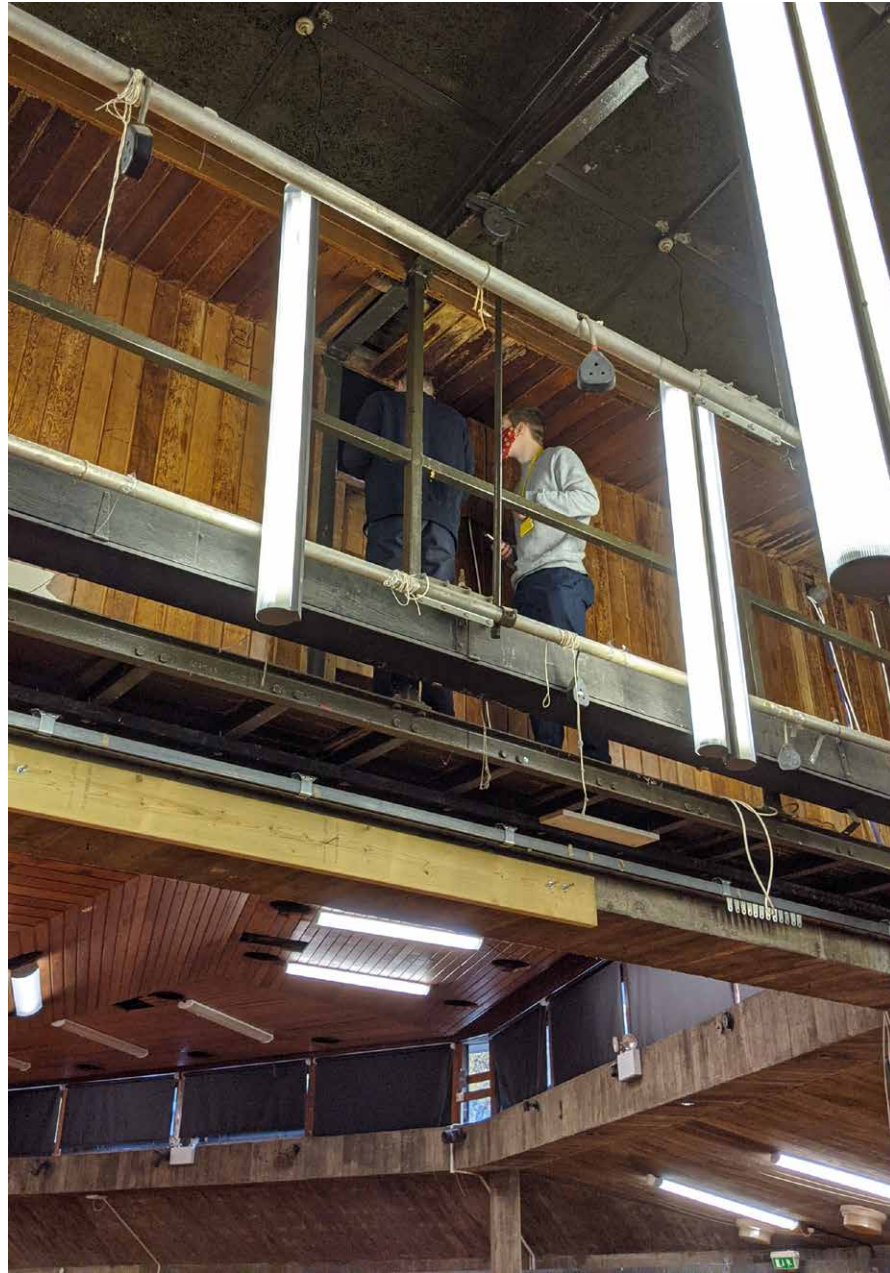
The ceiling void is accessed via a gantry above the stage.

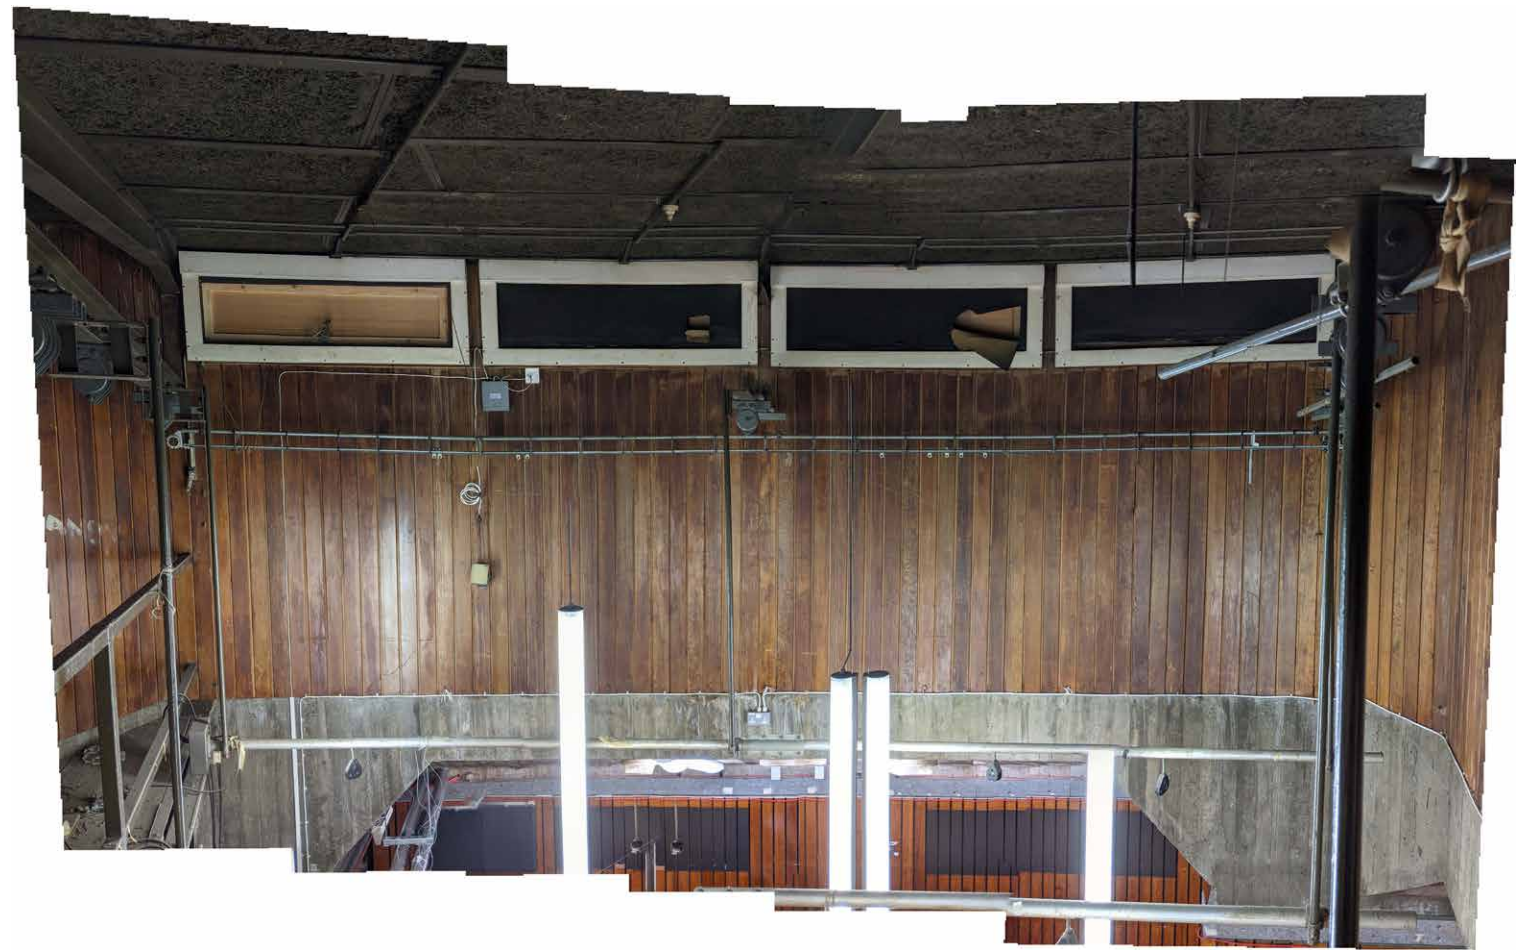
Four high-level windows in the building's south facade are partly covered in blackout paper. A series of pulleys are suspended from the existing structure.

Extract is proposed via a new plenum constructed beneath the existing ceiling of the stage house. 4 no. existing high level windows are to be replaced with ventilation grilles.

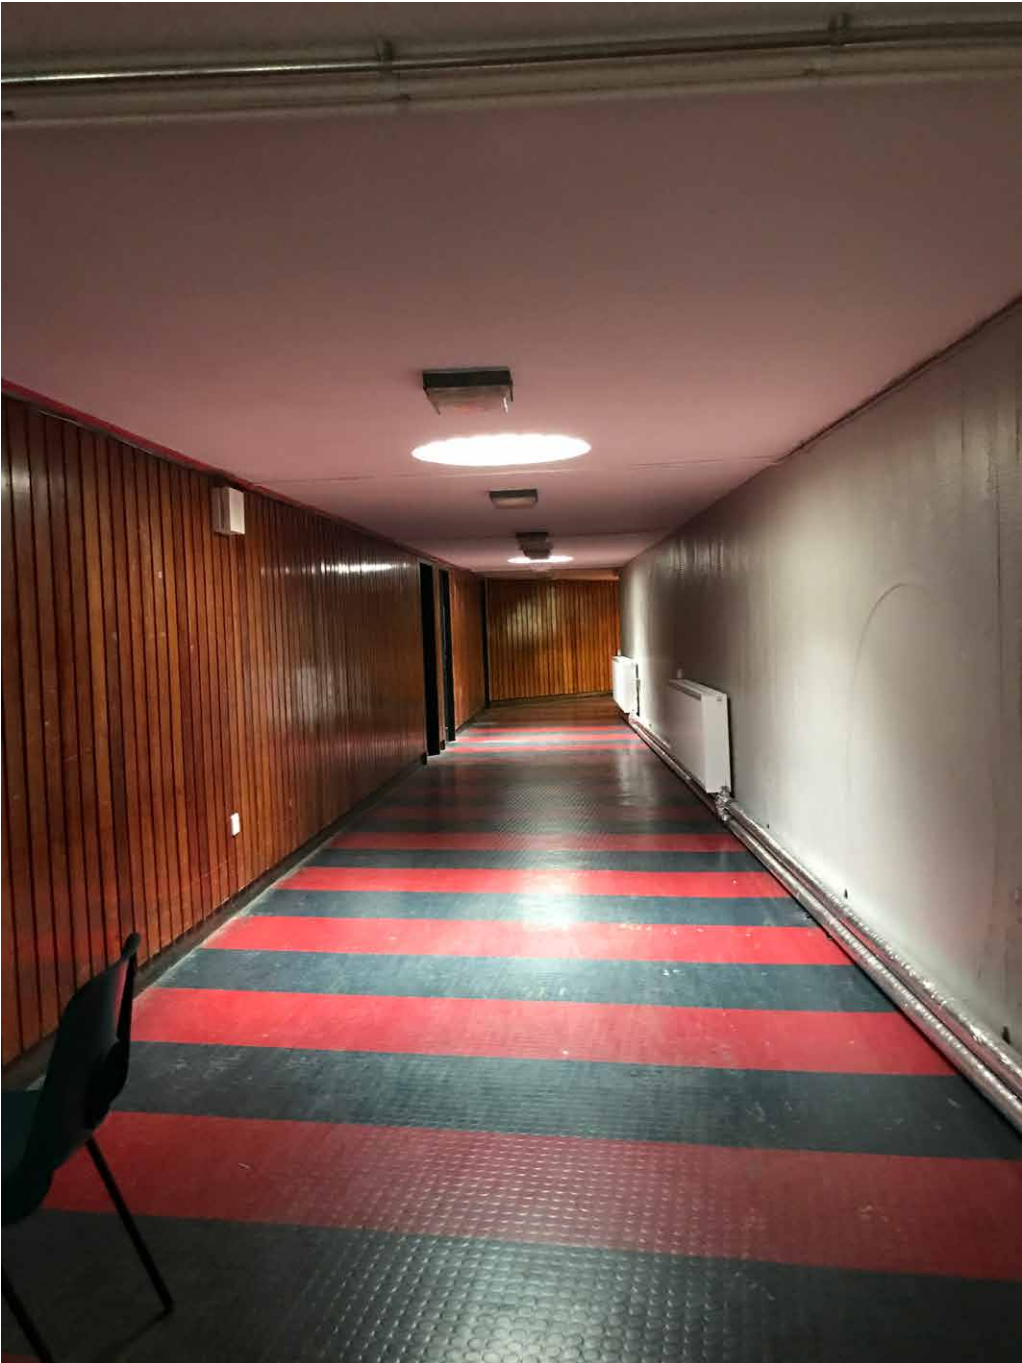
The original flooring to the corridor has been replaced, and the striped, studded rubber current flooring pictured above installed prior to the building's listing. The original concrete has been painted to one side of the corridor and ceiling, and new bulkhead light fittings installed. The outline of infilled circular holes is visible to the right hand side of the image.
