ACLAND BURGHLEY SCHOOL ASSEMBLY HALL REFURBISHMENT

Design and Access Statement
Heritage Statement
Statement of Community Involvement

March 2021

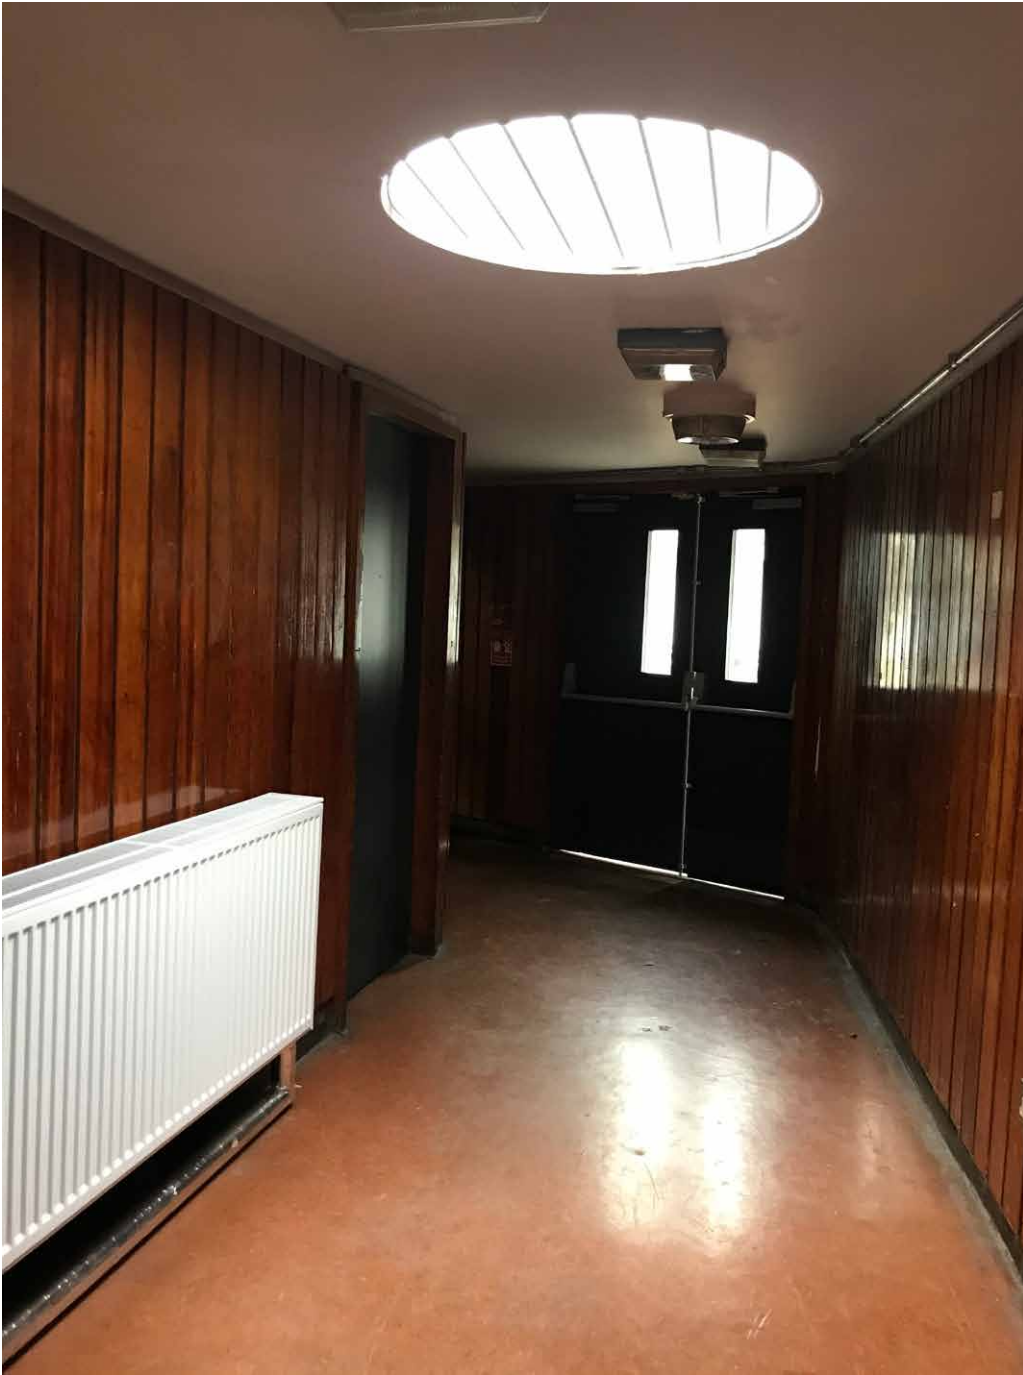
A single colour sheet flooring remains in part of the corridor. It is not known whether this is the existing floor. Radiators in the corridor are less appropriate for the building than those recently installed in the main hall. The foil lagging is also visually insensitive.

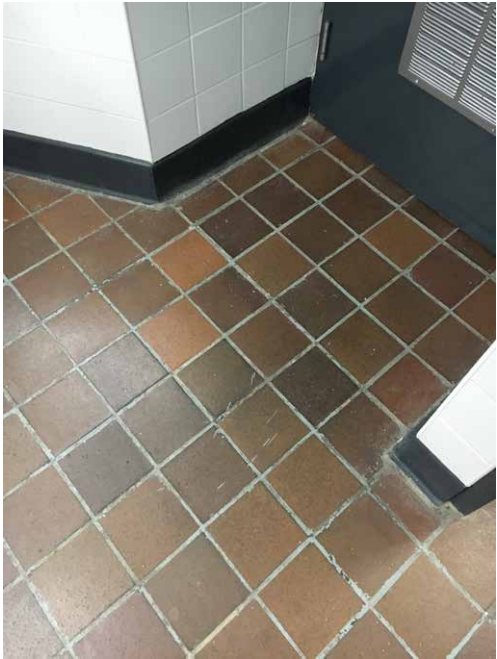
Original brown terracotta coloured quarry tiles remain in the WCs

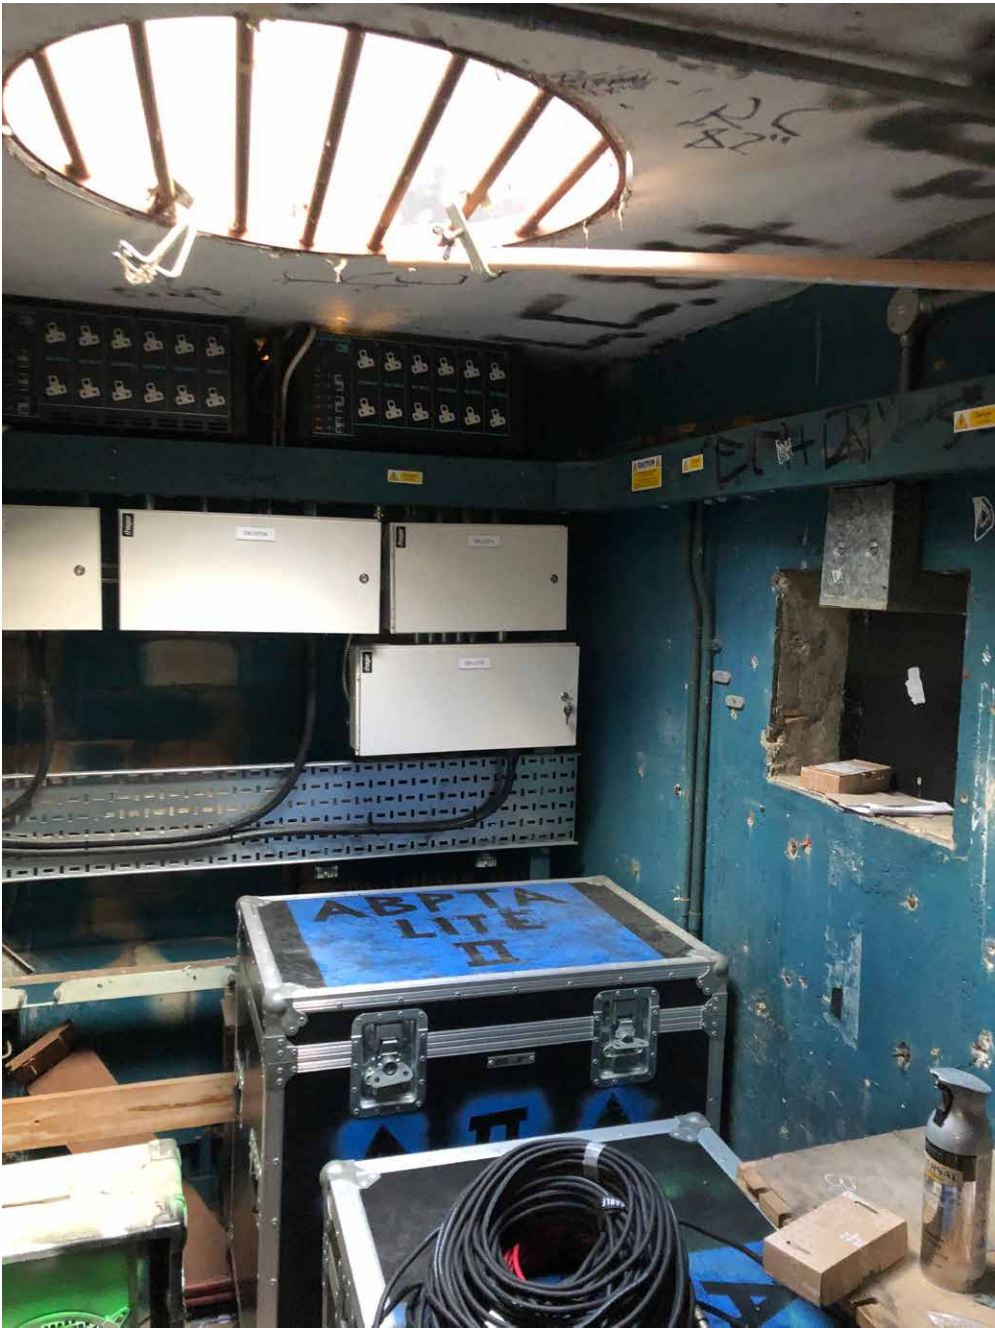
The existing store is in poor repair and is congested with services and electrical plant. The original roof light remains.

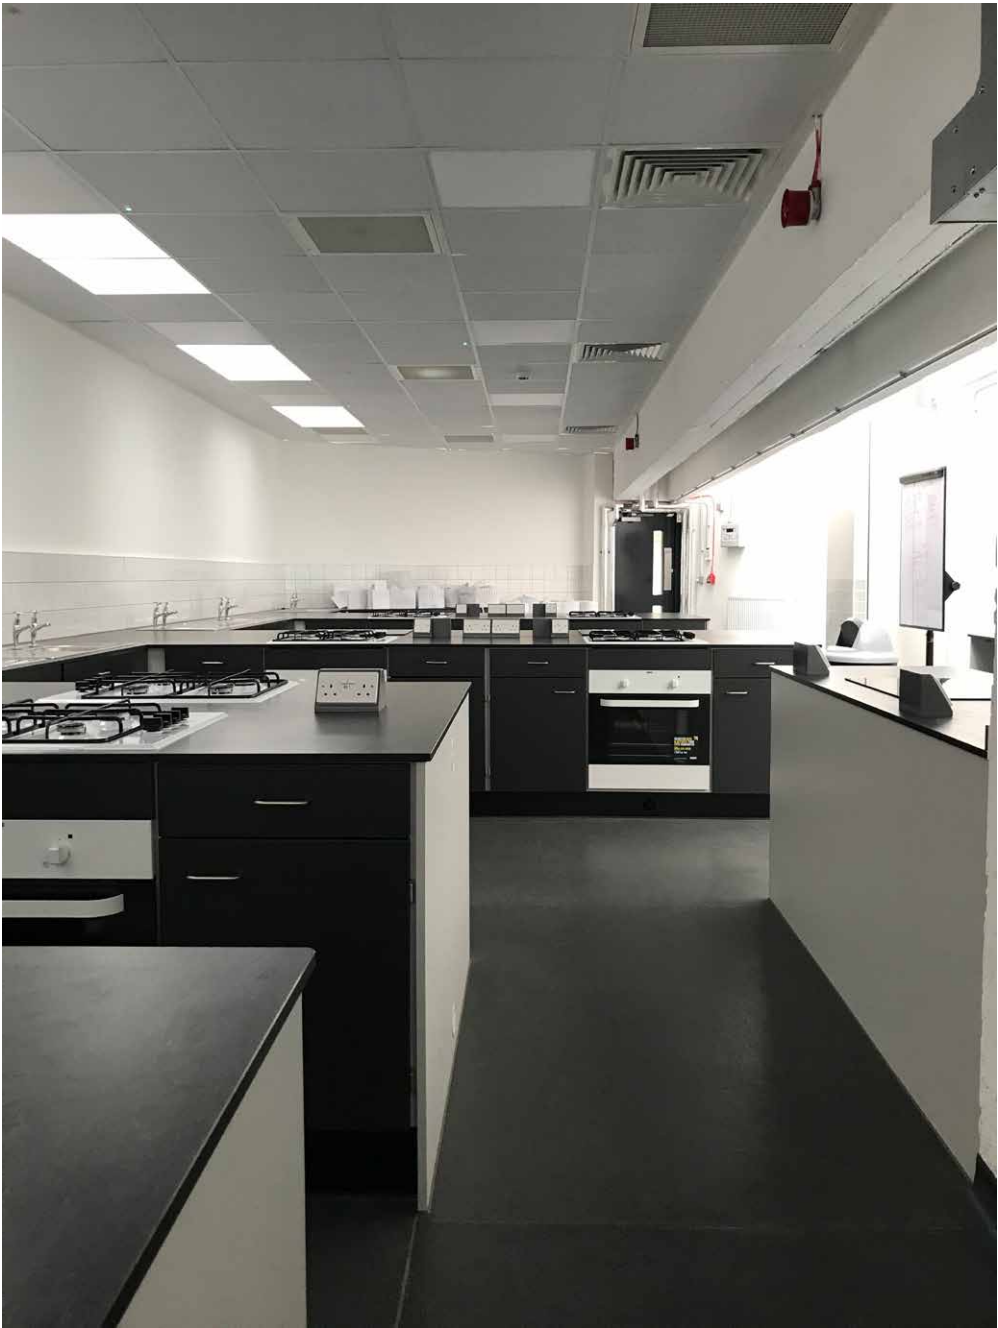
The food tech classroom has been recently refurbished and fitted out, and a new boiler installed. New hand wash basins have been installed at one end so that it may be used as a changing room.

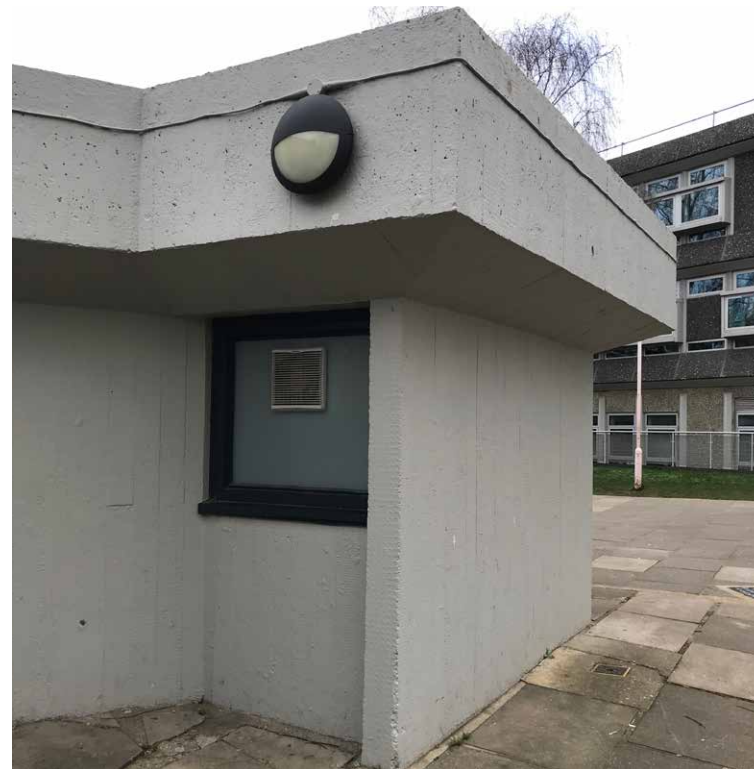
Grey painted concrete

The building has been subject of a number of alterations over time, most of which were implemented prior to its listing in 2016. The frames to the clerestory glazing over the Assembly Hall have been refurbished (with new glazing installed) and the timber cladding to the exterior has recently been replaced. Many of the original concrete finishes, both internally and externally, have been over-painted in light grey, altering the appearance when compared to as built photographs from 1967.

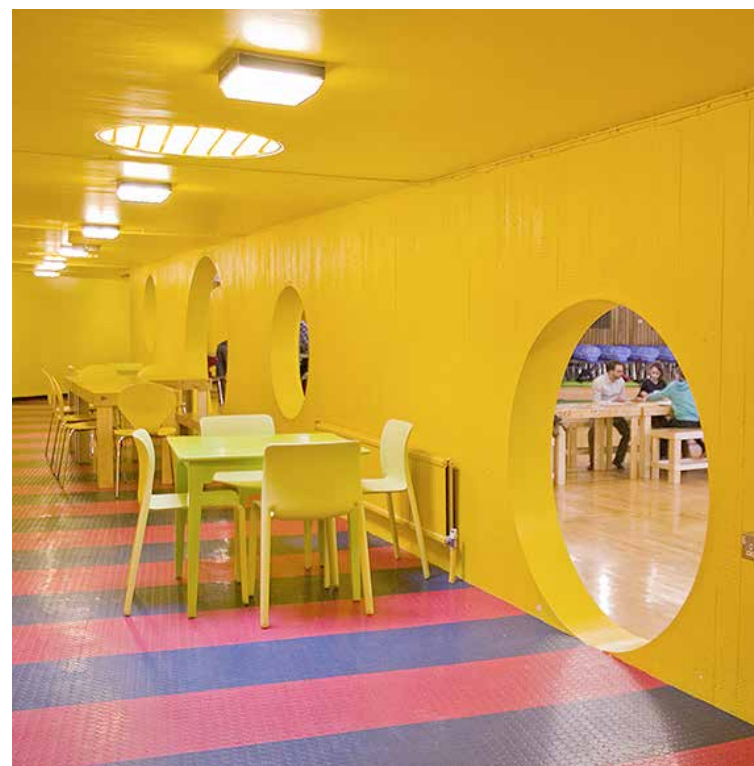
Yellow corridor and holes in walls

The circular holes pictured, cut into the existing walls prior to the building's listing and later in infilled, cause considerable harm to the building in heritage terms, damaging both the structure and the timber linings to the auditorium, and detracting from the building's material strategy. In functional terms, they detract from the acoustics of the building allowing sound bleed into the corridor, and removing absorbency provided by the original wood wool and timber strip wall linings.

In 2010 a series of circular holes were cut into the wall separating the auditorium from the perimeter corridor. These have now been filled, with the exception of a large arch remaining in the centre of the plan, making the adjacent door redundant. The hole also breaks the acoustic and visual separation between the hall and circulation space around it, severely compromising its use as a performance space..

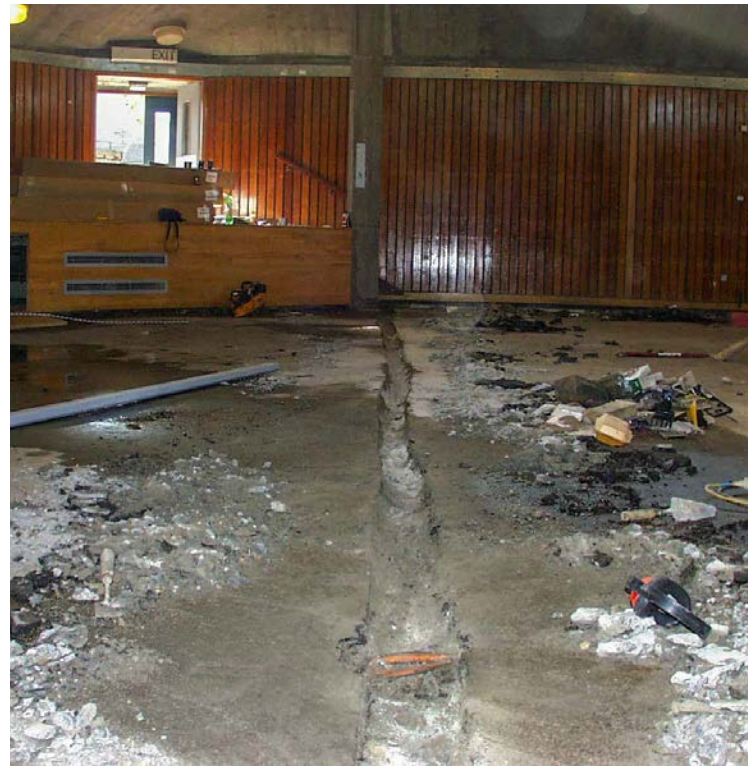
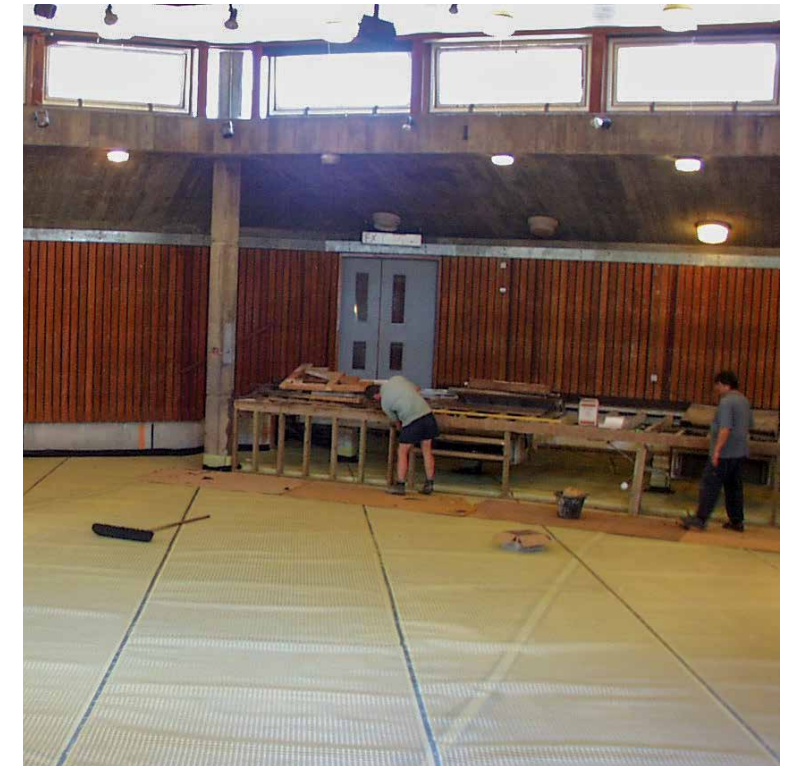
Archive photograph of the 2001 works

Although the replacement floor is timber, it does not appear to be the same species of timber originally specified. Archive photos (see below) show a much more varied colour to the timber (which is noted as missanda on the architect's drawings) than the current flooring.

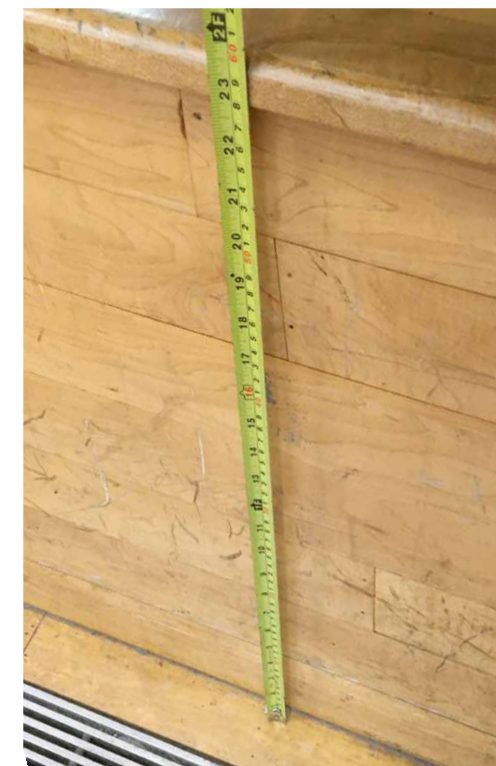
Site dimension of current drop and ventilation grille

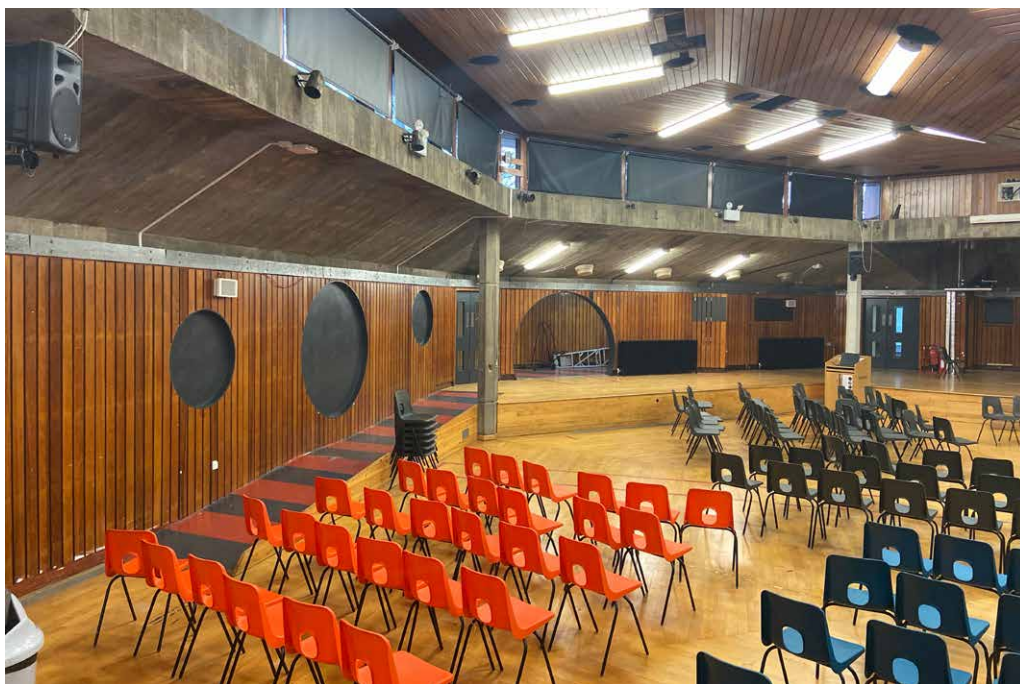
The main hall in its current condition, Spring 2020

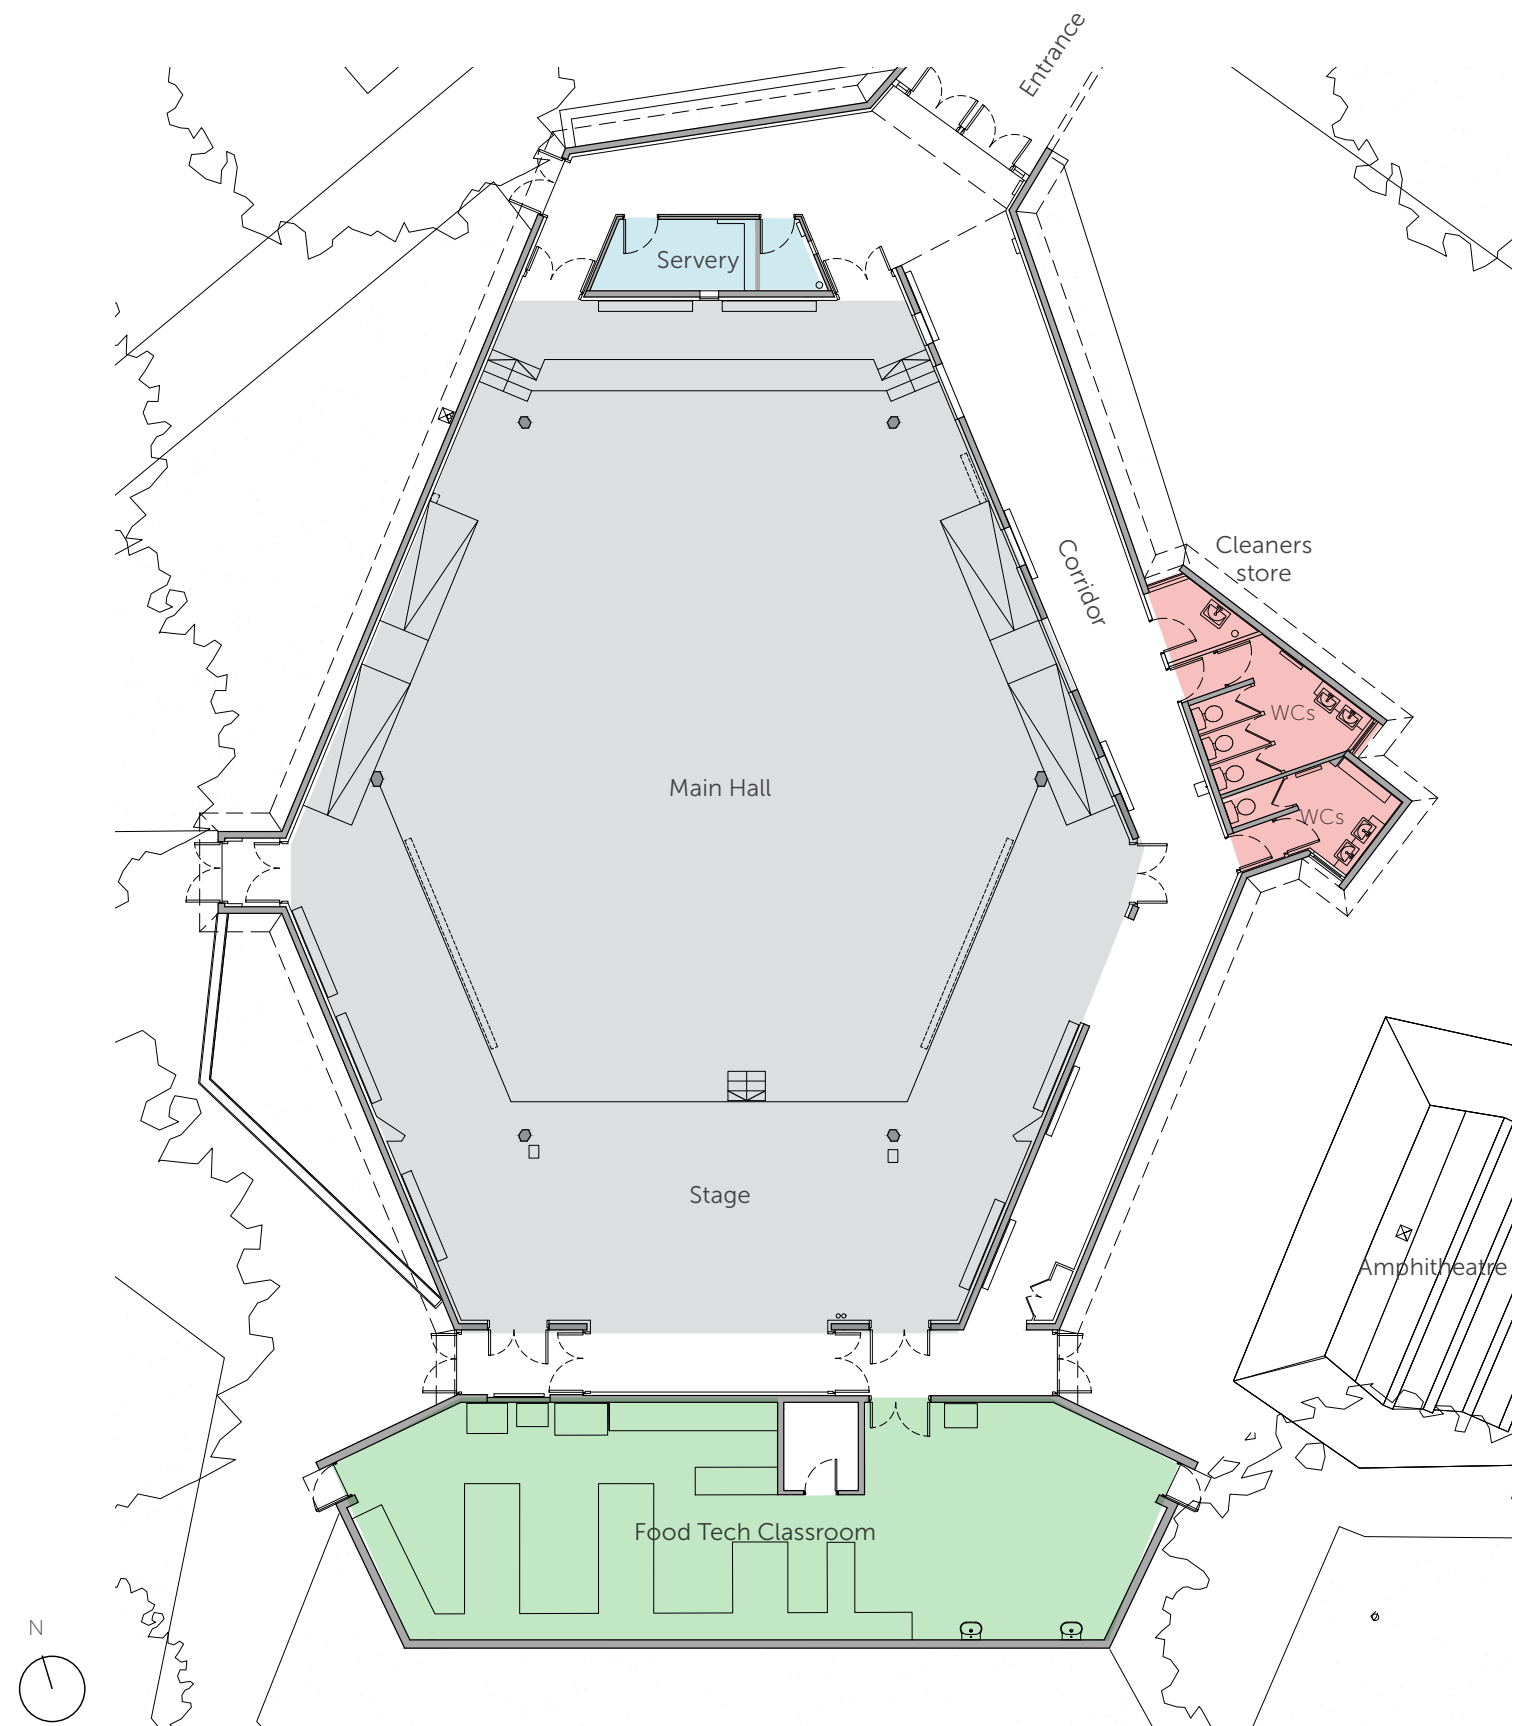
PROPOSED PLAN

The proposed plan shown opposite is the product of a series of options investigated in order to test and develop the project brief, and is felt to effectively balance various demands of the brief, including:

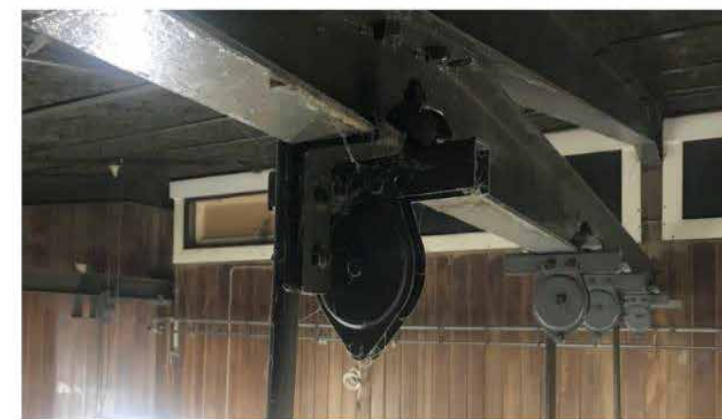
High level windows marked in red on the building's south elevation are to be replaced with extract ventilation grilles.

4 no. extract grilles are to be fitted in place of the windows shown in the photograph below.

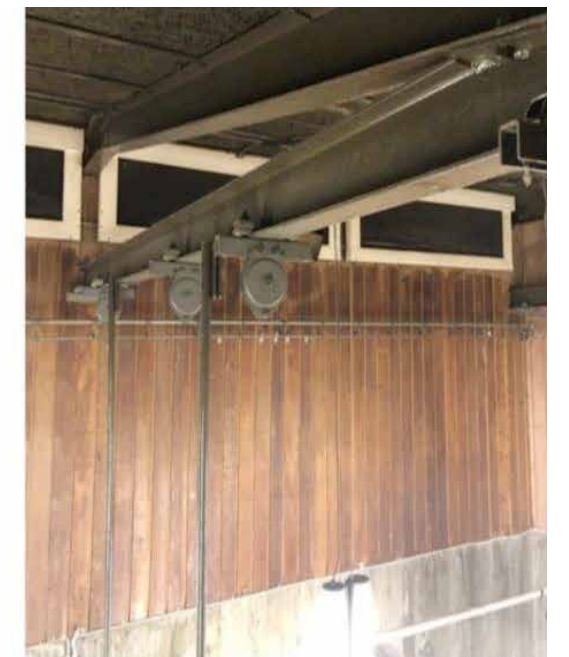
Existing blocked up windows within stage house to be reinstated with insulated opening vents

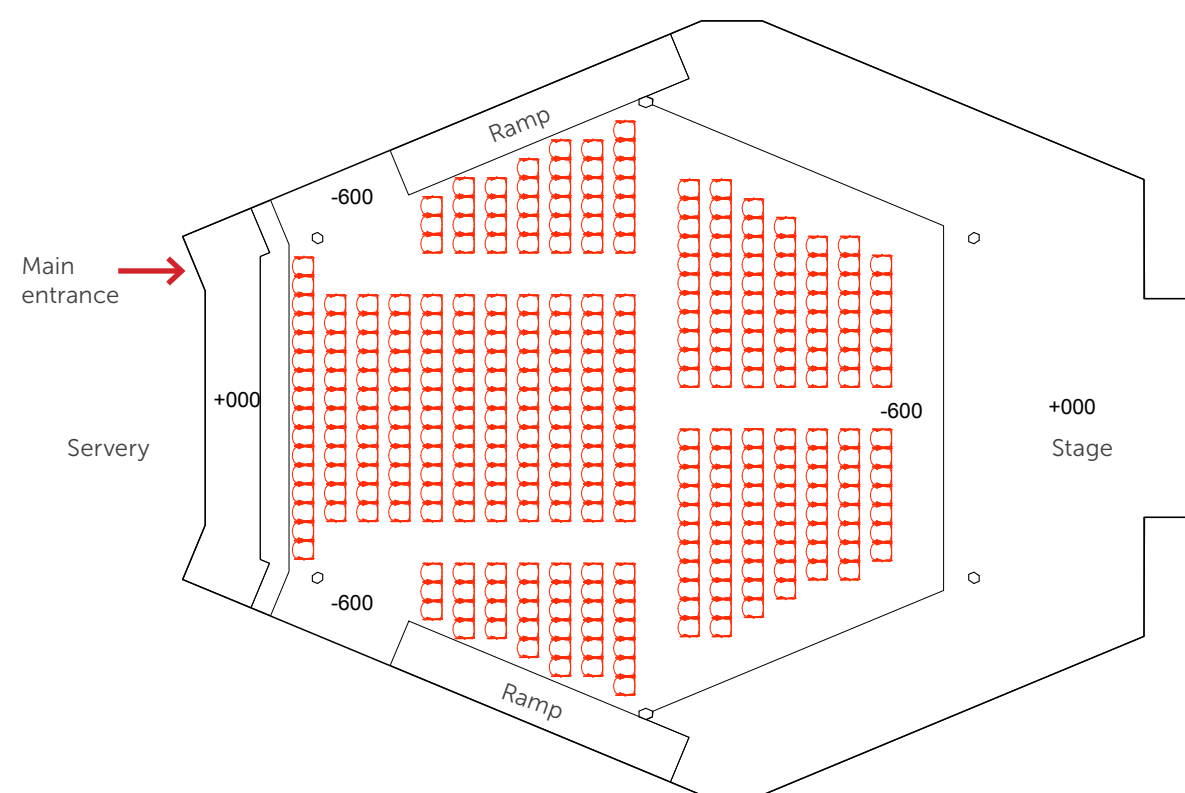
The existing floor plan shown with 334 seats.

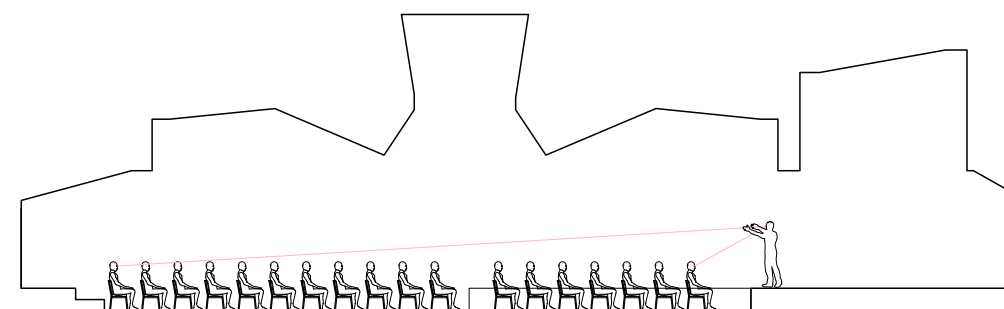
The existing section with central lowered section 600mm below stage level
