Guilford Place Drinking Fountain, Camden

Design, Access and Heritage Statement

July 2024

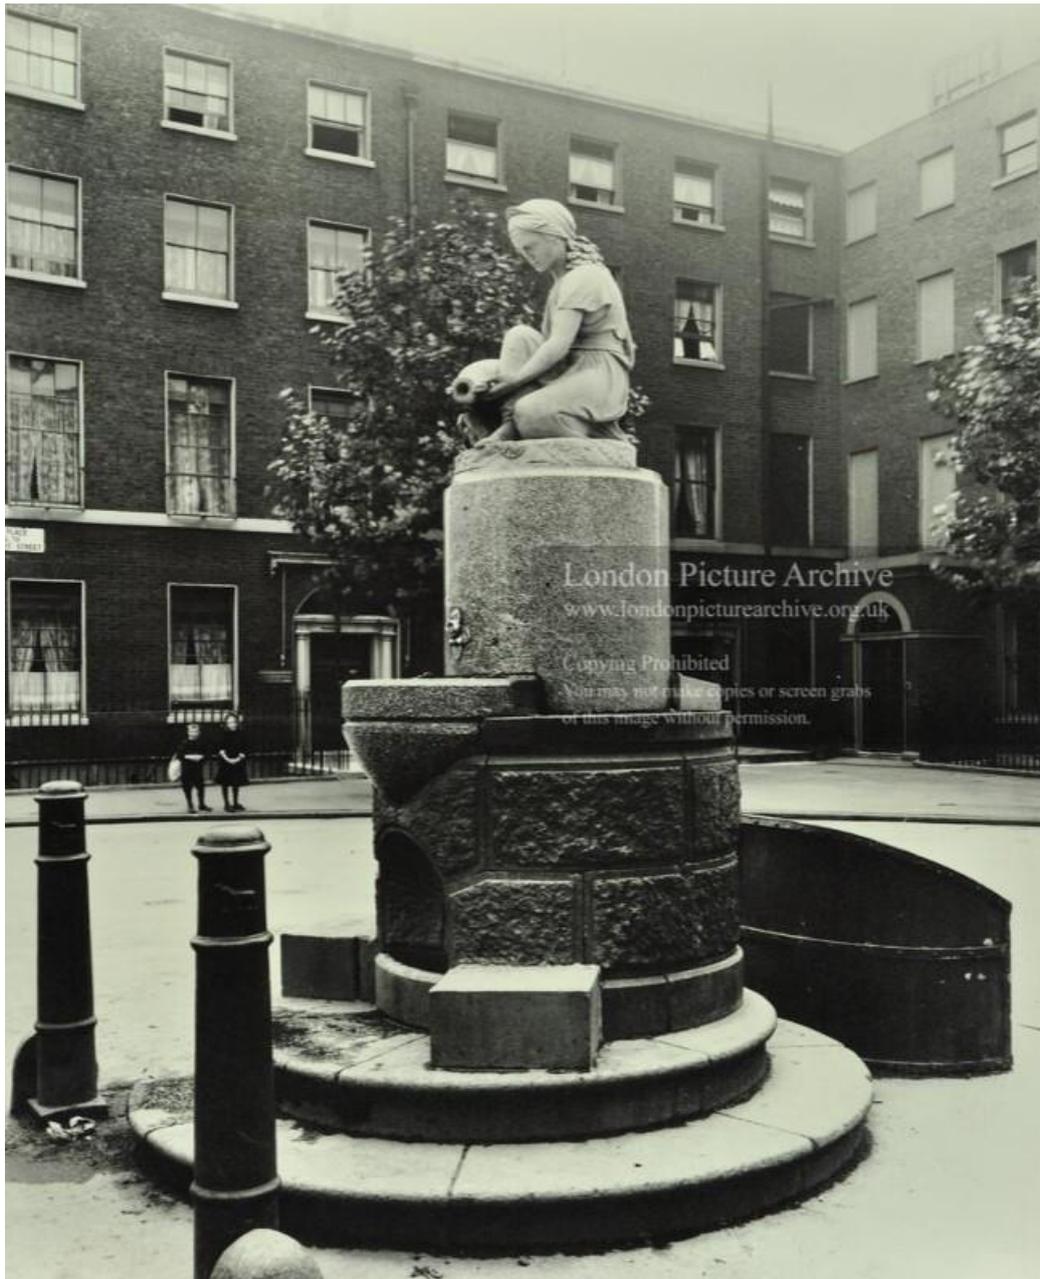
Fig 01 – Photograph of the drinking fountain in 1912, prior to the construction of the public lavatories immediately to the south. (Credit: London Picture Archive)

The Guilford Place fountain was erected in around 1870 to the memory of Mrs Francis Whiting by her daughters, who lived in nearby Mecklenburgh Square. Some sources claim that it is in fact dedicated to Mr (not Mrs) Francis Whiting. The fountain was designed by Henry Darbishire (1825-1899), an accomplished architect who completed many works for charitable causes and organisations including the Peabody Trust. It comprised a Carrara marble statue of the Woman of Samaria, crouched and holding a jug, sitting atop a large Aberdeenshire granite plinth. The fountain originally had a floral motif push button tap (see Fig 01).

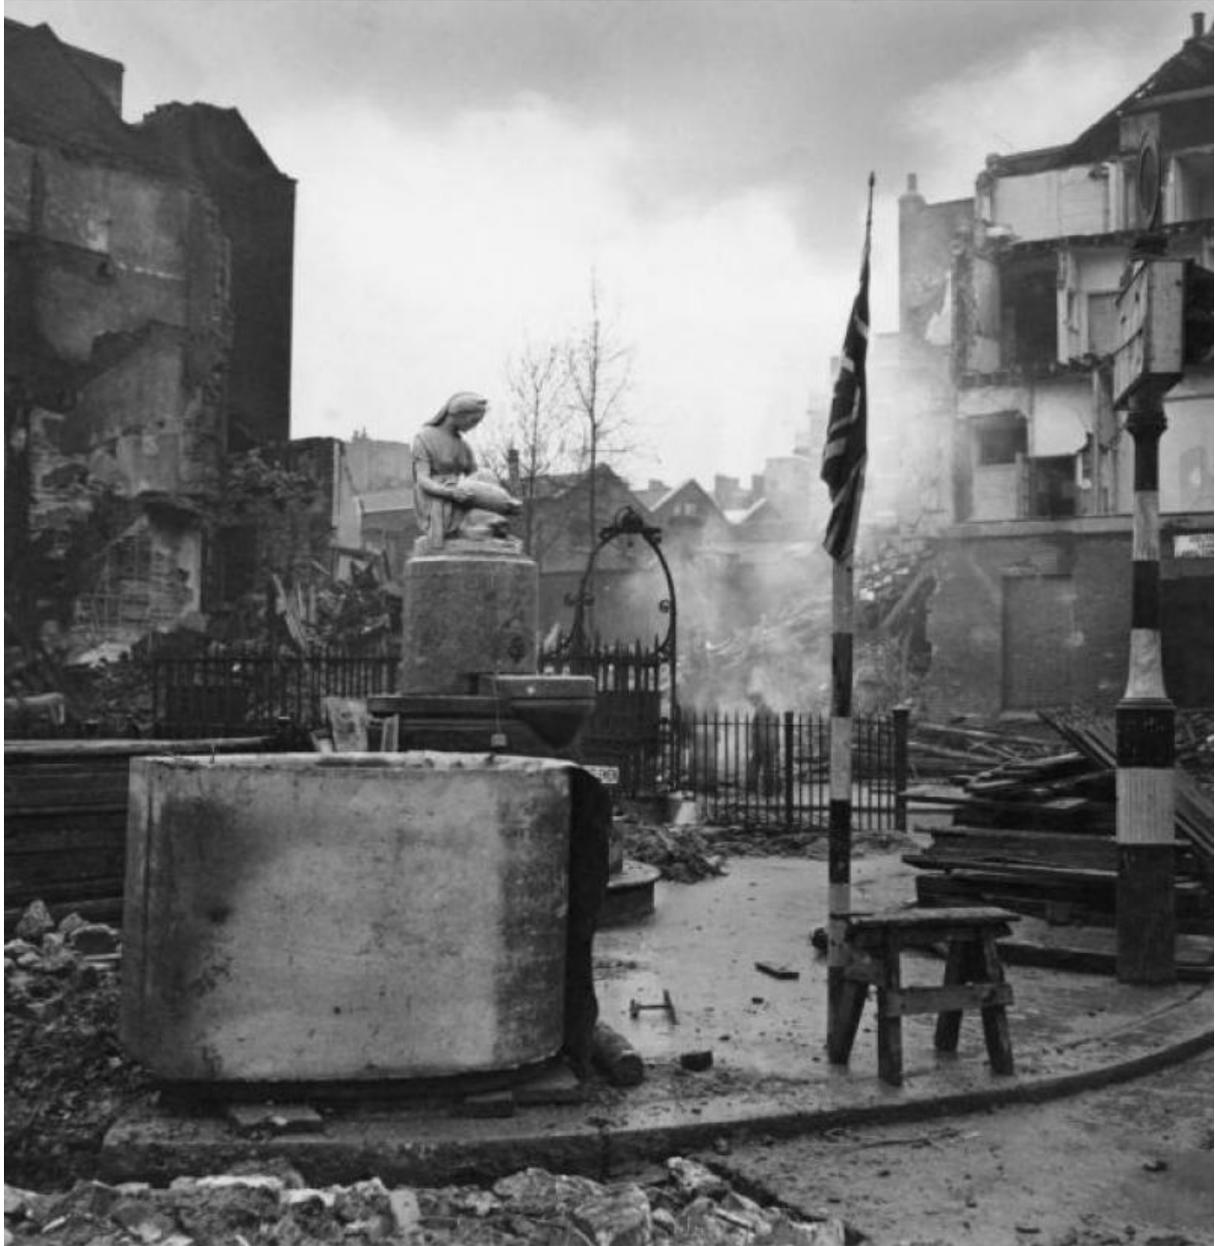
Fig 02 – Photograph of the Guilford Place Drinking Fountain during the Blitz, c.1940-41

Bloomsbury was severely bombed during the Second World War. The fountain survived but many buildings in the local area were destroyed (see Fig 02).

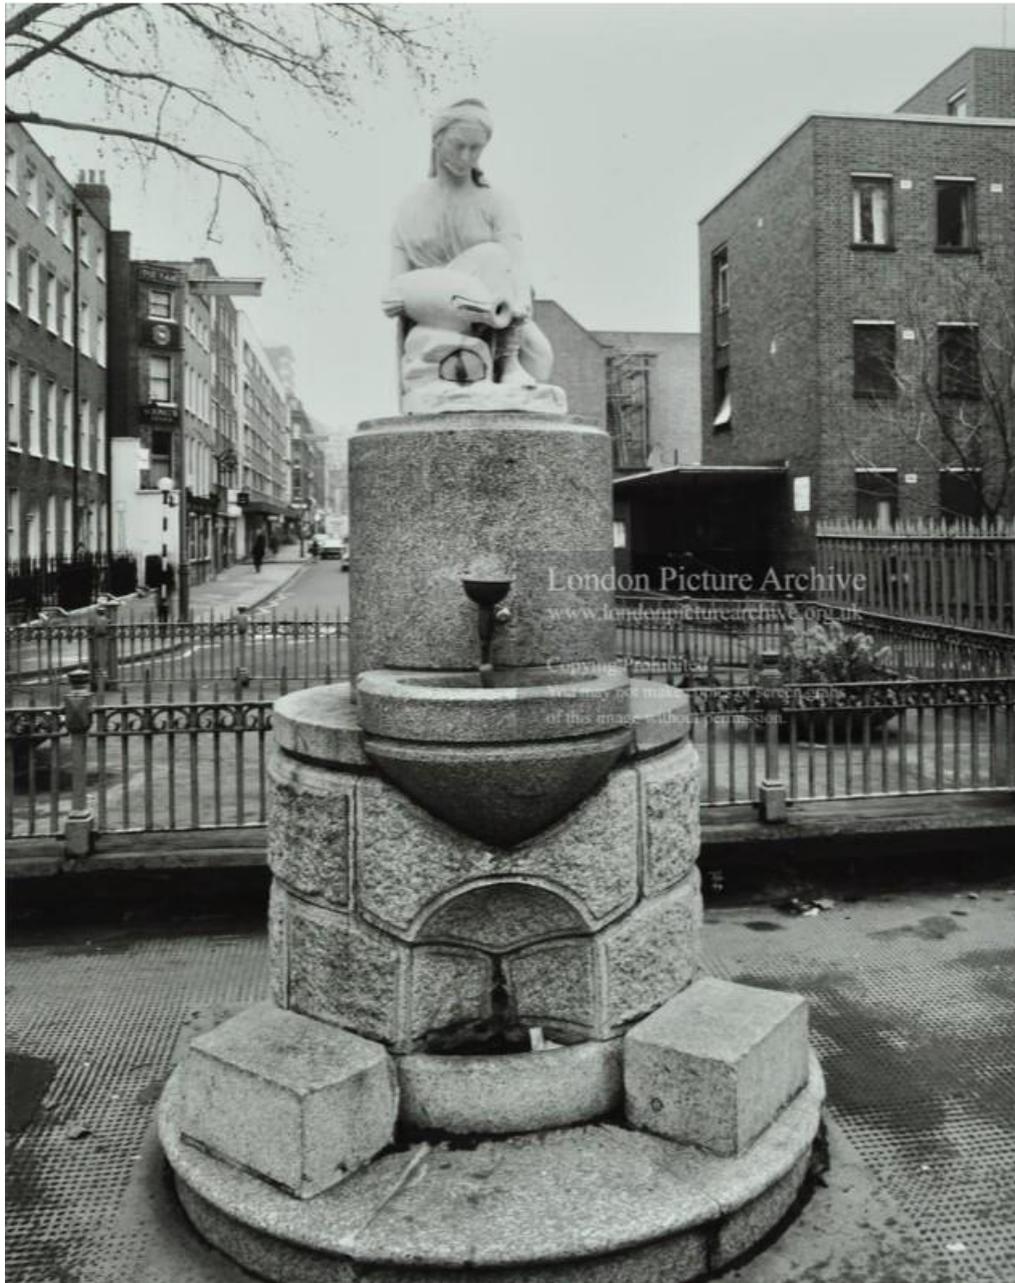
Fig 03 – Photograph of the Guilford Place Drinking Fountain in 1971. Note that the original floral tap had been replaced with a cup-type fountain. Note also the relative lack of damage to the granite base at this time, and the ‘withered’ appearance of the marble jug’s handle.

The fountain was refurbished on several occasions during the twentieth century. This included replacement of the statue's nose in Portland cement mortar and replacement of the floral motif tap with a cup-style drinking fountain sometime before 1977 (see Fig 03 below). The adjacent public lavatories are believed to have been closed in the 1980s.

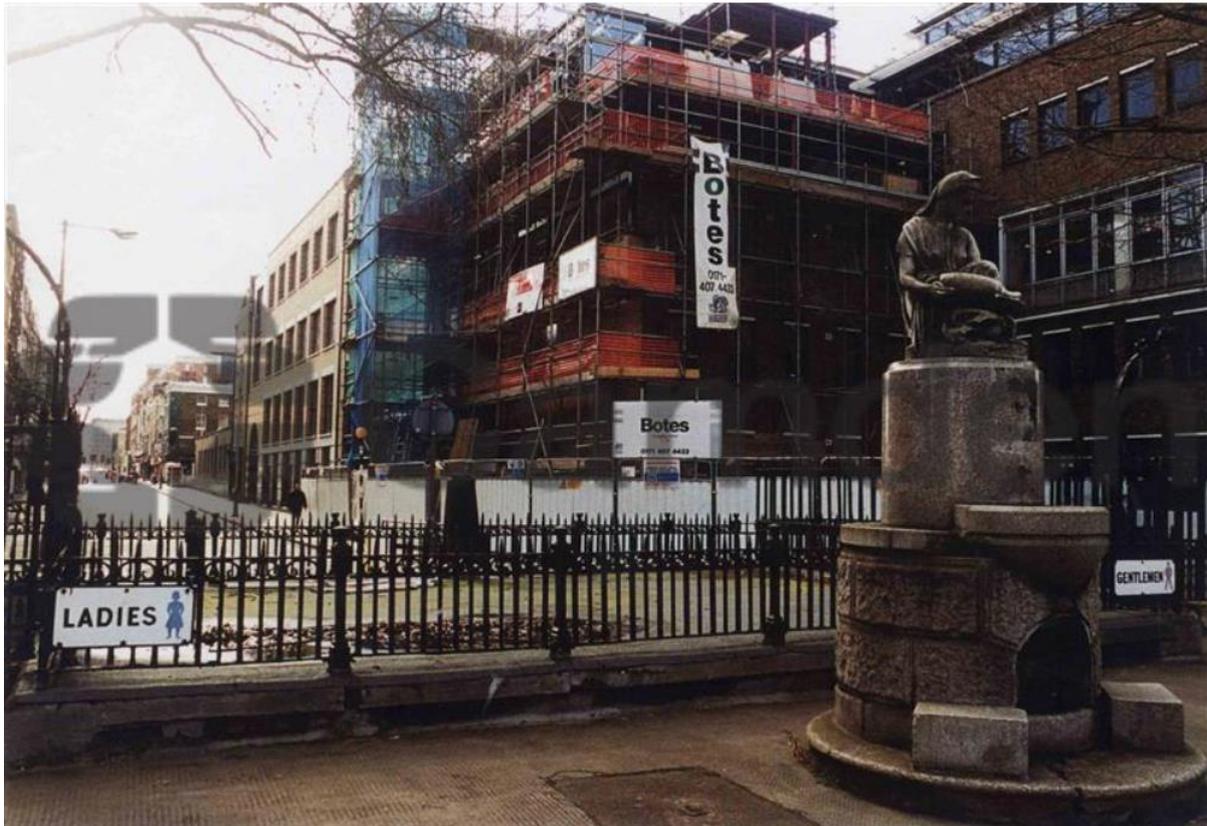
Fig 04 – Photograph of the Guilford Place Drinking Fountain, c.1990s

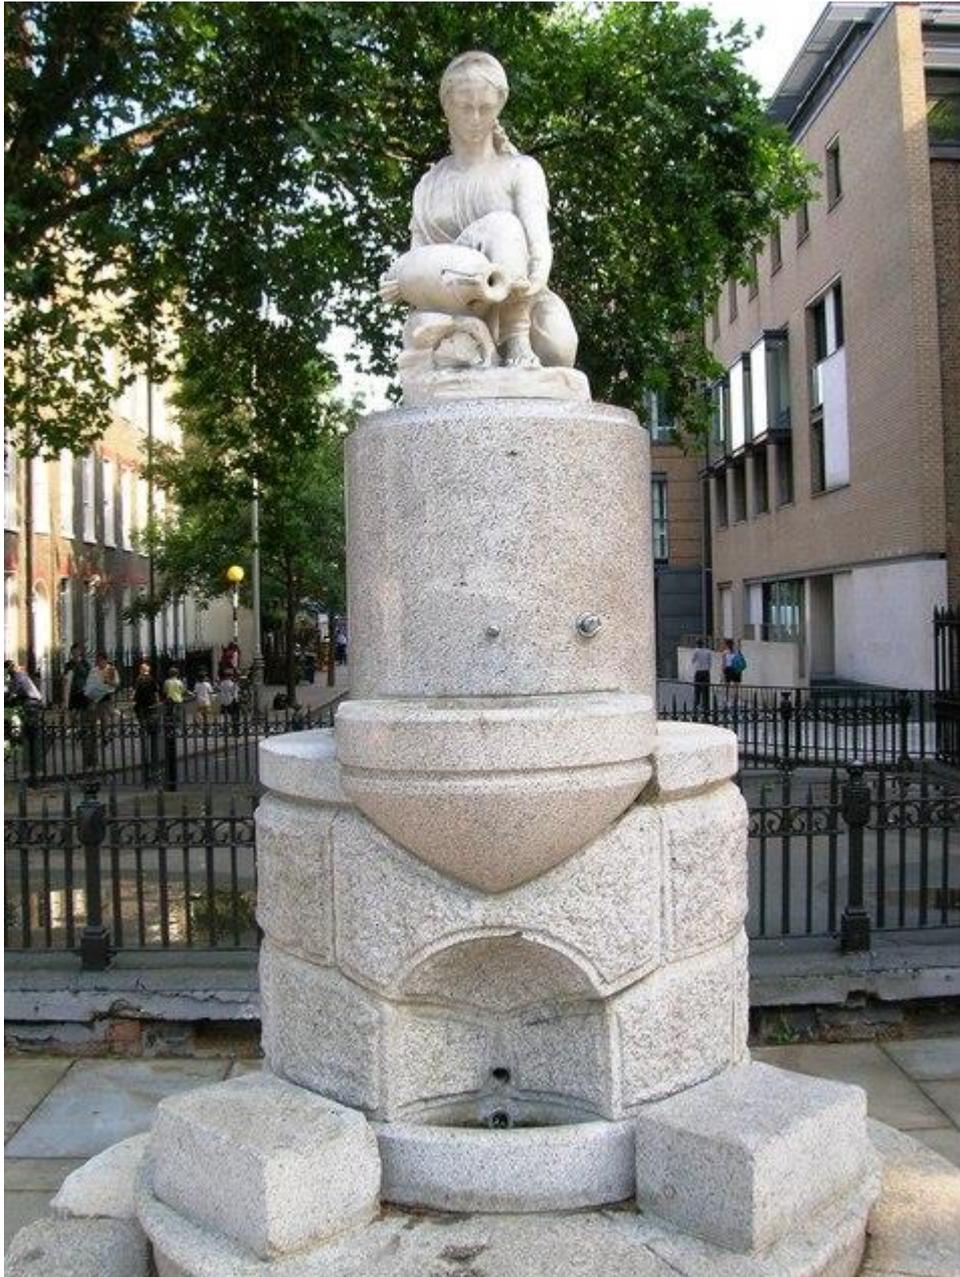
Fig 05 – Photograph of the Guilford Place Drinking Fountain, 2006. Note the damage to the granite base, the cleaner appearance of the marble statue and the new push button tap and spout.

During the late 1990s or early 2000s, the heavily stained statue was cleaned and another fountain system was installed, comprising a stainless steel push button and separate stainless steel spout. A stainless steel access panel was installed in the rear of the statue providing access to the internal plumbing, which also appears to have been renewed at this time. In contrast to these interventions, the bottom step of the fountain suffered significant damage around this time, with several chunks knocked off of the bullnose edge and one of the rear treads infilled with cementitious render.
