# UCL Bicentennial Projects : Wilkins Cloisters and Main Quad

Civil and Structural Design Report for Planning and Listed Building Consent Submission

Revision: 01  
Date: July 2024  
Document Ref: UCL-BDP-XX-XX-RP-S-000001

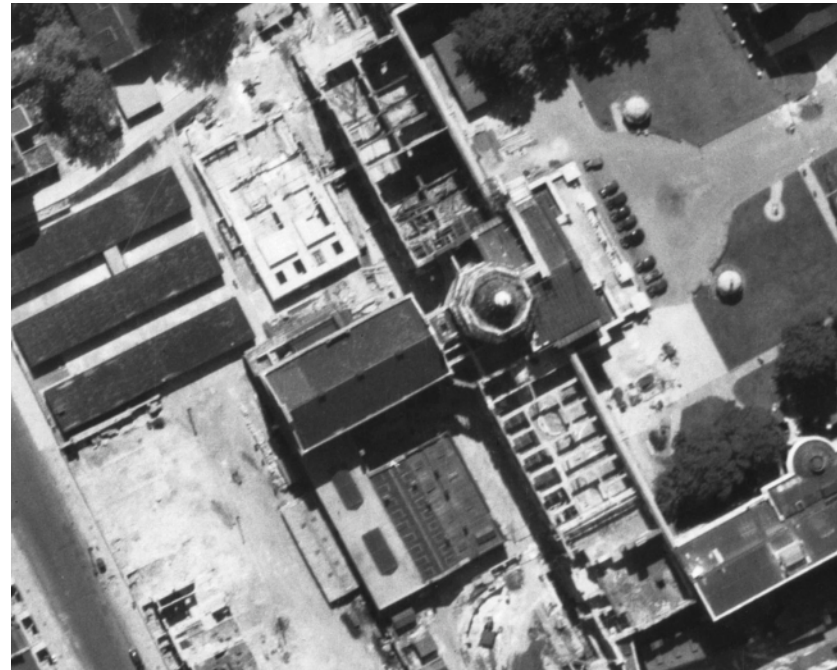
Reconstruction appears to have begun sometime around early 1948 as confirmed by the following photo from May 1948 showing the area in construction. The photo also shows the removal of the propping to the North cloister.

*Aerial footage of Bloomsbury Campus 1948 (Source: Historic England)*

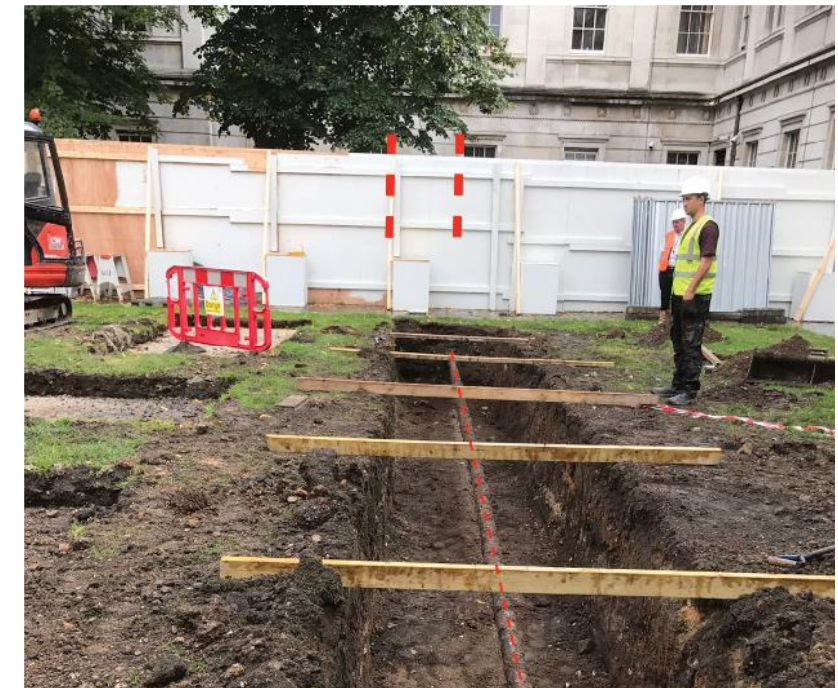
Existing gas main

A gas pipe seen in the photo below, running parallel to the Chadwick building in the south Quad was identified during some recent construction work which the Contractor should be made aware of.

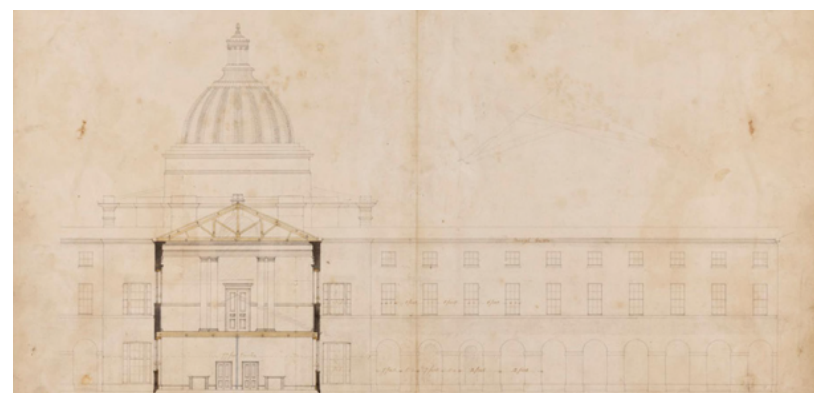
Original Wilkins Building Section through Great Hall (UCL)

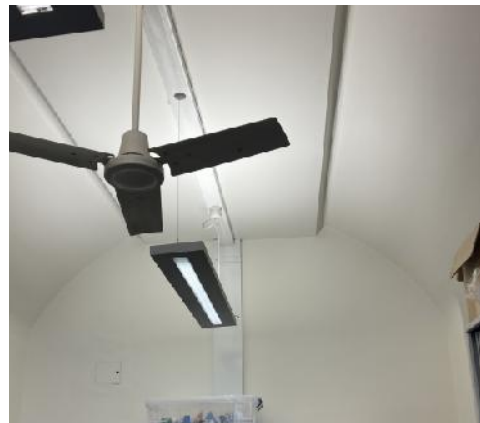
Photo of lower ground arches

The lower ground floor is assumed to be a ground bearing slab.

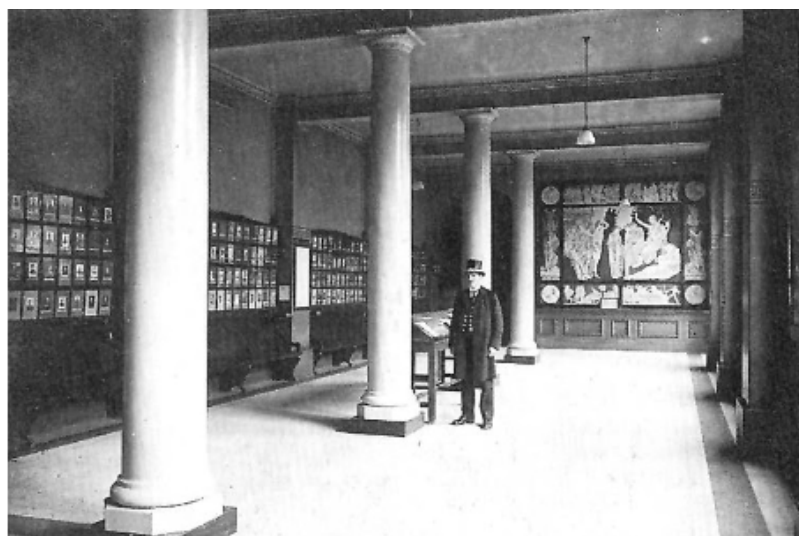
S. Cloisters at GL in the inter war period showing the columns which did not survive.

The original double row of central columns flanking the library at 1st and 2nd floors was wider apart and in the South Cloisters there were cast iron columns at ground floor aligning with the columns above as evidenced by pre-war photographs and the original plans.

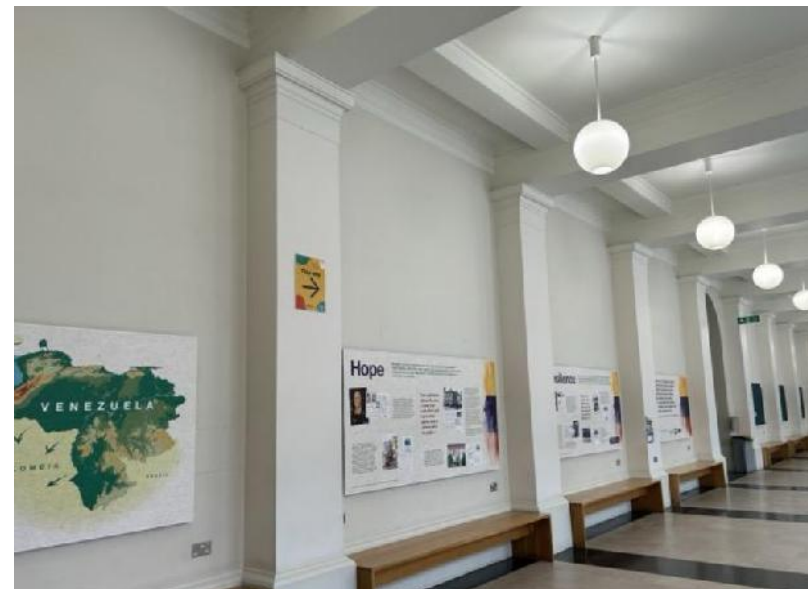
Cloisters at Ground Floor showing current column free configuration

After World War II, the building was reconstructed with 3 new storeys over the existing ground floor as evidenced by the archive drawings from this period.

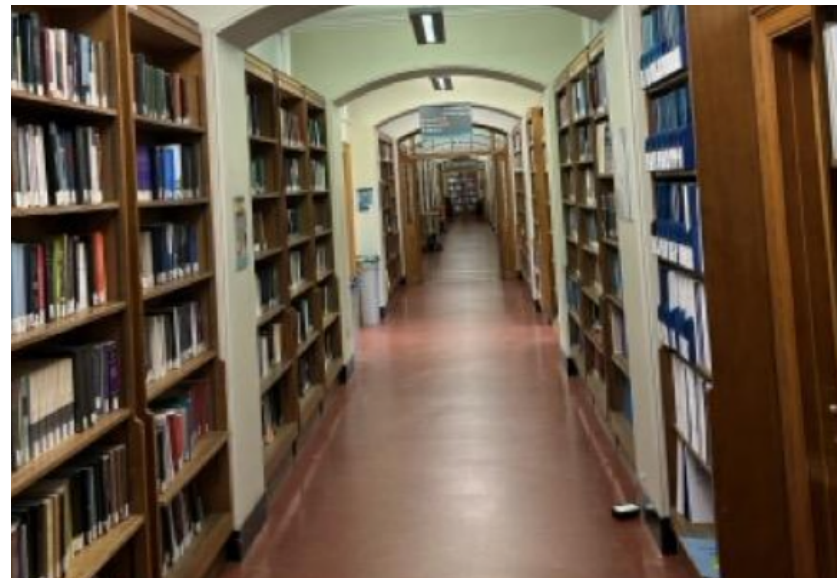
Photo from 1st floor corridor

1st floor transfer beams span between the spine wall and external wall. These provide support for internal columns which align with the corridors walls at 1st and 2nd floors.

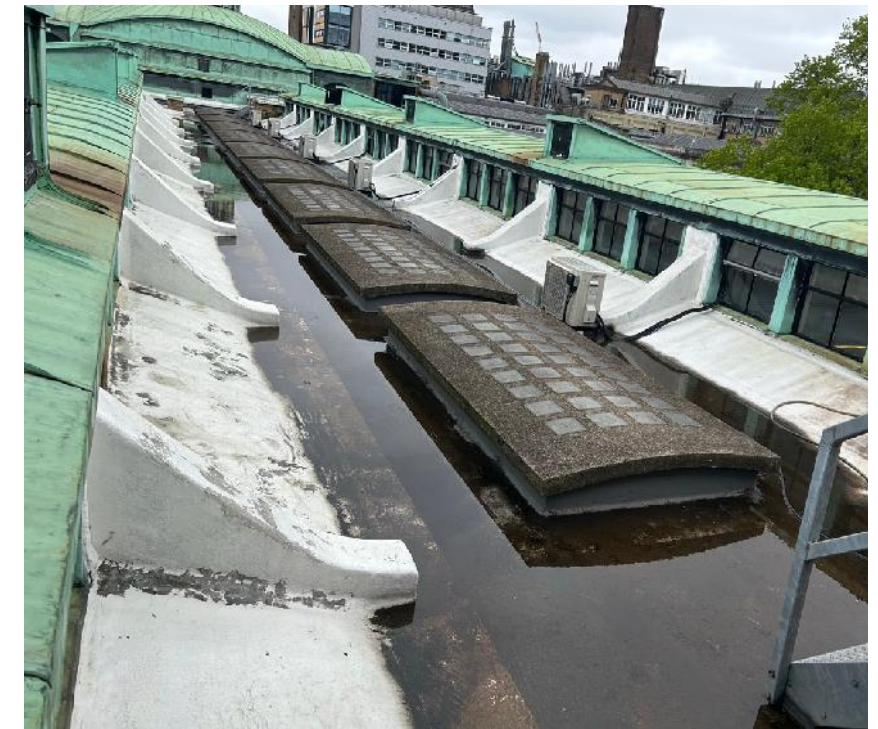
Photograph of South Cloister roof

At roof level concrete trusses appear to span from the external walls to internal 2nd floor columns restrained by concrete encased steel purlins. There are a number of precast concrete elements at roof level. It is assumed that the curved slabs at roof are precast panels

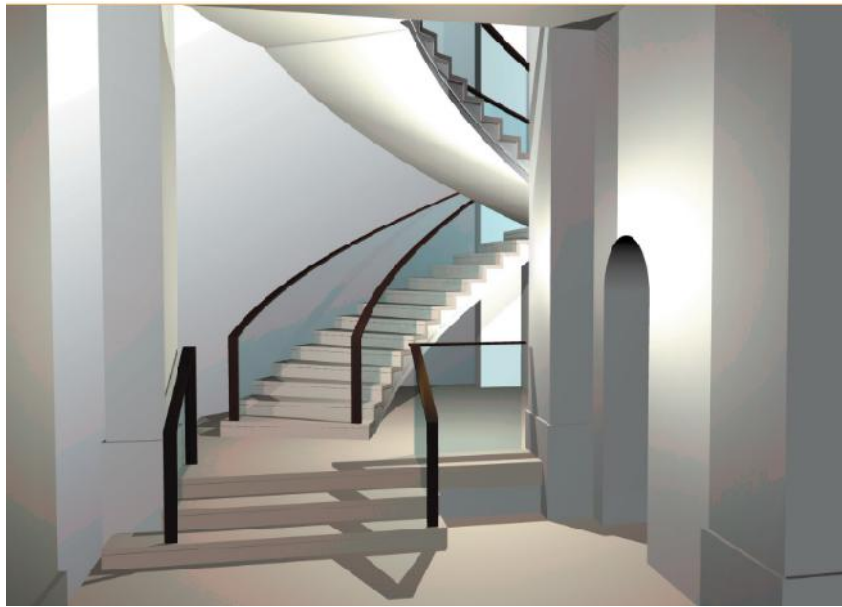
It is noted that a curved reinforced concrete stair exists in the opposite access route leading to the Donaldson Library.

Render of curved stair leading to Donaldson Library(BA)

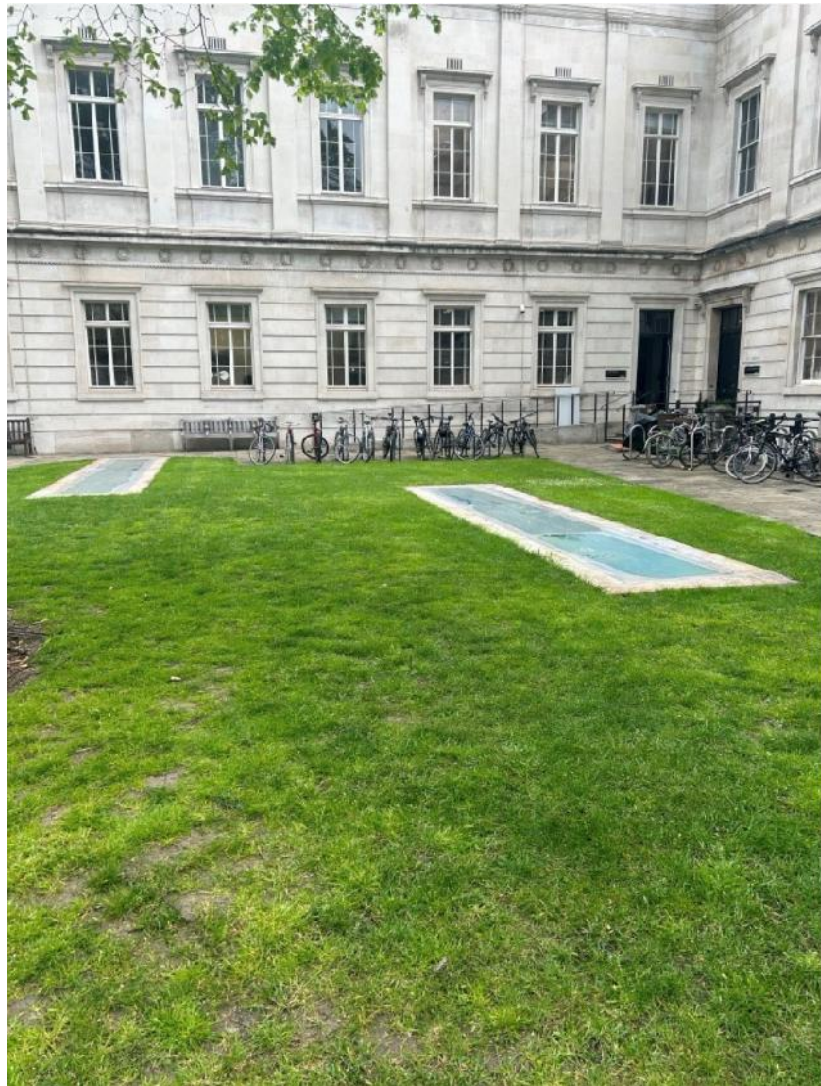
Slade basement roof lights

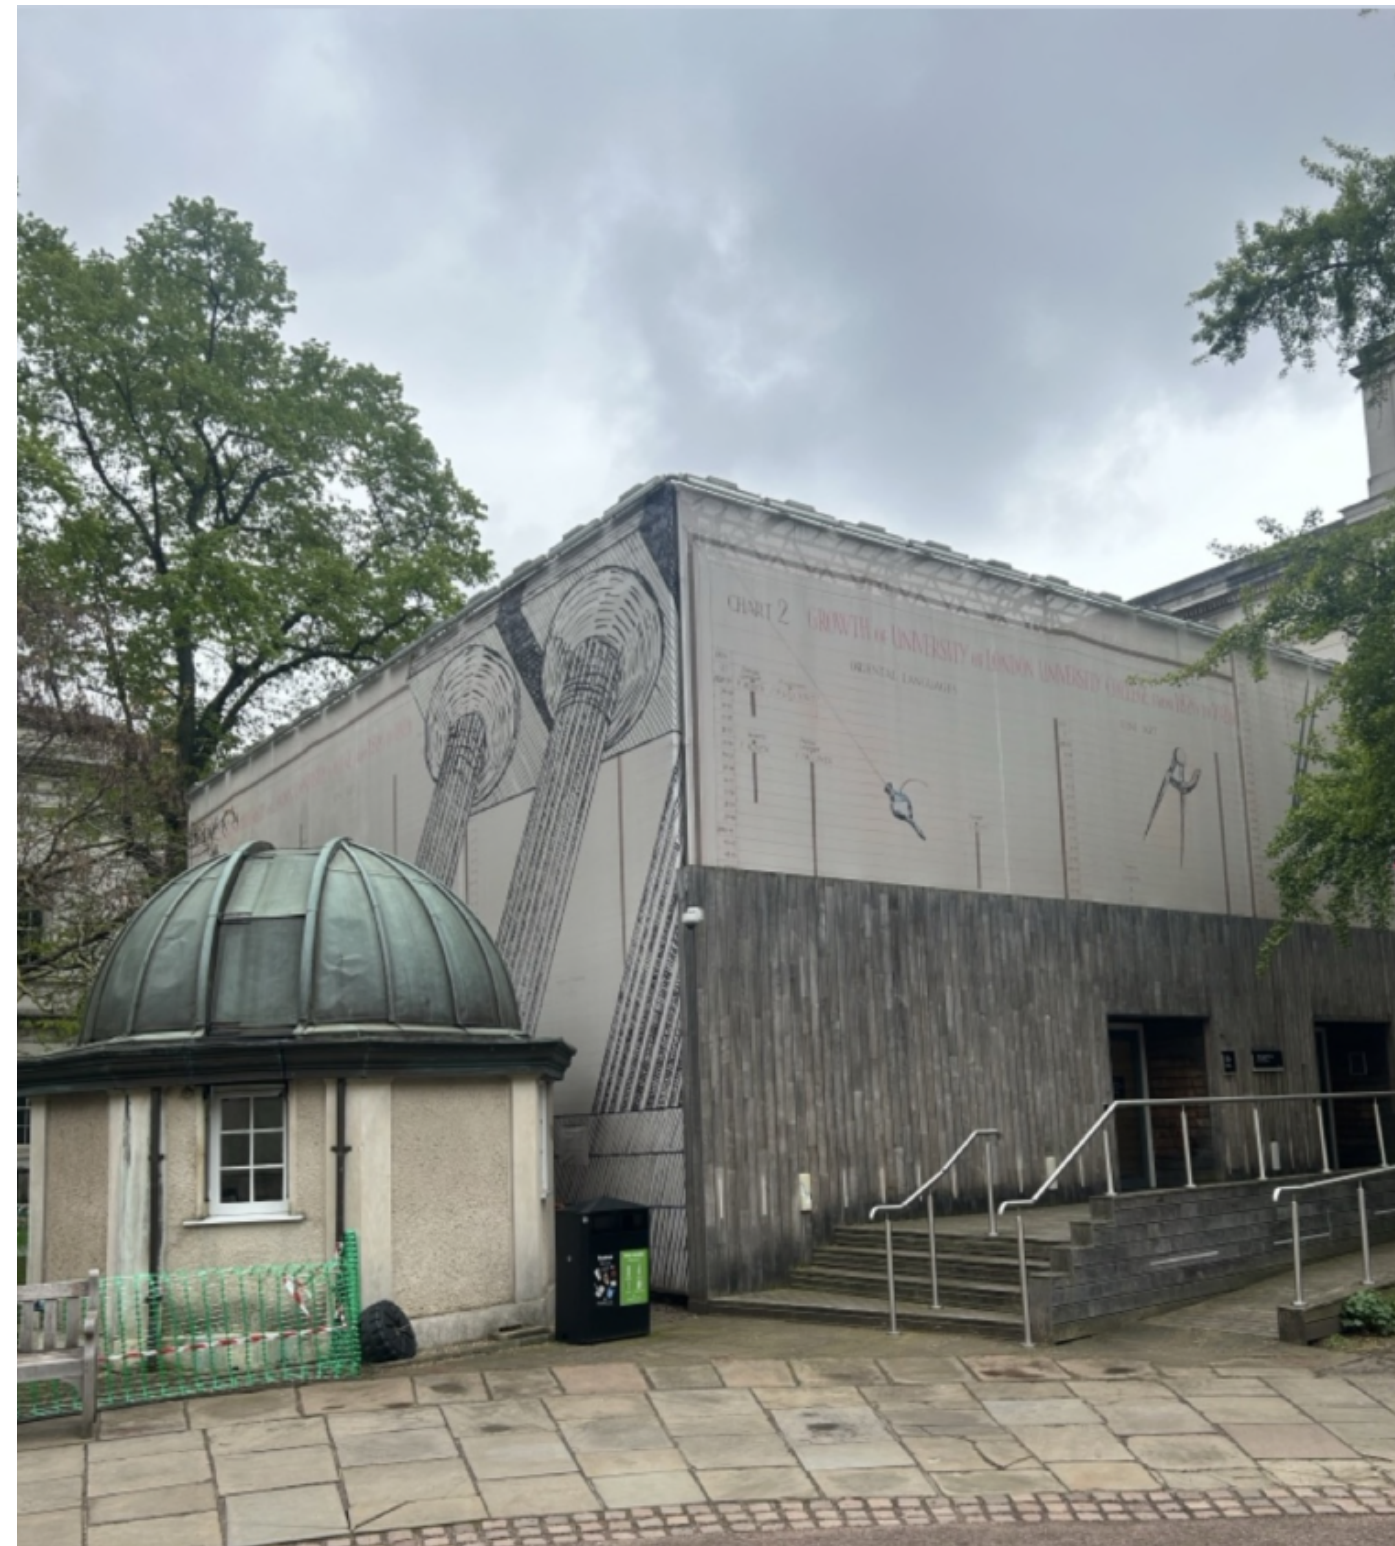
A two storey modular building currently exists in the south west corner of the quad built circa 2017 according to archive drawings. The building appears to be steel framed supported off pad foundations bearing into the Made Ground with an Assumed Ground Bearing Pressure of 50kPa. The footings are 1.2m deep and project slightly above ground.

'Temporary' teaching Facility and observatories

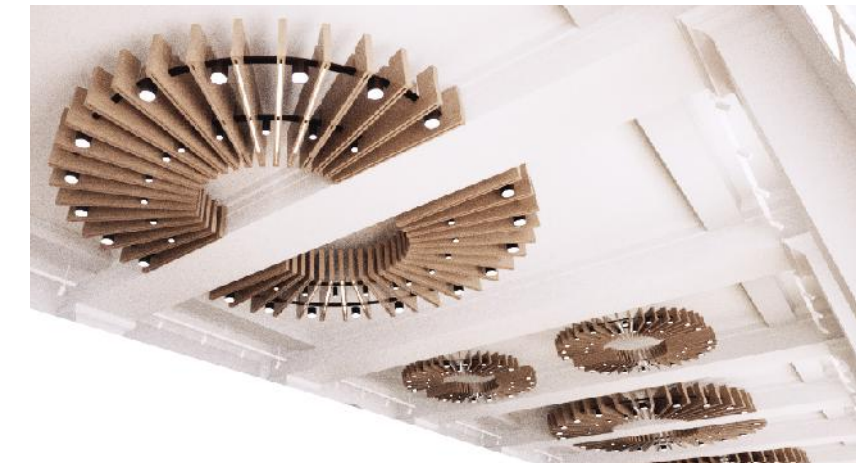
*Architectural render of proposed light fittings*

As part of the update to lighting within the Wilkins building new pendants are to be installed in the Cloisters and 'Level Access Zone'. It is understood that these are to be timber and therefore relatively light. The pendants are to be fixed to the underside of the existing 6 1/2 inch thick 1st floor RC slab.

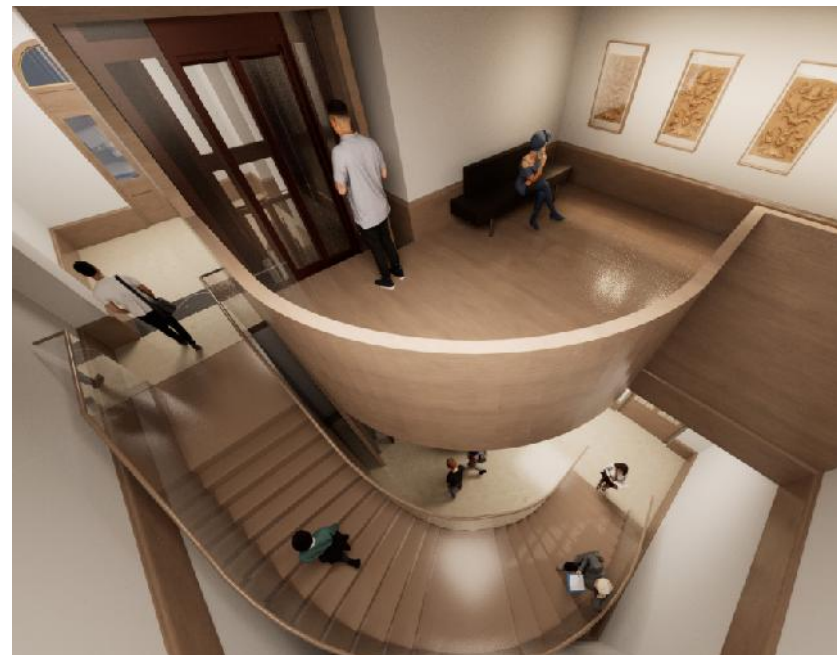
The space is to be reconfigured to include:

- A new 'column free' curved staircase from lower ground to ground through what is currently the Provost Dining Room.
- A platform lift in order to provide level access to the Jeremy Bentham Room which will carry occupants between lower ground floor, ground floor and upper ground floor

Architectural render of level access zone (Burwell Architect's)

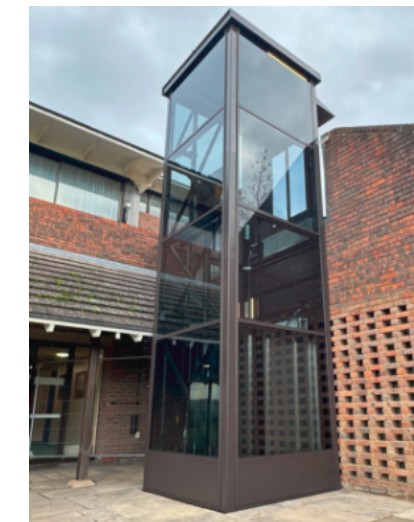
The image below is an example platform lift from a potential lift supplier showing unpropped bracing which provides stability to the lift in one direction and a horizontal tie into existing brickwork to provide stability in the other direction. A similar philosophy can be utilised for the proposed platform lift with the exception that the bracing will require a high level prop to reduce uneven raft loads and displacements.

At ground floor level and upper ground floor the composite slabs can act as a diaphragm to help restrain the platform lift, if necessary, and transfer any lateral loads back to the existing masonry walls.
