Scale @ A1 As indicated	Date 10/07/24	Job Number 17056A	Project IoN/DRI Redevelopment Project 256 Grays Inn Road, London, WC1X 8LD	1 Lochrin Sq 92 Fountainbridge Edinburgh EH3 9QA mail@hawkinsbrown.com hawkinsbrown.com
Drawn By MM	Checked By JP	Status S3	Drawing New Window Type 4 (L00/Stone Plinth/North Facade)	Hawkins\Brown
Drawing No. BEMP-HBA-P2-ZZ-DR-A-31-1413	Rev P03	Purpose of Issue For Review & Comment

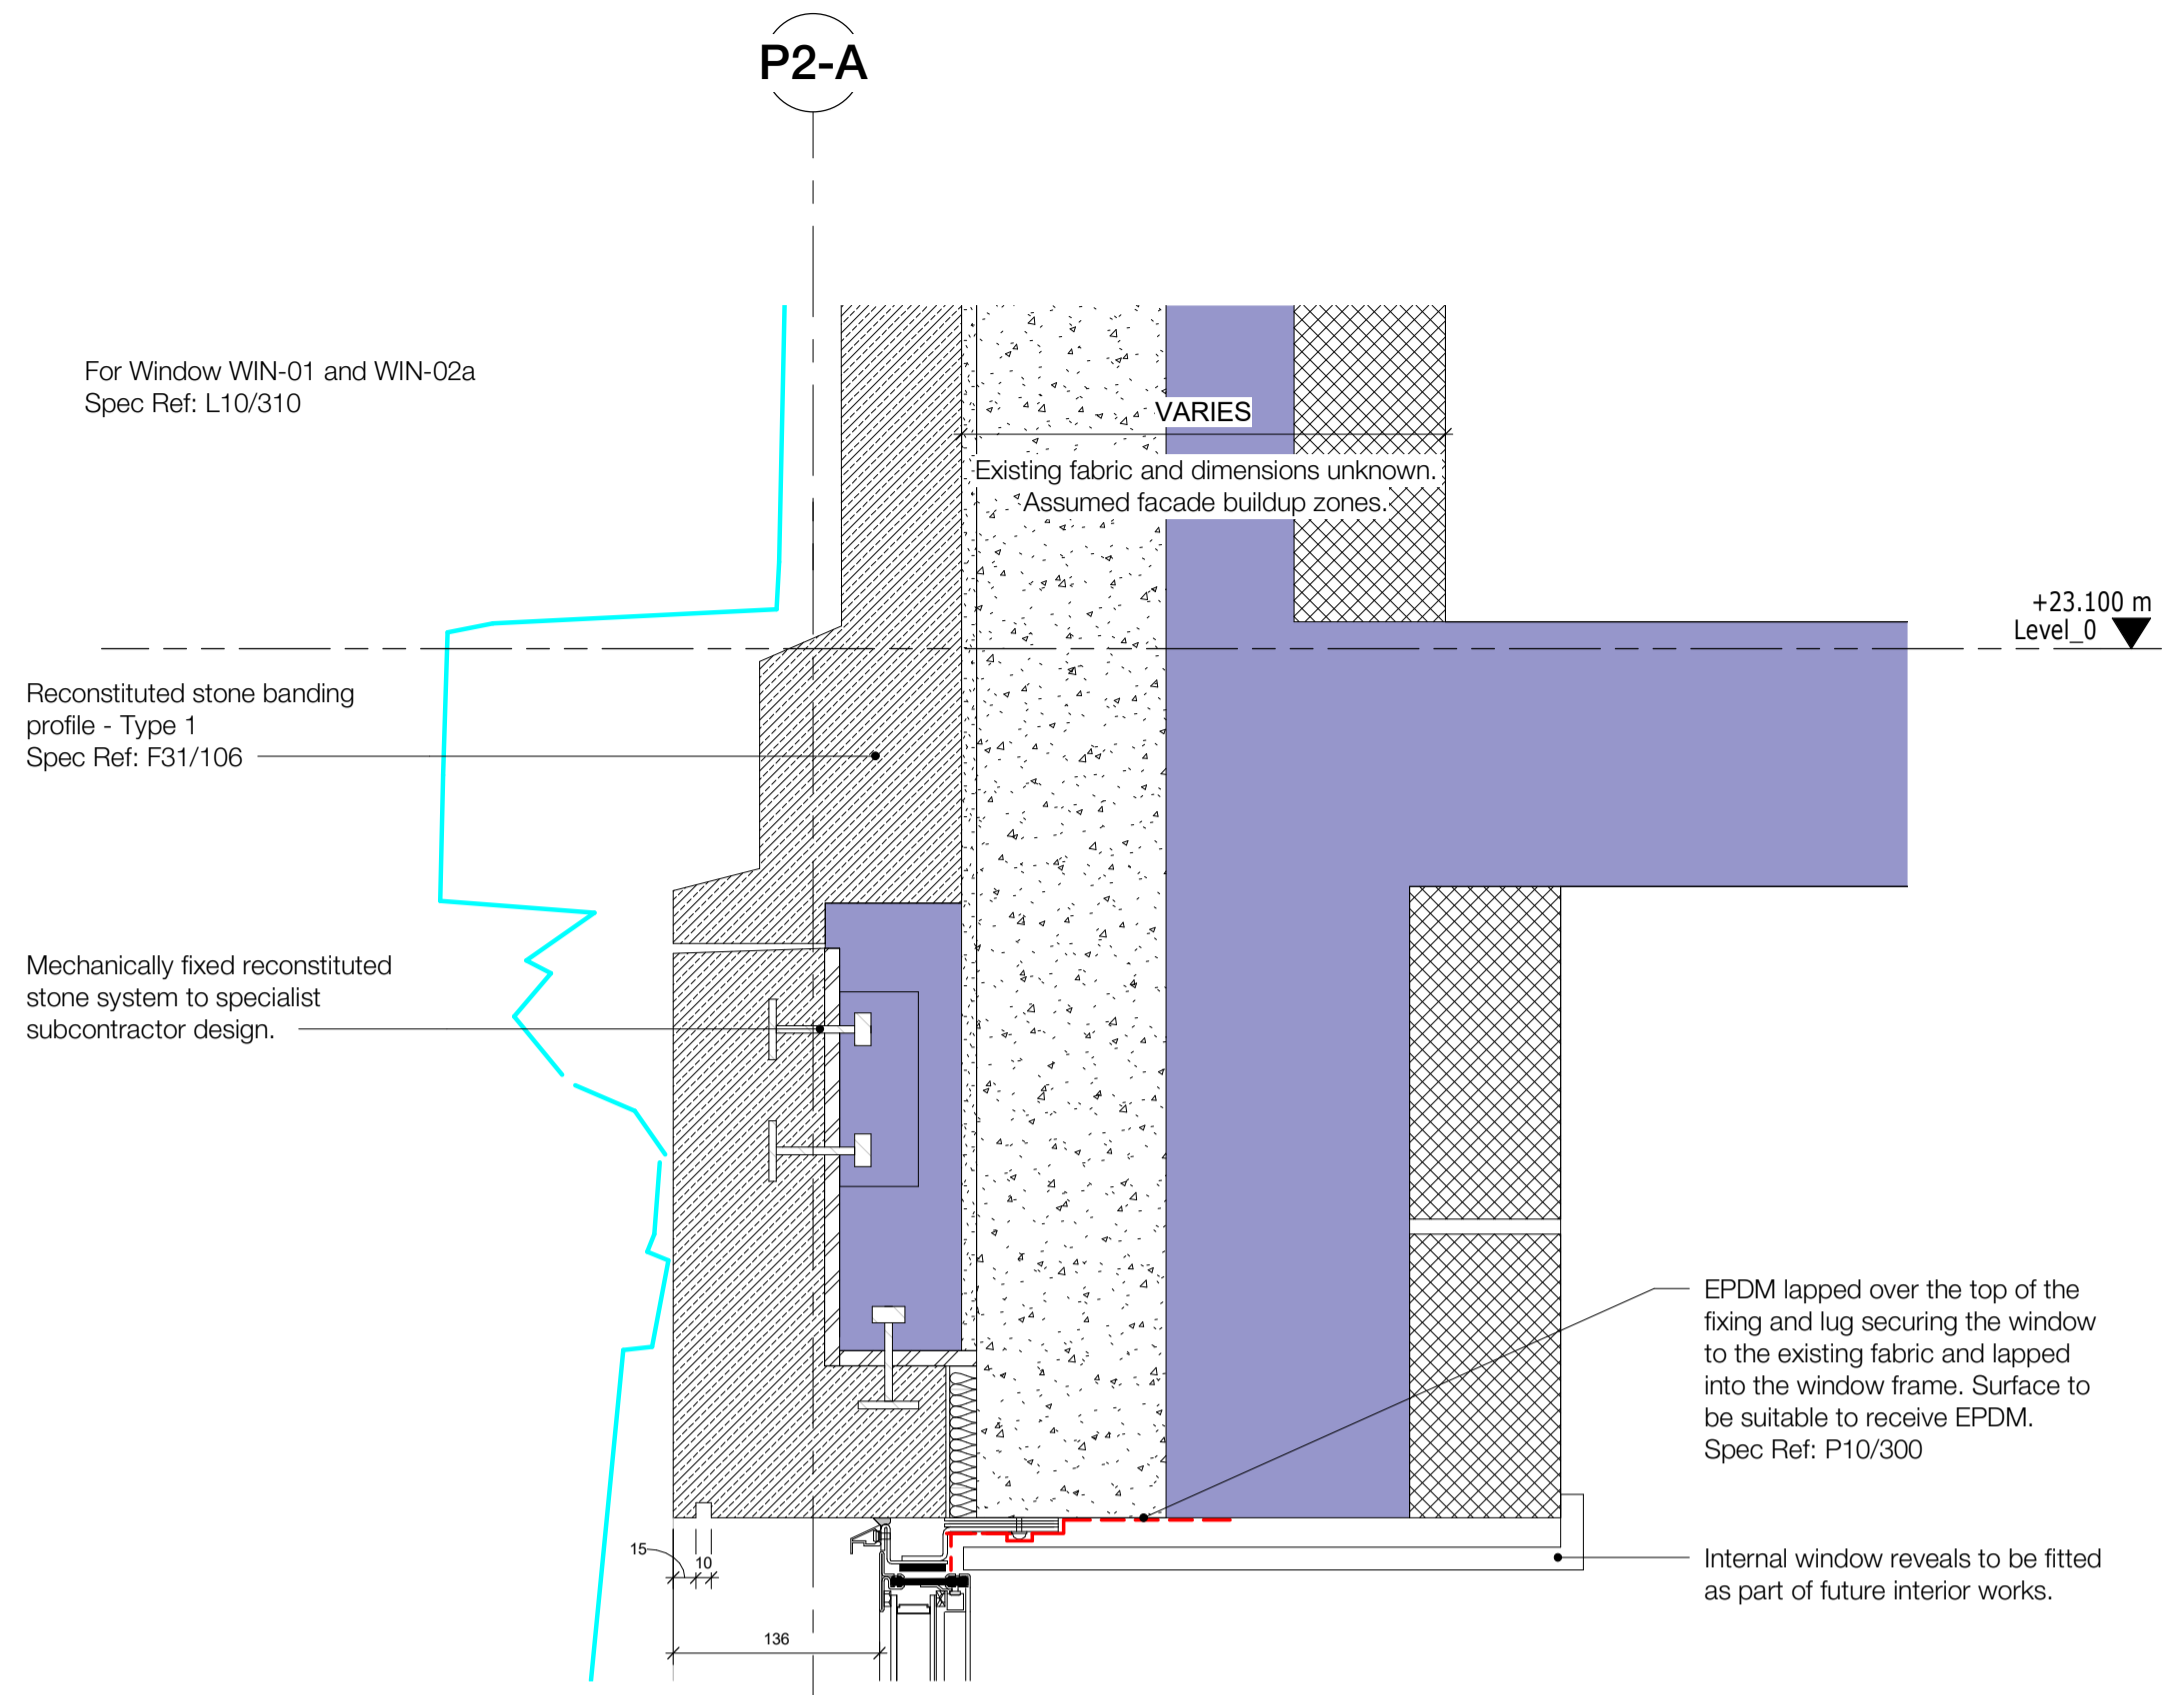
1
1 : 5

Existing Opening / Typical fixed window head in stone overclad
