WINDOW DETAIL W01 & W02
TD:W:001

drawing title Windows				do not scale dimension from this drawing. all measurements given are indicative. all dimensions to be determined on site prior to purchase and manufacture. all discrepancies between indicative dimensions and those measured on site to be brought to the architect's attention. this drawing is copyright and should not be copied or duplicated in anyway without the consent of the architect.
Proposed				
project 2 Villas on the Heath Hampstead NW3 1BA	status Planning	project No 952 drawing No TD'W'001 revision A	date 02/24 scale 1:20

Window Reference	Elevation	Historic Significance	Existing condition	Proposed Works	Glazing Type	Method Statement	Drawing Reference
W01	Front elevation Ground floor	Original frames New glass	Realtively good condition. Painted shut.		Histoglass Mono	Please refer to Windows Method statement for repairing and replacement	TD'W'001 W'X'06 W'06
W02	Front elevation First floor	Main contour frame is original,while casement frame is non- original. New glass	Realtively good condition.	Refurbish original frame and casements, replace glazing.	Histoglass Mono	Please refer to Windows Method statement for repairing

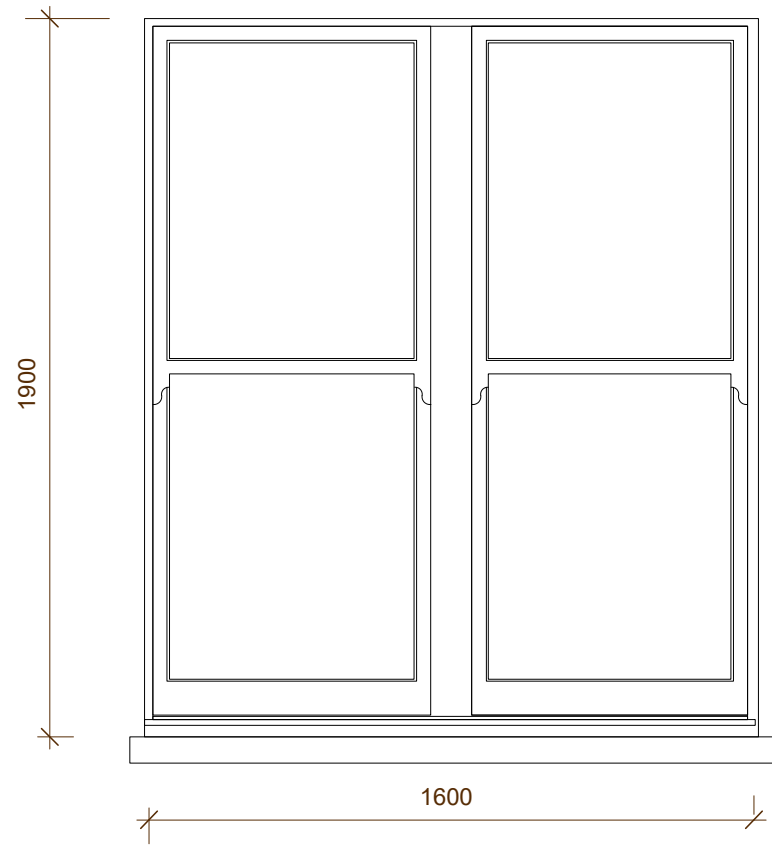
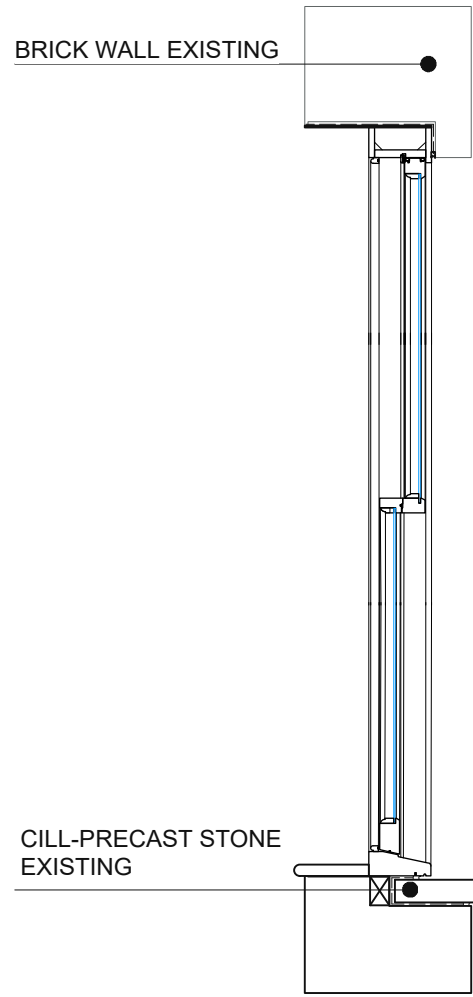
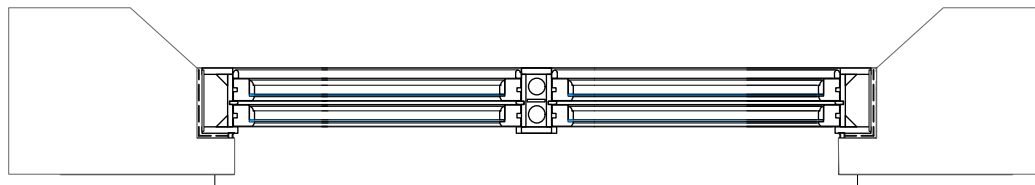
W 01

EXTERNAL ELEVATION

SECTION

PLAN

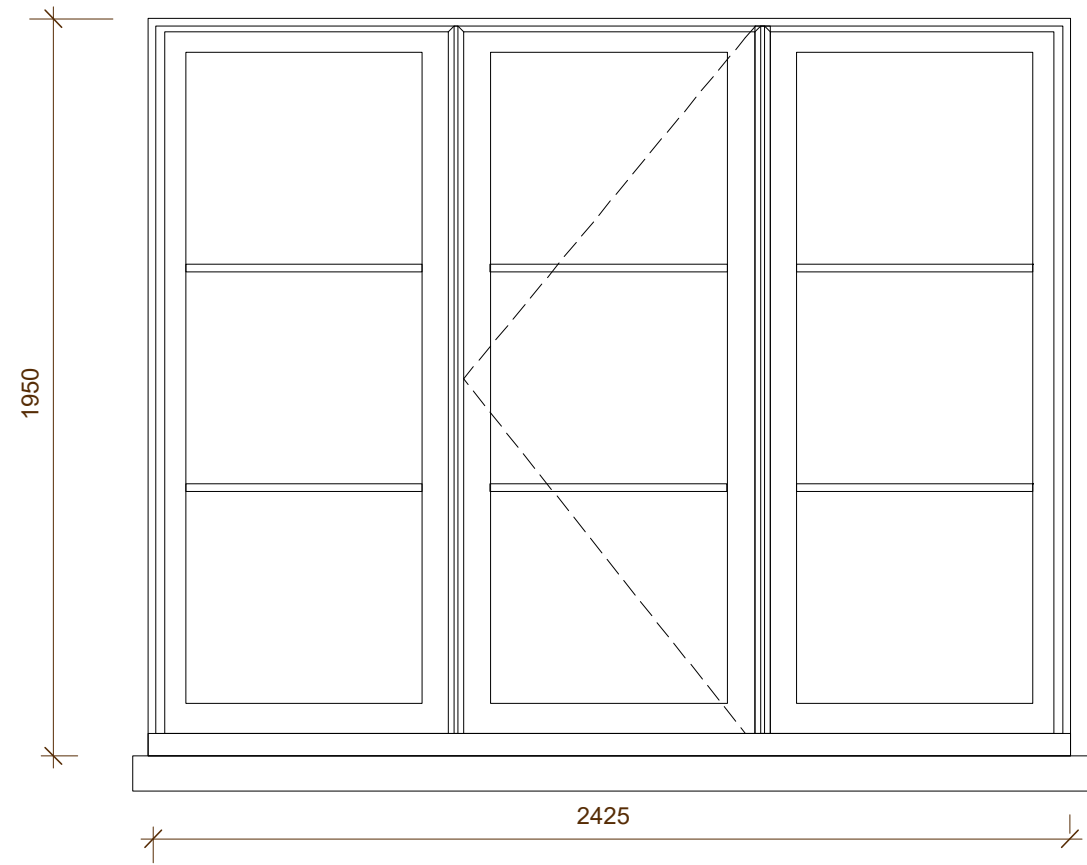
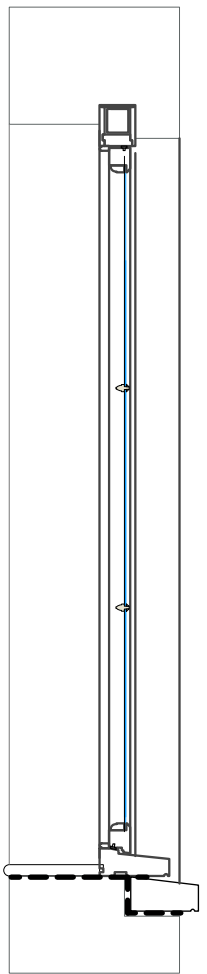
W 02

EXTERNAL ELEVATION

SECTION

PLAN

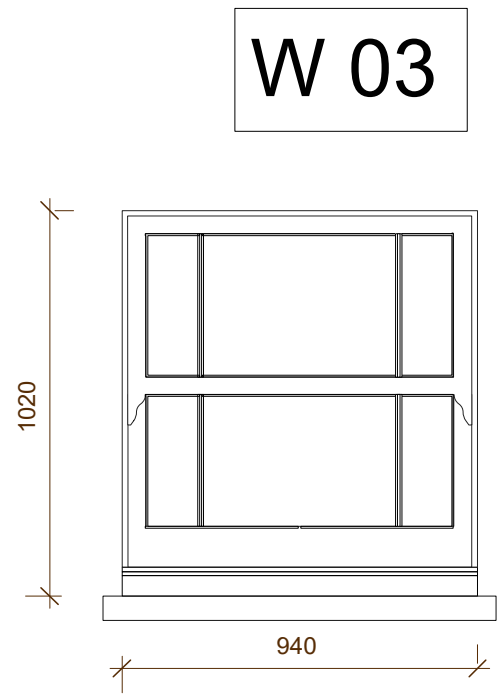
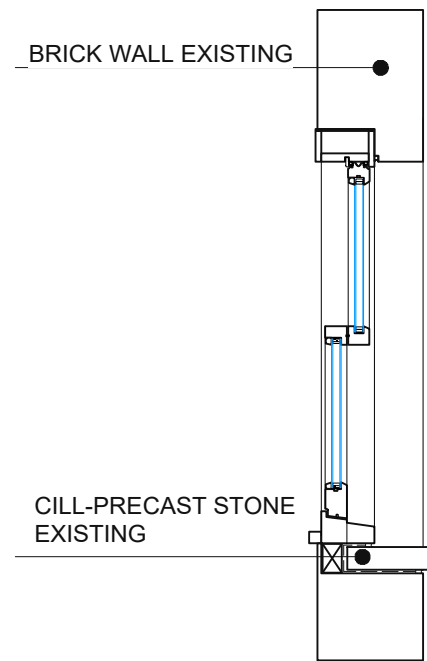
WINDOW DETAIL W03 & W04
TD:W:003

EXTERNAL ELEVATION

SECTION

PLAN

W04	Rear elevation First floor	Non- original frames New glass	Poor condition. Externally rotten frames.	Replace frames and glass with like for like.	Slimlite Histoglass double glazing.	Please refer to Windows Method statement for repairing and replacement	TD'W'003 W'X'06 W'06
W05	Front elevation Second floor	Main contour frame is original,while casement frame is non- original. New glass	Realtively good condition.	Refurbish original frame and casements, replace glazing.	Histoglass Mono	Please refer to Windows Method statement for repairing and replacement	TD'W'002 W'X'06 W'006
W06	Side elevation Second floor	Non- original frames New glass	Poor condition. Sash cord broken Externally rotten frames.	Replace frames and glass with like for like.	Slimlite Histoglass double glazing.	Please refer to Windows Method statement for repairing and replacement	TD'W'004 W'X'06 W'006
W07	Rear elevation Second floor	Non- original frames New glass	Poor condition. Externally rotten frames.	Replace frames and glass with like for like.	Slimlite Histoglass double glazing.	Please refer to Windows Method statement for repairing and replacement	TD'W'004 W'X'06 W'006

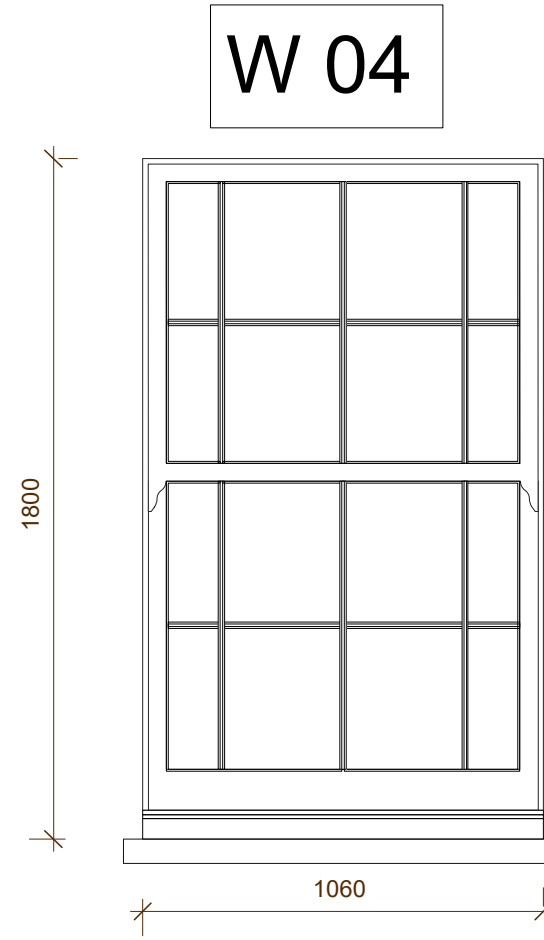
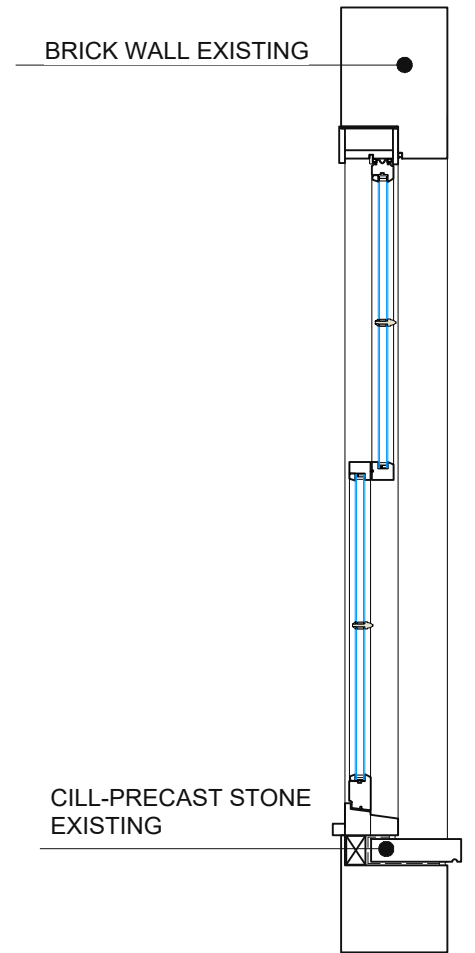
EXTERNAL ELEVATION

SECTION

PLAN

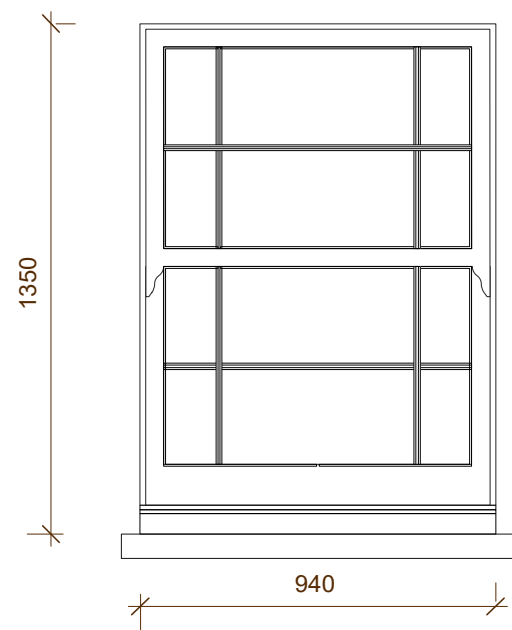
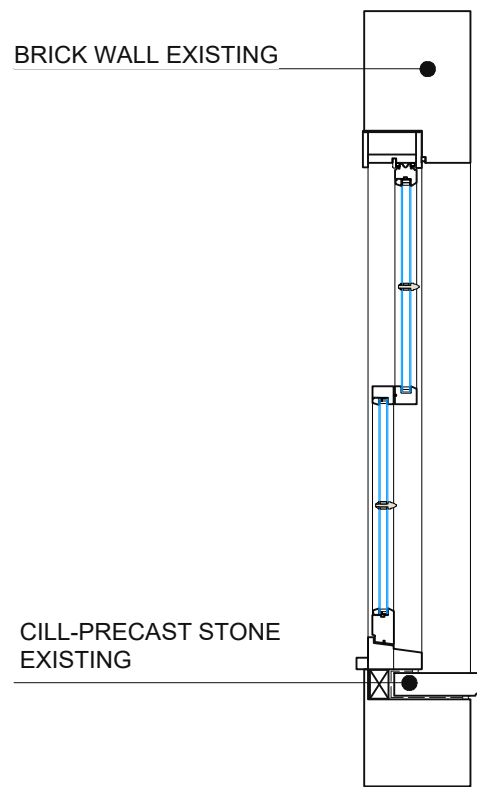
W 06

EXTERNAL ELEVATION

SECTION

PLAN

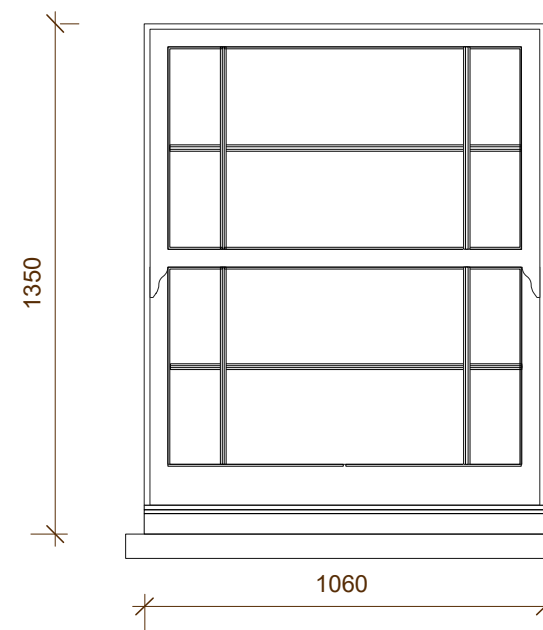
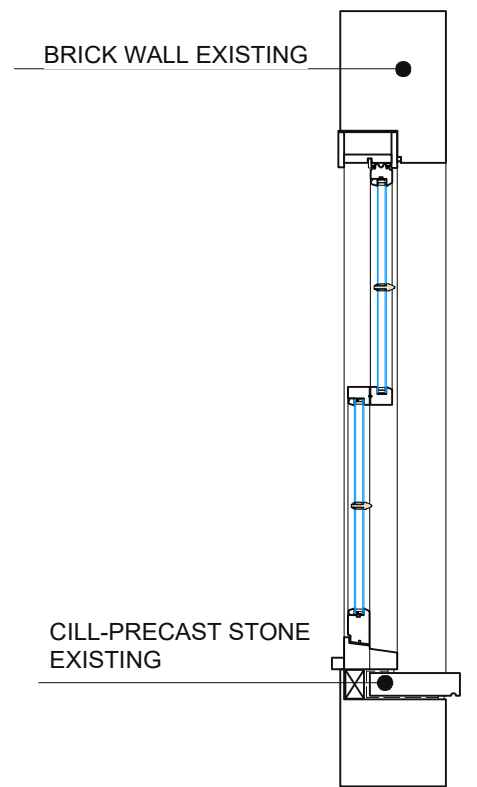
W 07

EXTERNAL ELEVATION

SECTION

PLAN

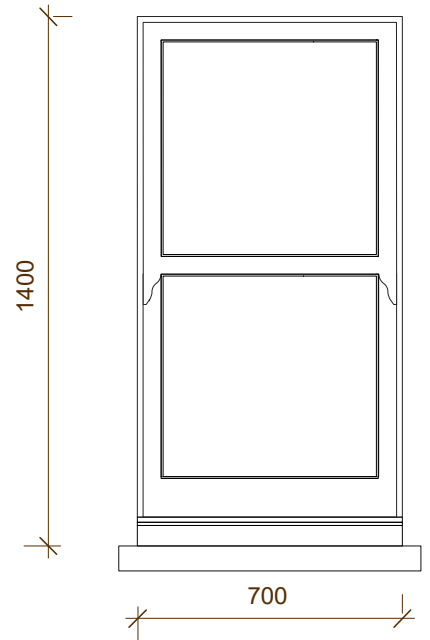
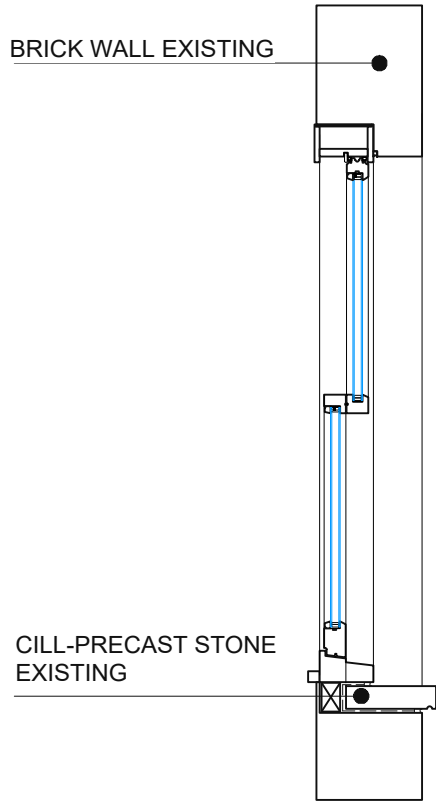
W 08

EXTERNAL ELEVATION

W08	Rear elevation Third floor	Non- original frames New glass	Poor condition. Sash cord broken Externally rotten frames.	Replace frames and glass with like for like.	Slimlite Histoglass double glazing.	Please refer to Windows Method statement for repairing and replacement	TD'W'005 W'X'06 W'006
W09	Side elevation Third floor	Non- original frames New glass	Poor condition. Externally rotten frames.	Replace frames and glass with like for like.	Slimlite Histoglass double glazing.	Please refer to Windows Method statement for repairing and replacement	TD'W'005 W'X'06 W'006
W10	Front elevation Third floor	Original frames New glass	Poor condition, rotten frames internally & externally	Refurbish original frame, if possible replace glazing.	Histoglass Mono	Please refer to Windows Method statement for repairing and replacement	TD'W'002 W'X'06 W'006
