02 JOINERY  
30. RECEPTION : J.30.01

03 STAIRS

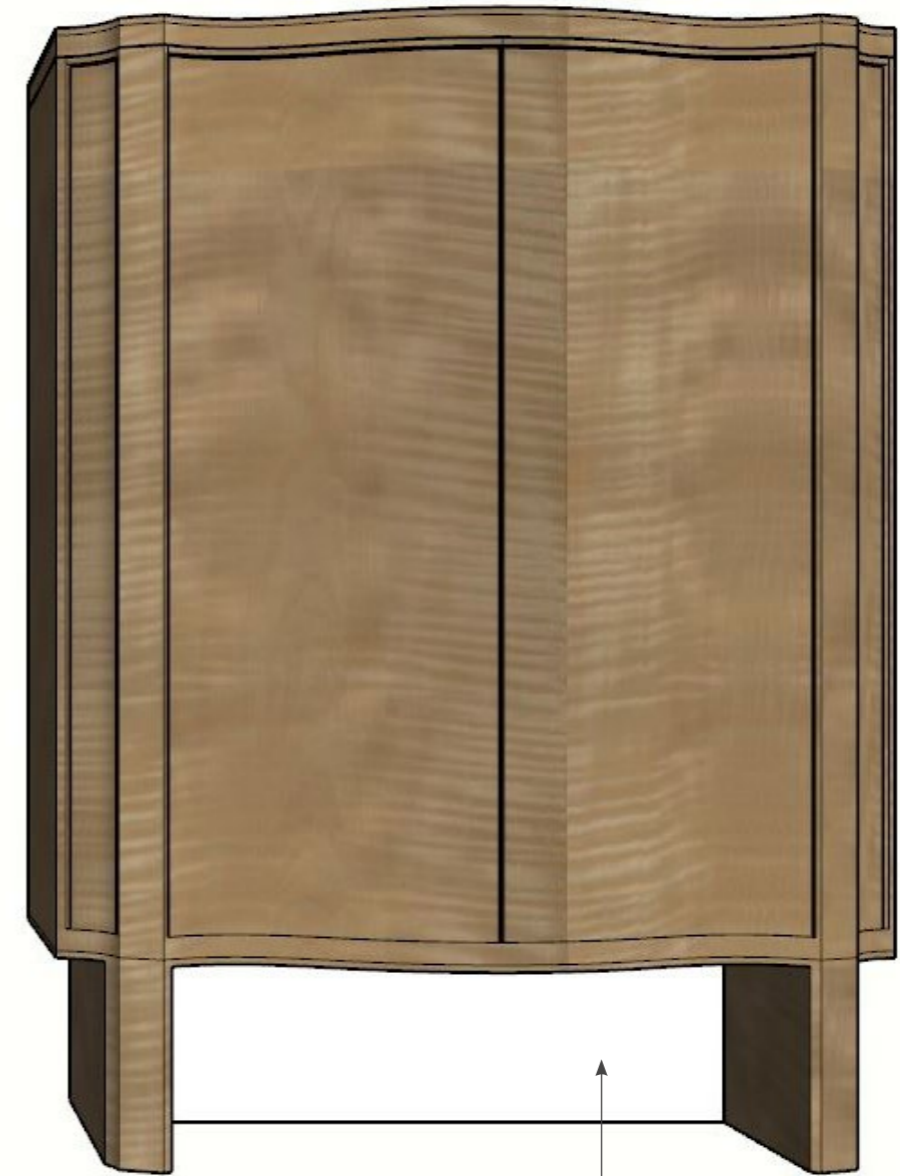
PERSPECTIVE OF FCU JOINERY

Plate to hide connection to duct

In order to house the FCU in the space, we propose to build 2 identical units, flanking the fireplace., one for the FCU, one for storage, to create symmetry

The Proportions are intended to remain light, and not overwhelming, and with a 'free standing' quality of a piece of furniture. Therefore we have raised the unit on legs, and set it slightly off the wall.

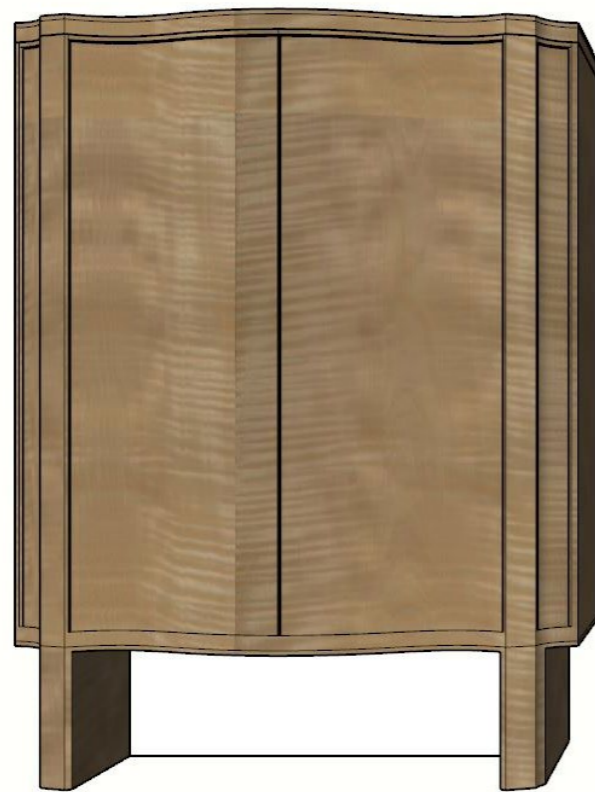
PERSPECTIVE of FCU

The detailing and construction will be of the utmost quality, integrating the requirements of the Fan Coil Unit with consideration and thought.

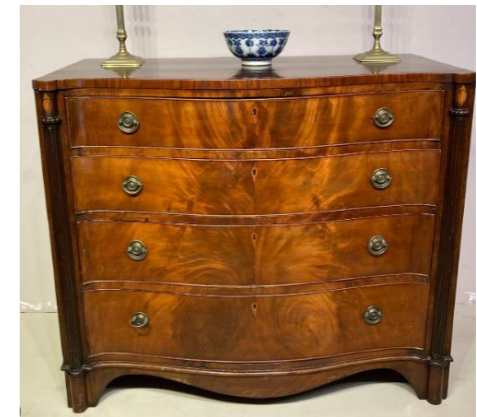
WILLIAM IV CHEST OF DRAWERS

We have looked to some traditional cabinet designs - some contemporary to the era, as seen with the chest of drawers to the right. The glass cabinet below is an Edwardian design, taking influence from earlier periods.

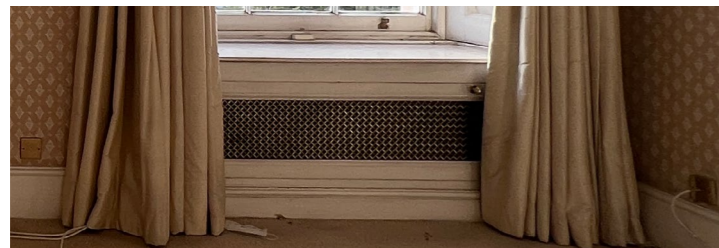
EXISTING

The existing radiator covers are of modern construction, without any original fabric.

We propose to carefully remove the existing radiator covers, making sure the window shutters and architraves are protected, and replace with new covers. The new covers will be traditional in detail, but they will integrate the modern requirements of the building, including the requirement for roller blinds, that currently sit at the top of the window reveal, and block the use of the shutters

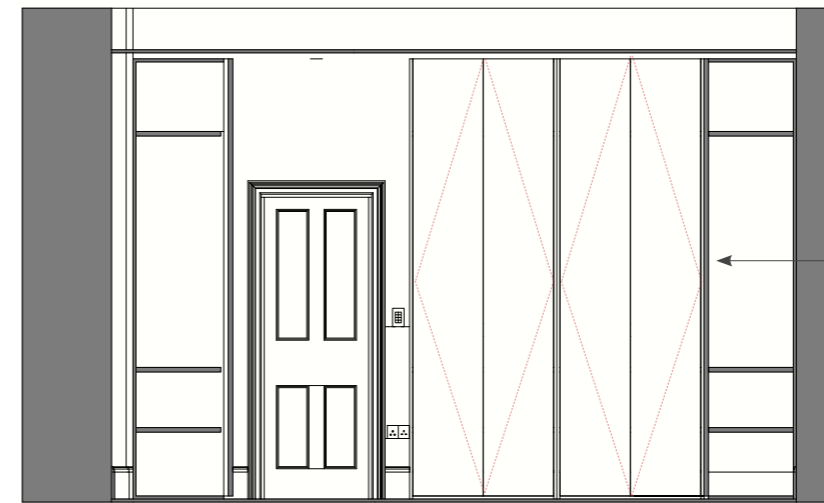
PROPOSED ELEVATION 02, 1/50 @ A3

Joinery to be full height, with fixing required to the wall for support. However architectural details will be unaffected, with the skirting running behind the joinery

We propose to carefully remove the existing dressing room joinery, and reinstate skirting boards throughout the room. We then propose to install new wardrobes within the space, of excellent quality and craftsmanship.

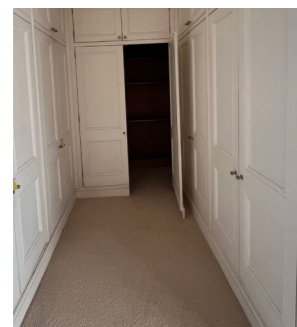
Sliding doors to wardrobe

The dressing room is of modern construction, without any original fabric, and is in poor condition

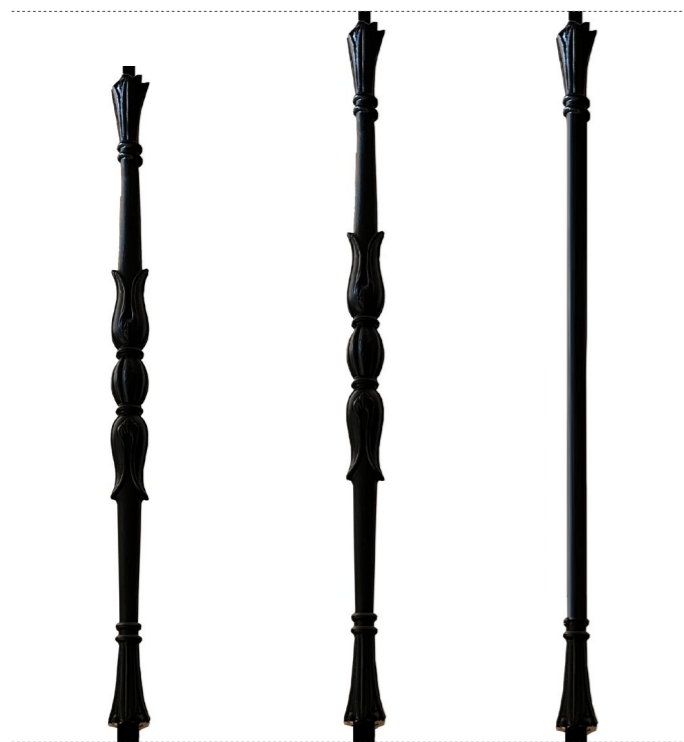
SPINDLES

Existing Spindle      Spindle TYPE A  
Elongated      Spindle TYPE B  
Diminishing scale

New Spindles to be made from cast iron, and painted to match the main staircase.

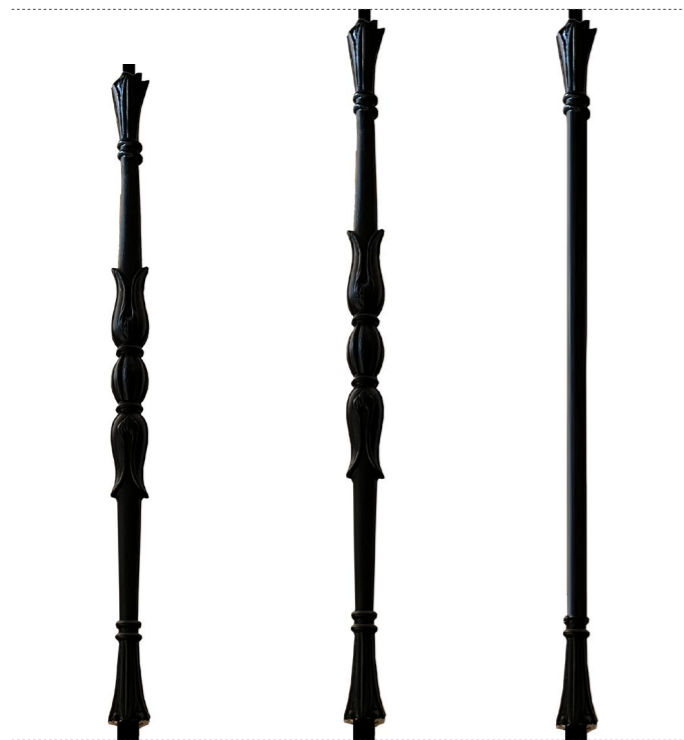
SPINDLES

Existing Spindle

Spindle TYPE A  
Elongated

Spindle TYPE B  
Diminishing scale

New Spindles to be made from cast iron, and painted to match the main staircase.

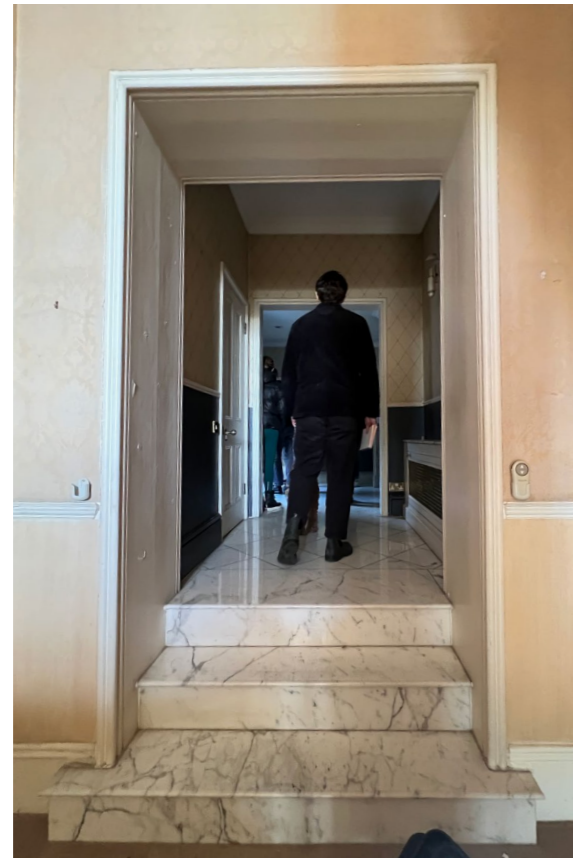
PHOTO OF EXISTING CONNECTION FROM LANDING TO CLOSET WING

The current opening and steps are a modern addition, the steps constructed in marble. The bottom step is quite crude in its protrusion onto the landing, looking boxy. Moreover the quality of construction is poor. The opening is also of modern construction, with double reeded flush architrave

We propose to demolish the existing steps, replacing with new marble steps, that better reflect the quality of the building, and also connect better with the new architecture of the closet wing

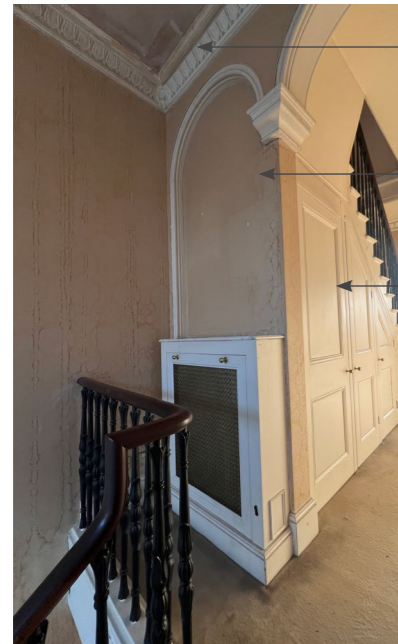
PHOTO OF TOP OF MAIN STAIR

- Modern fibrous cornice
- Modern archway, see investigative hole
- Modern joinery, staircase balustrade
- Modern archway & wall, see investigative hole

The arch way that separates the main flight of stairs from the secondary stairs is entirely of modern construction, with modern timbers and mesh visible.

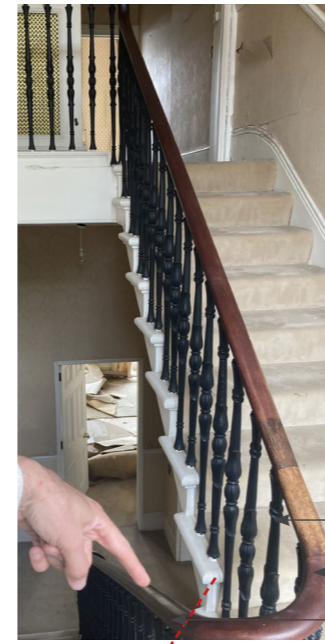
PHOTO OF MAIN STAIR

- Hollow crude castings of spindle
- Modern mahogany handrail
- Original Cuban mahogany handrail

- Modern fibrous cornice
- Modern spindles - see broken one
- Modern joinery to underside of the stair

The handrail species changes from a Cuban Mahogany (what we would expect from an original handrail) to a more recent mahogany at the turn on the quarter landing.

The Spindles also change from a solid casting (original), to a more hollow and crude cast at the same point.
