1 Existing Side Elevation

2 Proposed Side Elevation

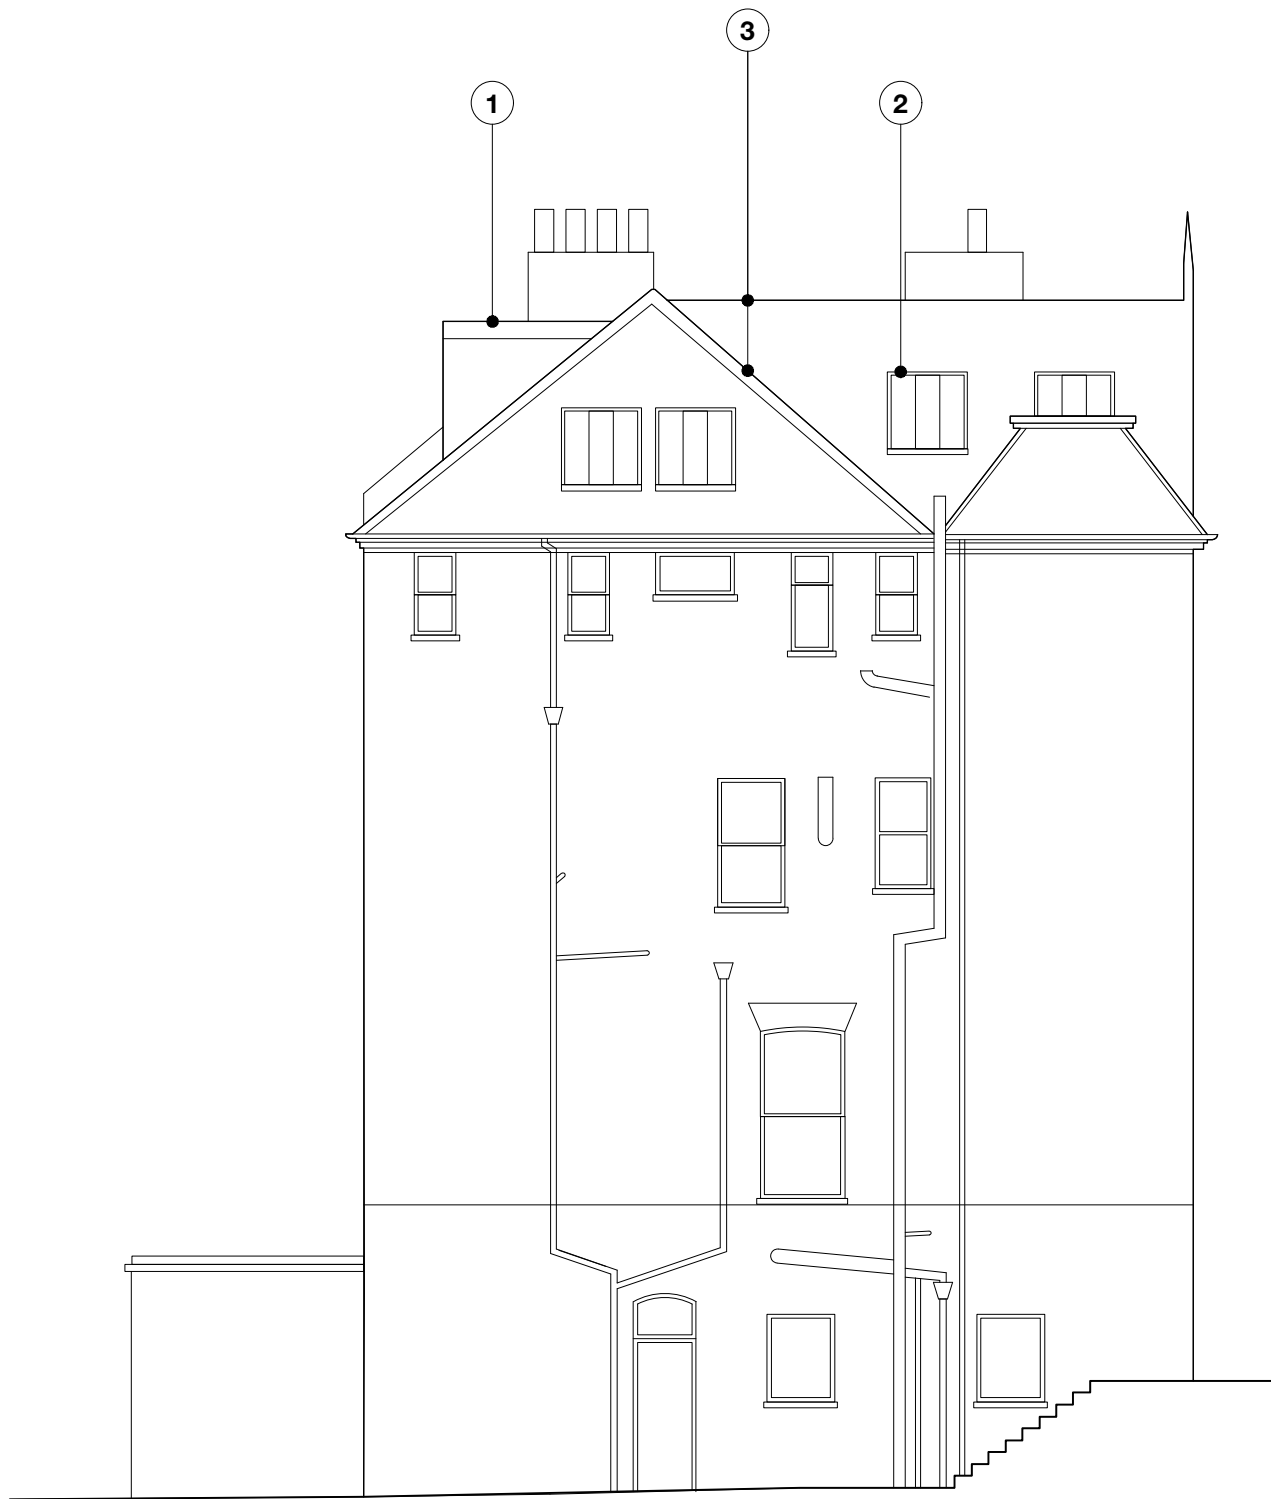
- Key**
- ① Existing dormer
 - ② Existing rooflights
 - ③ Existing roof profile

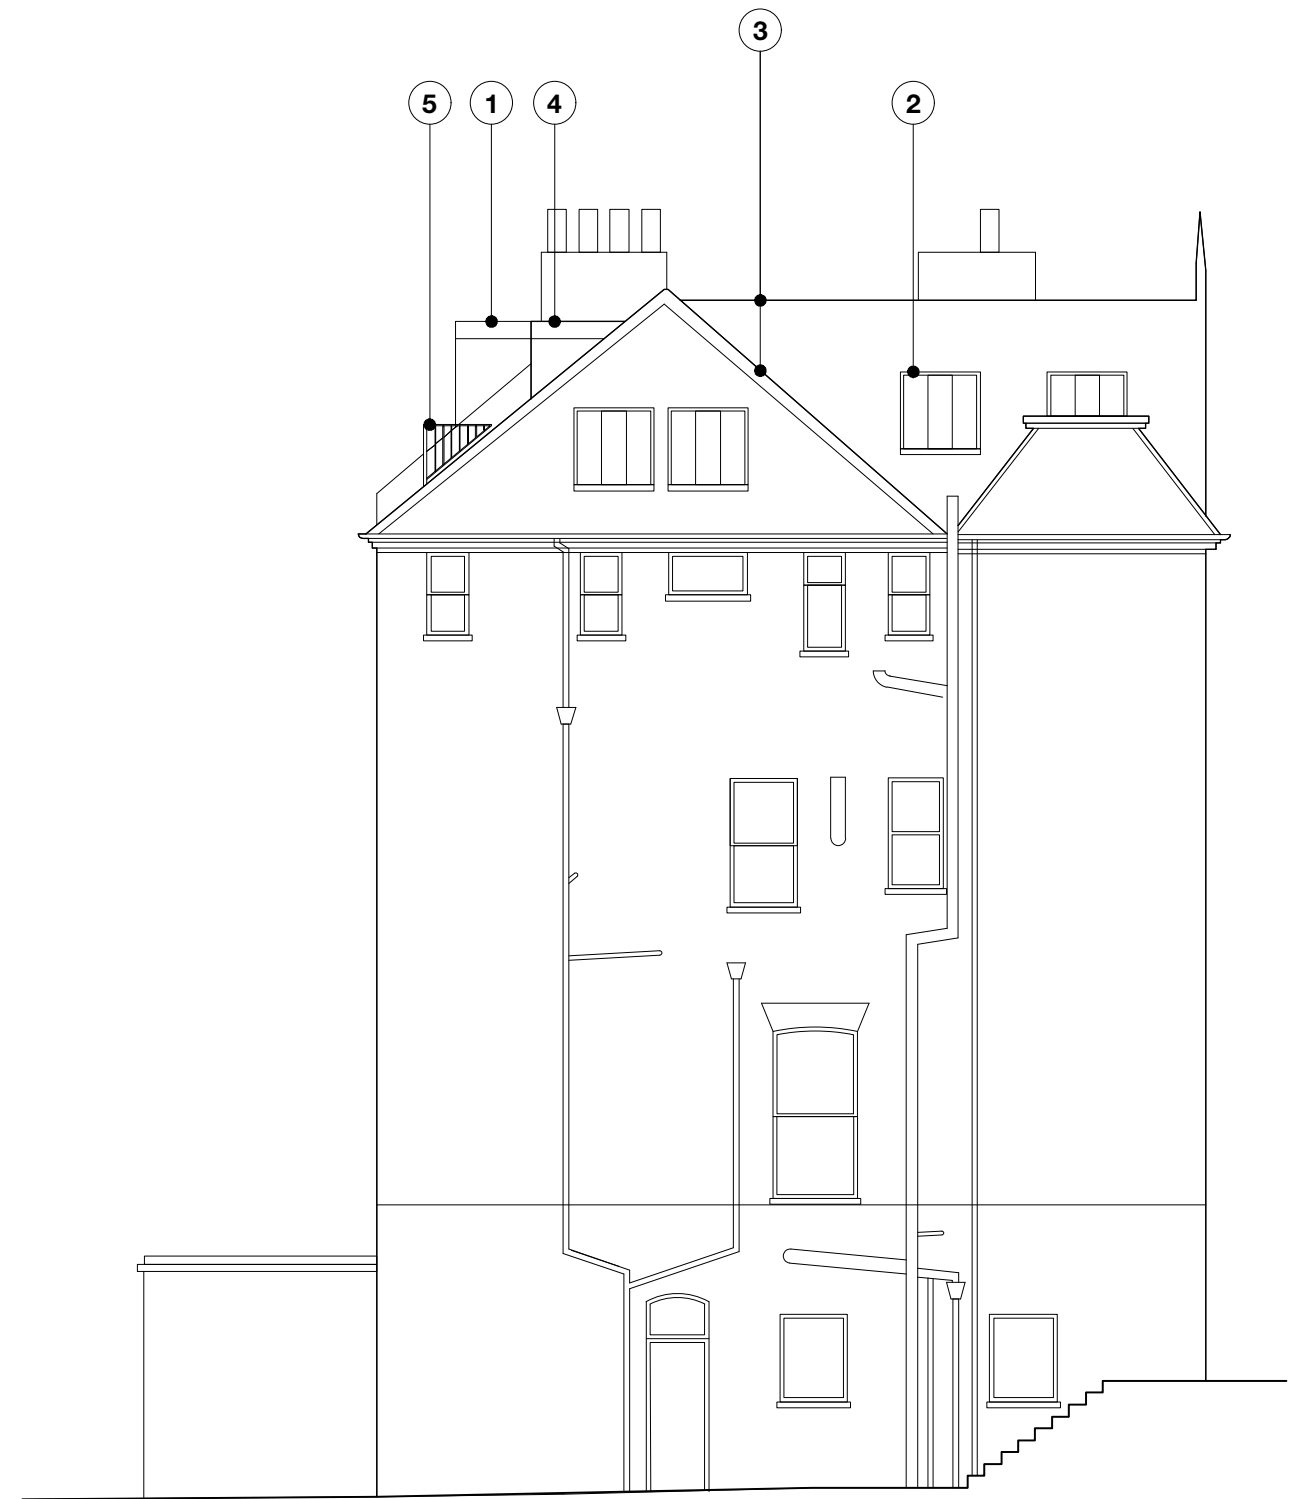
- Key**
- ① Existing dormer of 21 Nassington (now visible)
 - ② Existing rooflights
 - ③ Existing roof profile
 - ④ Proposed side profile of dormer made more shallow
 - ⑤ Balustrading of terrace
