# GONDAR GARDENS, SITE TO THE REAR OF 12 SARRE ROAD, LONDON, NW2 3SL For NORMA JONES

PHASE 1 PRELIMINARY CONTAMINATION RISK ASSESSMENT REPORT

**Project Name:** Gondar Gardens, Site to the rear of 12 Sarre Road, London

**Document No:** 15682-EWGCE-XX-01-PRA-001

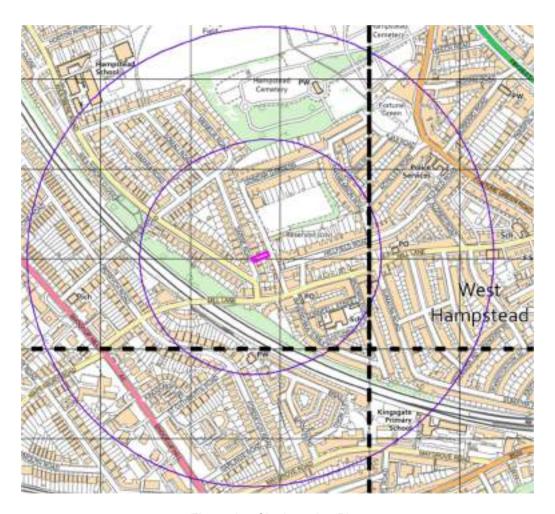
Figure 1: Site Location Plan

The site is roughly rectangular in shape and comprises an area of approximately 0.04 hectares as shown in Figure 1.

Taken from Environmental Insight Report OS Mapping Records

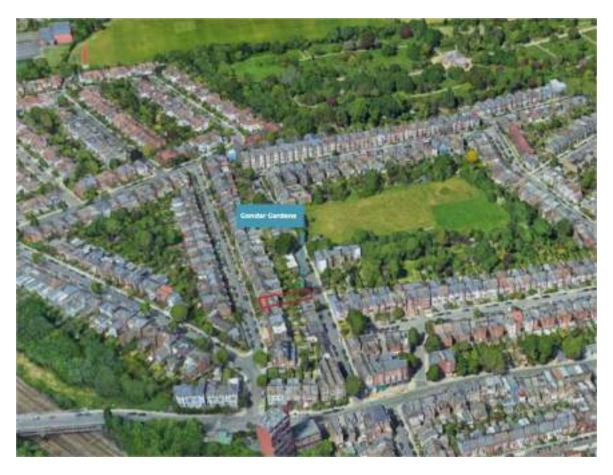
Figure 2: Aerial Site View

The site lies on the eastern side of Sarre Road in West Hampstead in North-West London. The centre of the site is located at approximate National Grid Reference 524760, 185200. An aerial view of the site showing the existing red line boundary is presented in Figure 2.

Taken from the Pre-Application Statement for the site produced by UPP Architects + Town Planners
