Historic Building Record

No. 34 Belsize Lane, Camden,
London NW3 5AE

August 2024 | Project Ref. 00567 | V.1

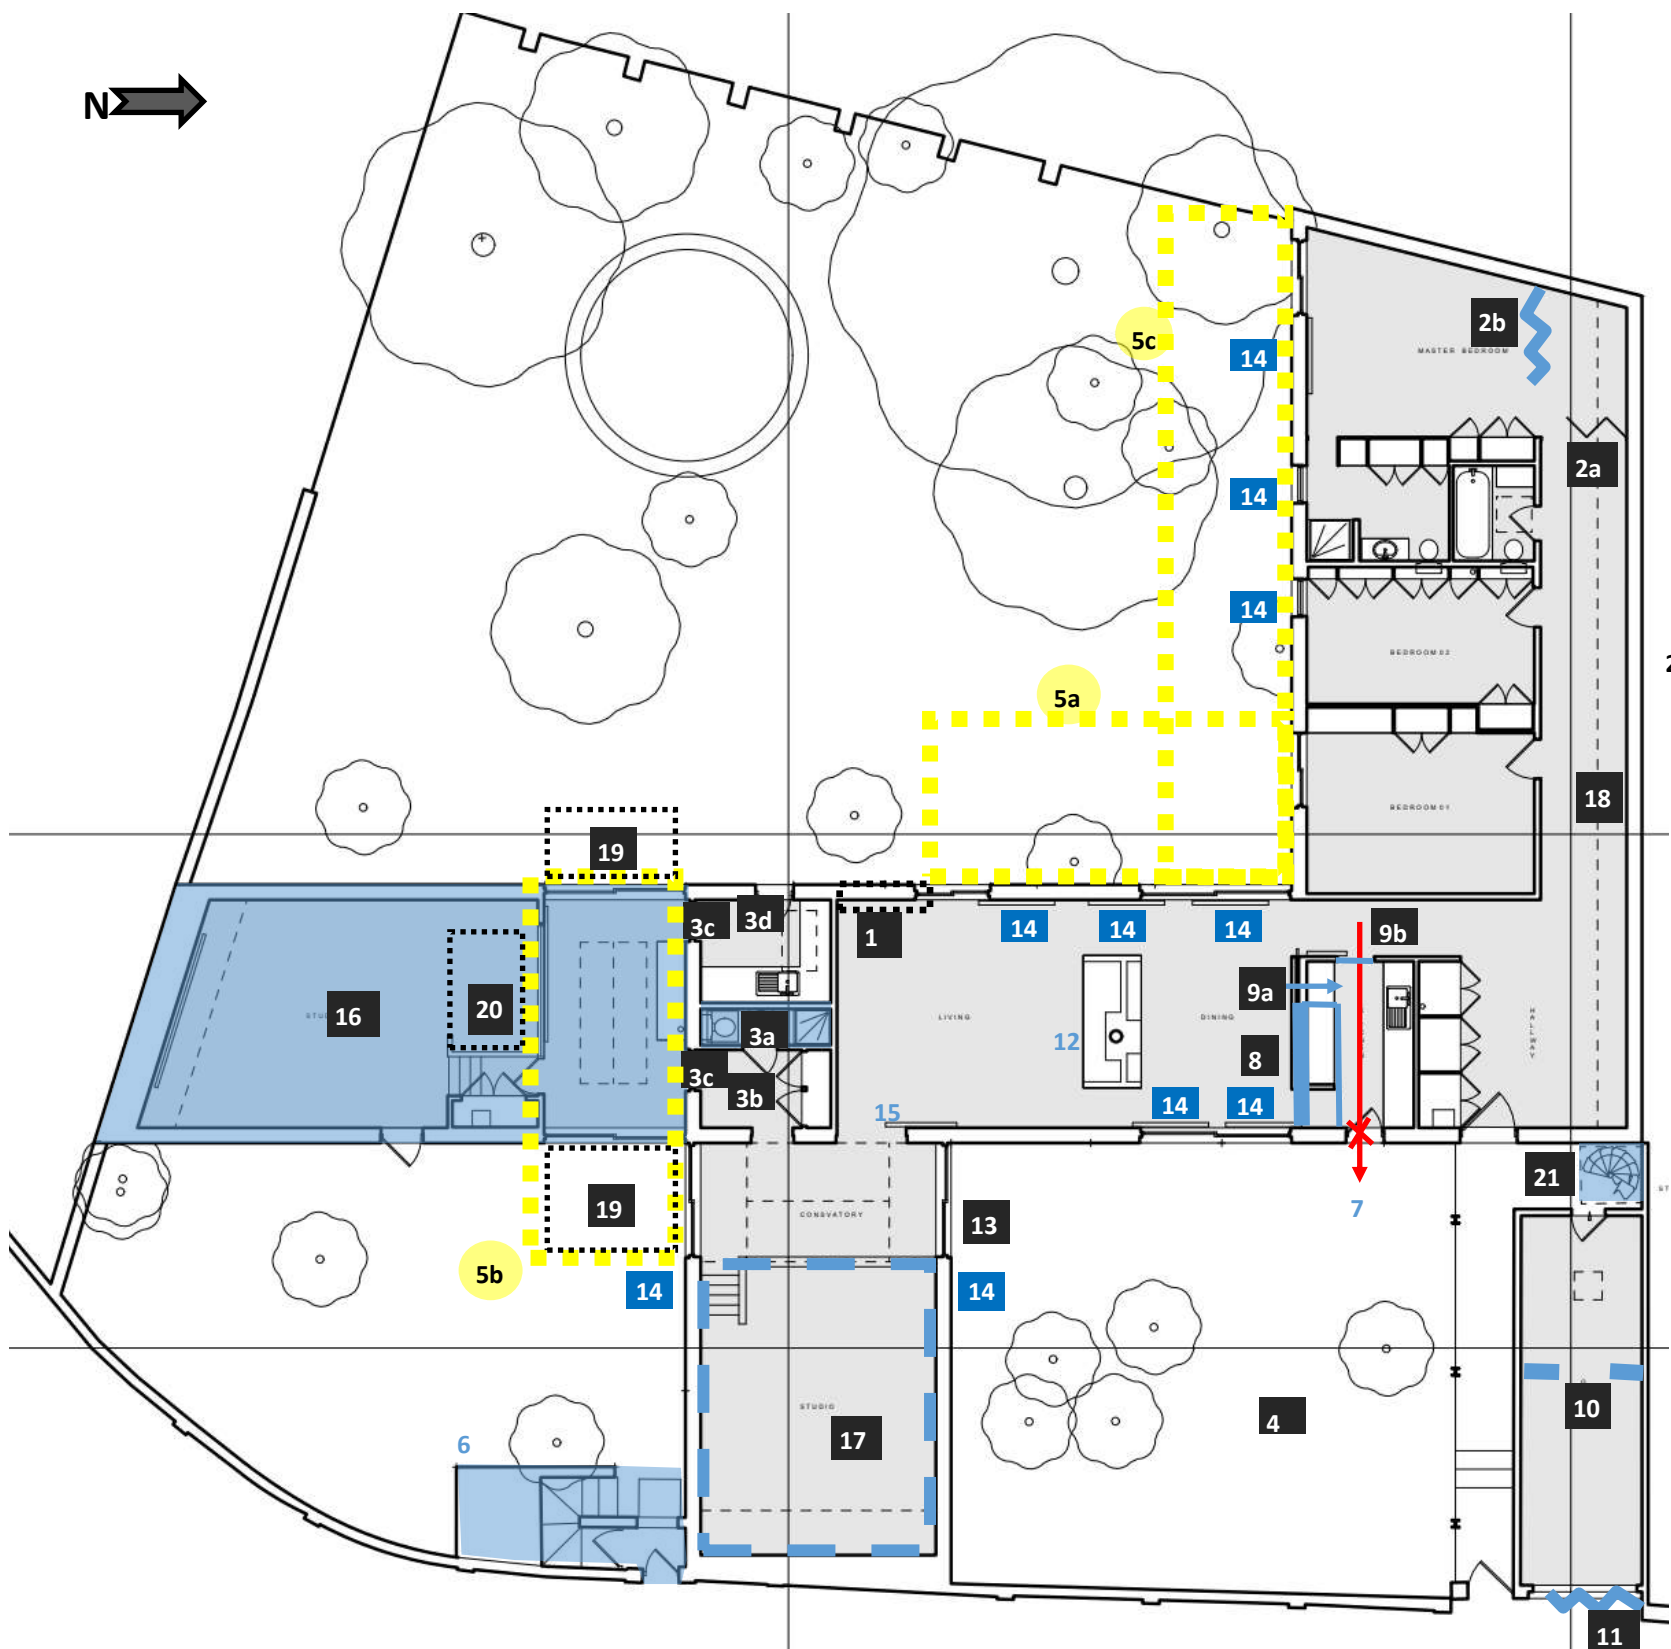
- 1) Living room window originally intended to abut the cross wall.
- 2) Concertina screen installed in this position in 1981 (2a), position originally intended to align with corridor (2b).

- 3) Former Study, compromised by subdivision to form a WC (3a), linkage to extension (3b) after 1981. Works included forming two new internal doorways within a former external wall (3c), and a single external door in place of a window to the garden (3d). Note: This space was allocated as a bedroom in the 1981 permission with shared bathroom (20) to an additional bedroom within the extension used as a Studio.

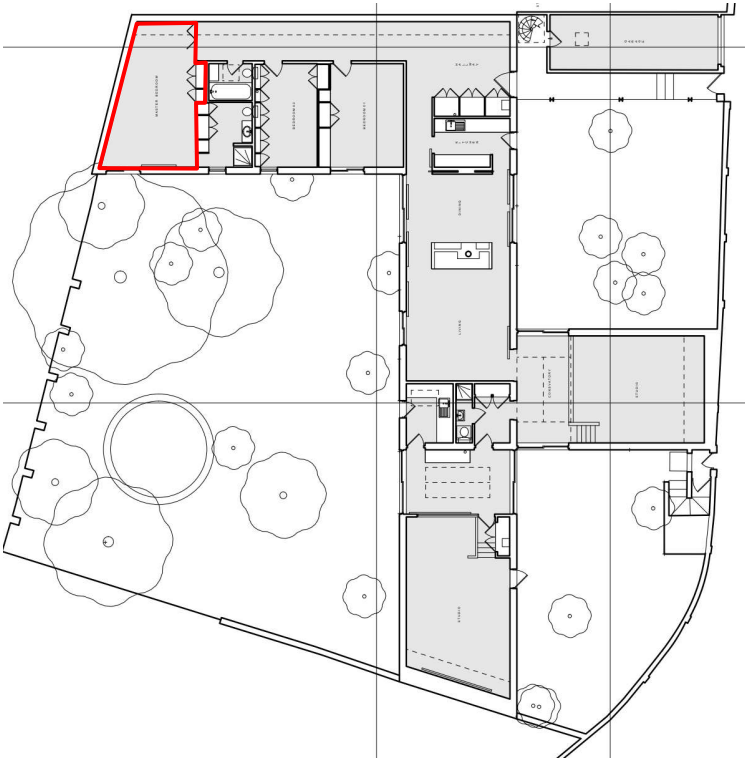
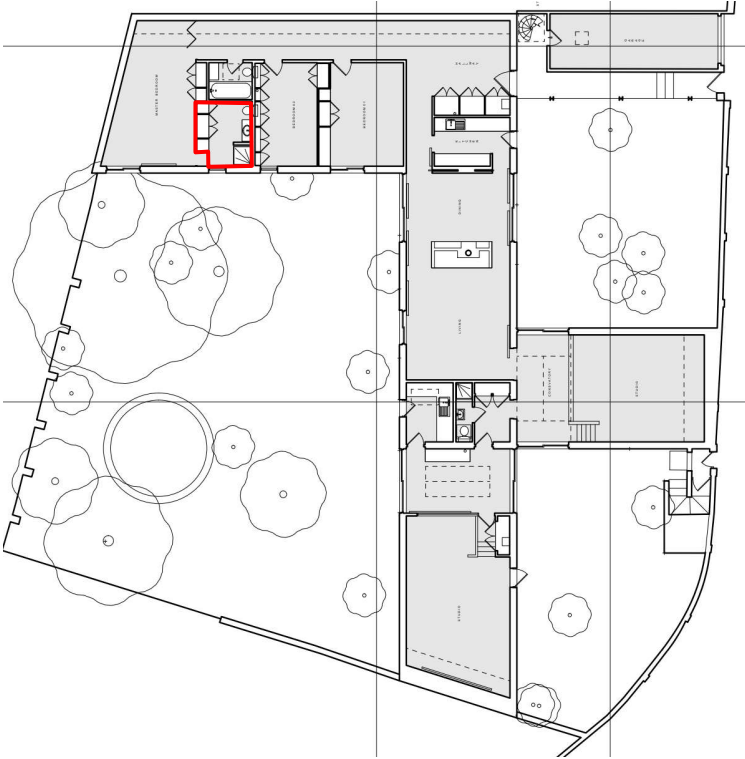
En suite Bathroom	
General Description	En suite bathroom accessed from the south-east corner of the master bedroom, comprising a shower, toilet, basin and inbuilt plywood cupboards and storage.
Floor	Floor finished in Spanish red and buff clay tiles. Smaller tiles than the circulation space with the buff-coloured tiles arranged in a diaper pattern.
Walls	Plain stud and plaster walls. Wall shared with master bedroom comprises full-height maple-veneered ply drawers and cupboards. Original toilet, basin and white tile-lined shower cubicle with original fixtures and fittings located on the east wall
Windows	Full height aluminium fixed window on south wall with louvred transom light.
Doors	N/A
Ceilings	Suspended plastered ceiling on timber joists with modern downlights

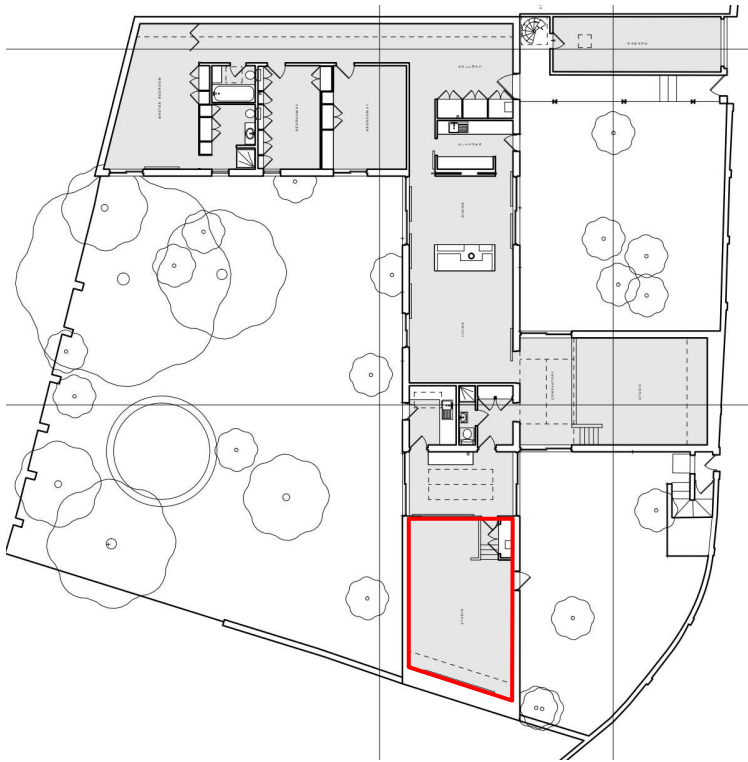
Studio Extension	
General Description	Office extension, a later addition, that like the studio is set lower than the adjacent house and is accessed via a short flight of steps. The room has an irregular plan form, owing to the southern wall following the angled form of the plot boundary.
Floor	Concrete slab with carpet finish
Walls	External walls are masonry with plaster finish. Timber and glazed screen on north side, lights arranged 7x5. Screen has glazing bars with stepped detailing. Fitted office furniture on west, north and east walls, comprising drawing desk attached adjacent staircase wall, full height shelving on west wall and desktop, filing cabinets and maple veneered ply drawer units on east wall. Cupboard adjacent to stair landing, accessed through double full-height doors with U-shaped handles.
Windows	Full width canted clerestory window, comprising 8 lights in aluminium frame located over south wall. A fixed single light window with aluminium frame and louvred transom light above is located on the south wall.

Doors	Full-height maple-veneered ply door with brushed stainless U-shaped door handle and door furniture.
Ceilings	Suspended plastered ceiling on timber joists with original recessed downlight.

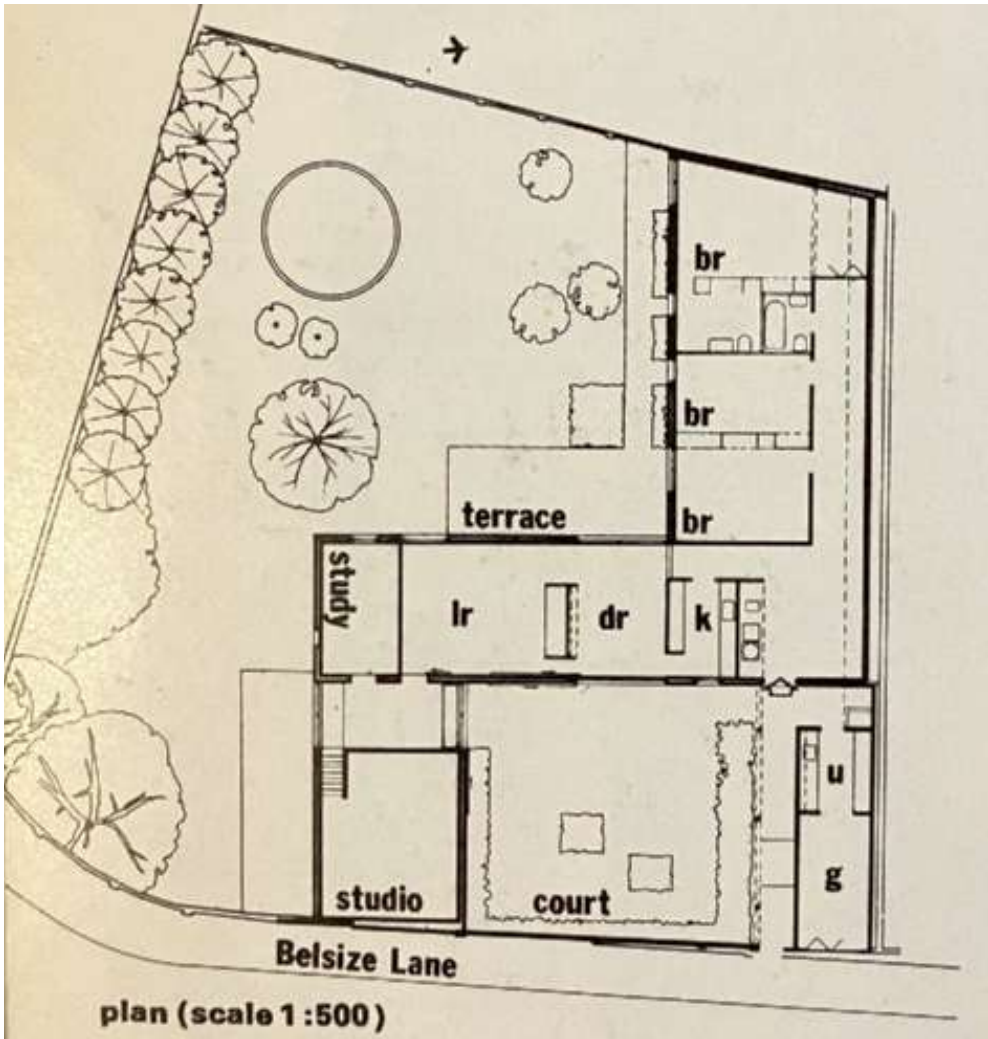
Original proposed plan, approved by Camden 11 March 1975: Note: Bedroom corridor extended to western boundary, kitchen was open to dining space, and garage divided to house a utility room

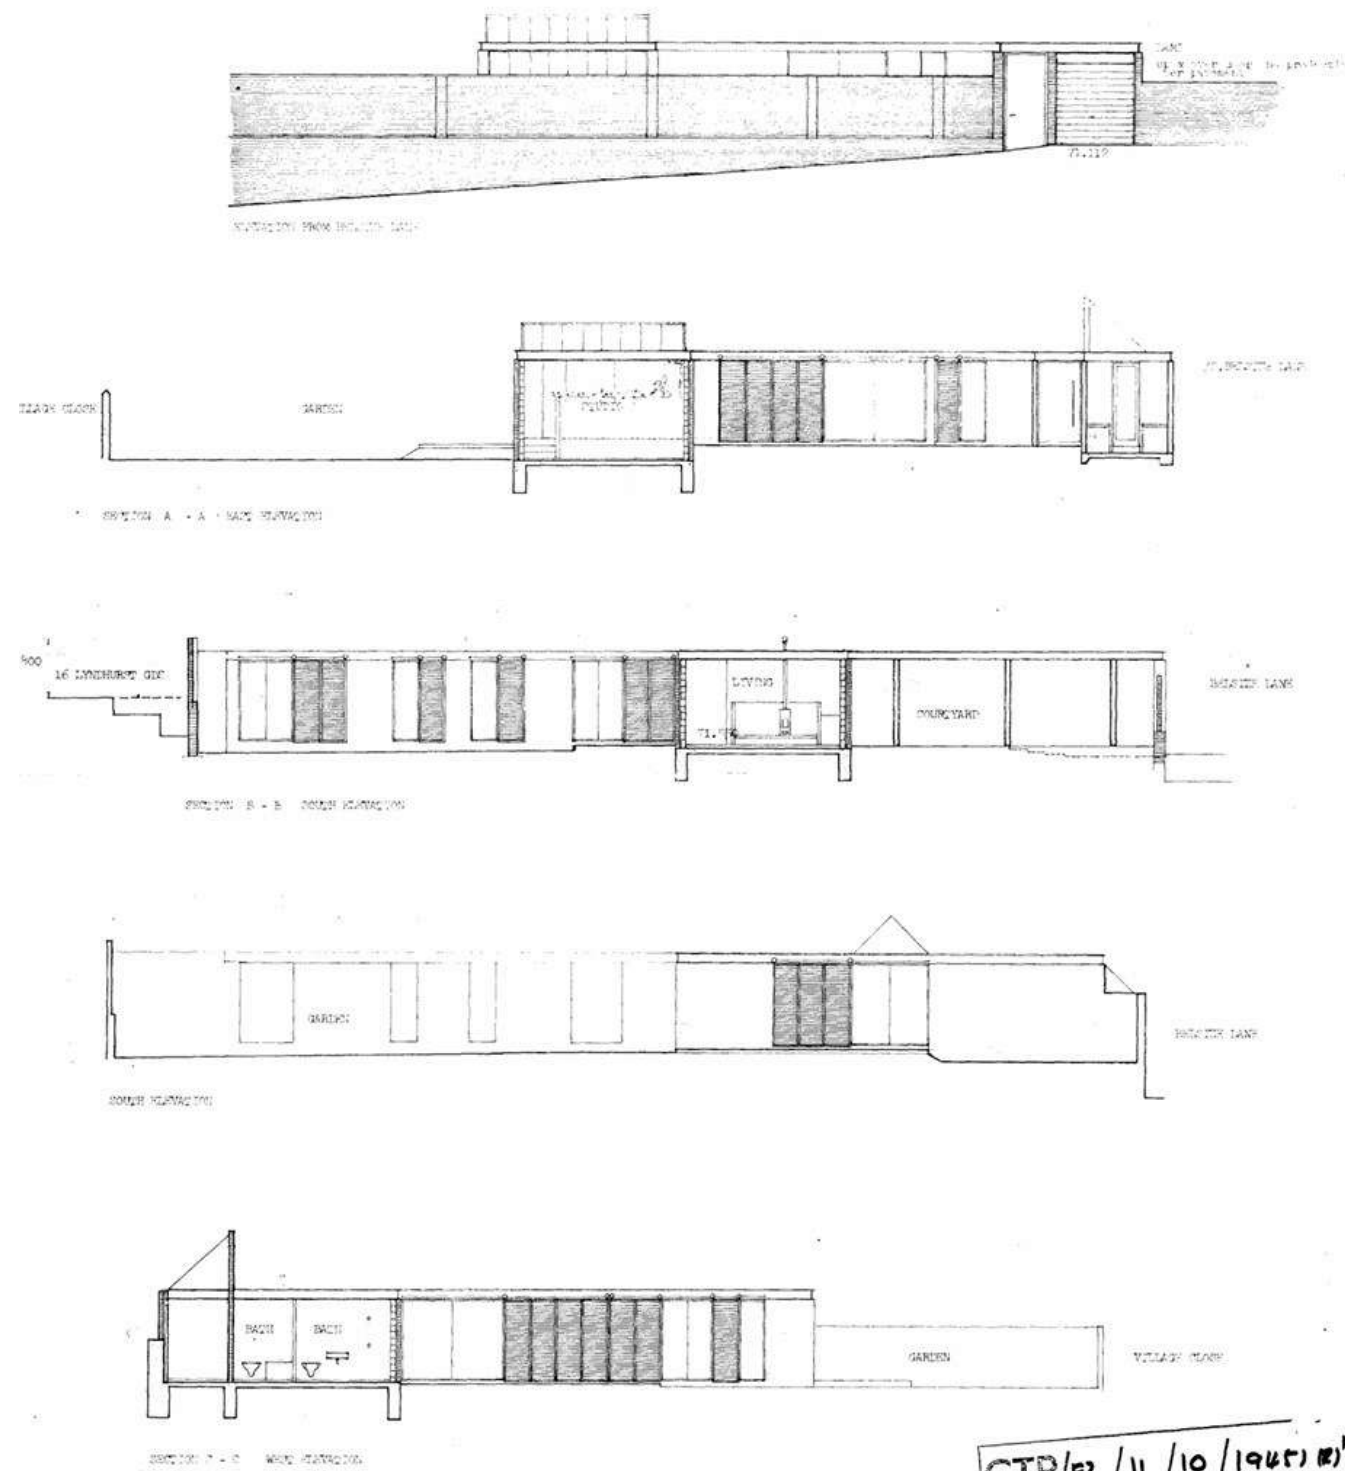
Original proposed plan, approved by Camden 11 March 1975: Note: Building originally designed to feature external shutters and a taller north facing clerestory window to the bedroom range
