29 Edis Street, London, NW1 8LE

CRACK MONITORING

for SMS (LV)

Client: SMS (LV)
Client Contact: Robbie Taylor
Claim Number: [REDACTED]
Client Reference: [REDACTED]
Policy Holder: [REDACTED]
Report Date: 17 July 2024
Our Ref: [REDACTED]

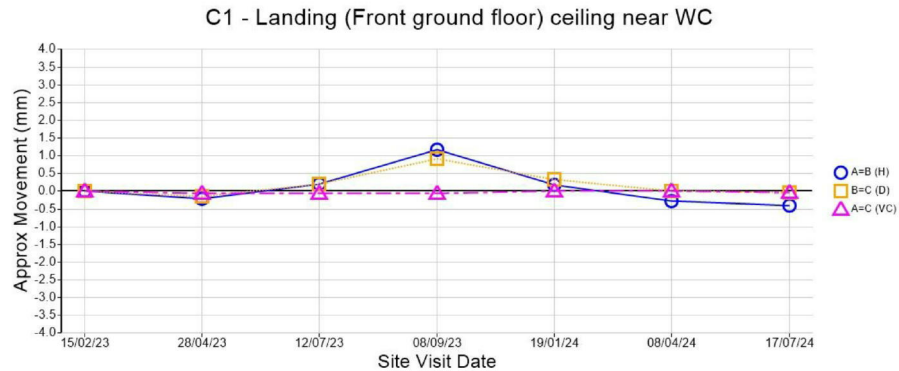
Crack Monitoring Difference Graphs

Date	A=B (H)	B=C (D)	A=C (V)(C)	Crack Width
C1 - Landing (Front ground floor) ceiling near WC				
15 February 2023	66.12	89.06	65.51	1.30 - 2.00
28 April 2023	65.91	88.91	65.45	1.60 - 1.70
12 July 2023	66.33	89.27	65.46	2.30 - 2.30
8 September 2023	67.30	89.97	65.45	4.40
19 January 2024	66.31	89.40	65.51	3.80 - 1.90
8 April 2024	65.85	89.06	65.53	4.50 - 1.80
17 July 2024	65.73	89.03	65.47

The following graphs display the progressive movement that each Crack Monitoring Station recorded at each separate site visit date to give an overall look at how much the property is moving.
