Appendix J – First floor

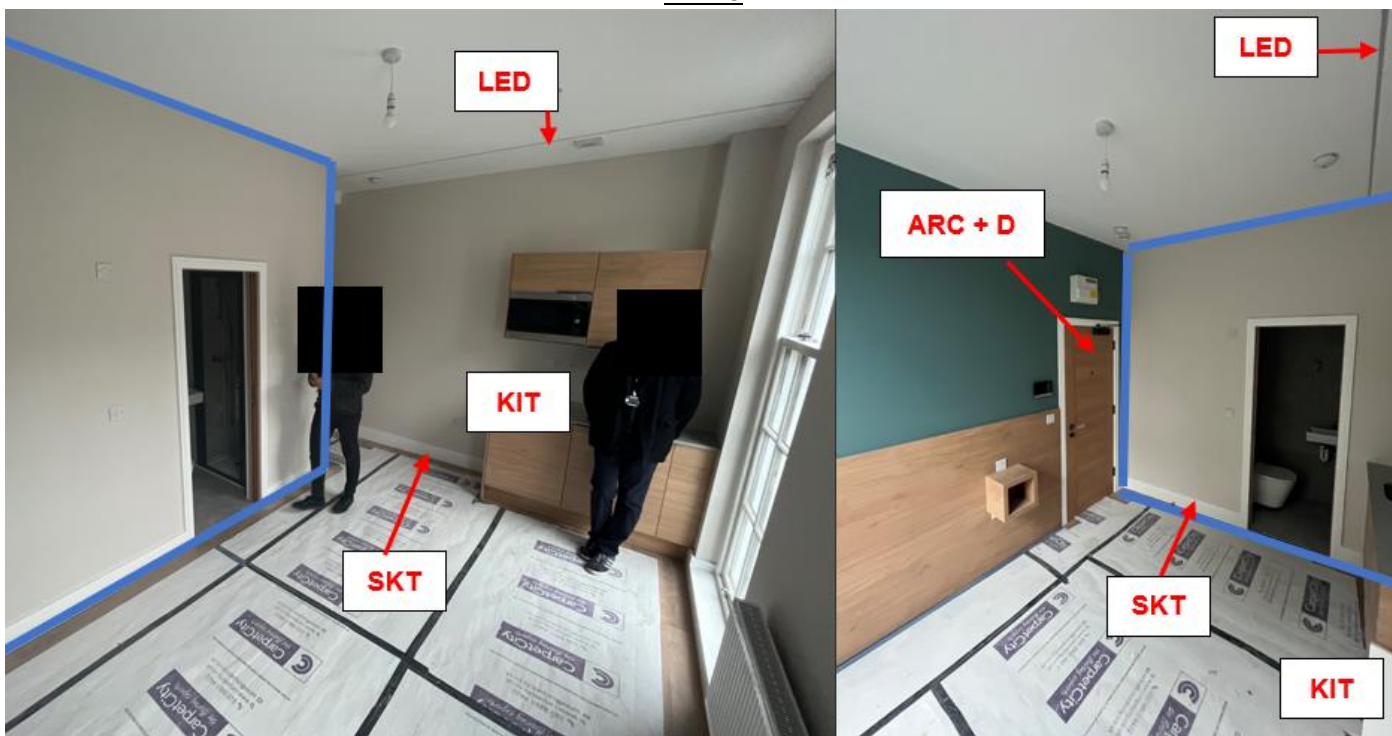
No.18

Front room [left] and rear room [left]: Unauthorised door architraves (**ARC**), skirting boards (**SKT**), modern doors (**D**), kitchenettes (**KIT**), recessed LED track lightings (**LED**), & full height ensuite partitions (highlighted **blue**).

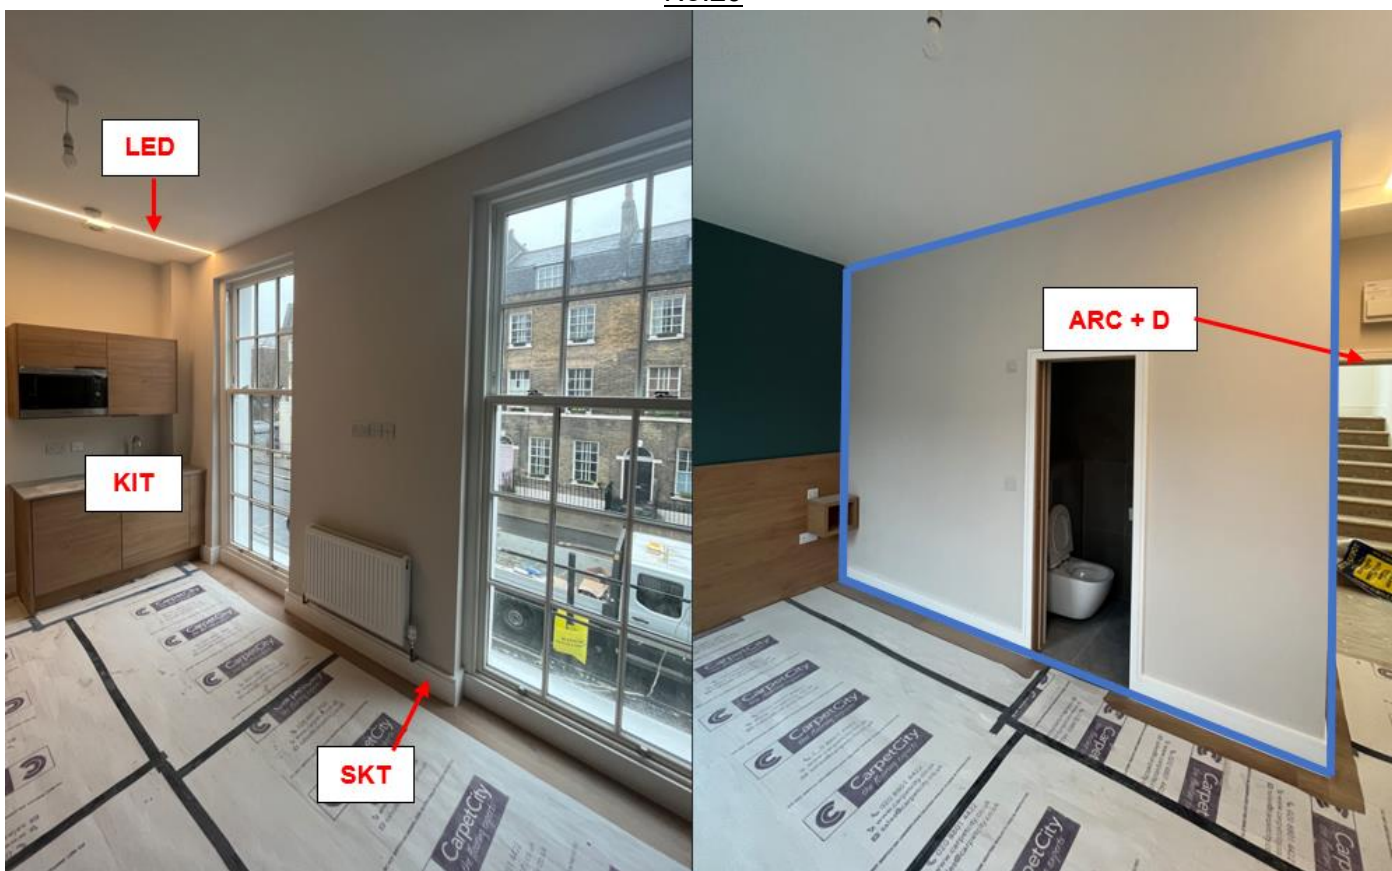
No.20

Front room: Unauthorised door architraves (**ARC**), skirting boards (**SKT**), modern doors (**D**), kitchenettes (**KIT**), recessed LED track lightings (**LED**), & full height ensuite partitions (highlighted **blue**).

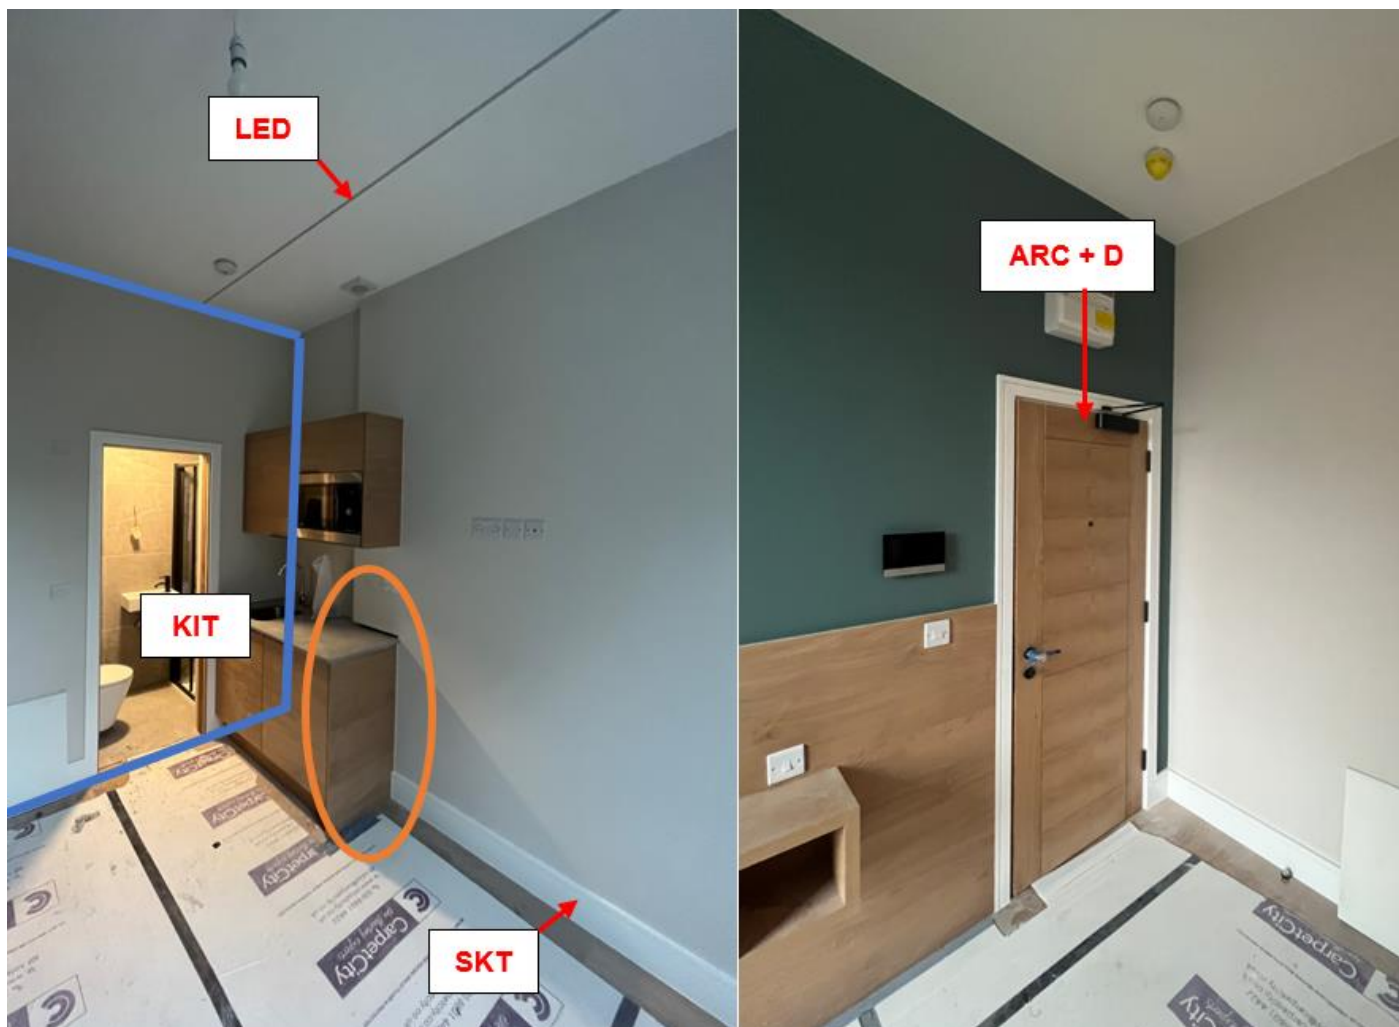
Rear room: Unauthorised door architraves (**ARC**), skirting boards (**SKT**), modern doors (**D**), kitchenettes (**KIT**), recessed LED track lightings (**LED**), damage to chimney breast (circled **orange**) – further depicted in Appendix 13 – & full height ensuite partitions (highlighted **blue**).
