Report - 76948/K

REPORT ON THE PETROGRAPHIC EXAMINATION OF FOUR BRICKS
(Project: (ae1613)71AR 240301 brick testing)

REPORT ON THE PETROGRAPHIC EXAMINATION OF FOUR BRICKS (Project: (ae1613)71AR 240301 brick testing)

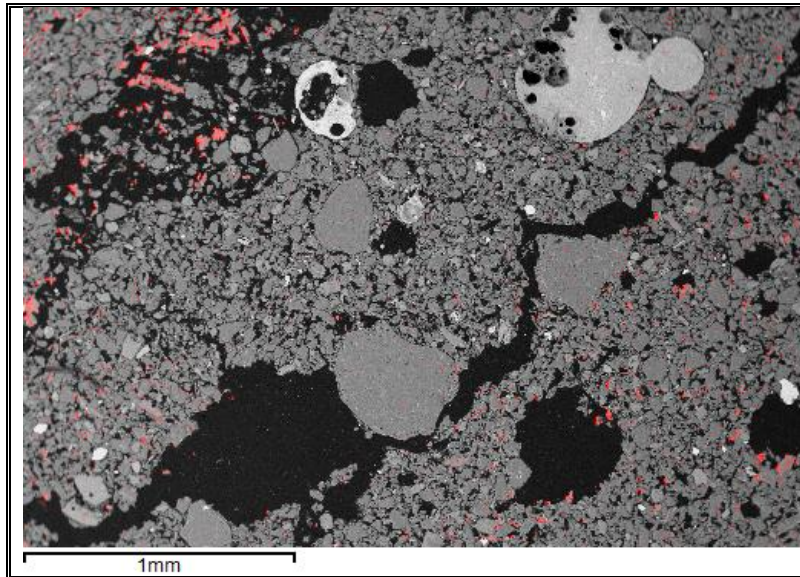
Sample 11:

Polished surface, backscattered electron image where the scale bar represents 1mm.

View showing a cross section through a fine crack intersecting the outer surface. The image has a superimposed X-ray phase map for gypsum shown in -red.

Gypsum crystallization is taking place in the surfaces of Samples 8, 11 and 13. In Sample 11 the gypsum appears to be growing passively within existing void and pore space in the brick without causing damage. In Sample 8 and to a lesser extent in 13 where gypsum crystallization is more extensive gypsum growth in cracks is contributing to superficial surface spalling.

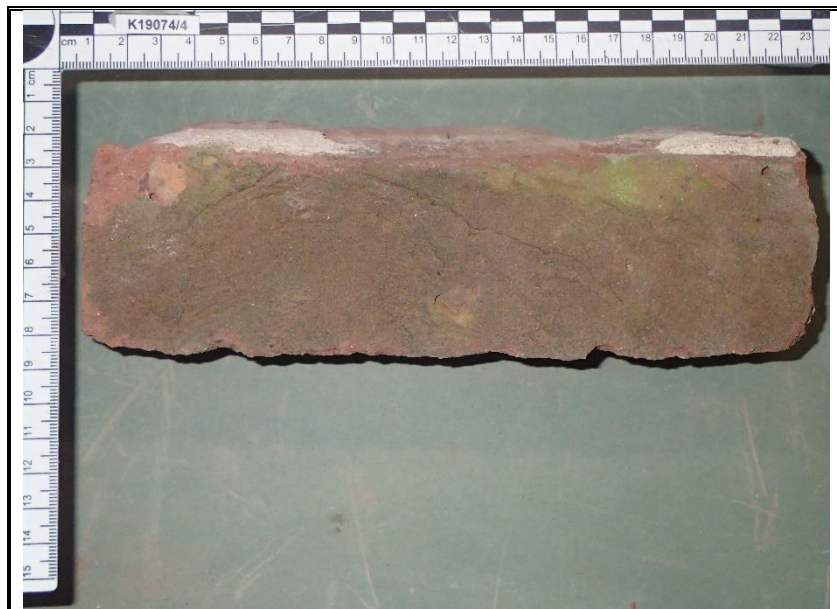
Figure B1

Sample 4: Front face

The front face of Sample 4 retains its original surface and the surface of this sample is an uneven moulded surface with fine sand particles exposed on the surface.

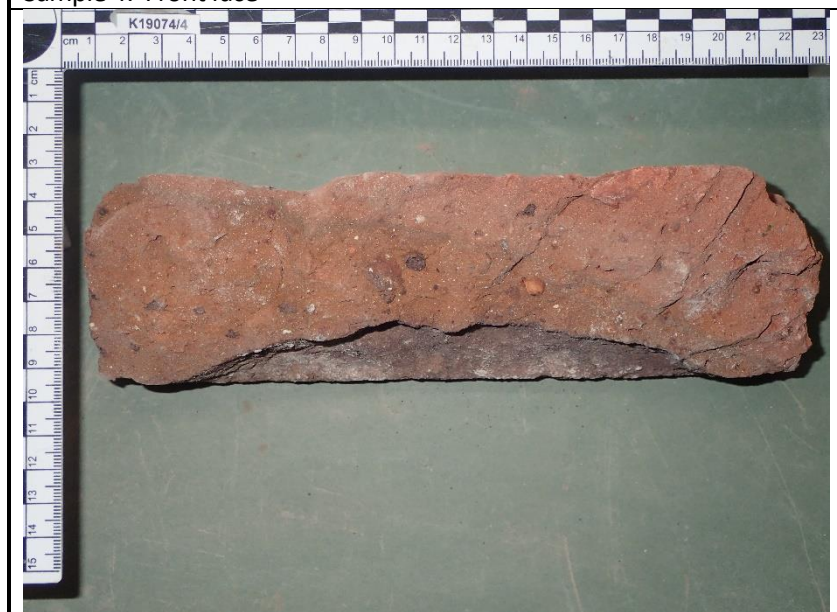
Sample 4: Back face

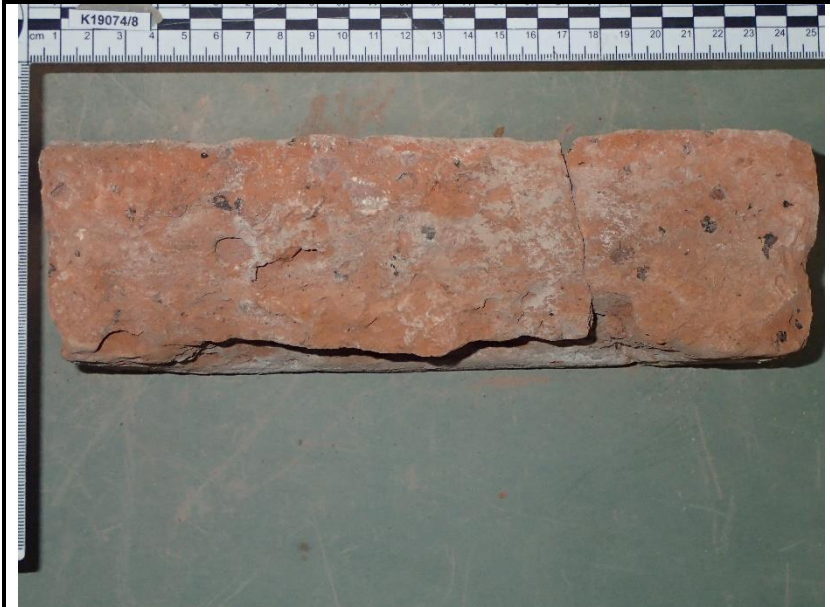
Figure B2

Sample 8: Ground front face

The surfaces of Samples 8, 11 and 13 have flat ground surfaces and the original surfaces of these samples have been removed by surface grinding. The removal of the surfaces of the brick has led to an obvious change in the surface appearance of the bricks.

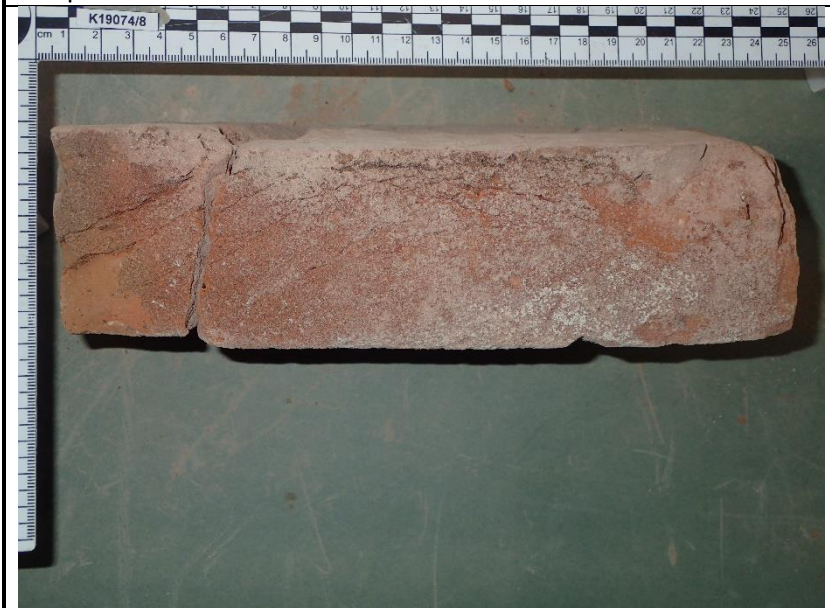
Sample 8: Back face

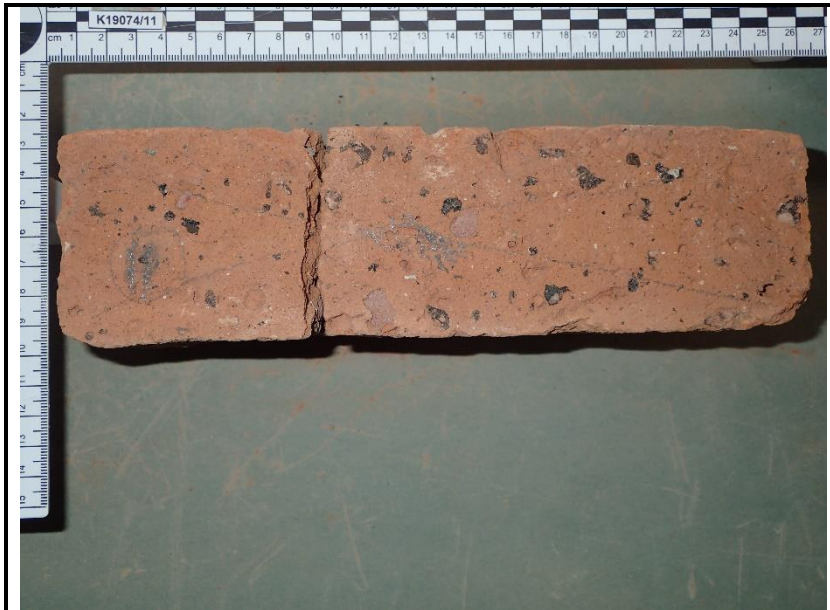
Figure B3

Sample 11: Ground front face

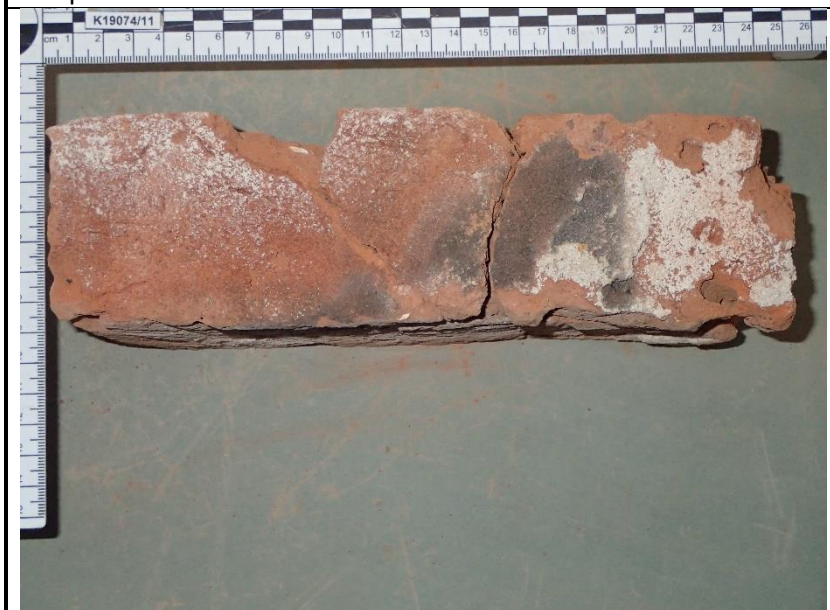
Sample 11: Back face

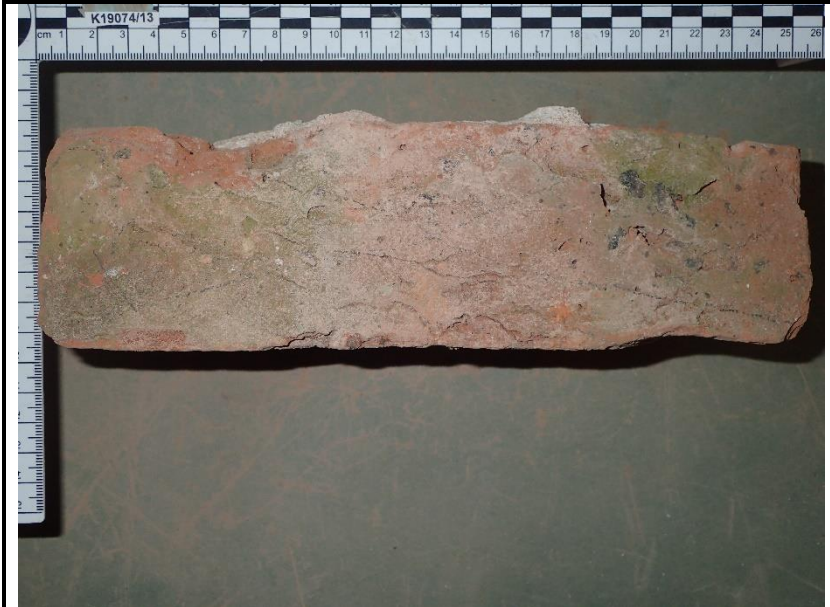
Figure B4

Sample 13: Ground front face

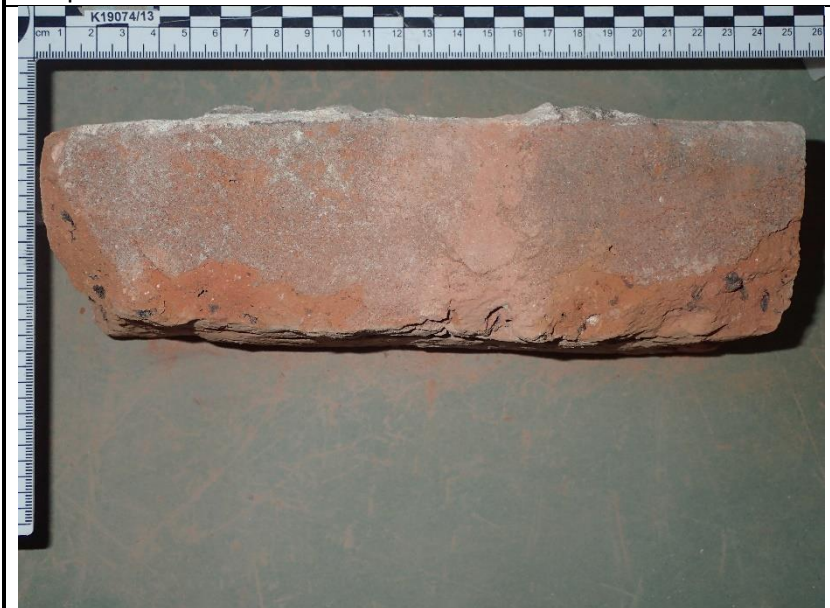
Sample 13: Back face

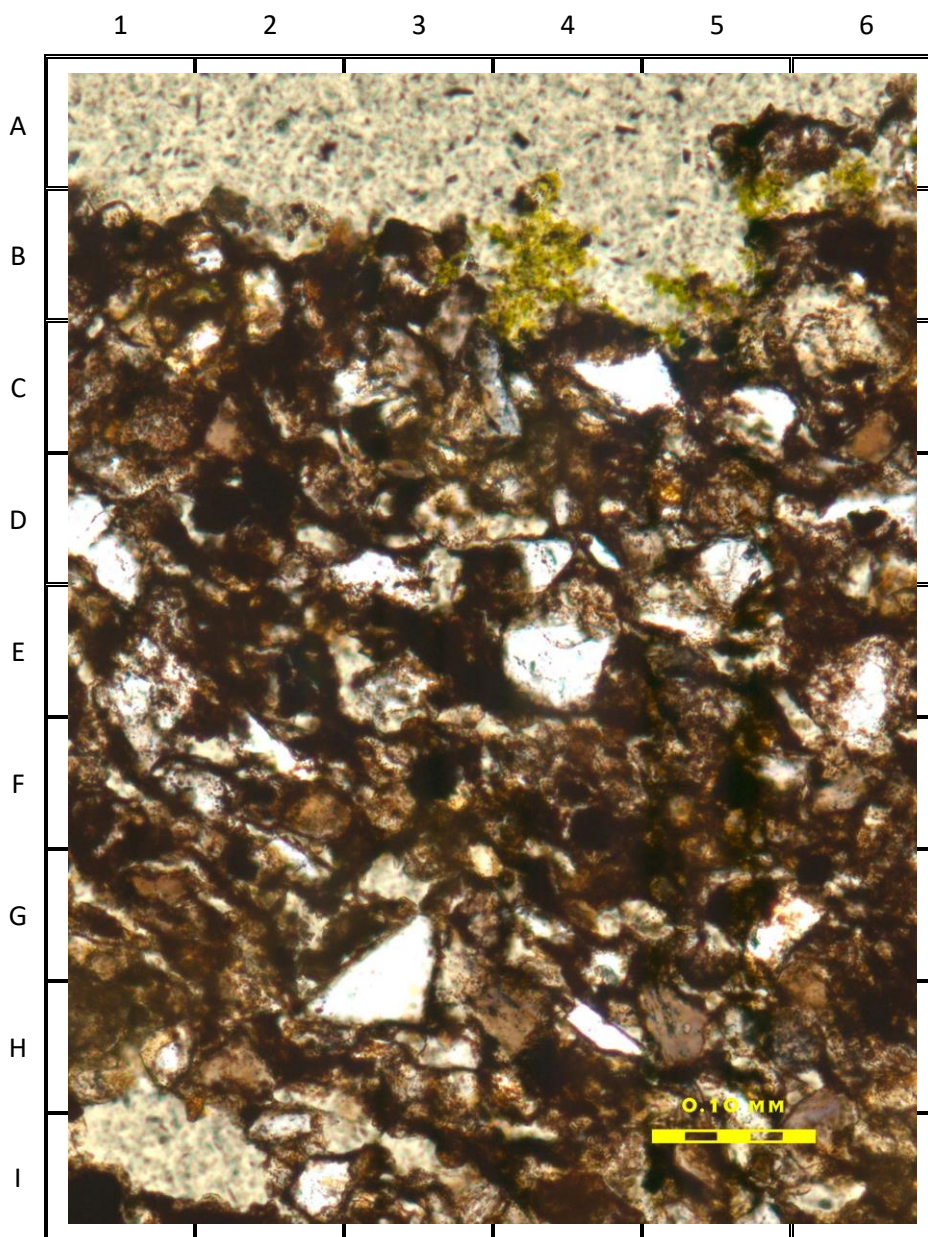
Figure C1

Thin section, crossed polars: View showing a cross section through the outer surface. The surface runs from A1 to A6 and has patchy lichen growths visible for example in B4. The majority of the field of view is occupied by a fired clay matrix that surrounds quartz particles that are visible for example in E4 and G/H3.

In Sample 4, a high degree of firing is indicated by the glassy nature of the brick matrix and lack of residual sheet silicate structures.

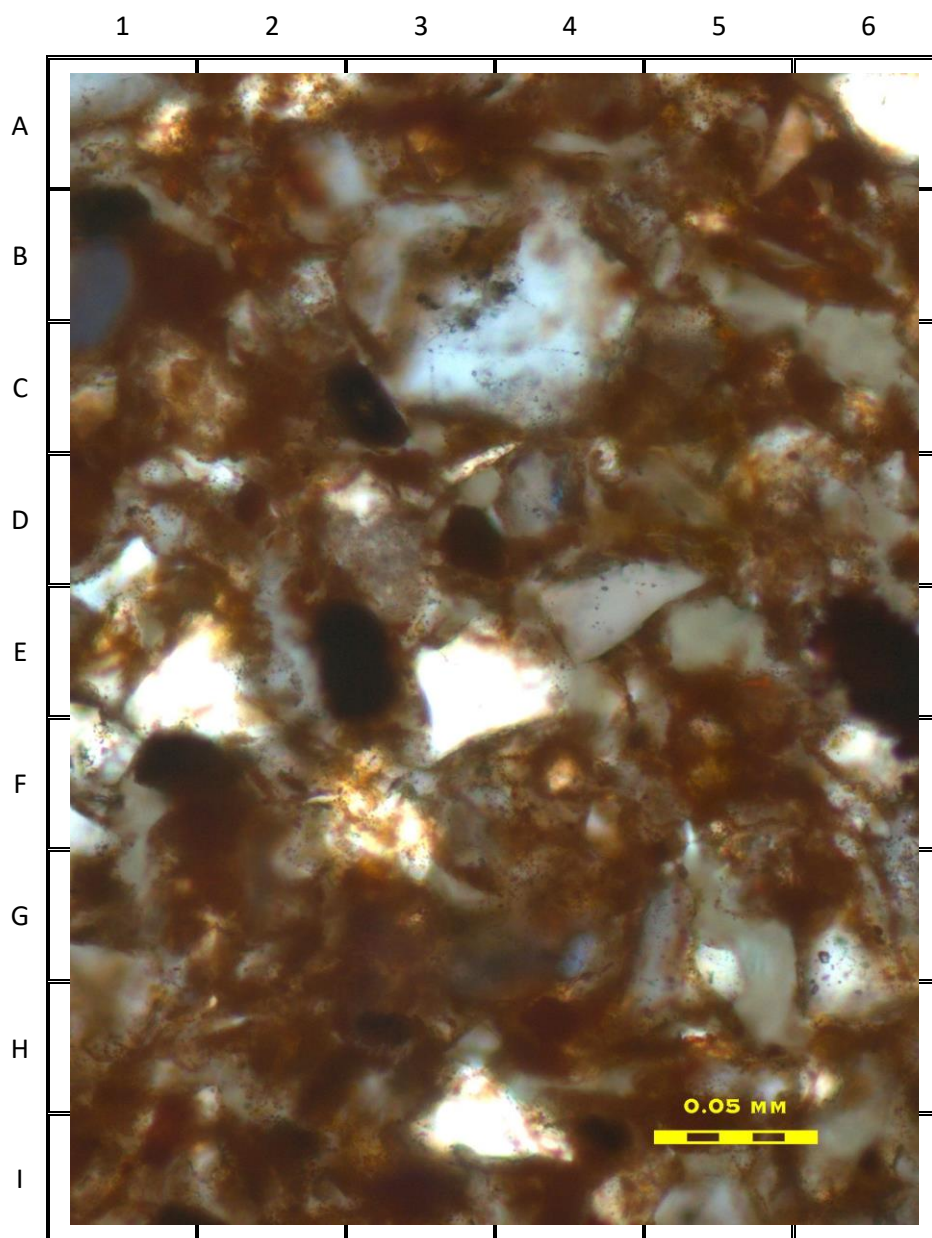
Figure C2

Thin section, oblique polars: Glassy red fired clay matrix dominates the field of view and can be seen for example in A4 and G3. Quartz particles can be seen in C4 and E/F3.

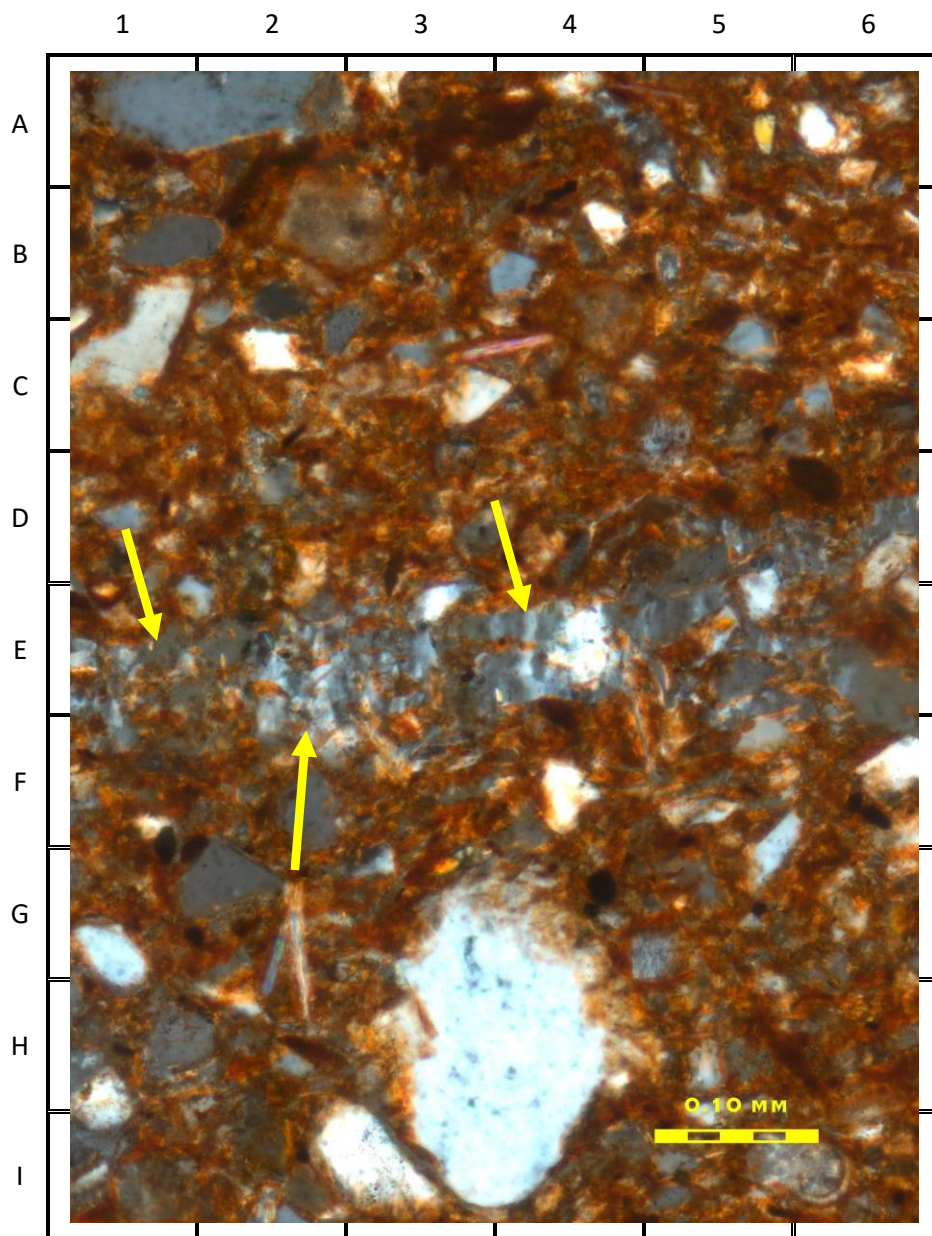
Figure C3

Thin section, oblique polars: View showing an area of the brick close to the ground outer surface. A gypsum-filled is highlighted by yellow arrows. Fired clay matrix with abundant clearly visible mica flakes can be seen for example in C3/4 and G2. Quartz particles are visible for example in H3/4.

- 6.3 Gypsum crystallization is contributing to shallow surface delamination in Samples 8 and to a lesser extent in Sample 13. A future potential for salt crystallization damage cannot however be ruled out.

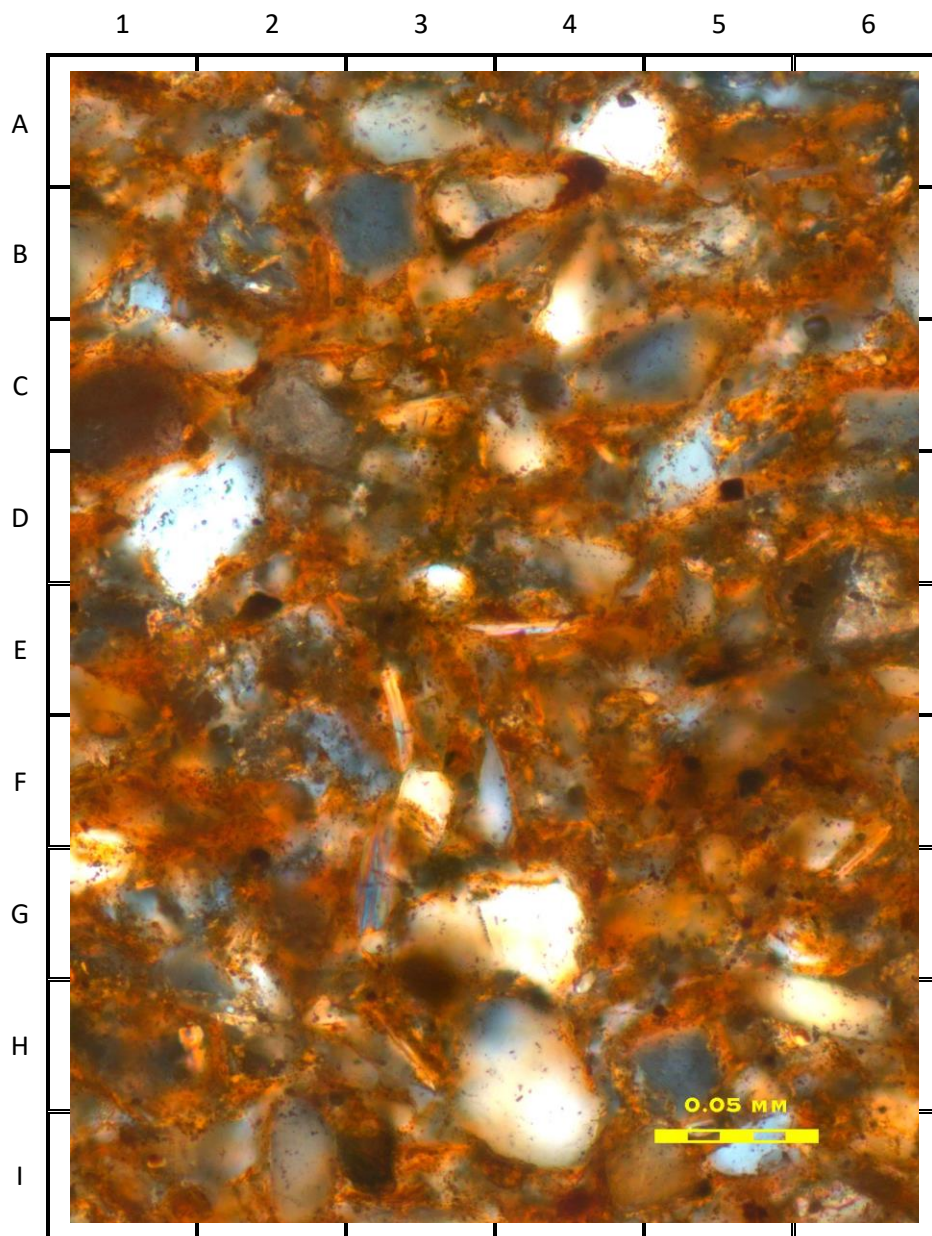
Figure C4

Thin section, oblique polars: View showing the typical appearance of the brick matrix at depth. The matrix contains numerous flaky mica crystals visible for example in F3 and F/G6. Quartz particles can be seen in D2 and G4.

In Samples 8, 11 and 13 a low degree of firing is indicated by the abundance of residual sheet silicates in the matrix and the lack of glass in the matrix.

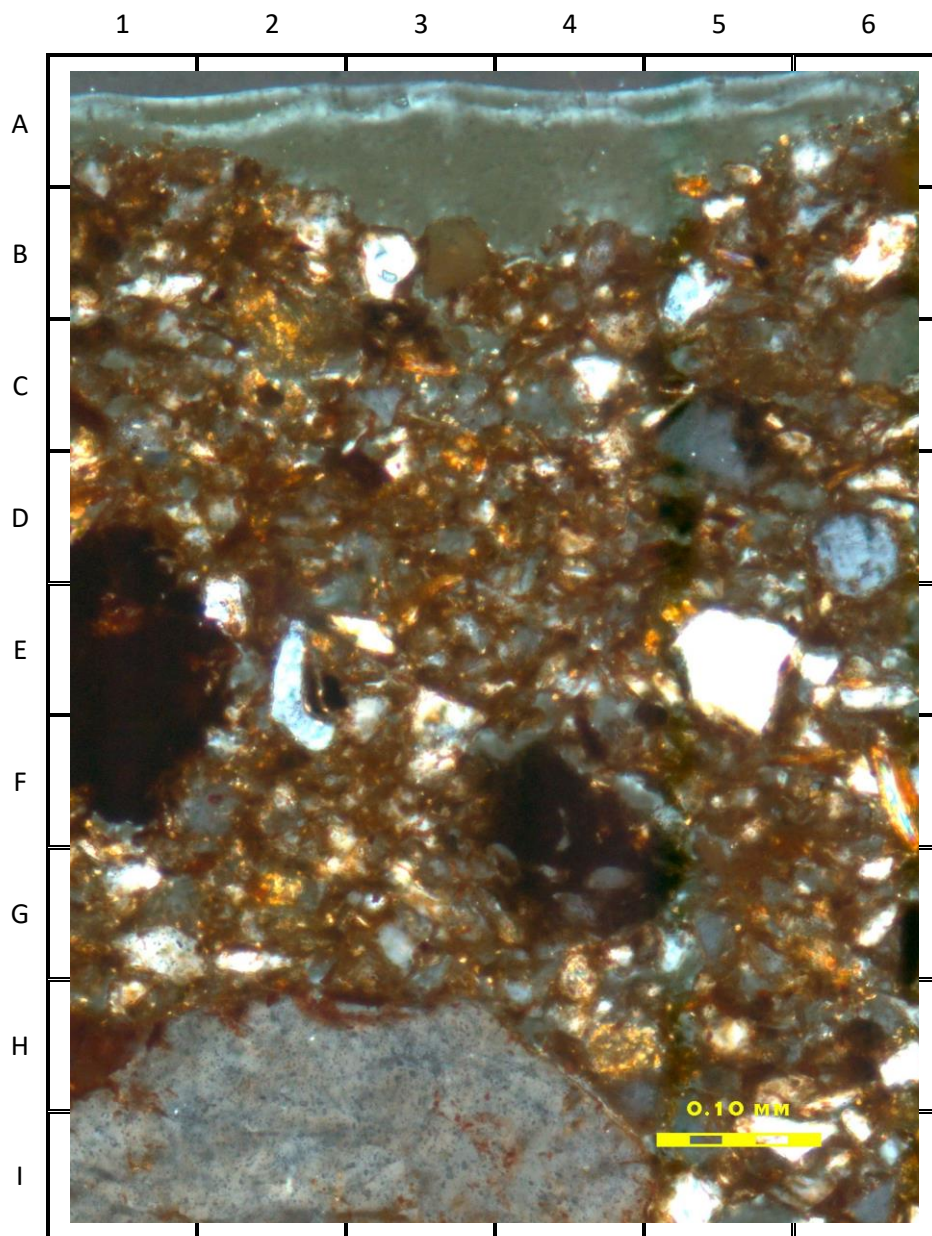
Figure C5

Thin section, oblique polars: The ground -outer surface runs along the top of the field of view from A1 to A6. The field of view is dominated by fired clay matrix and quartz particles appearing various shades from grey to white. Traces of gypsum are present in some of the abundant voids.

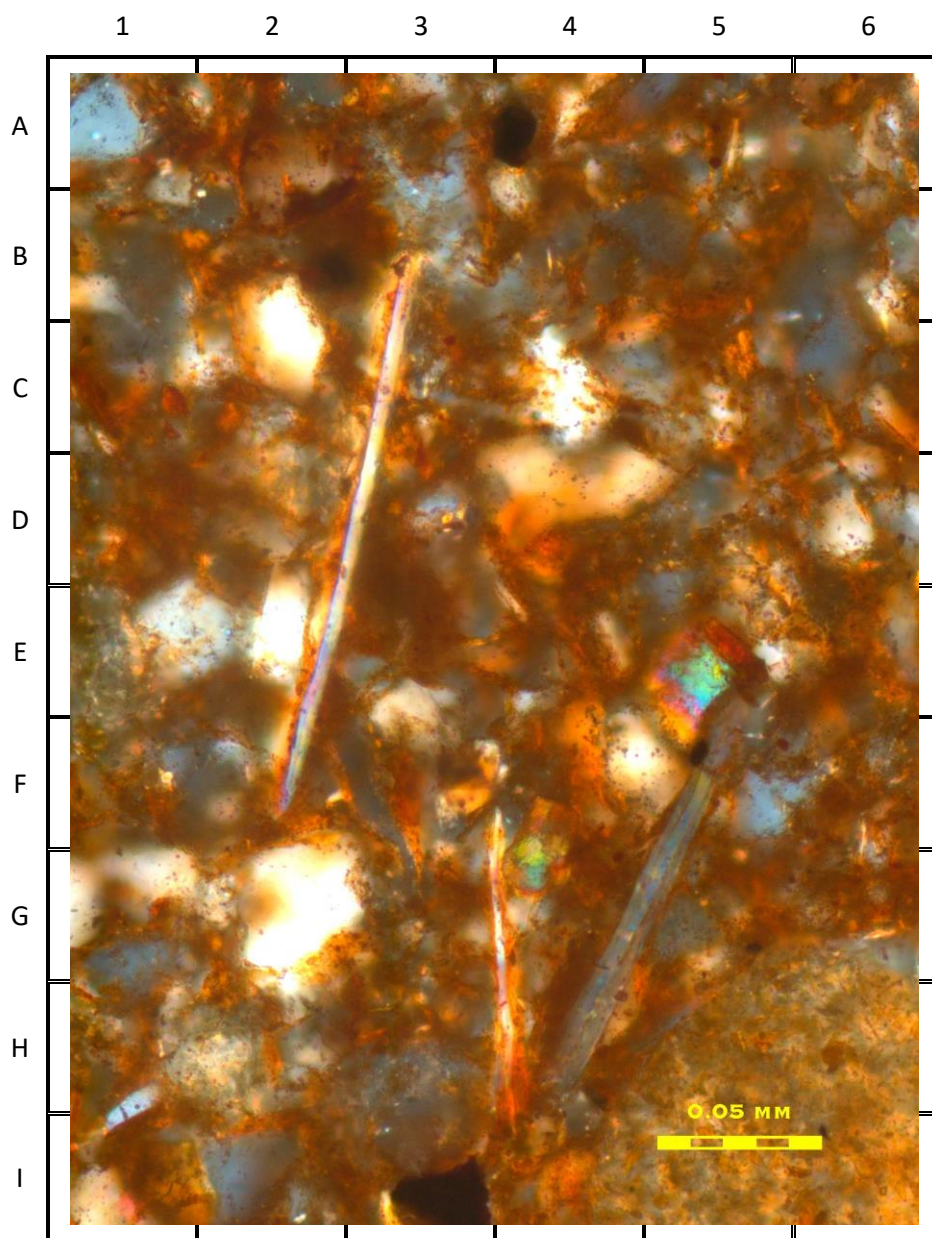
Figure C6

Thin section, oblique polars: View showing the typical appearance of the brick matrix at depth. The matrix contains numerous flaky mica crystals visible for example in C3 and G4/5. Quartz particles can be seen in A1 and G2.

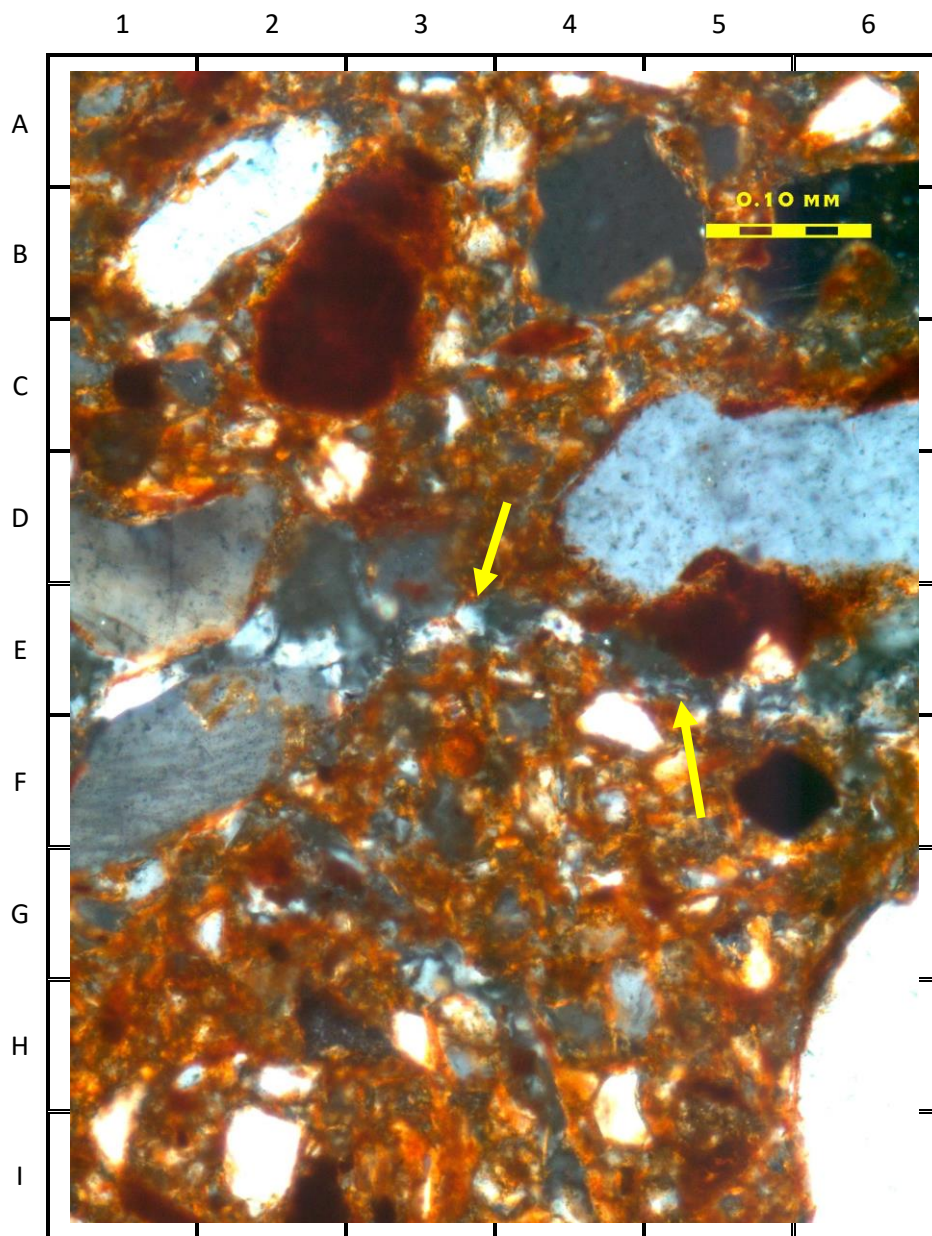
Figure C7

Thin section, oblique polars: View showing an area of the brick close to the outer surface. Minor amounts of gypsum occur in crack that is highlighted by yellow arrows. Quartz particles can be seen for example in D6 and B1/2. Fired clay matrix can be seen in H1 and A1.

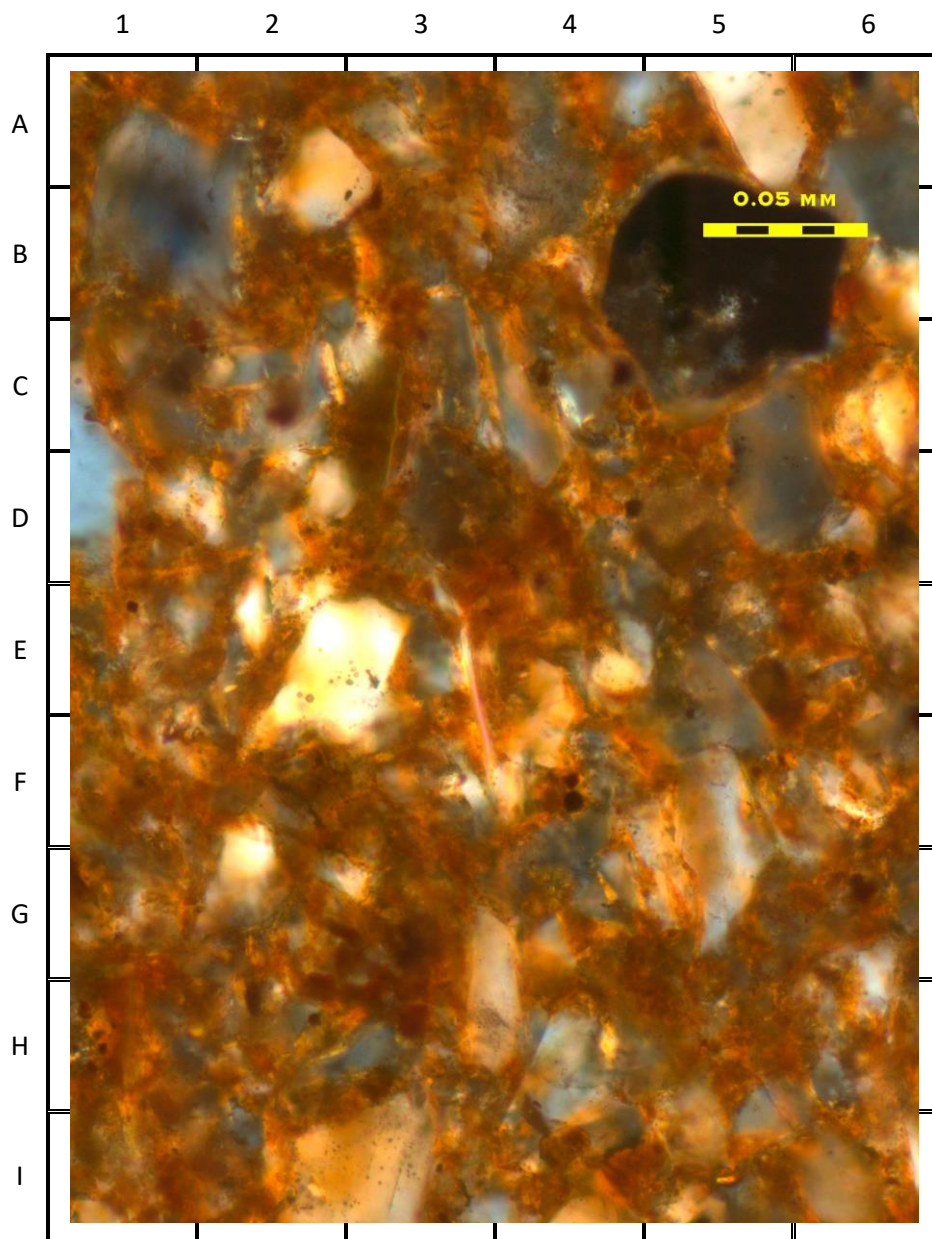
Figure C8

Thin section, oblique polars: View showing the typical appearance of the brick matrix at depth. The matrix contains numerous flaky mica crystals visible for example in C3/4 and F3. Quartz particles can be seen in E2/3 and B1.
