This document is an addendum to the Banfield Wood LLP Structural Condition Survey (Rev D 25.01.2024). Additional intrusive investigations were undertaken following completion of the report. The additional investigations aimed to expose the existing floor joists to the upper residential floors at multiple locations and remove finishes locally from walls to ascertain if they comprise modern stud partitions or original timber load bearing walls.

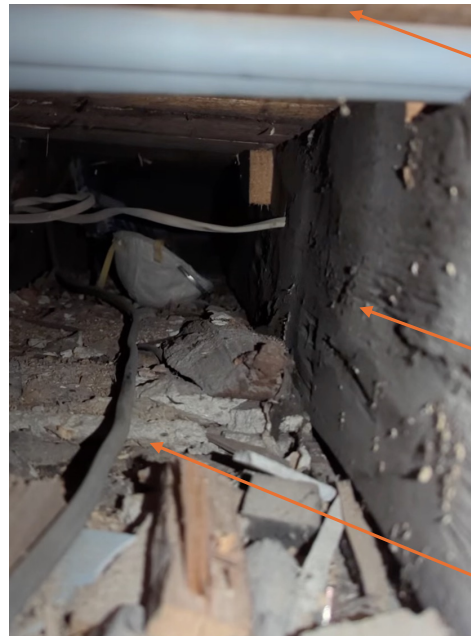
*Photo taken between ceiling and floor boards (first to second floor)*

*Original floorboards, nailed perpendicular to joists*

*Original lathe and plaster*

*Original timber joists*

*Line of original timber stud*

*Modern plasterboard ceiling*

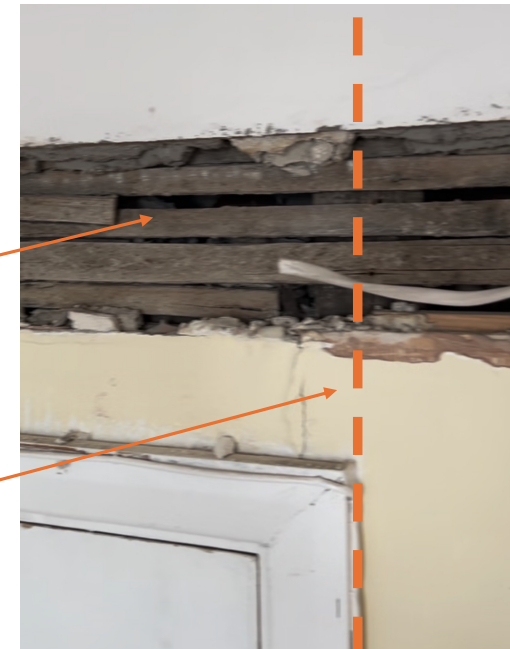
The following pages show our findings from the investigations. The floor joists are original and span from the external walls onto an original central spine wall. The spine wall is constructed as original timber studs with lathe and plaster finishes to both sides. The wall has been altered in the past to create new openings to serve the existing residential arrangement.

*Photo taken of spine wall at first floor level*

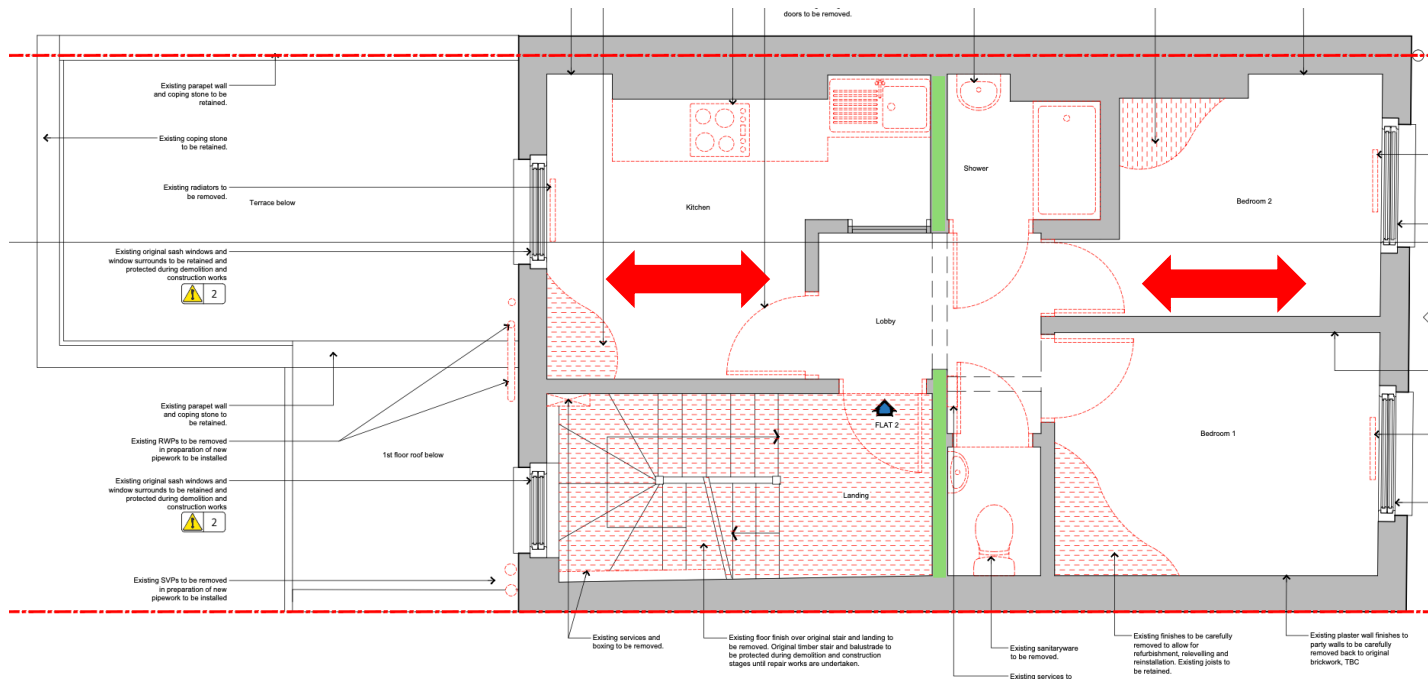
## Second Floor Structure

Denotes original (circa 1800s) timber structural stud wall. Some of the existing studs have been removed to open up the space and form the existing hallway area. Nevertheless, the header plate remains in place. The stud wall is supported on the corresponding wall at first floor level below

Denotes span of original floor joists.  
165 x 40 @ 400mm Ctrs
