PHOTO RECORD

THE CITY OF LONDON CORPORATION

KEATS HOUSE
10 KEATS GROVE, HAMPSTEAD
LONDON NW3 2RR

CCTV, FIRE AND INTRUDER ALARM SYSTEMS

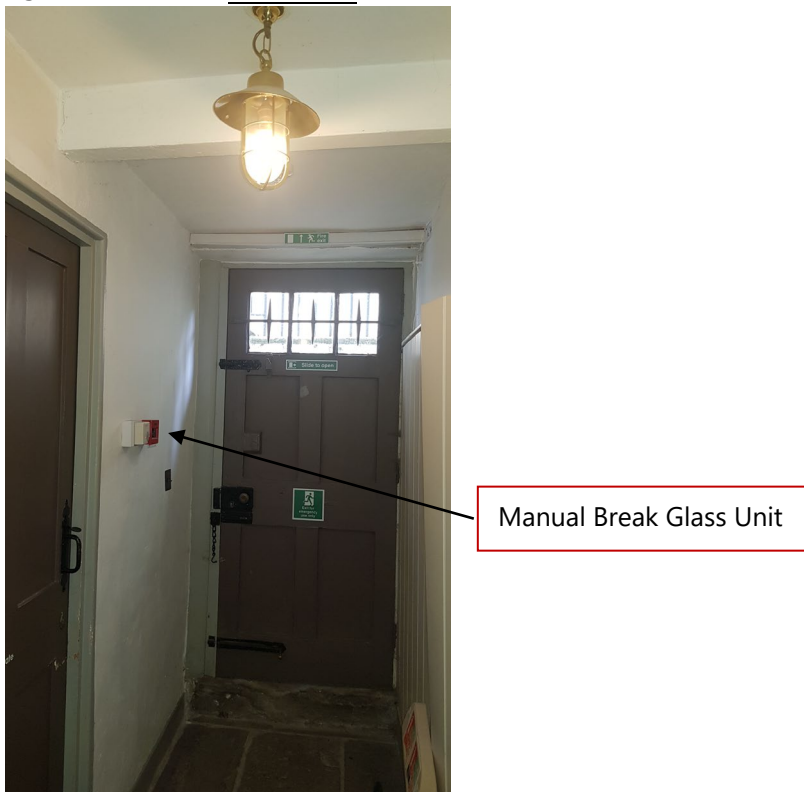
B5

Fire Alarm	Existing manual break glass to be replaced with a wireless type. Existing detector hidden behind (downstand beam) to be replaced with a wireless smoke detector.
Intruder Alarm	New door contact to be a direct replacement and connected to existing cabling.

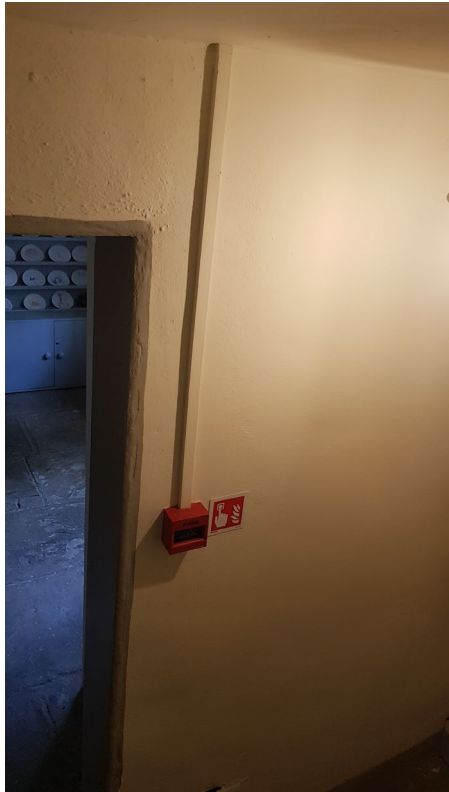
B7

Fire Alarm

Existing manual break glass to be replaced with a wireless type, therefore the section of mini trunking dropping down from the ceiling will be removed. Redundant holes within the wall will be filled and painted.

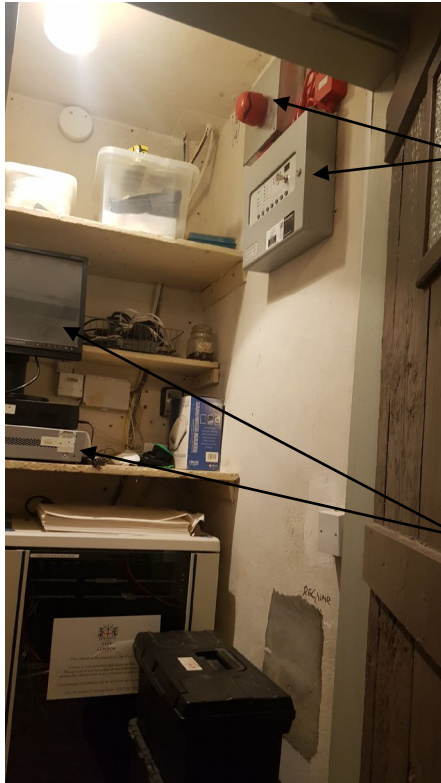
B7/2

Main Fire Alarm Panel & Ancillaries

Intruder Alarm Panels

Keypad

CCTV Monitor & Hard Drive

- CCTV Monitor and Hard Drive to be direct replacements and connected to existing cabling.
- Intruder Alarm Panels and Keypad to be direct replacements and connected to existing cabling. Redundant holes within the wall will be filled and painted.
- Fire Alarm Main Fire Alarm Panel and Ancillaries' to be removed. New wireless smoke detector to be installed.

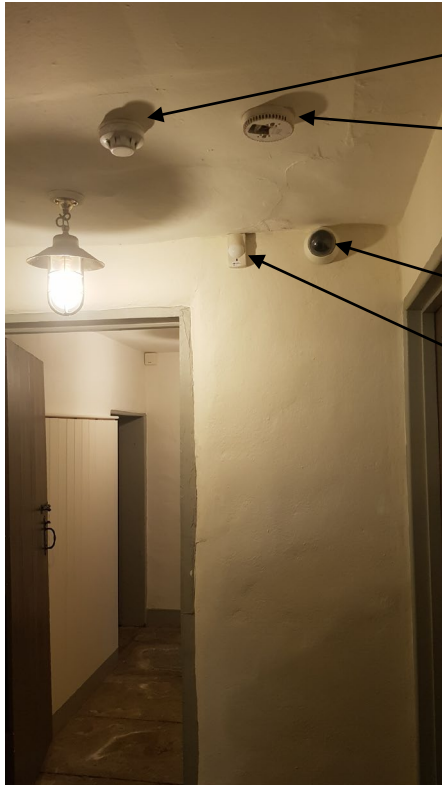
B9

Smoke Detector

Fire Alarm Sounder

CCTV Camera

Intruder Detector

CCTV

Intruder Alarm

Fire Alarm

New camera to be a direct replacement and connected to existing cabling.

New detector to be a direct replacement and connected to existing cabling.

Existing detector to be replaced with a wireless smoke detector mounted onto a base sounder.

Note:- Existing sounder to be removed and redundant holes within the wall will be filled and painted.

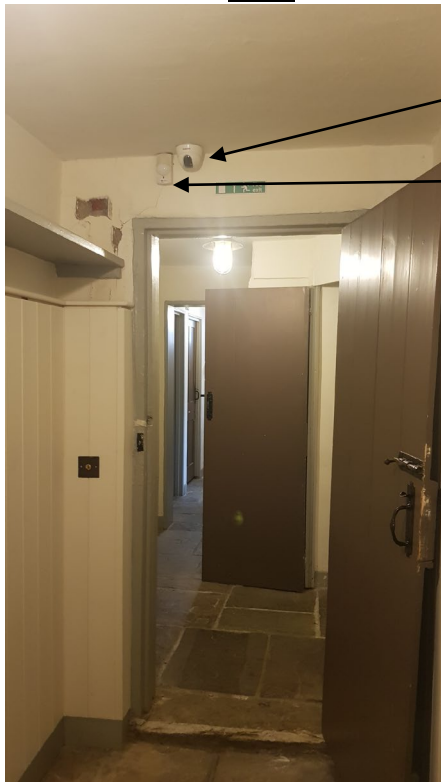
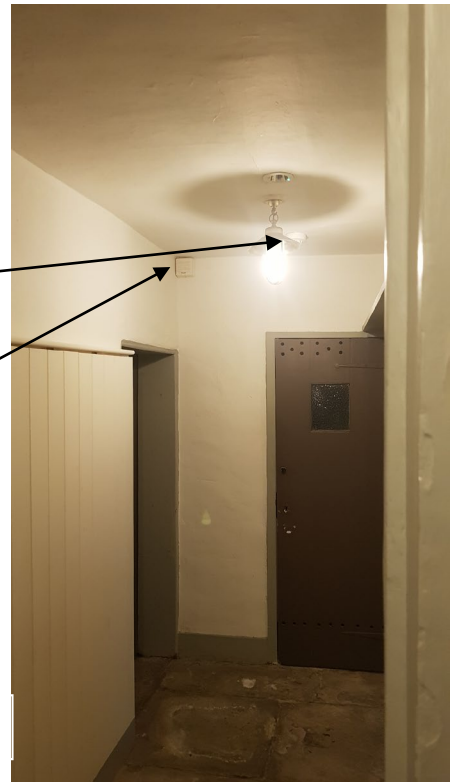
B11

- CCTV Camera
- Intruder Detector
- Smoke Detector
- Intruder Alarm Sounder

CCTV
Intruder Alarm
Fire Alarm

New camera to be a direct replacement and connected to existing cabling.
New detector and sounder to be direct replacements and connected to existing cabling.
Existing detector to be replaced with a wireless smoke detector mounted onto a base sounder.

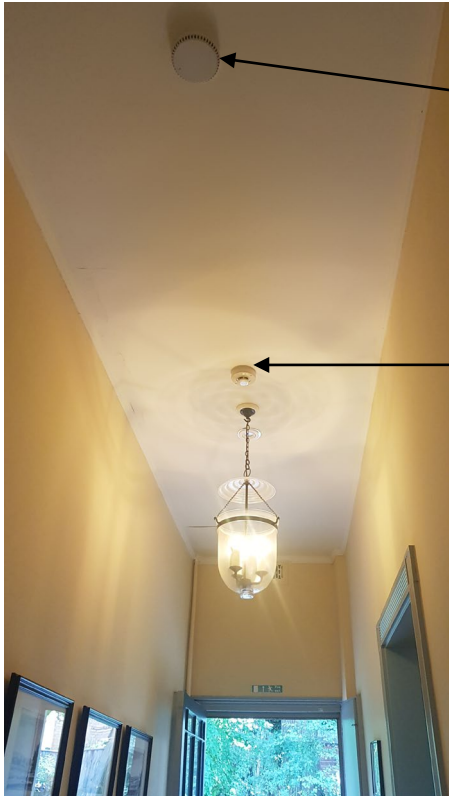
VIEW 1
FROM HALLWAY LOOKING TOWARDS REAR DOOR

Fire Alarm Sounder

Smoke Detector

Fire Alarm

Existing detector to be replaced with a wireless smoke detector mounted onto a base sounder.

Note 1:- Existing sounder to be removed and redundant holes within the wall will be filled and painted.

Note 2:- Existing manual break glass (not shown by door) is to be replaced with a wireless type.

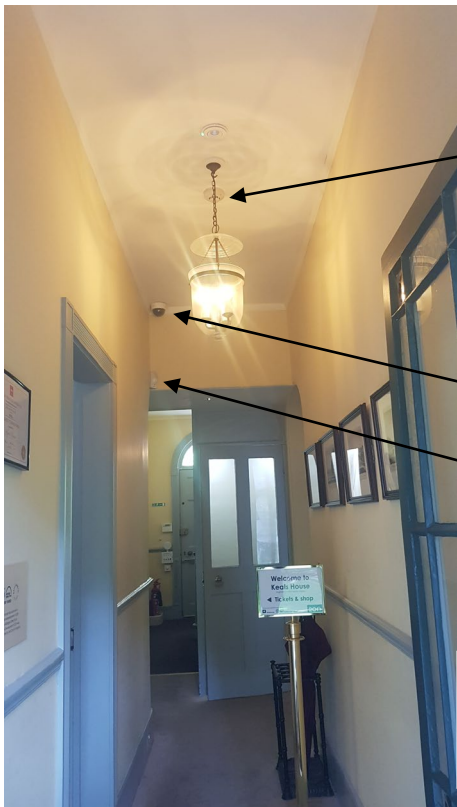
VIEW 2
FROM REAR DOOR LOOKING DOWN HALLWAY (G2)
TOWARDS FRONT DOOR AND HALLWAY (G5)

Smoke Detector

CCTV Camera

Intruder Detector

CCTV

New camera to be a direct replacement and connected to existing cabling.

Intruder Alarm

New detector to be a direct replacement and connected to existing cabling.

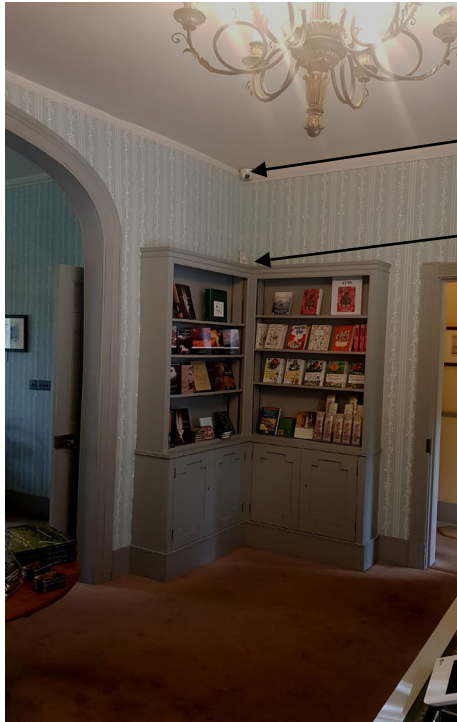
VIEW 1

CCTV Camera

Intruder Detector

Intruder Alarm New detector to be a direct replacement and connected to existing cabling.

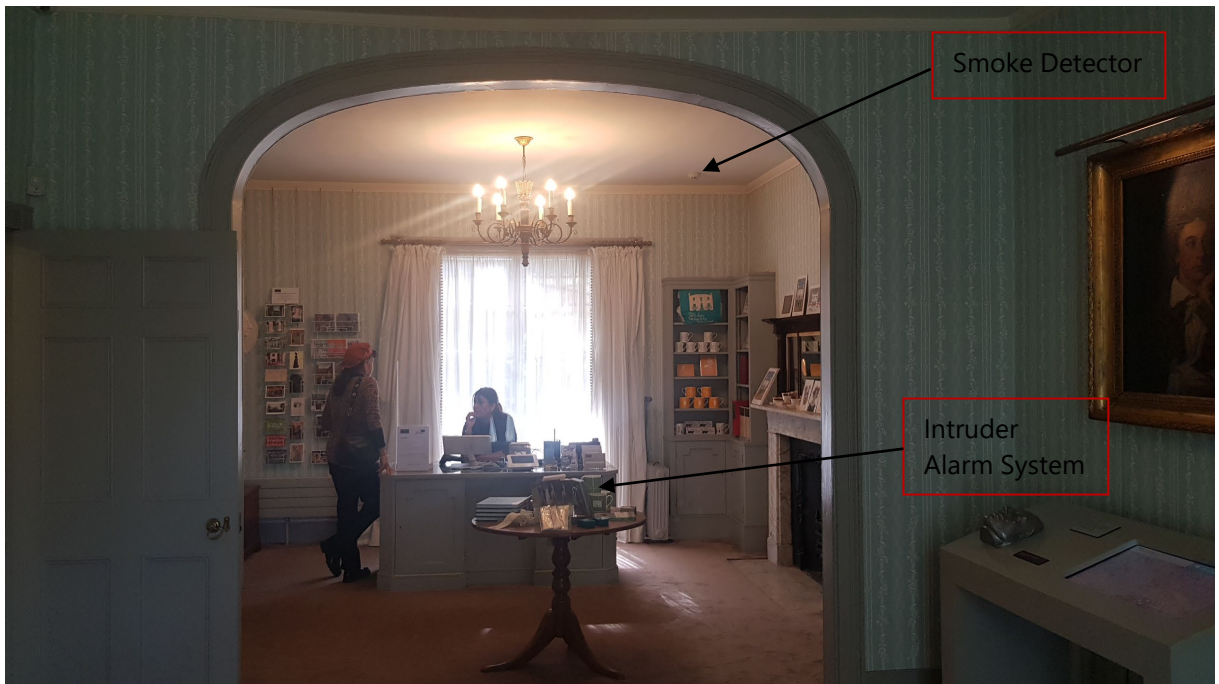
FROM DISPLAY ROOM (MRS BRAWNE'S ROOM) INTO VISITORS WELCOME POINT (G3)

Smoke Detector

Intruder Alarm System

Intruder Alarm New Panic Button (mounted under desk) is to be a direct replacement and connected to existing cabling.

Fire Alarm Existing detector to be replaced with a wireless smoke detector mounted onto a base sounder and beacon.

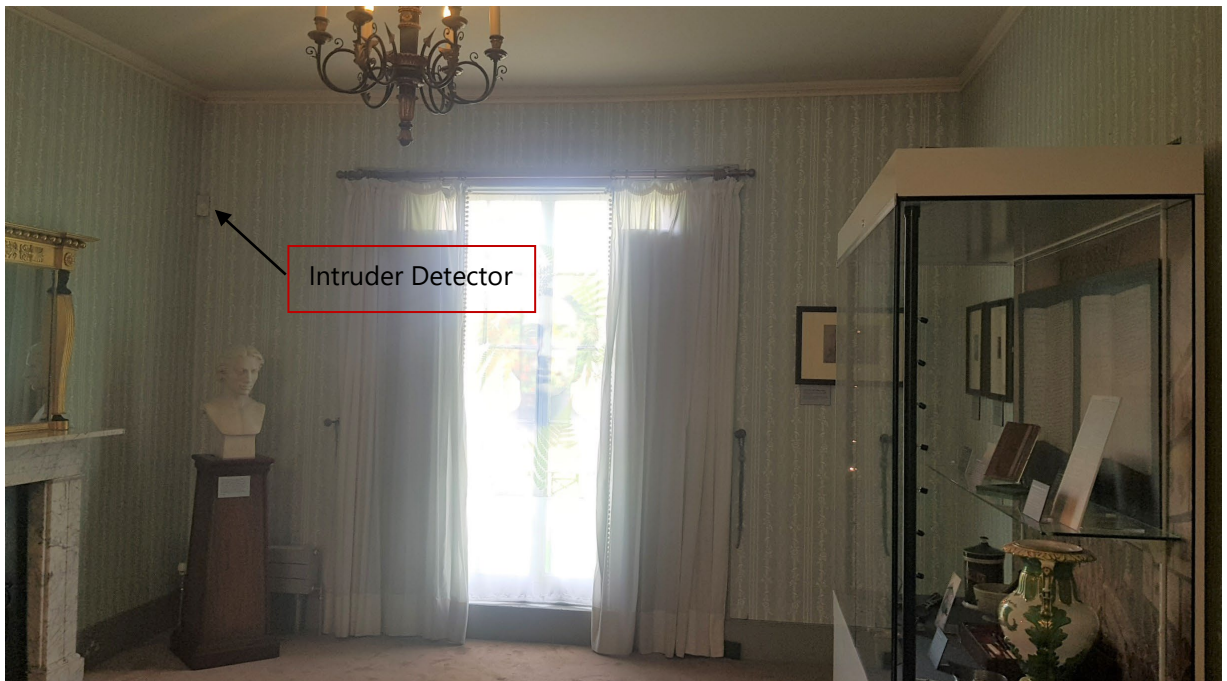
G4

CCTV
Intruder Alarm
Fire Alarm

New camera to be a direct replacement and connected to existing cabling.
New detector to be a direct replacement and connected to existing cabling.
Existing detector to be replaced with a wireless smoke detector mounted onto a base sounder and beacon.

Intruder Alarm

New detector to be a direct replacement and connected to existing cabling.

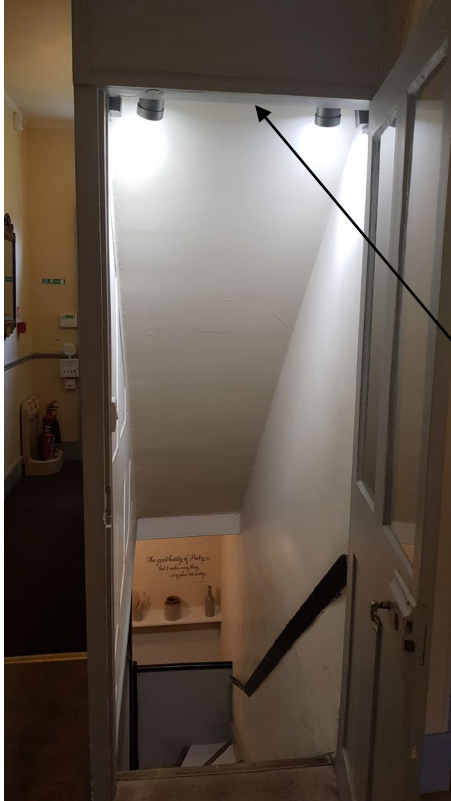
FROM HALLWAY LOOKING INTO STAIRWELL DOWN TO BASEMENT HALL (B7)

Smoke Detector

Fire Alarm

New ceiling mounted wireless smoke detector to be fitted within the void on the inside the door frame that leads down to basement.

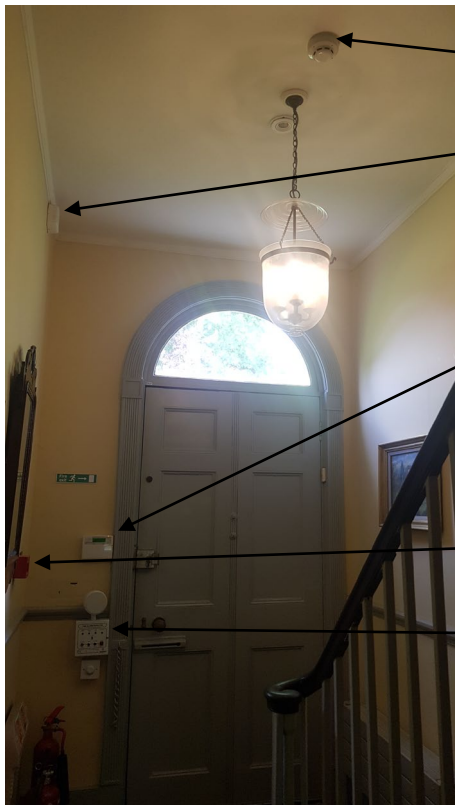
VIEW 3
FROM HALLWAY LOOKING TOWARDS FRONT DOOR

- Smoke Detector
- Intruder Alarm Sounder
- Intruder Alarm Keypad
- Manual Break Glass Unit
- Fire Alarm Repeater Panel

- Intruder Alarm New detector and keypad are to be a direct replacement and connected to existing cabling.
- Fire Alarm Existing detector to be replaced with a wireless smoke detector. Existing manual break glass to be replaced with a wireless type.
Note:- Existing repeater panel and associated accessories are to be removed and redundant holes within the wall will be filled and painted.

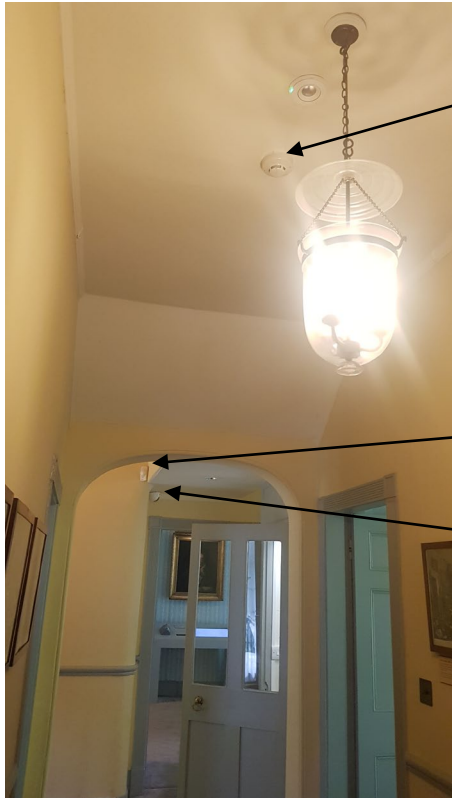
LOOKING DOWN HALLWAY TOWARDS DISPLAY ROOM (G4)

Smoke Detector

Intruder Detector – Hallway (G2)

CCTV Camera – Hallway (G5)

CCTV
Intruder Alarm
Fire Alarm

New camera to be a direct replacement and connected to existing cabling.
New detector to be a direct replacement and connected to existing cabling.
Existing detector to be replaced with a wireless smoke detector.

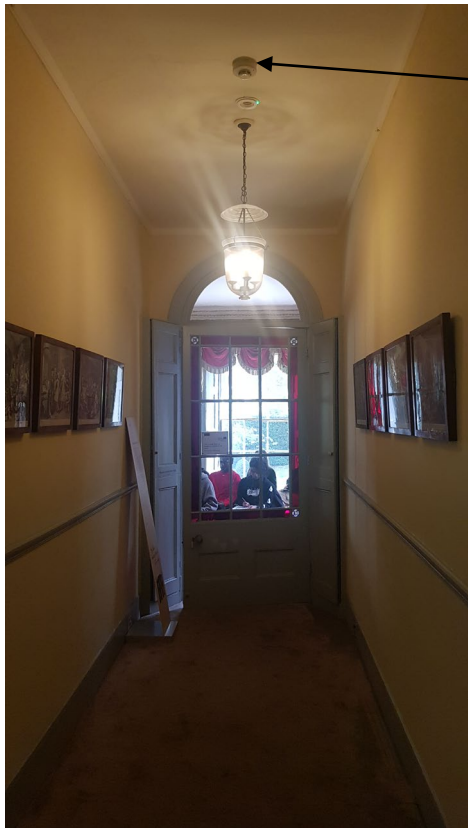
LOOKING DOWN HALLWAY TOWARDS MISS CHESTER'S DRAWING ROOM (G8/1)

Smoke Detector

Fire Alarm

Same item as above.

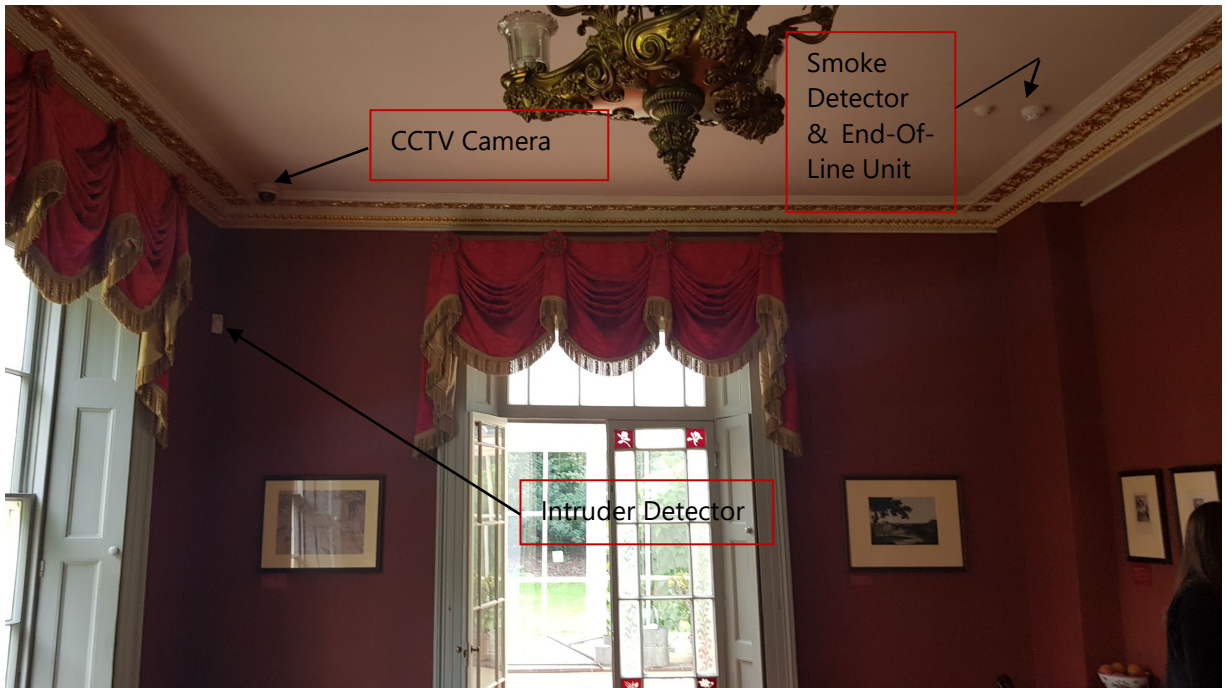
VIEW 2

CCTV Camera

Smoke Detector & End-Of-Line Unit

Intruder Detector

CCTV

Intruder Alarm

Fire Alarm

New camera to be a direct replacement and connected to existing cabling.

New detector to be a direct replacement and connected to existing cabling.

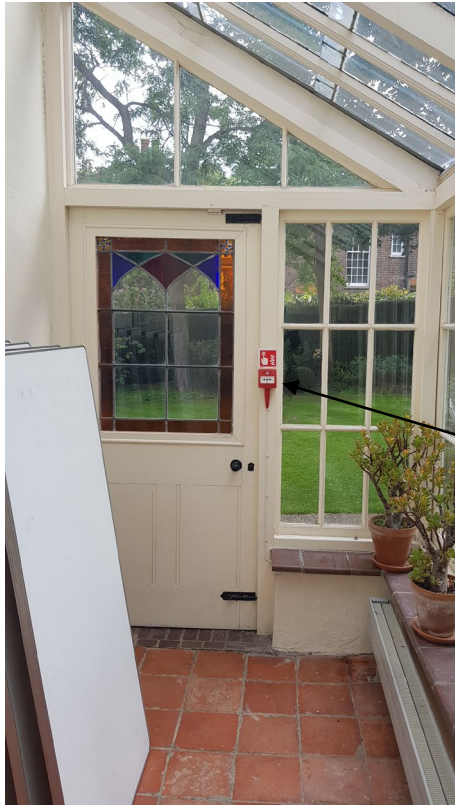
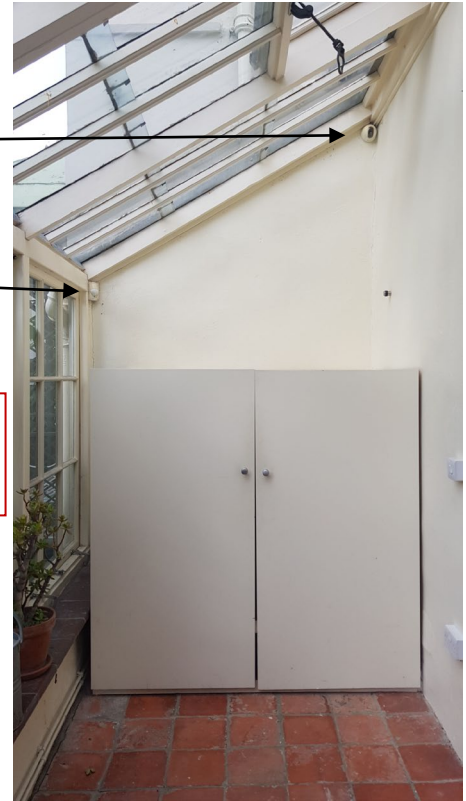
G8/2

CCTV Camera

Intruder Detector

Manual Break Glass Unit

CCTV
Intruder Alarm
Fire Alarm

New camera to be a direct replacement and connected to existing cabling.
New detector to be a direct replacement and connected to existing cabling.
Existing manual break glass to be replaced with a wireless type.
Note:- Cable and clips to be removed and redundant holes will be filled and painted.

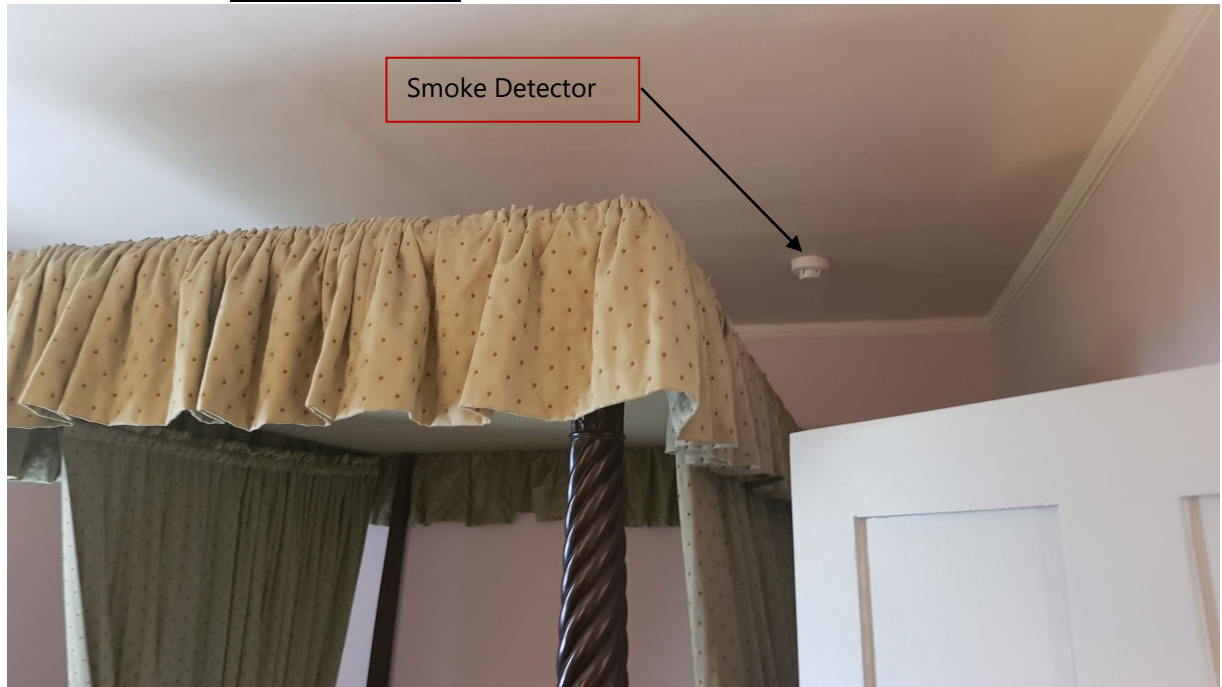
VIEW 1

Fire Alarm

Existing detector to be replaced with a wireless smoke detector mounted onto a base sounder and beacon.

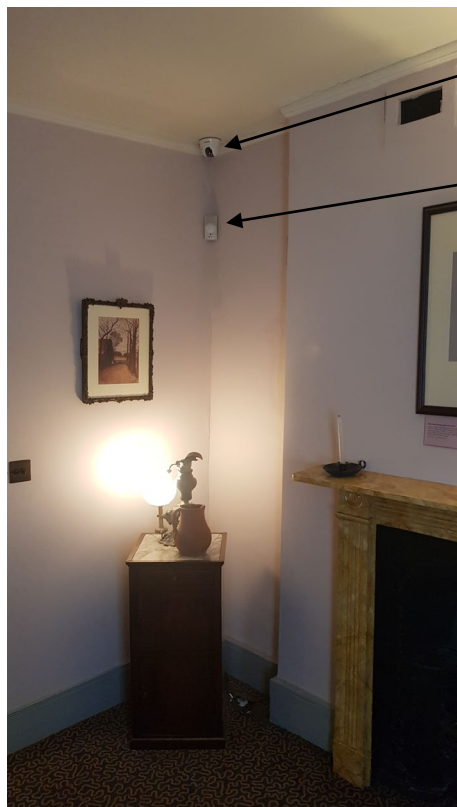
VIEW 2

CCTV

New camera to be a direct replacement and connected to existing cabling.

Intruder Alarm

New detector to be a direct replacement and connected to existing cabling.

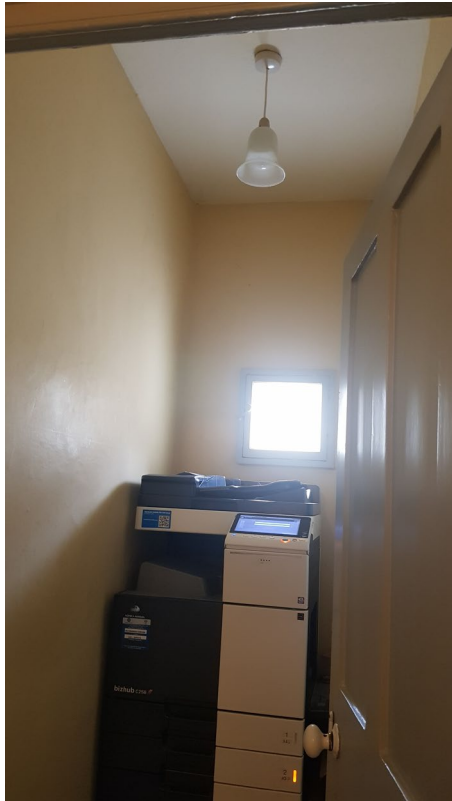
F4/3

Fire Alarm

New wireless detector to be installed.

New Radio Hub (RH) & Power Supply Unit (PSU) to be installed above door.

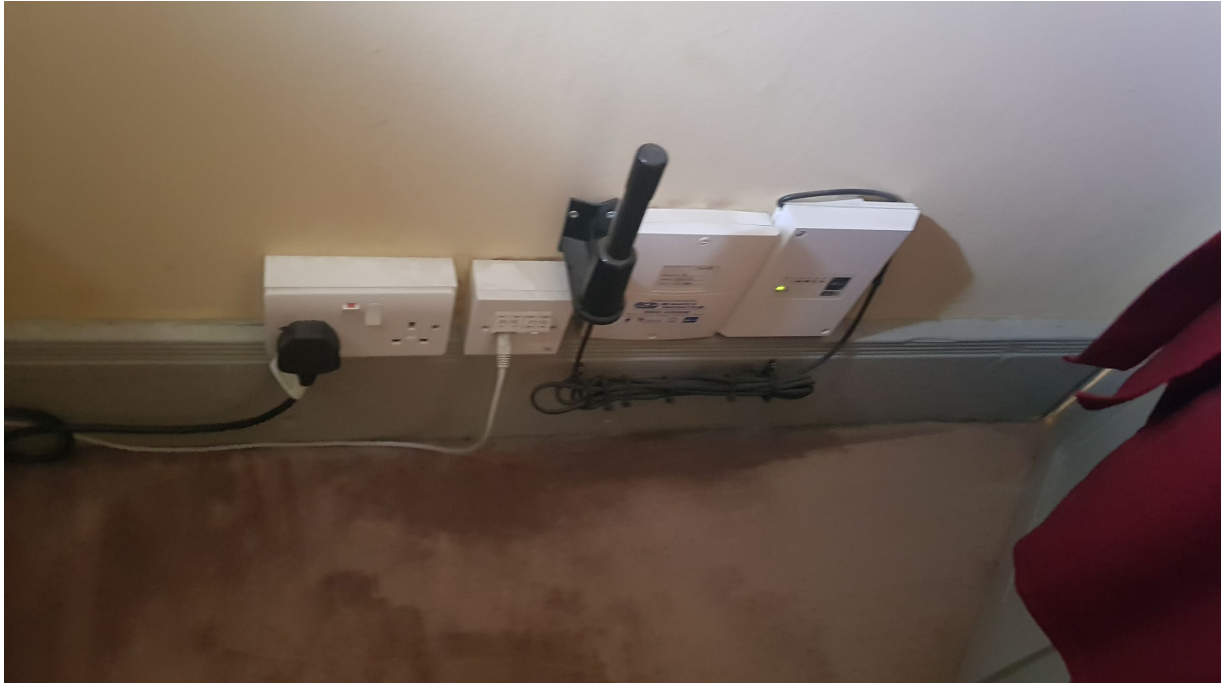
VIEW 3

Intruder Alarm It is envisaged that the existing intruder alarms expander and radio receiver (for the mobile panic button) is to be relocated to the Store (B7/2) within the basement next to the panel.

Note 1:- The relocation of the equipment is subject to a radio survey. If the survey is found to be unsatisfactory, the existing equipment will remain in-situ.

Note 2:- If the equipment can be removed, the redundant holes within the wall will be filled and painted.

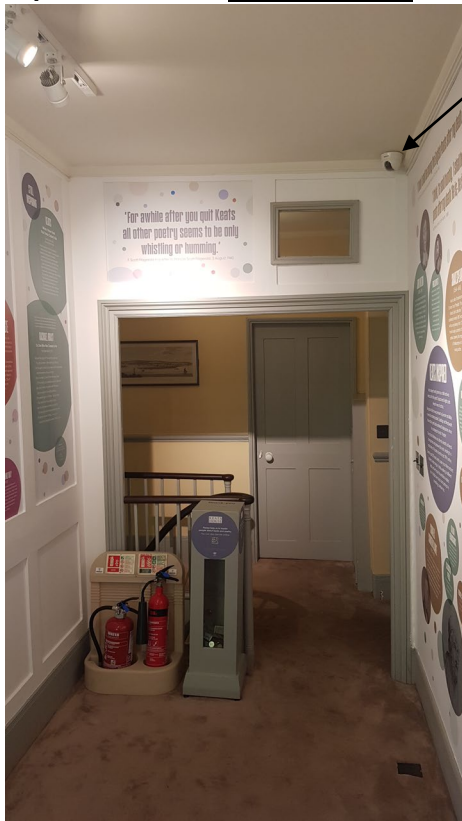
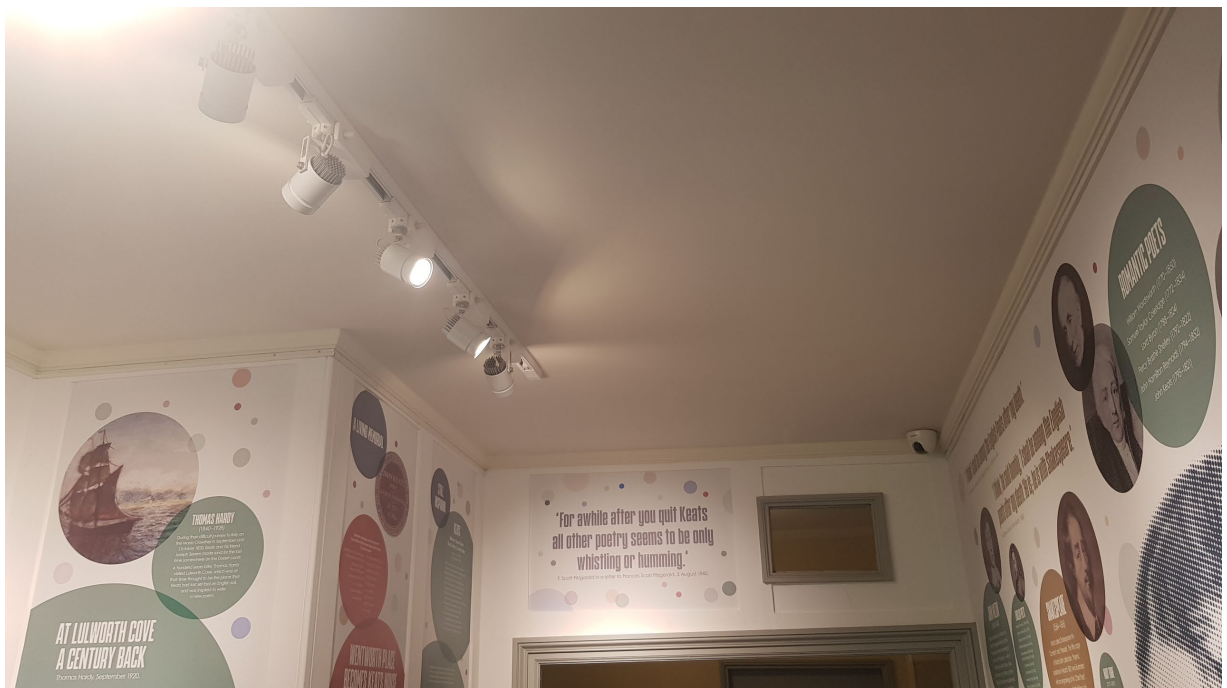
F5/1

CCTV Camera

| CCTV | New camera to be a direct replacement and connected to existing cabling. |
| Intruder Alarm | Existing detector (not shown by window) is to be a direct replacement and connected to existing cabling. |
| Fire Alarm | New wireless smoke detector is to be installed and mounted onto a base sounder and beacon. |

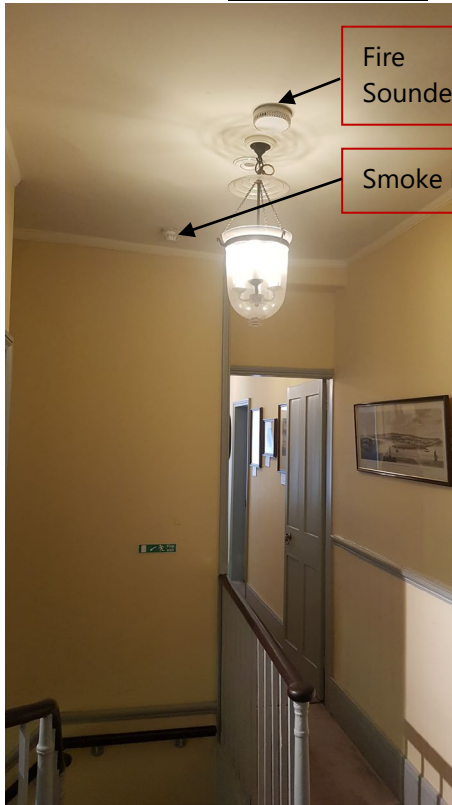
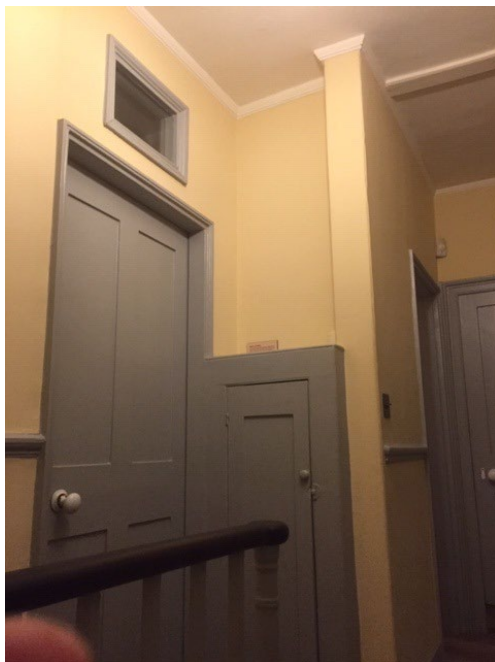
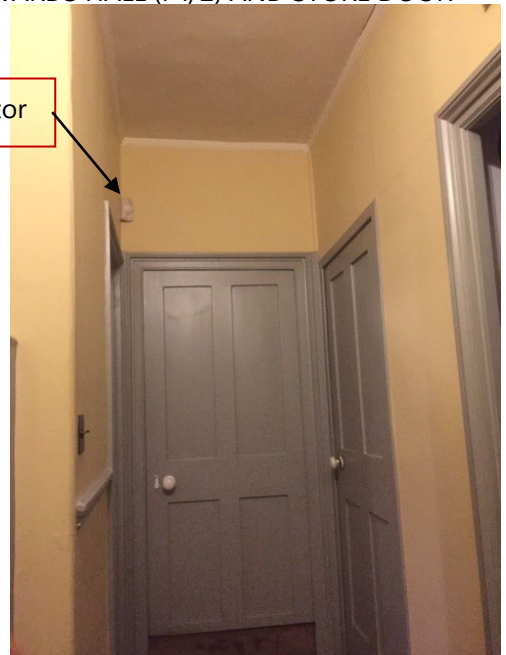
F5/2

Intruder Detector

Intruder Alarm
Fire Alarm

New detector to be a direct replacement and connected to existing cabling. Existing detector to be replaced with a wireless smoke detector but relocated so as it is not over staircase.

Note:- Redundant holes within the ceiling will be filled and painted.

New wireless smoke detector mounted onto a base sounder is to be installed in Hall (4/2).

New break glass unit to be installed onto wall above first stair tread.

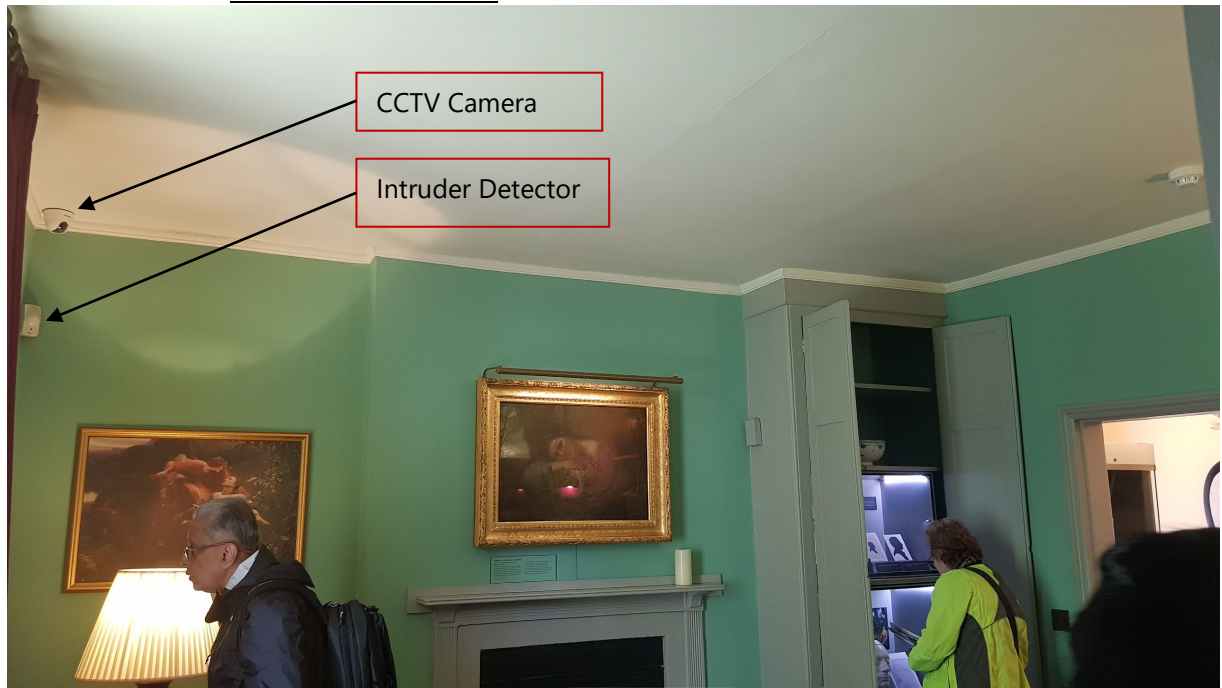
VIEW 1

CCTV Camera

Intruder Detector

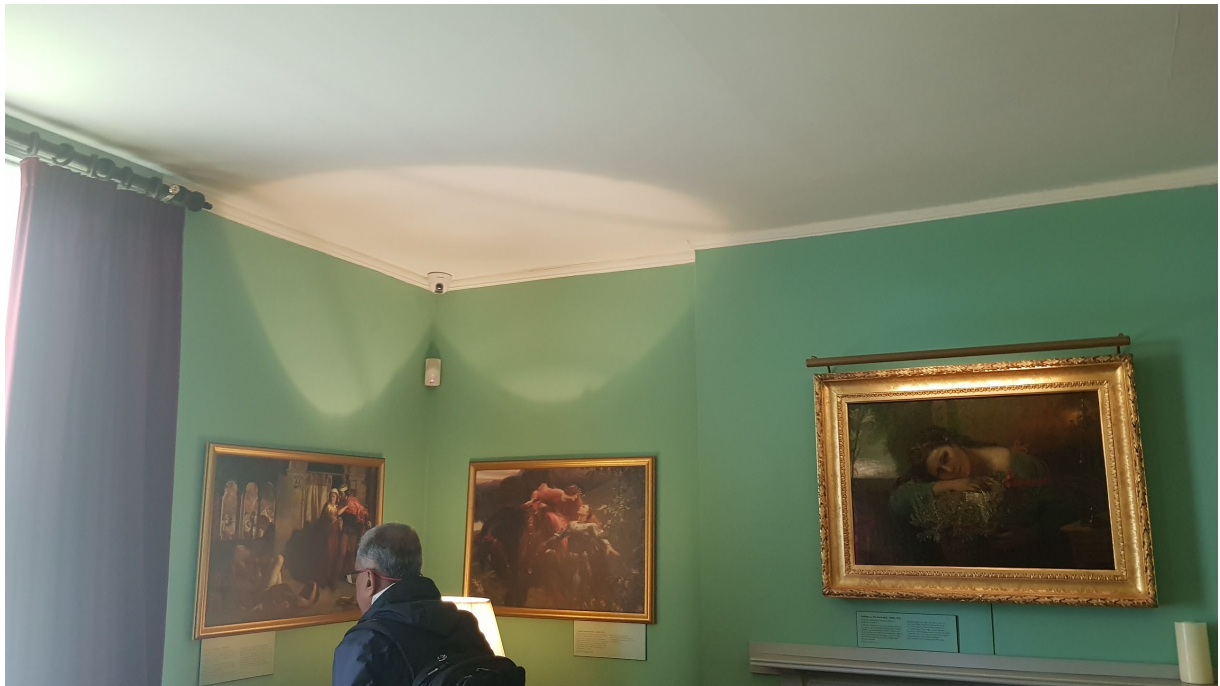
VIEW 3

CCTV New camera to be a direct replacement and connected to existing cabling.
 Intruder Alarm New detector to be a direct replacement and connected to existing cabling.

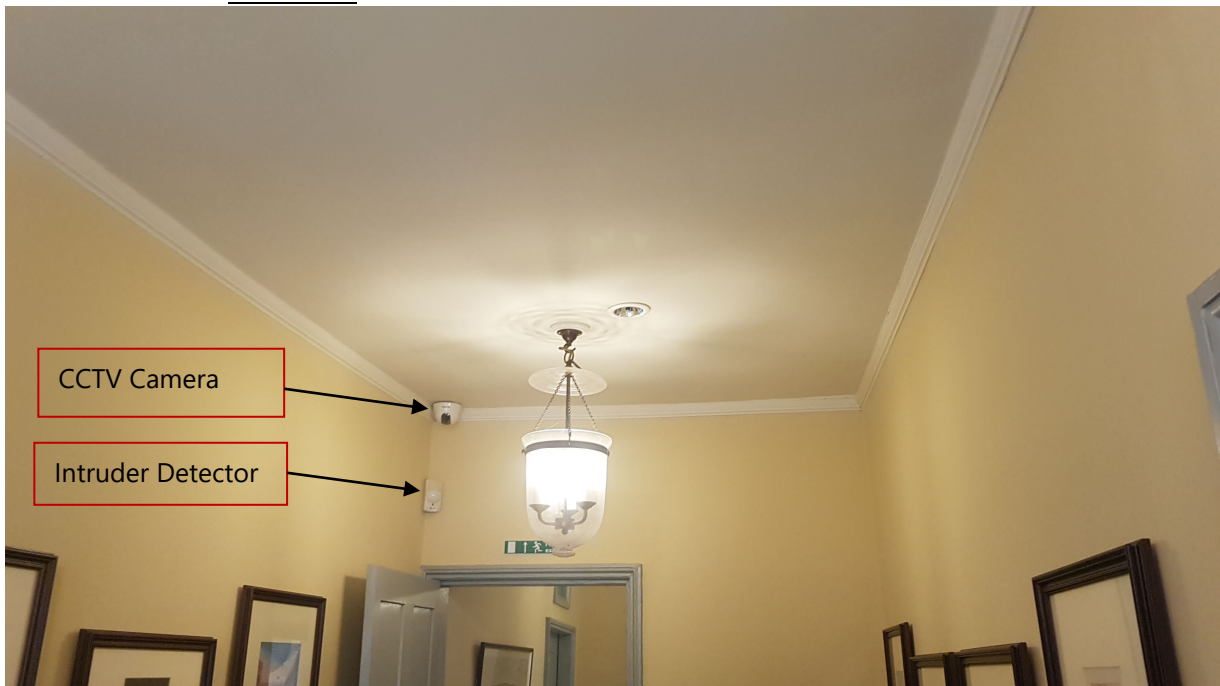
F7 HALLWAY

CCTV New camera to be a direct replacement and connected to existing cabling.
 Intruder Alarm New detector to be a direct replacement and connected to existing cabling.
 Fire Alarm New wireless smoke detector is to be installed.
