—The British Museum
Contractors' Toilets Refurbishment

Design Access Statement
Heritage Impact Statement
R02

The British Museum
Contractors' Toilets Refurbishment
Design and Access Statement
Heritage Impact Statement
Rev 02

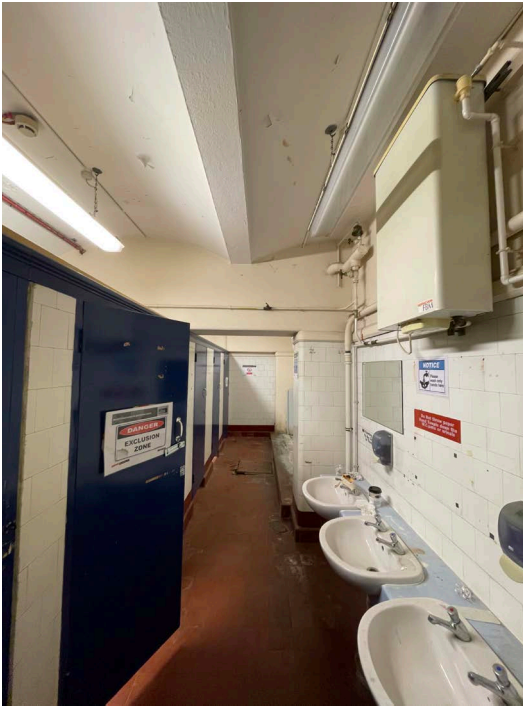
View looking east

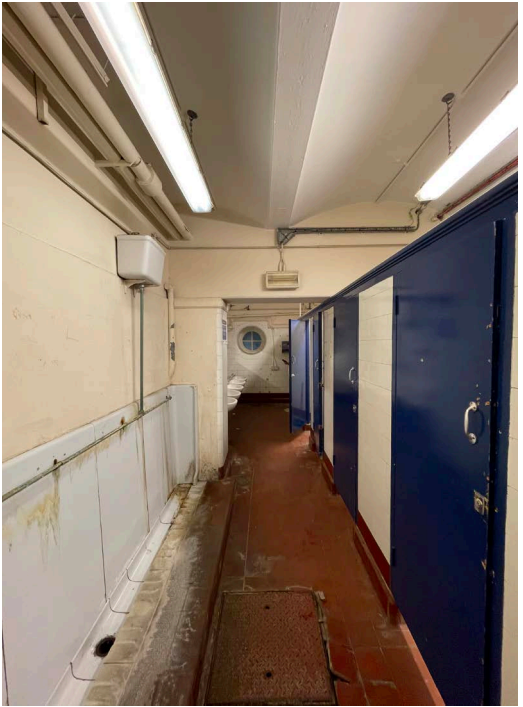
View looking west

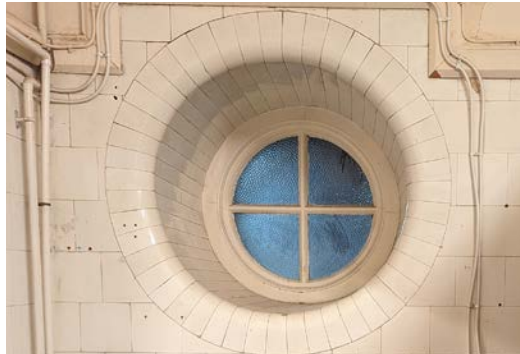
The majority of the walls are covered with white glazed wall tiles, which although not original to the 1830s construction of the space, are identified in the 2023 CMP as be part of the 1930s toilet conversion, as 'tightly jointed white ceramic tiling of good quality' with some bespoke tiles installed around a circular window inserted into the space in the 1930s. The tiles are in a mixed condition, with some cracked or containing drill holes. Where in good condition, the tiles are proposed to be kept, with repairs and replacements made to damaged/broken tiles respectively. Where in poorer condition, the tiles are proposed to be replaced like-for-like.

Tiling around existing window

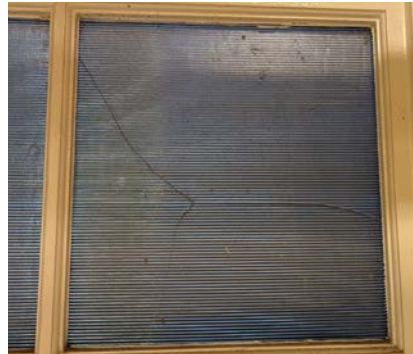
Several panes of glass to the windows are either cracked or have been replaced with mismatched glass.

Cracked windowpane

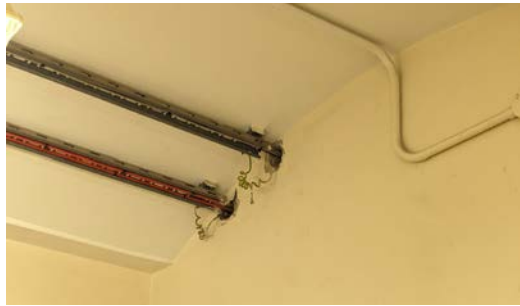
The upper parts of the walls and ceiling are finished in plaster, presumably over the masonry. The existing services and light fittings are surface mounted, running in a series of ad-hoc conduits, or face fixed. All of the services are life-expired and proposed for removal and replacement

Existing services and penetrations

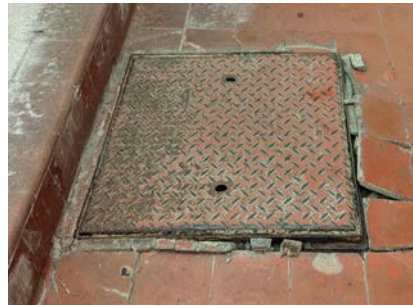
The existing floor tiles are also proposed for removal. They are terracotta in colour - possibly dating from the 1930s conversion, although the CMPs do not comment - and are in a poor condition, with many areas worn and cracked, with severe cracking to the tiles around a filled in manhole by the urinals.

Lifted manhole cover

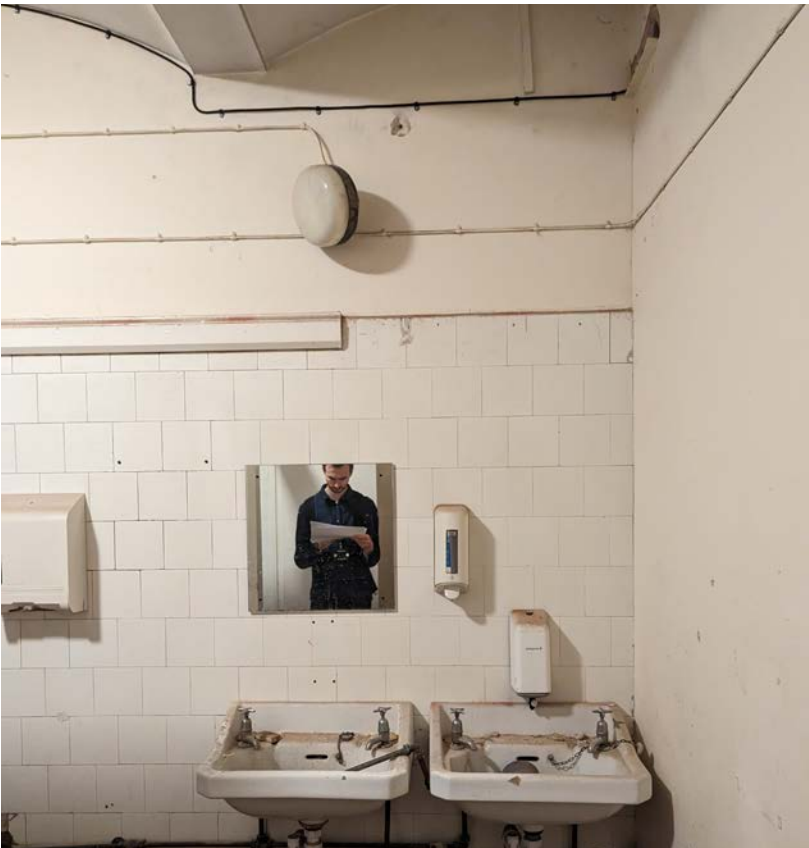
View looking east

The existing floor finish is marmoleum, which is worn and lifting in places, and is proposed for removal.

The majority of the walls are covered with same white glazed wall tiles as the male toilet, again a mixed condition, with some tiles cracked or containing drill holes.

Several panes of glass to the windows are either cracked or have been replaced with mismatched glass.

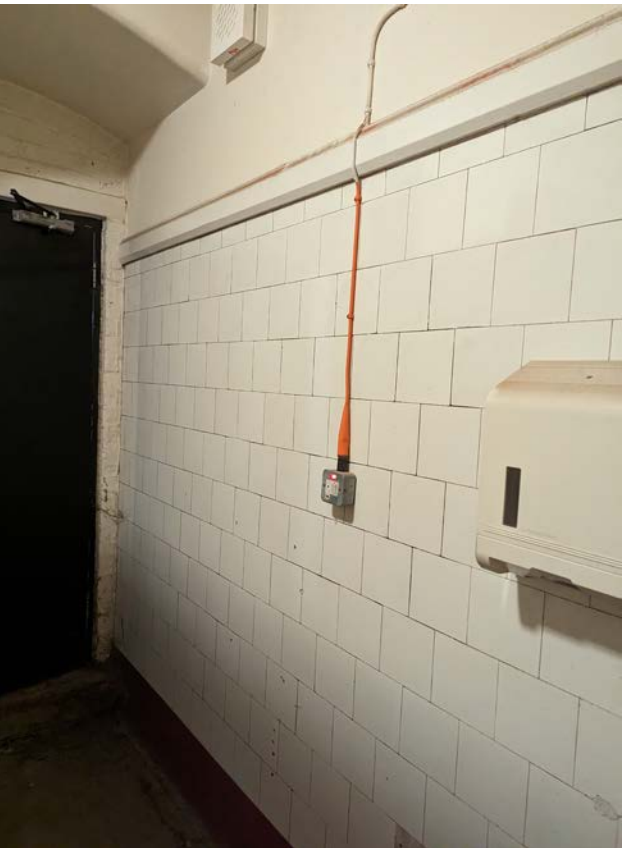
1930s wall tiling

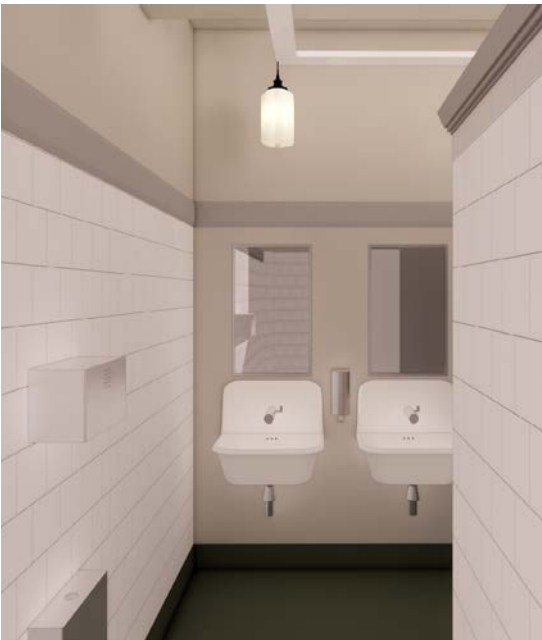
Female WC - Proposed CGI, looking south

Where currently plastered, walls will be cleaned and re-plastered where damaged before being painted. Tiled walls will be cleaned and re-grouted, retaining as many tiles as possible, with only cracked or damaged tiles replaced with like-for-like tiles. The walls of the new shower will be lined and tiled to ensure a waterproof lining, with new tiles the same size as the existing to pick up on the existing detailing, but in a different bond and colour to distinguish them as new. A total of 12no. cracked and mismatching windowpanes will be replaced with panes matching the most common obscured pattern - which is horizontally striated.

The existing tiled and linoleum floors are to be replaced with a new resin floor covering over repaired screed. New light fittings will be introduced, and cabling for light fittings and all other electronic services - including fire alarms and smoke detectors - will be replaced with new cabling in new steel conduit.

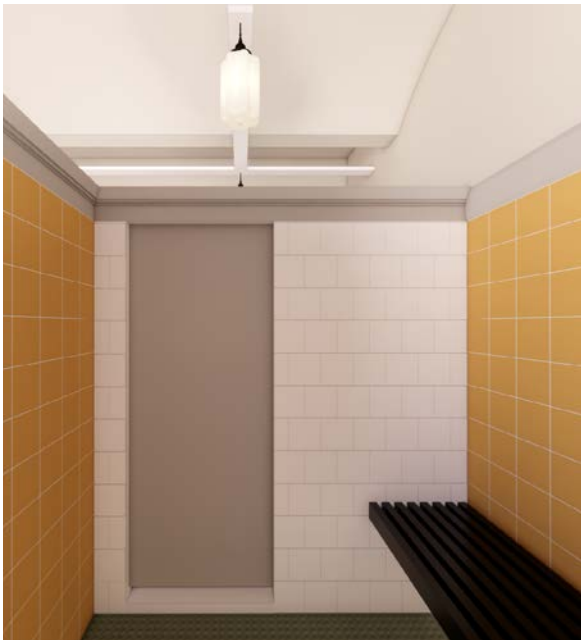
Male WC - Proposed CGI, shower cubicle

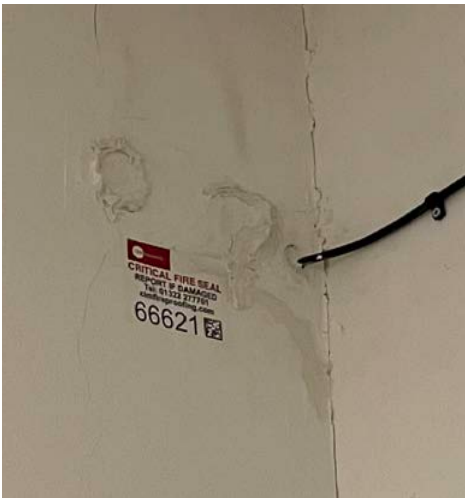
The hot water tank will be enclosed within a new cupboard, formed of a plasterboard and metal stud wall and painted timber door. The pipe penetration into the female WC will pass through an existing service penetration into the female WC, which will be fire-stopped with an intumescent batt.

Existing service penetration

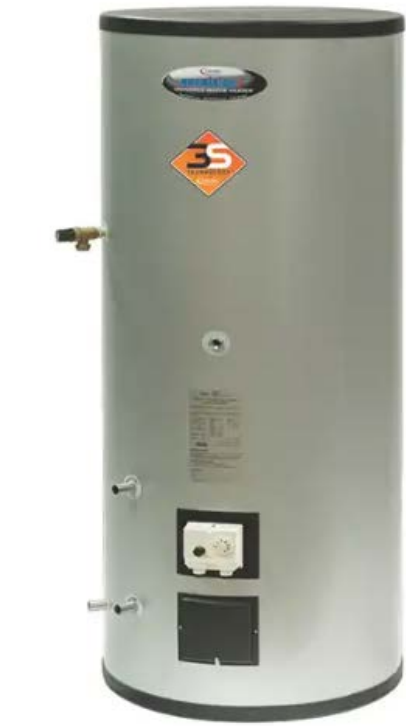
Example of hot water cylinder

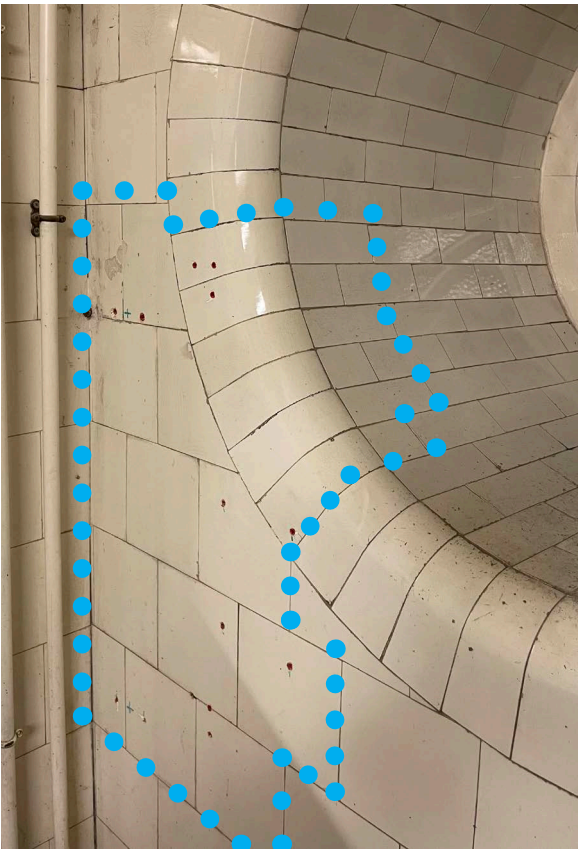
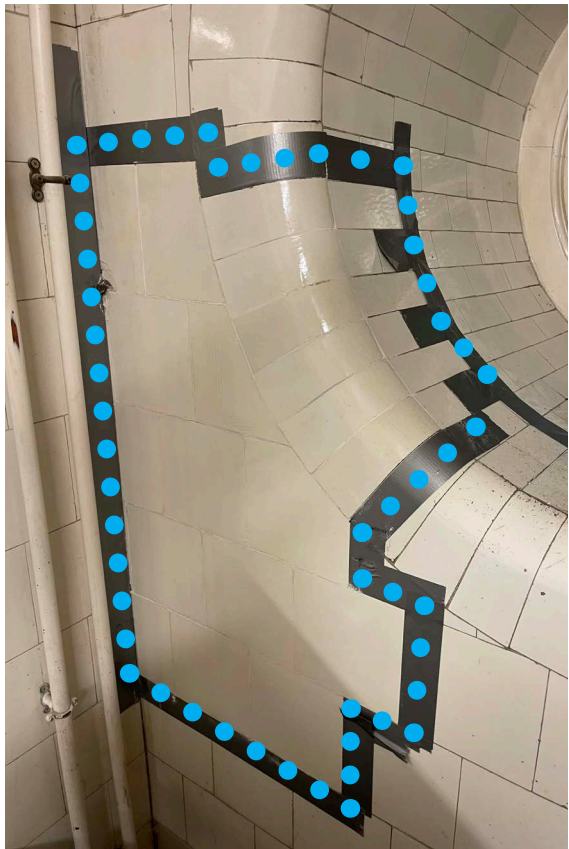
Over their 100-year life span, the tiles have undergone a lot of damage, including drill holes, chips and cracking. To ensure that the tiles could be restored to a level which was satisfactory to Nex, the Museum and the Conservation officers, a test repair was carried out by a tiling restoration specialist, who restored two areas of tiles which were badly cracked and damaged by drill penetrations.

After a couple of different methodologies were tried, and some trial and error with different coloured pigments, the test had good results, with a near seamless finish achieved to the existing tile finish, matching in colour and sheen, and close in texture.

Test area 1 (Before)

Test area 1 (After)

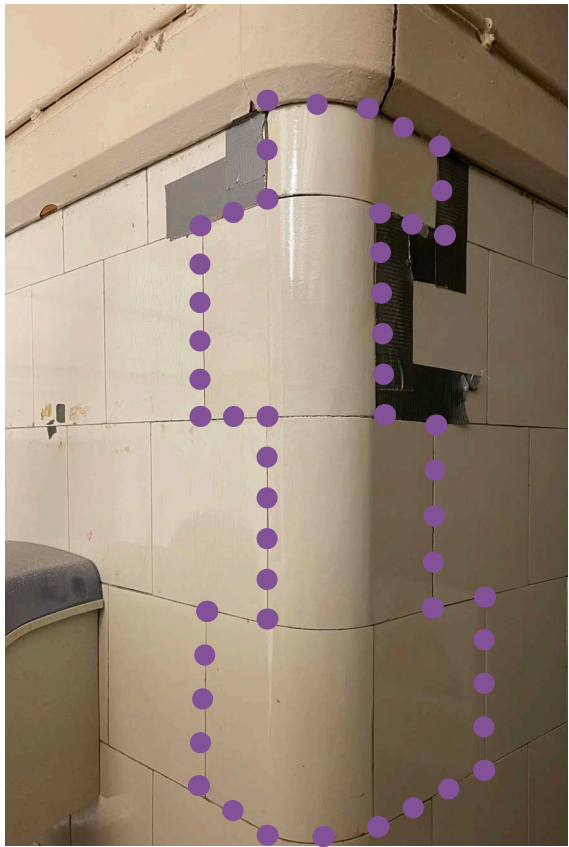
Test area 2 (Before)

Test area 2 (After)
