It is the works proposed to take place on the SWEC site, the West Road, the South West Gate, and the South Forecourt combined that result in the need for temporary noise mitigation measures to be installed in the form of secondary glazing within the West Residence.

Photographic Survey: The West Residence

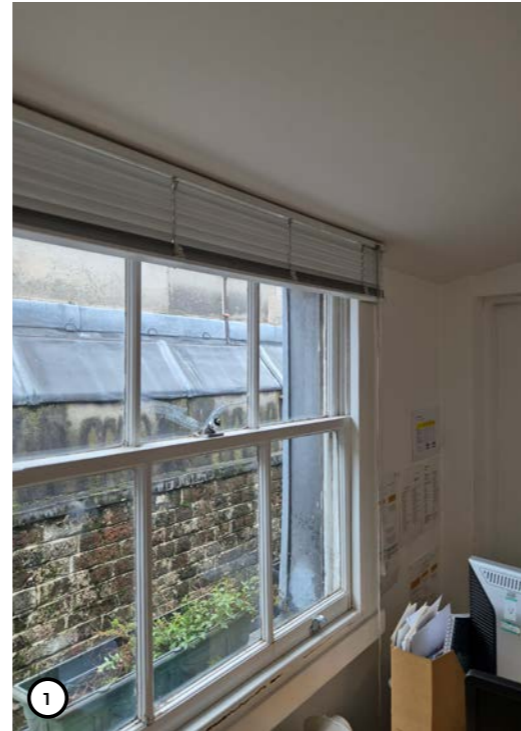
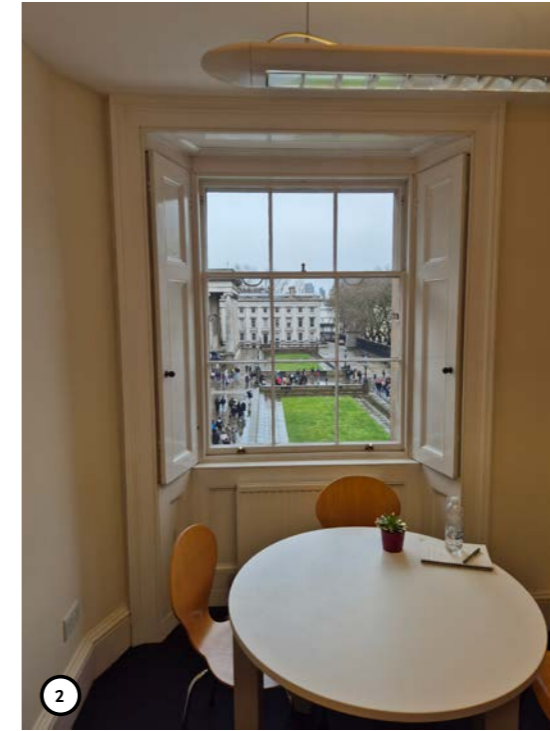
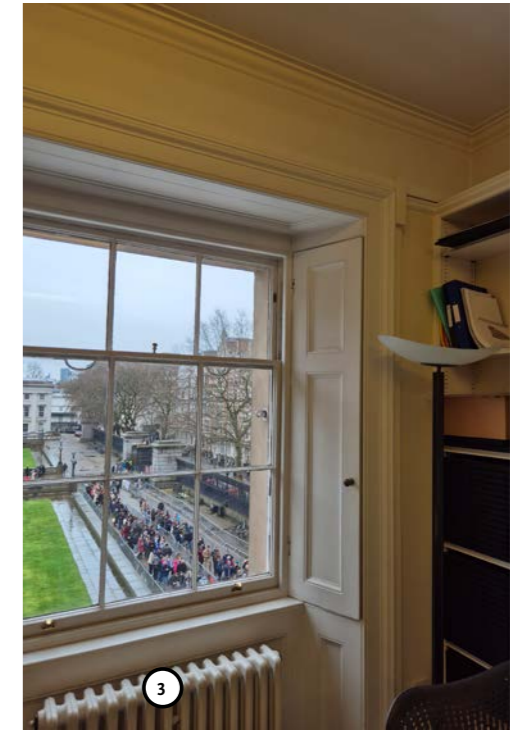
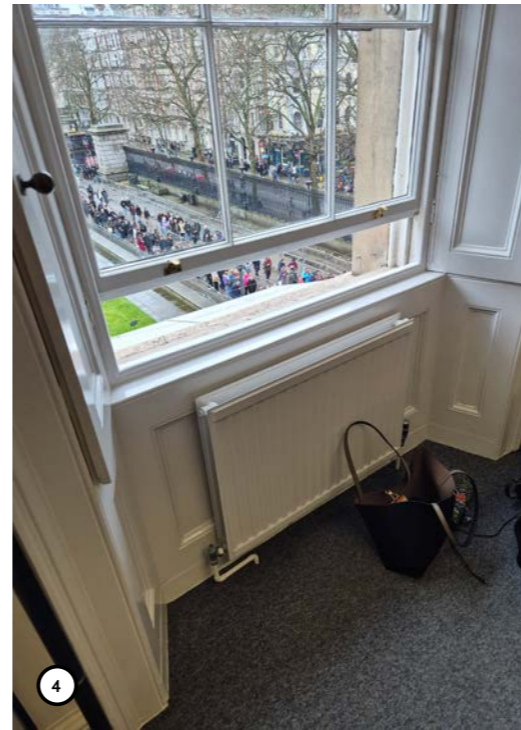
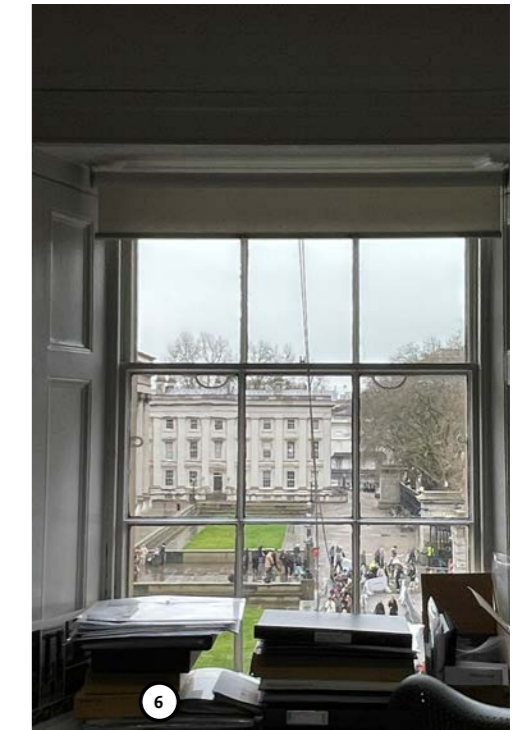
Existing photographic survey of windows proposed to have temporary secondary glazing acoustic mitigations installed within these proposals in Level 05 of the West Residence

In summary, Level 05 of the West Residence retains much of the original sash windows, shutters, and surrounds, though the CMP indicates the installation of secondary glazing was present in the building's recent history, though none was observed on site in undertaking photographic surveys of the existing window condition for these proposals. The secondary glazing mentioned must therefore have been removed at some time after the 2007 CMP surveys. This would go some way to explaining why some window surrounds already have shutters fixed in a pinned position, and whilst some windows are in need of repainting.

A photographic survey on the following spreads indicates the character and condition of the the window types within the West Residence where intervention is proposed.

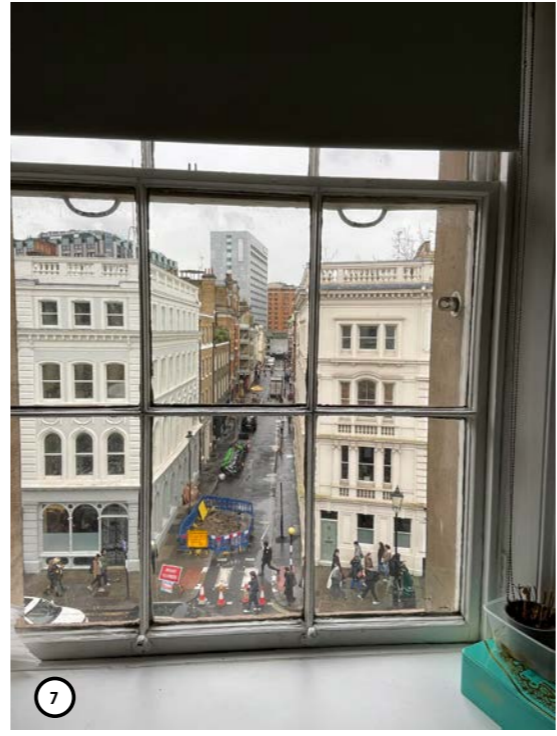
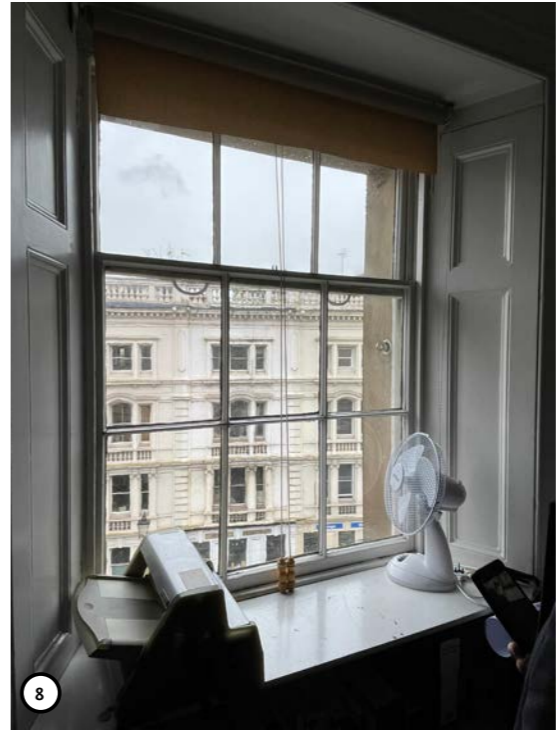
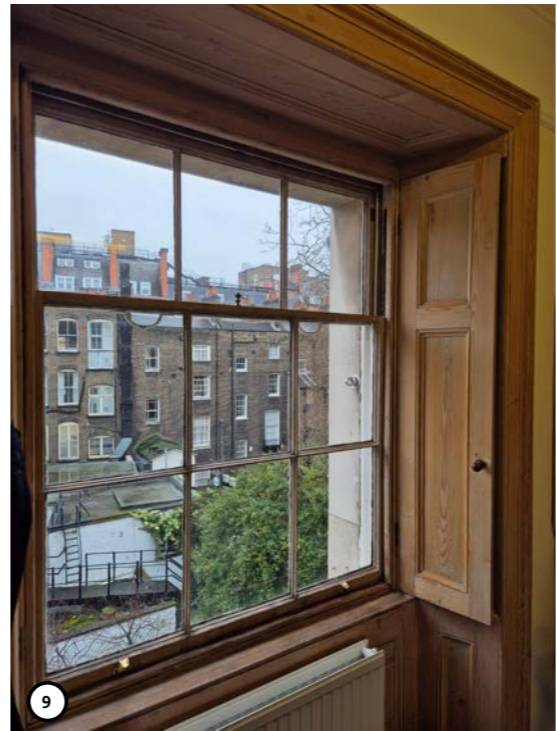
Existing photographic survey of windows proposed to have temporary secondary glazing acoustic mitigations installed within these proposals in Level 05 of the West Residence
