85 Heath St & 6 Golden Yard London NW3 6UG

1955-NMA-XX-01-DR-A-00601

Existing Stair Opening Up

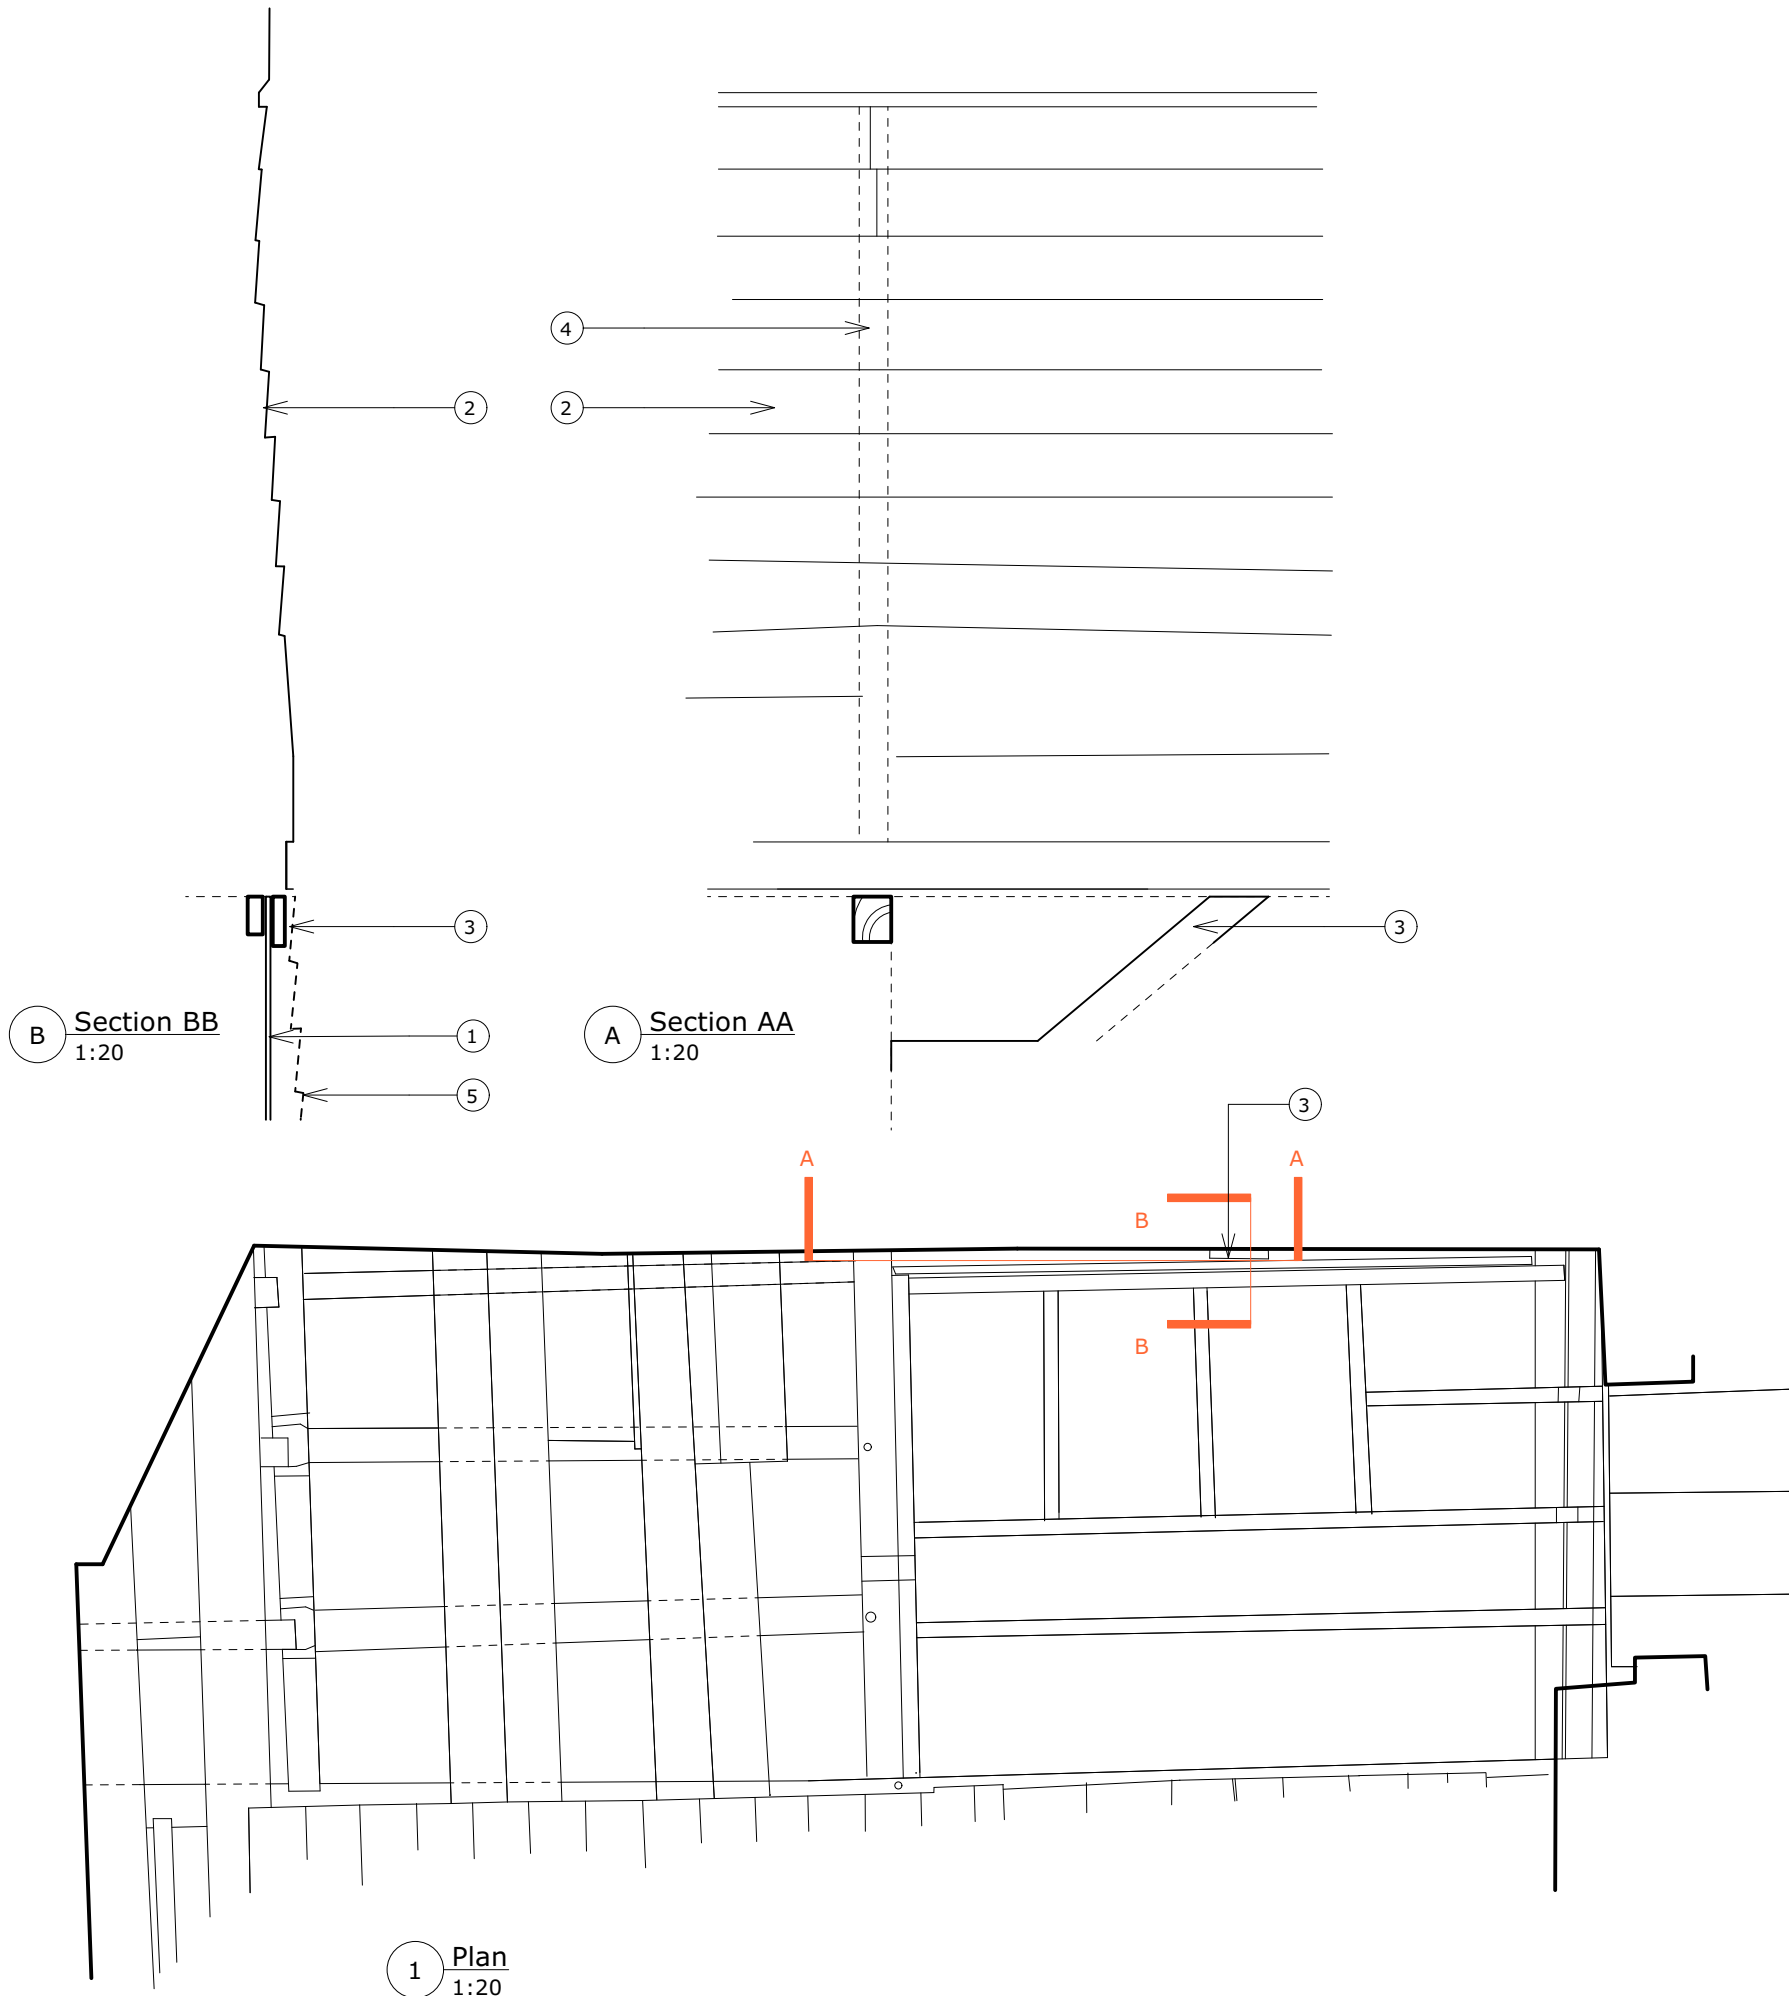
- Notes
1. T&G cladding / lining
 2. weatherboarding
 3. stair string?
 4. Exidence of removed partition? weatherboarding (not surveyed; concealed behind linings at floor below)
 - 5.
