Report prepared for: Philip Mizon

For the Site of: 1 Wadham Gardens, NW3 3DN

# Emergence and Activity Bat Survey (EBS)

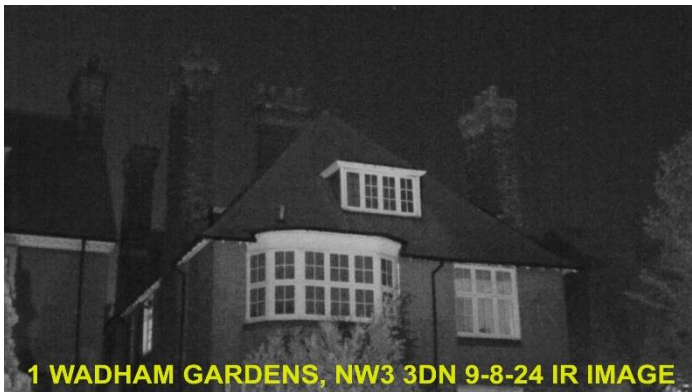
| Surveyor | Building, Tree or Structure | Dates, Times and Survey Type | Bat Activity Observed |
|---|---|---|---|
| PH | B1 | 09/08/2024<br>20:19 to 22:19<br>SS: 20:35 | <p>Common pipistrelle (CP) was heard five times between 21:04 and 21:40, with two passes observed flying south to north, past the western elevation of B1.</p> <p>1 WADHAM GARDENS, NW3 3DN 9-8-24 IR IMAGE</p> <p>Figure 2: Surveyor IR image</p> |

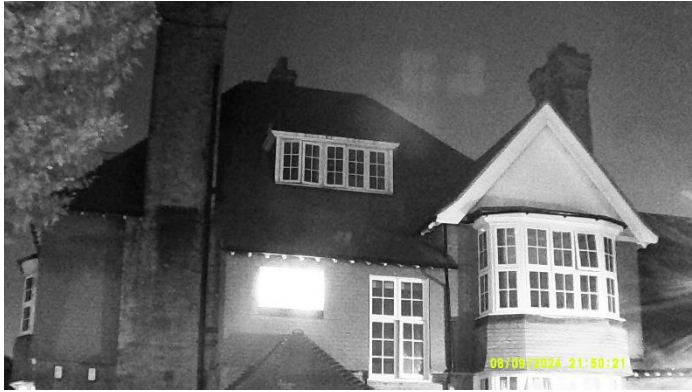
| Surveyor | Building, Tree or Structure | Dates, Times and Survey Type | Bat Activity Observed |
|---|---|---|---|
| ZH | B1 | As above | <p>A single CP pass was heard at 21:04, with the bat observed passing around the southeast corner of B1.</p> <p>08/08/2024 21:50:21</p> <p>Figure 3: Surveyor IR image</p> |

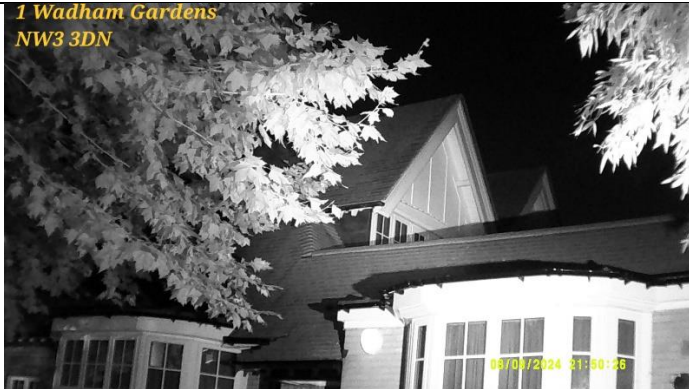
| | | | <div>1 Wadham Gardens<br/>NW3 3DN</div> <div>Figure 4: Surveyor IR image</div> |

| Surveyor | Building, Tree or Structure | Dates, Times and Survey Type | Bat Activity Observed |
|---|---|---|---|
| TH | B1 | As above | <p>Two passes of CP were heard at 20:56 and 21:00.</p> |

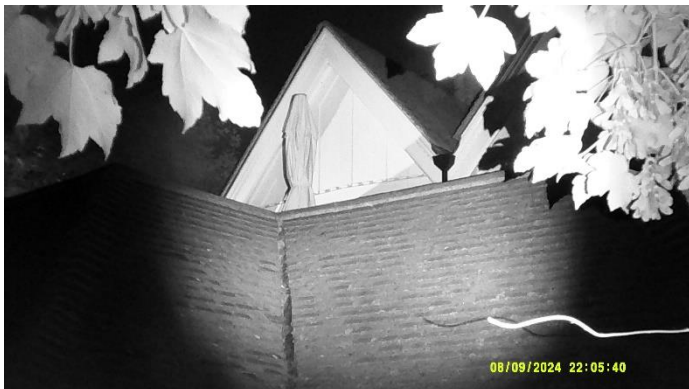
| HS | B1 | As above | <p>Four passes of CP were heard between 20:56 and 21:11, with one pass observed flying over B1 from the east (at 21:00).</p> <div>Figure 5: Surveyor IR image</div> |

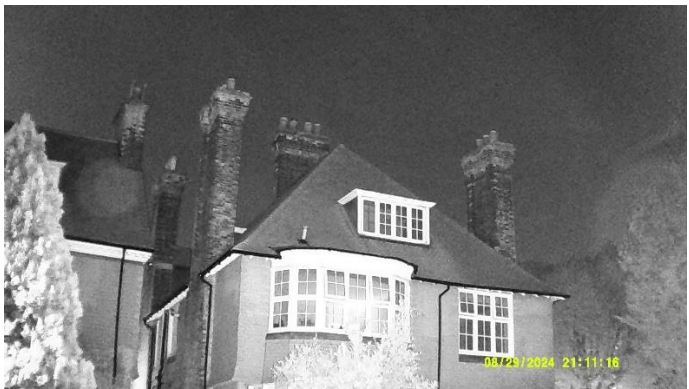
| DB | B1 | <div>29/08/2024<br/>19:37 to 21:37<br/>SS: 19:52</div> | <p>Four CP passes were heard but not seen between 20:23 and 21:03.</p> <div>Figure 6: Surveyor IR image</div> |

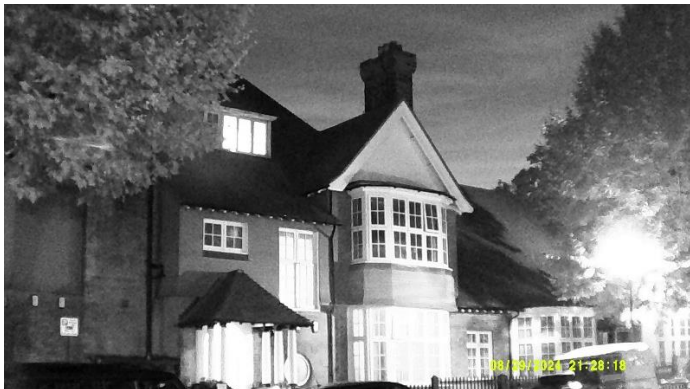
| HS | B1 | As above | <p>A single pass of CP was heard but not seen at 20:36.</p> <p>Figure 7: Surveyor IR image</p> |

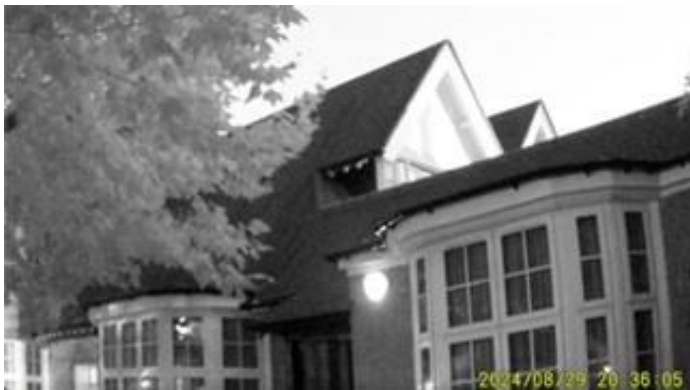
| CS | B1 | As above | <p>Three passes of CP were heard. At 20:11 a bat flew past the eastern elevation of B1, at 20:18 a bat flew in the reverse direction and at 20:19 a bat was heard but not seen.</p> <p>Figure 8: Surveyor IR image</p> |

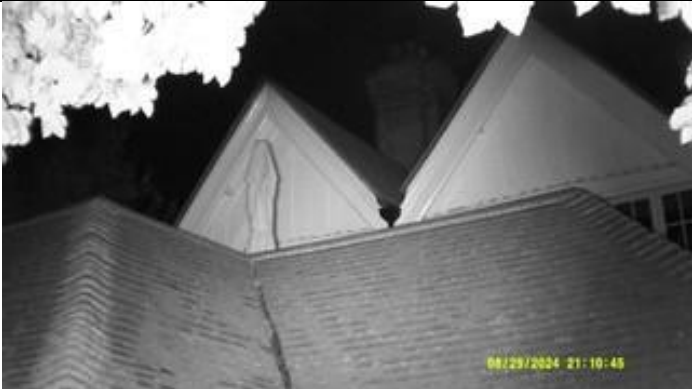
| | | | <p>Figure 9: Surveyor IR image</p> |

| KP | B1 | As above | <p>Passes of CP were heard between 20:11 and 20:54, with one pass observed flying over B1 from the west.</p> |

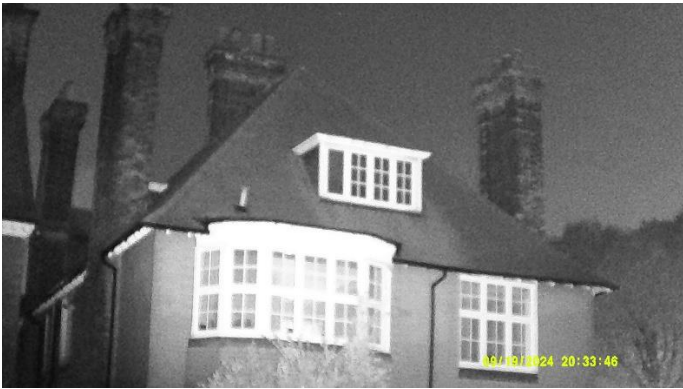
| AW | B1 | <p>19/09/2024<br/>18:50 to 20:50<br/>SS: 19:05</p> | <p>Three passes of CP were heard but not seen at 19:10, 19:53 and 28:20.</p> <p>Figure 10: Surveyor IR image</p> |

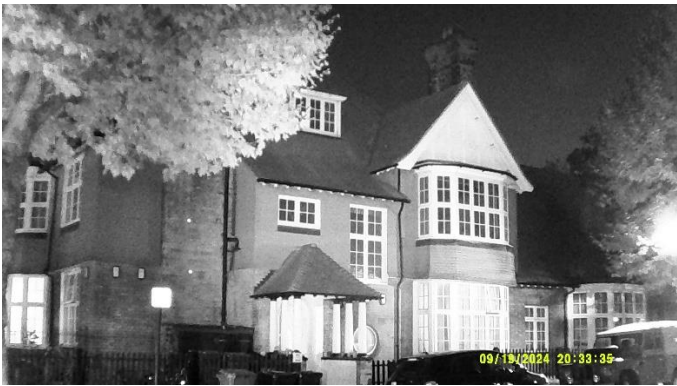
| HS | B1 | As above | <p>No activity recorded.</p> <p>Figure 11: Surveyor IR image</p> |

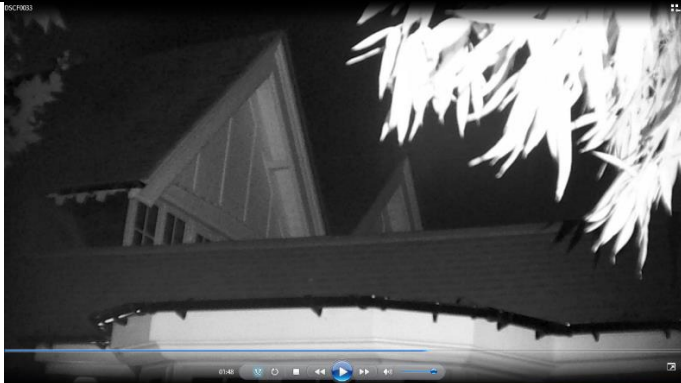
| GL | B1 | As above | <p>One pass of CP was heard but not seen at 19:30.</p> |

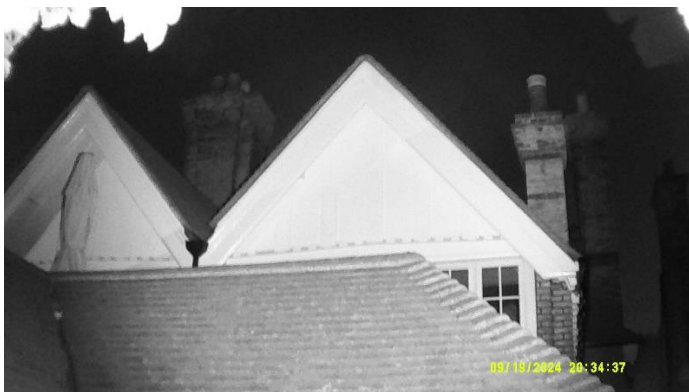
| JN | B1 | As above | <p>Two passes of CP were heard but not seen at 19:31 and 20:21.</p> <p>Figure 13: Surveyor IR image</p> |

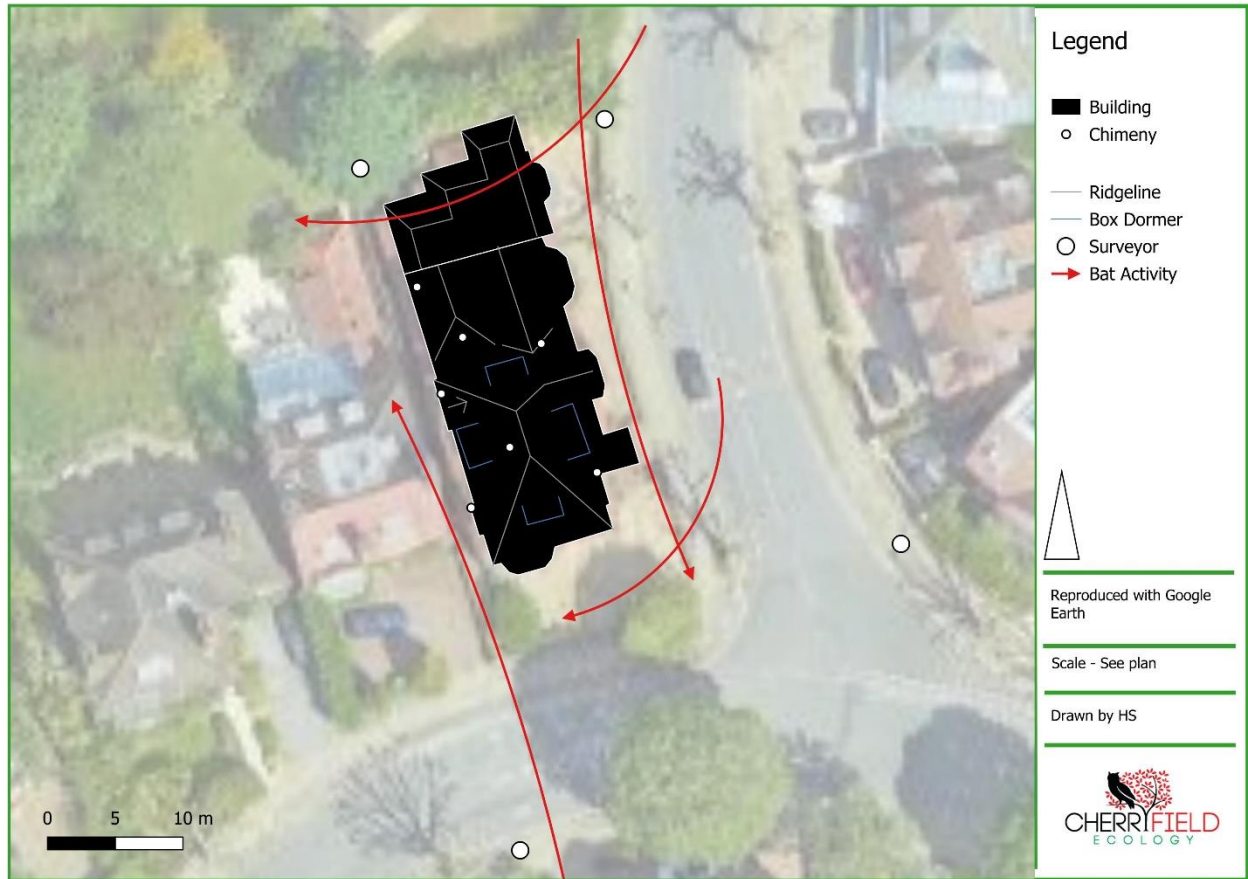
Figure 14: Site Plan

The following section details the structure(s) reference, bats located, evidence located and observed emergence/re-entry (see Figure 14 for Site Plan).
