GROUND APPRAISAL REPORT
for a site at
1 WADHAM GARDENS, LONDON, NW3 3DN
on behalf of
MARCUS COOPER GROUP

Report:	GROUND APPRAISAL REPORT
Site:	1 WADHAM GARDENS, LONDON, NW3 3DN
Client:	MARCUS COOPER GROUP
Date:	AUGUST 2024
Reference:	GE17691 – GARv5JT240807
Version:	5.0
Prepared by:

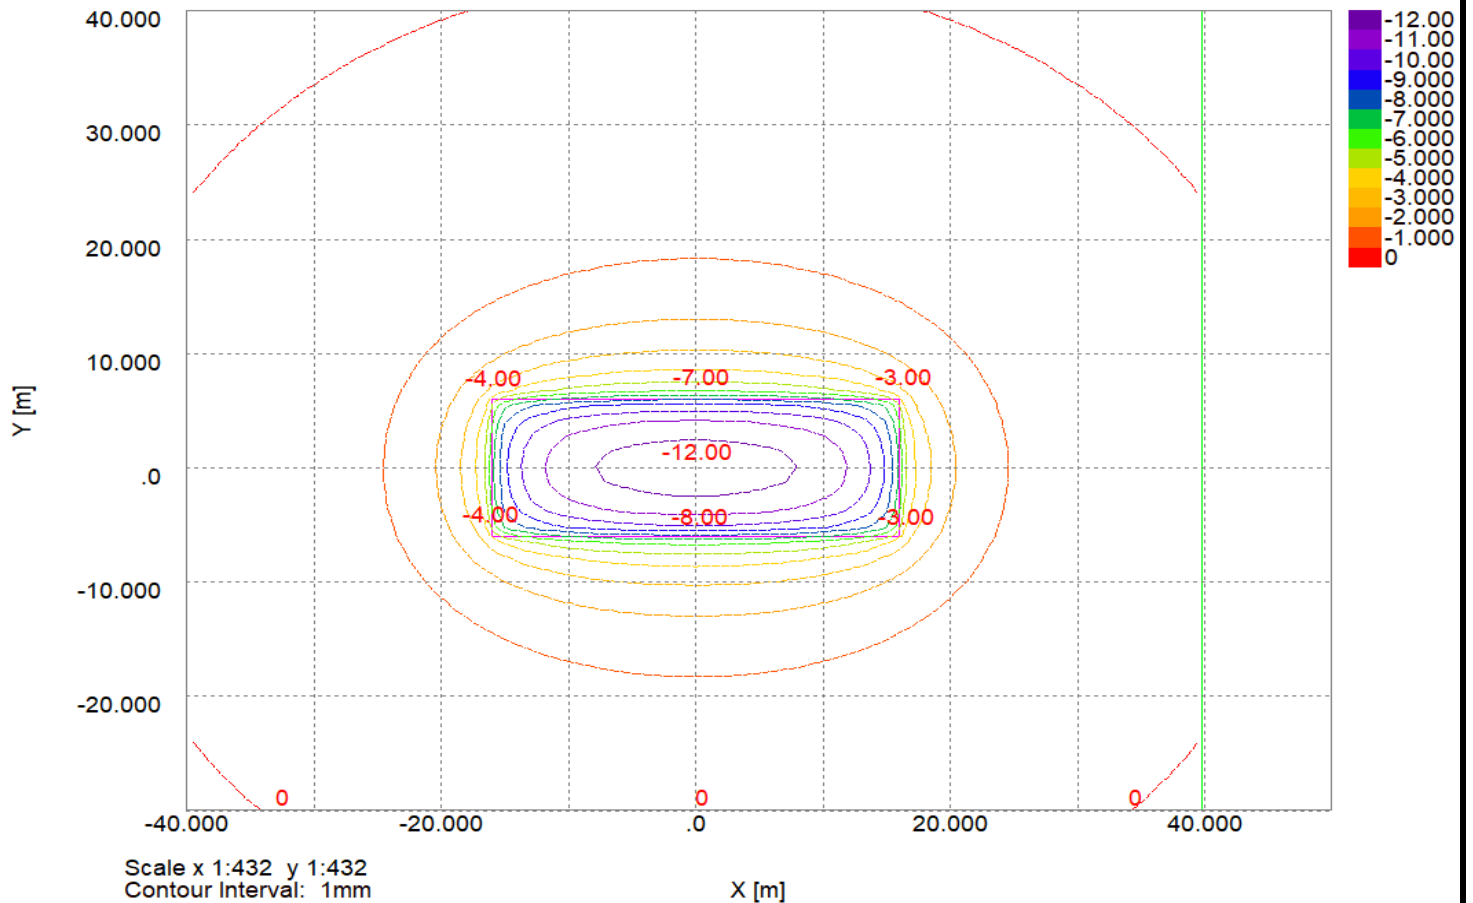
Settlement Contours : Grid 1 at -3.5000m

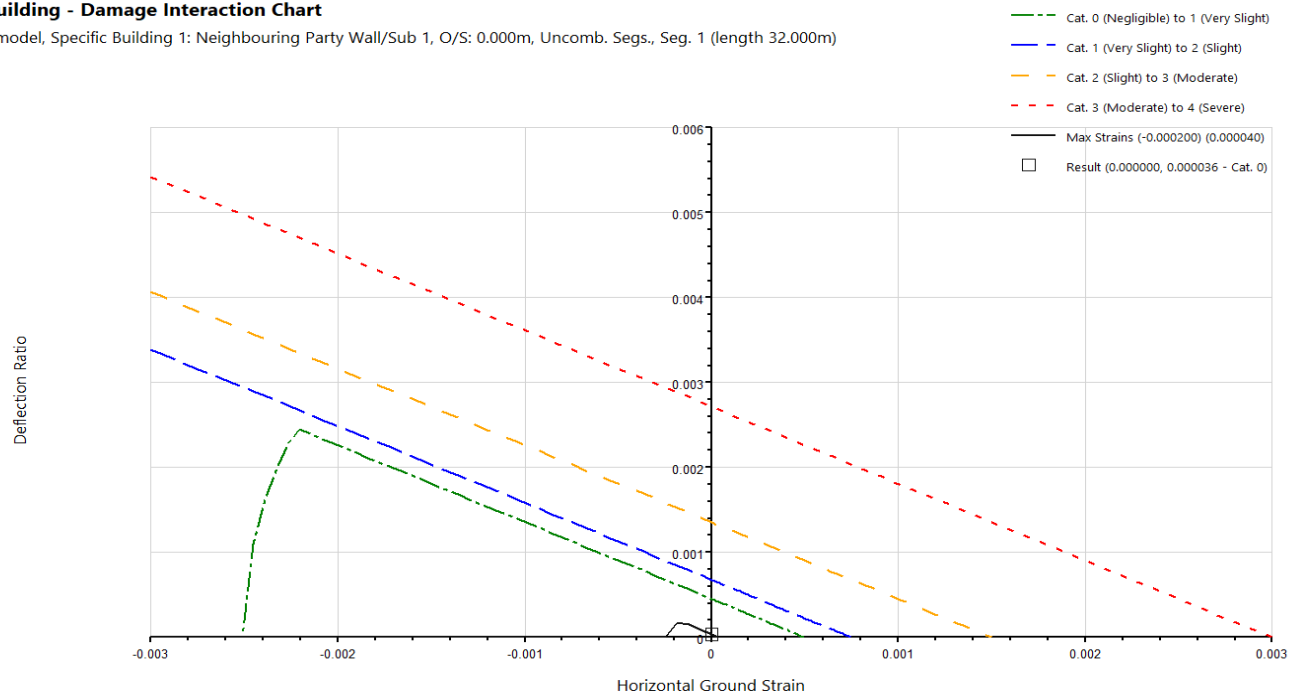
Specific Building - Damage Interaction Chart

Stage: Base model, Specific Building 1: Neighbouring Party Wall/Sub 1, O/S: 0.000m, Uncomb. Segs., Seg. 1 (length 32.000m)

Specific Building - Displacement Chart

Stage: Base model, Specific Building 1: Neighbouring Party Wall/Sub 1, Offset: 0.000m, Uncombined Segments

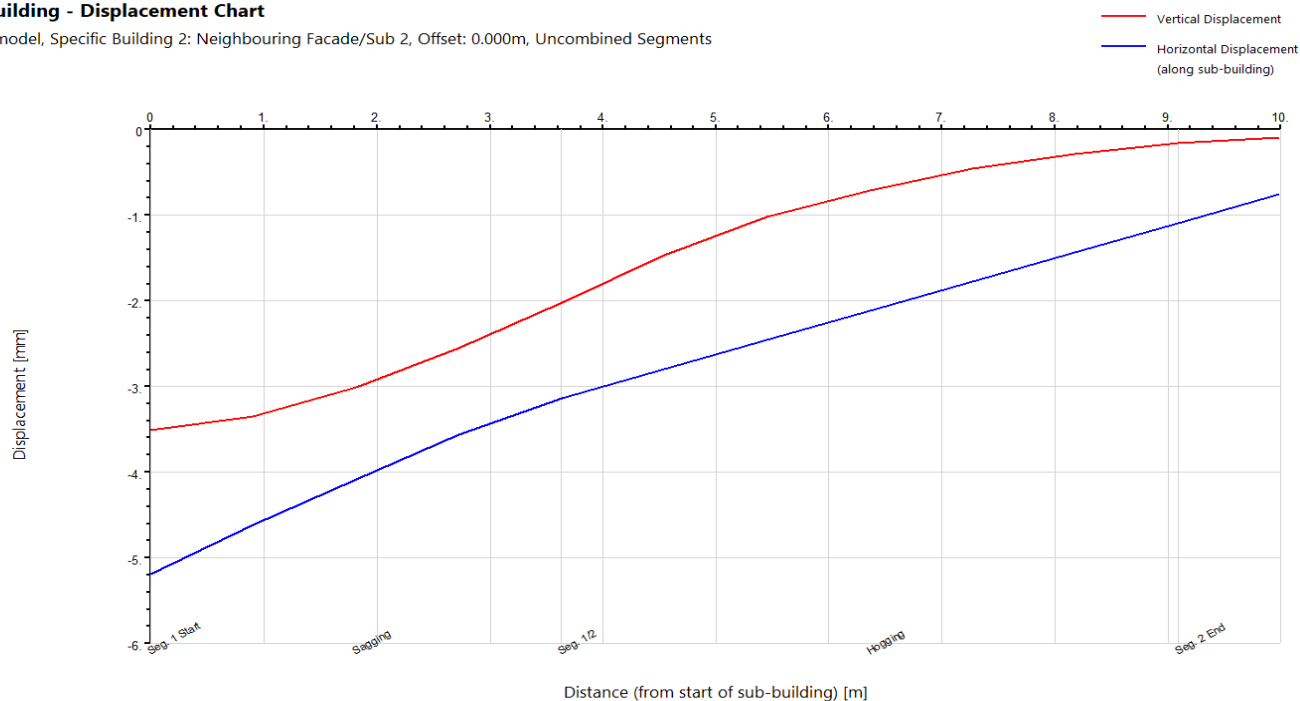
Specific Building - Damage Interaction Chart

Stage: Base model, Specific Building 2: Neighbouring Facade/Sub 2, O/S: 0.000m, Uncomb. Segs., Seg. 1 (length 3.631m)

Specific Building - Displacement Chart

Stage: Base model, Specific Building 2: Neighbouring Facade/Sub 2, Offset: 0.000m, Uncombined Segments
