BS 5837 Arboricultural Report

Impact Assessment & Method Statement

at
3a Upper Park Road
London
NW3 2UN

Dated
7th October 2024

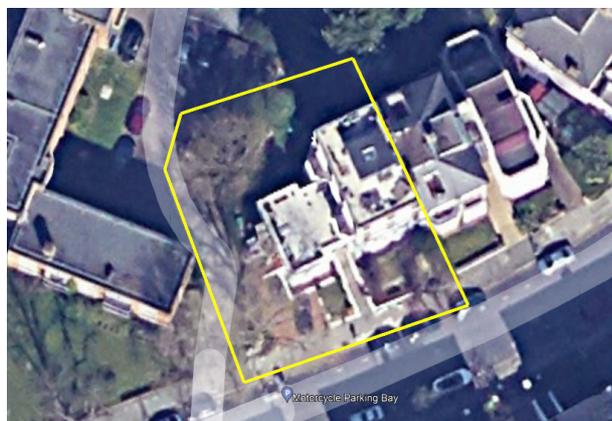
- 2.3.1. The area indicated below² shows the extent of our survey.

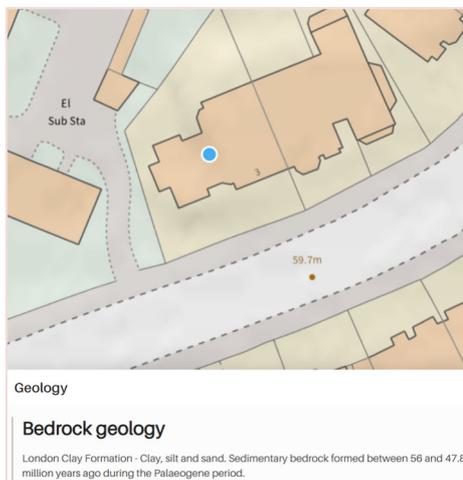
4.1.1. Desktop research into local geology based on the postcode **NW3 2UN** obtained the following results:

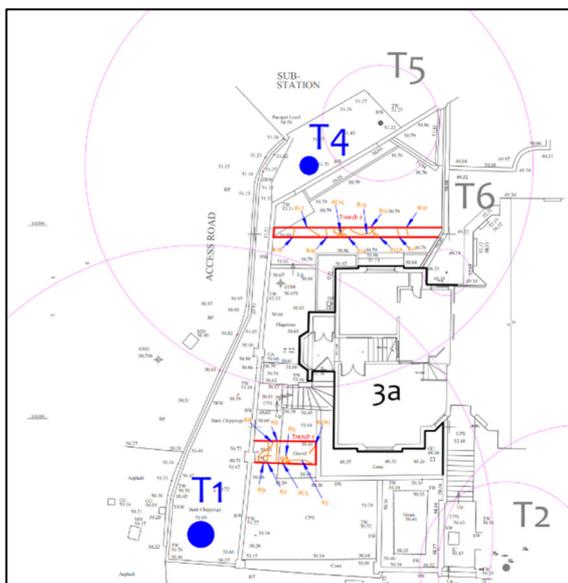
5.4.1. Trial excavations were undertaken at the site to assess the extent of rooting activity in the vicinity of the proposed basement extensions. Two trenches were excavated: Trench 1 at the front of the property to determine rooting activity from T1, and Trench 2 at the rear of the property to assess rooting activity from T4.

5.4.2. Crown Tree Consultants attended the site on the 7th May 2024 to catalogue the roots encountered after the excavations had taken place. We measured the diameter of the roots and recorded their location and their depth below ground level. A report was produced detailing the findings. Screenshots from the report are shown below and are replicated on the accompanying Impact Assessment Plan.

Root No.	Diameter (mm)	Depth (mm)	Comments
R1	40	1270	
R2	40	1400	
R3	240	760	
R4	45	870	
RC5	25, 30, 60	107	Root cluster.
R6	35	700	Branches off into a cluster of <25mm roots.
R7	150	680	A 30mm root protrudes from R7.
R8	50	370 – 750	
R9	50	1040

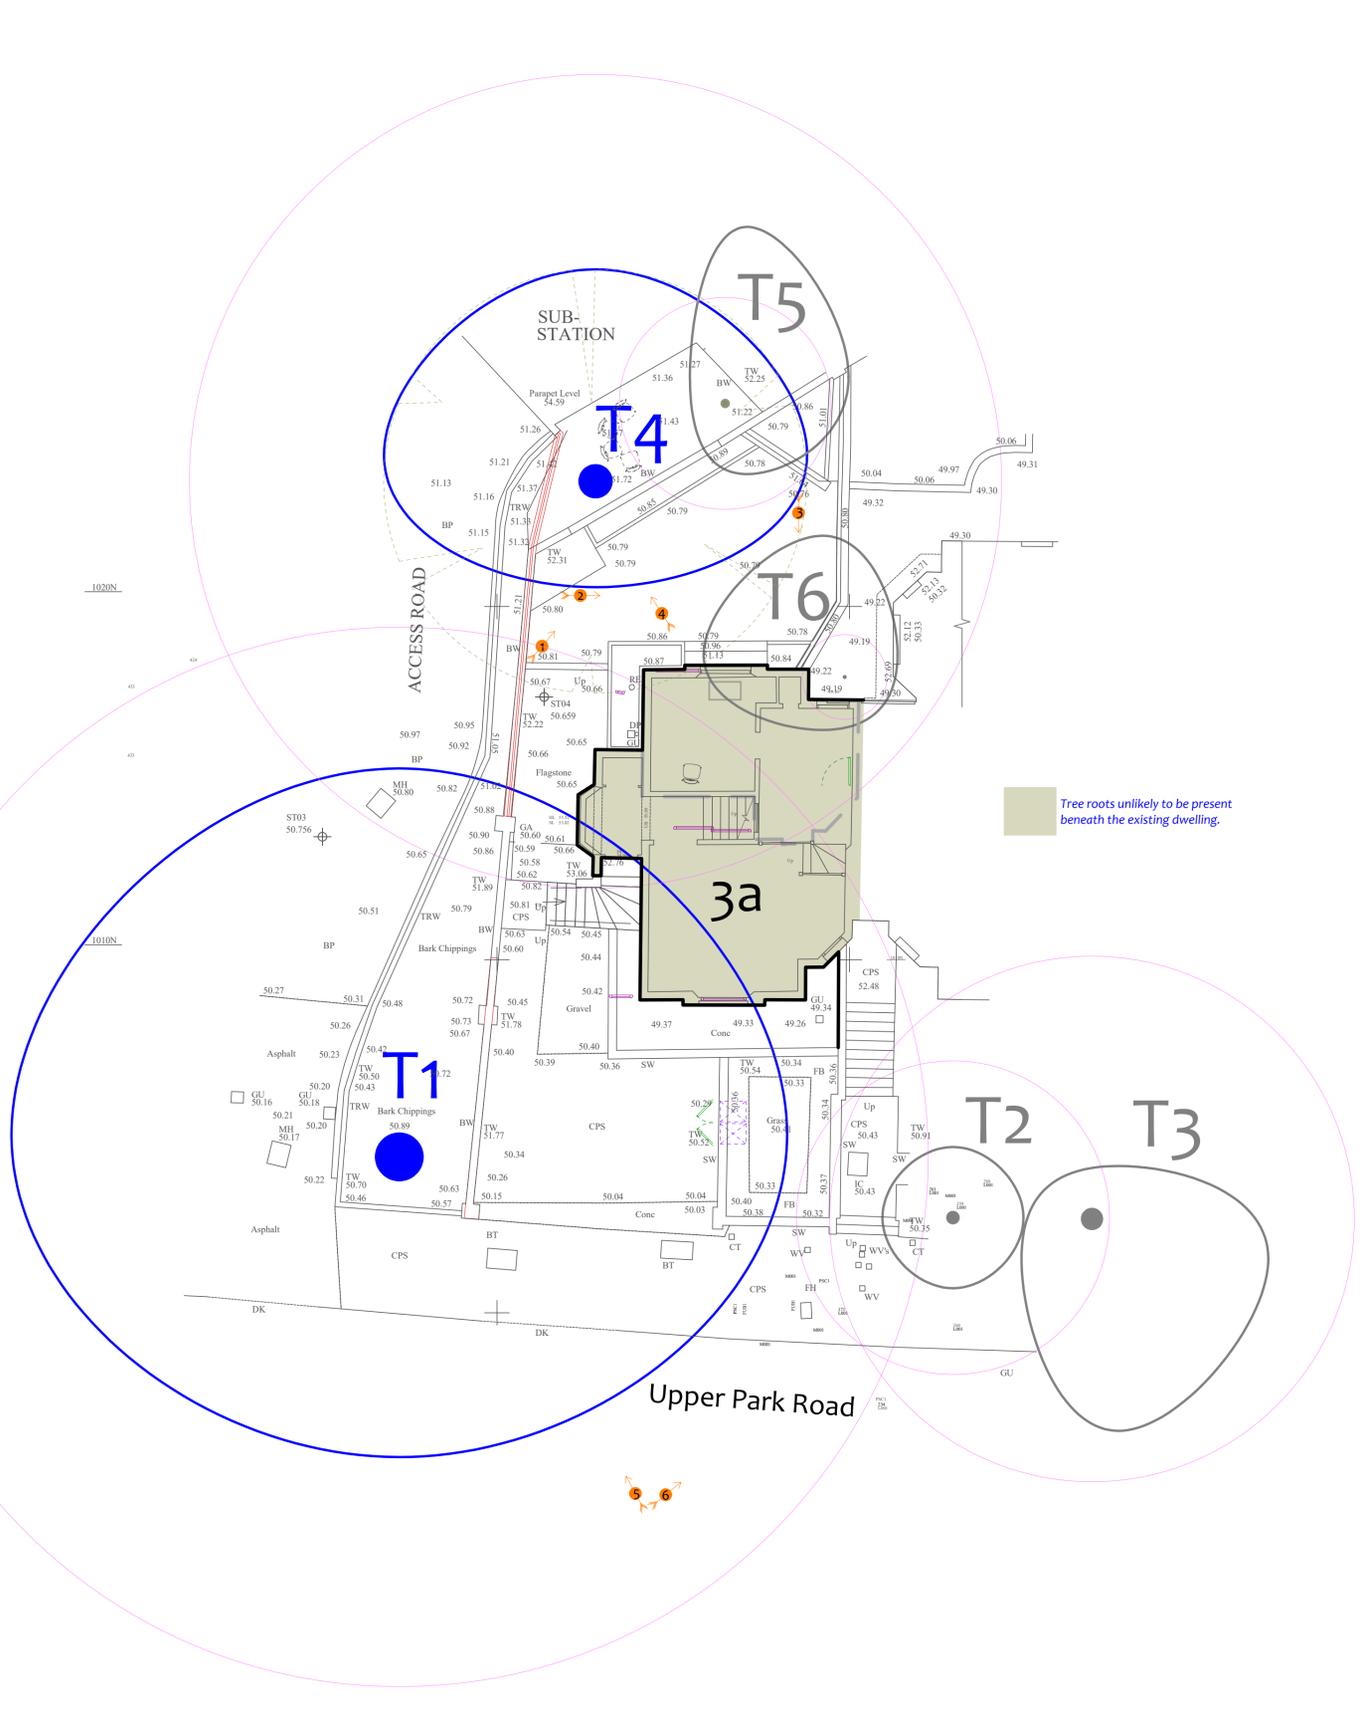
Drawing No: CCL 11774 / TCP Rev 1
 Title: Tree Constraints Plan (Existing Layout)
 Site: 3a Upper Park Road NW3 3UN
 Scale: 1:100 Paper Size: A1

Tree Constraints Plan (TCP). This indicates the position, crown spread, Retention Category and Root Protection Area of each tree. It is used to inform where development may proceed without causing damage to trees.

Refer also to the Tree Constraints Plan for photo locations.
