## **Curved Window Photographs:**

Top Floor Flat 27 Belsize Square, London NW3 4HU

Window Works Existing Elevations		
SCALE	DRAWN	
1:50@A3	Surveyor	
DATE	CHECKED	
29.07.2024	=	
DWG NO.	REVISION	
064 023	_

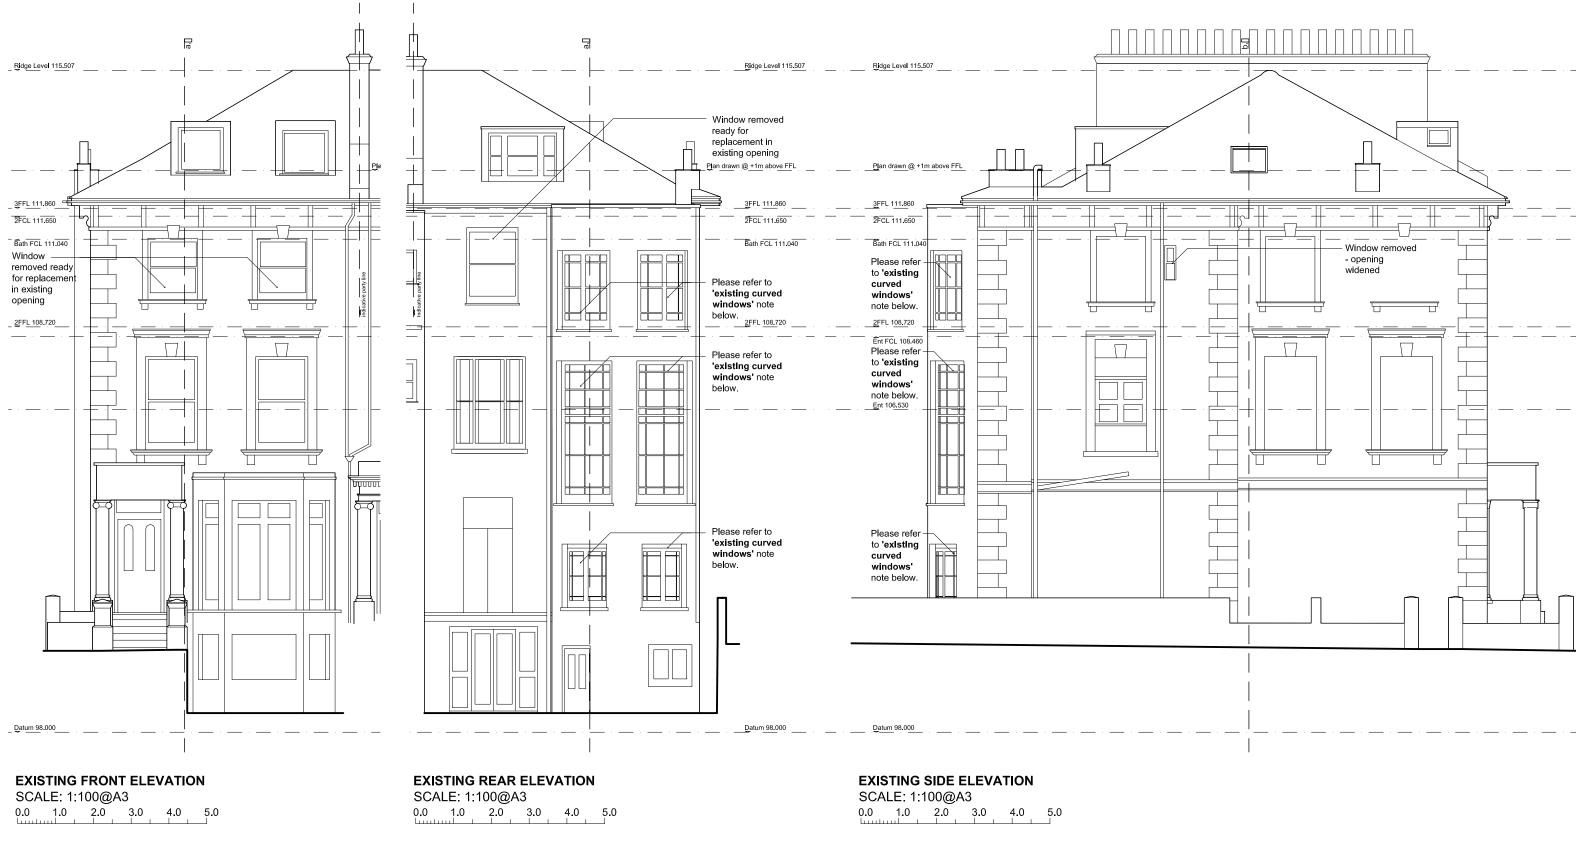
Existing windows incorporating non-original and unsympathetic later added/replaced glass panes replacement glass panes vary and are mis-matched (a mixture of stained. frosted, patterned, and clear). Please refer to photographs provided and which show historic curved glass panes replaced in some locations with straight panes within curved frames using putty. This straight panes and installation method has caused cracking and other deterioration overtime. Interim remedial work appears to have been undertaken by way of "sticky tape" to hold glass panes in place.
