EXISTING PLANS + ELEVATIONS

SITE ADDRESS: 11 BUCKLAND CRESCENT, BELSIZE PARK, LONDON, NW3 5DH

PROPOSED PLANS + ELEVATIONS

PROPOSED ELEVATIONS

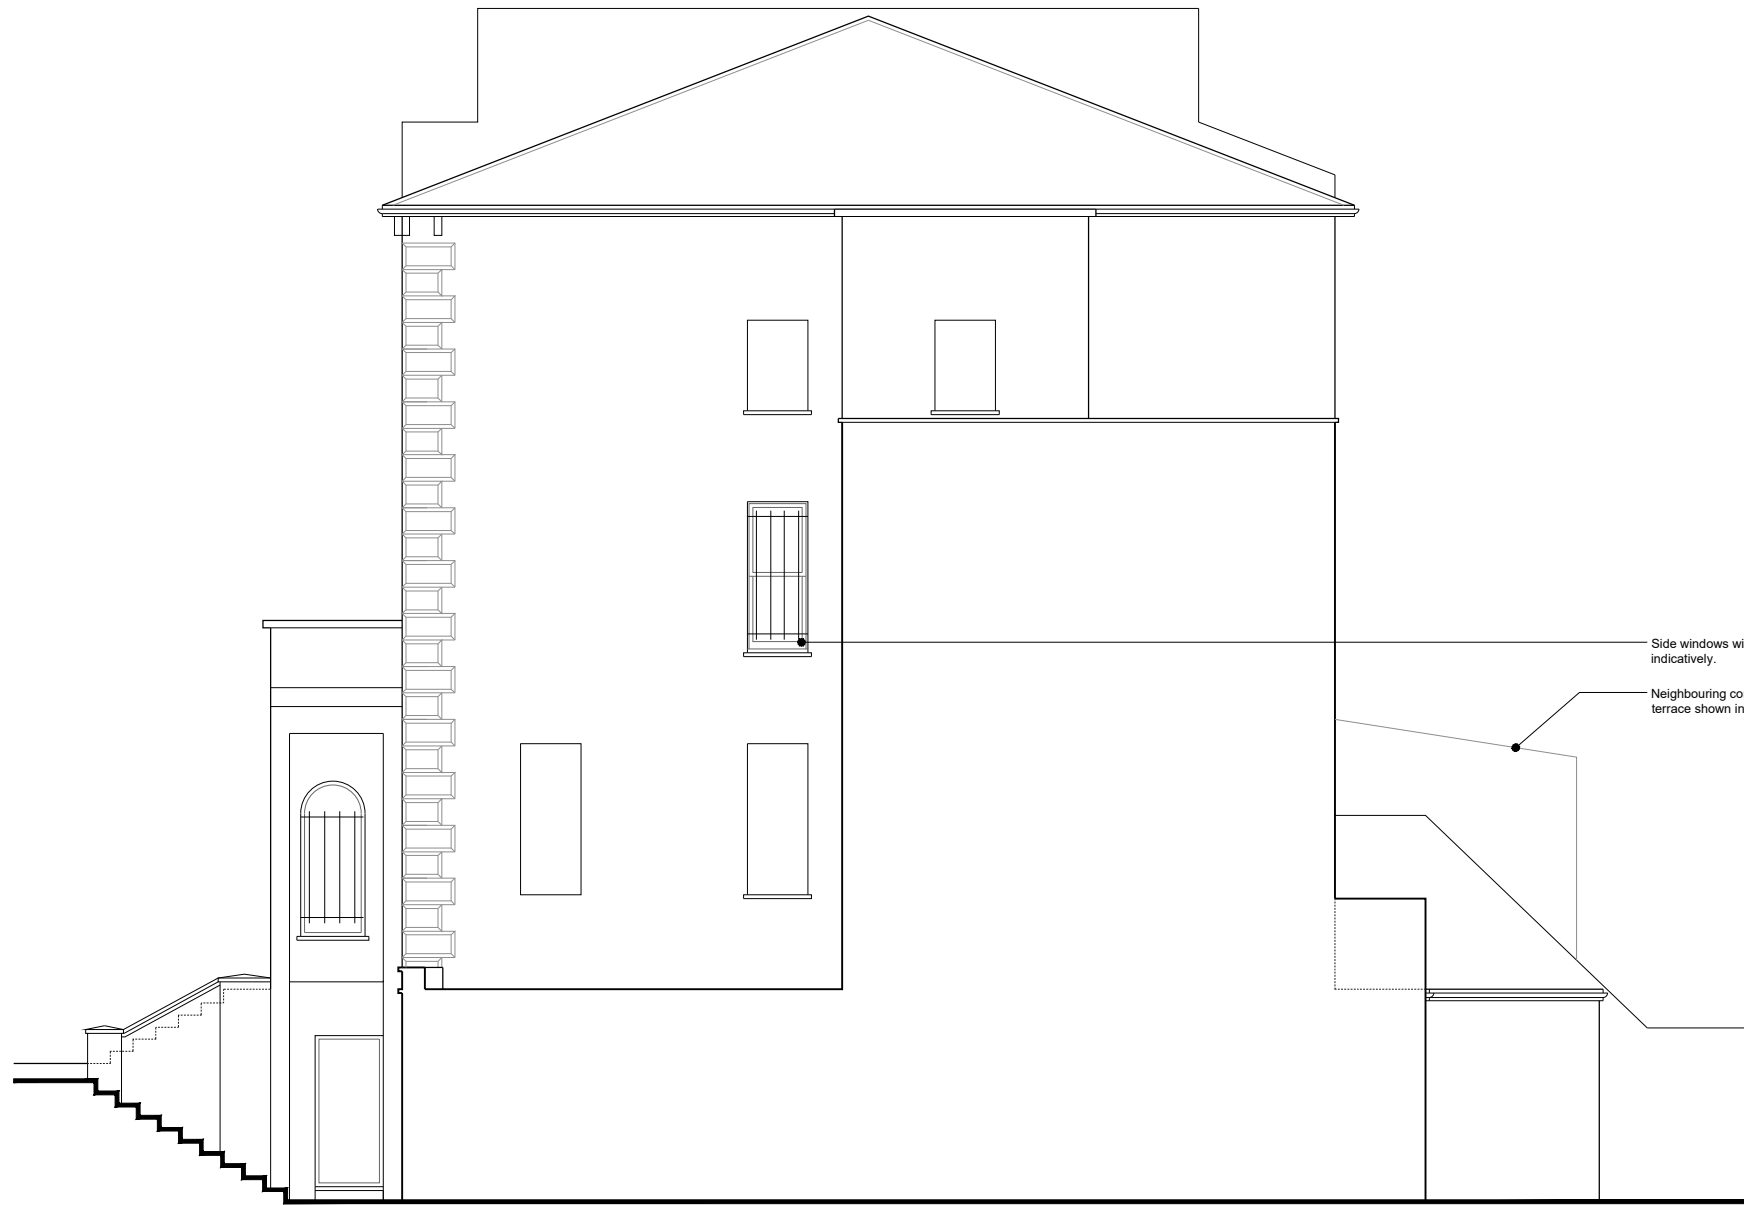
SIDE ELEVATION

Side windows with security grilles shown indicatively.
Neighbouring conservatory serving roof terrace shown in background.

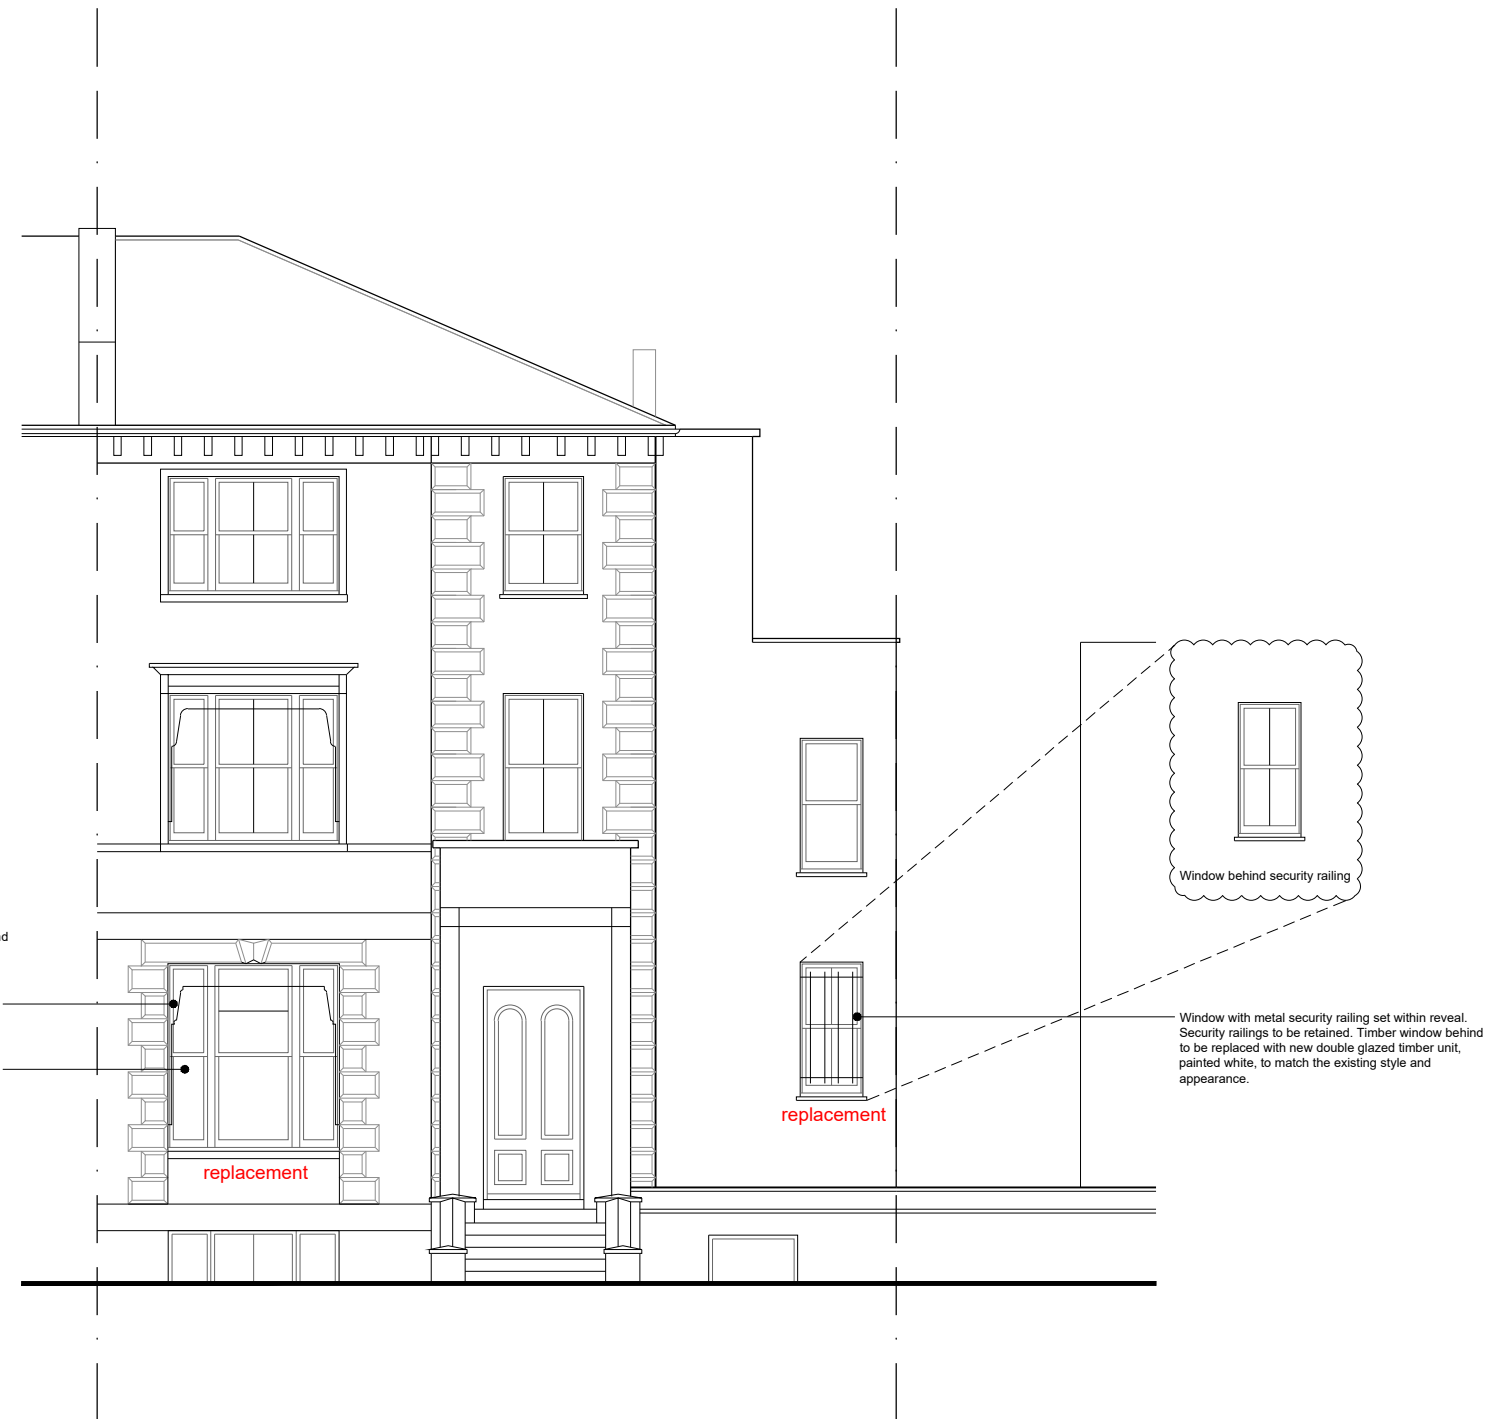
FRONT ELEVATION

Window with metal security railing set within reveal. Security railings to be retained. Timber window behind to be replaced with new double glazed timber unit, painted white, to match the existing style and appearance.
 External window opening dressing retained / reinstated to match.
 Existing doors / windows to apartment to be replaced with new double glazed timber units, painted white, to match the existing style and appearance.

Window with metal security railing set within reveal. Security railings to be retained. Timber window behind to be replaced with new double glazed timber unit, painted white, to match the existing style and appearance.
 Window behind security railing
