D.1 TRIAL REPAIRS REVIEW

D.1.2 This appendix reviews the repairs seven and a half months after completion.

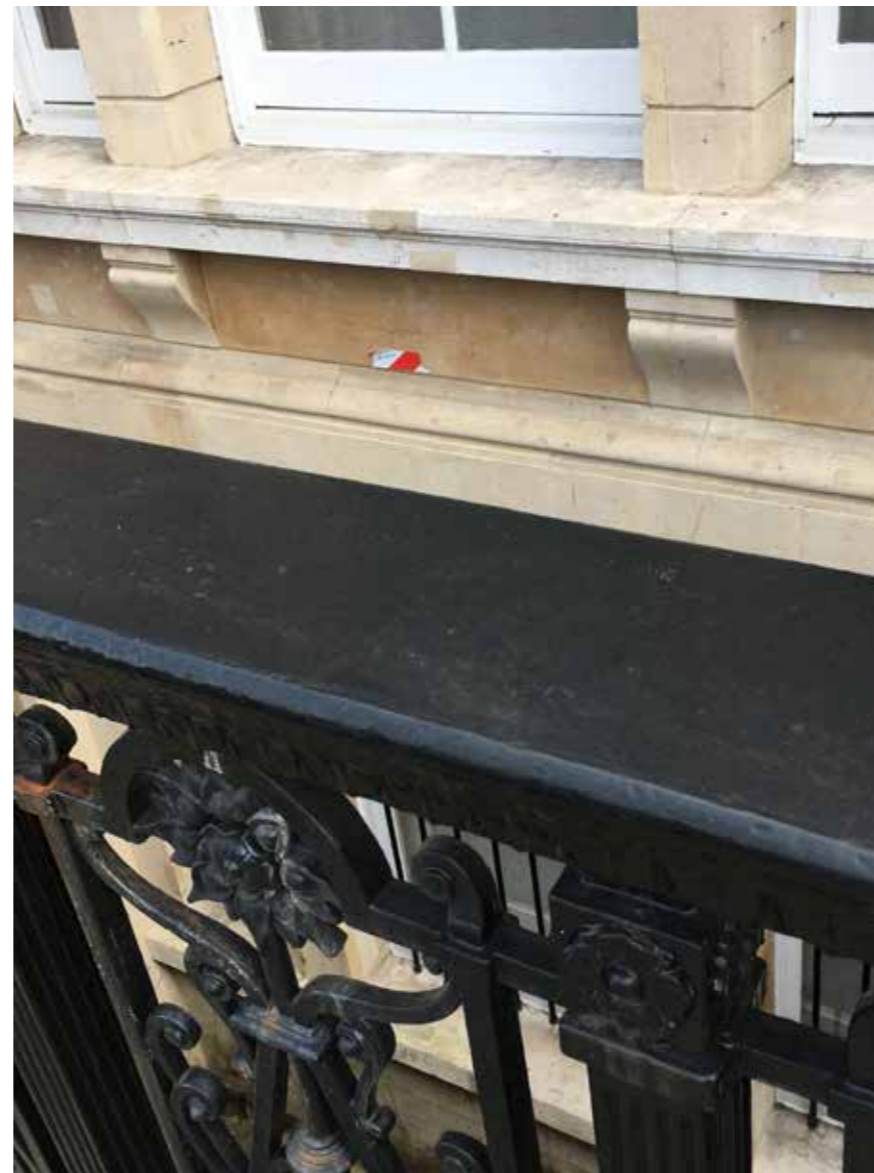
D.2.1 After seven and a half months there is no perceptible change to the repairs located under the window cill of House 5.

The repairs are almost imperceptible from the pavement which is the distance from which they are to be judged.

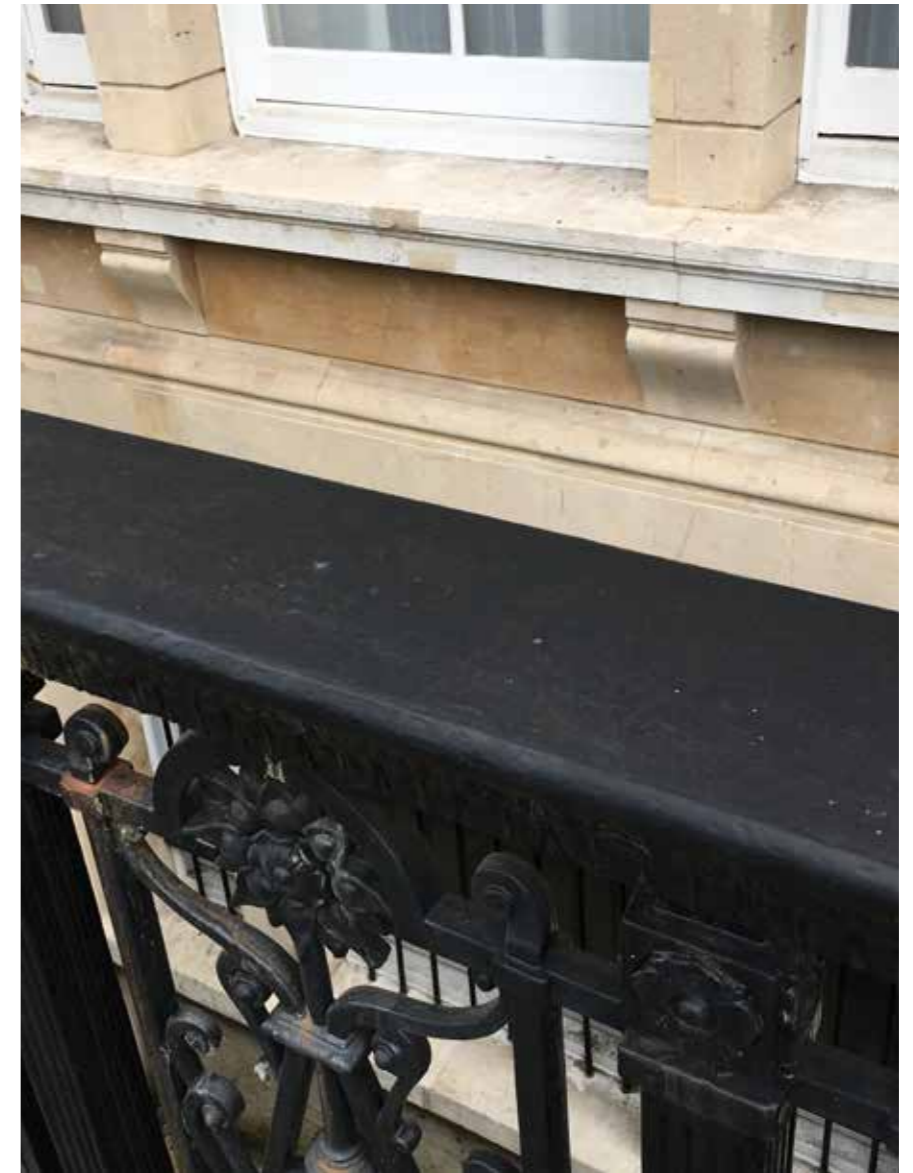
Photo of tinting repair taken on October 23rd, 2024.

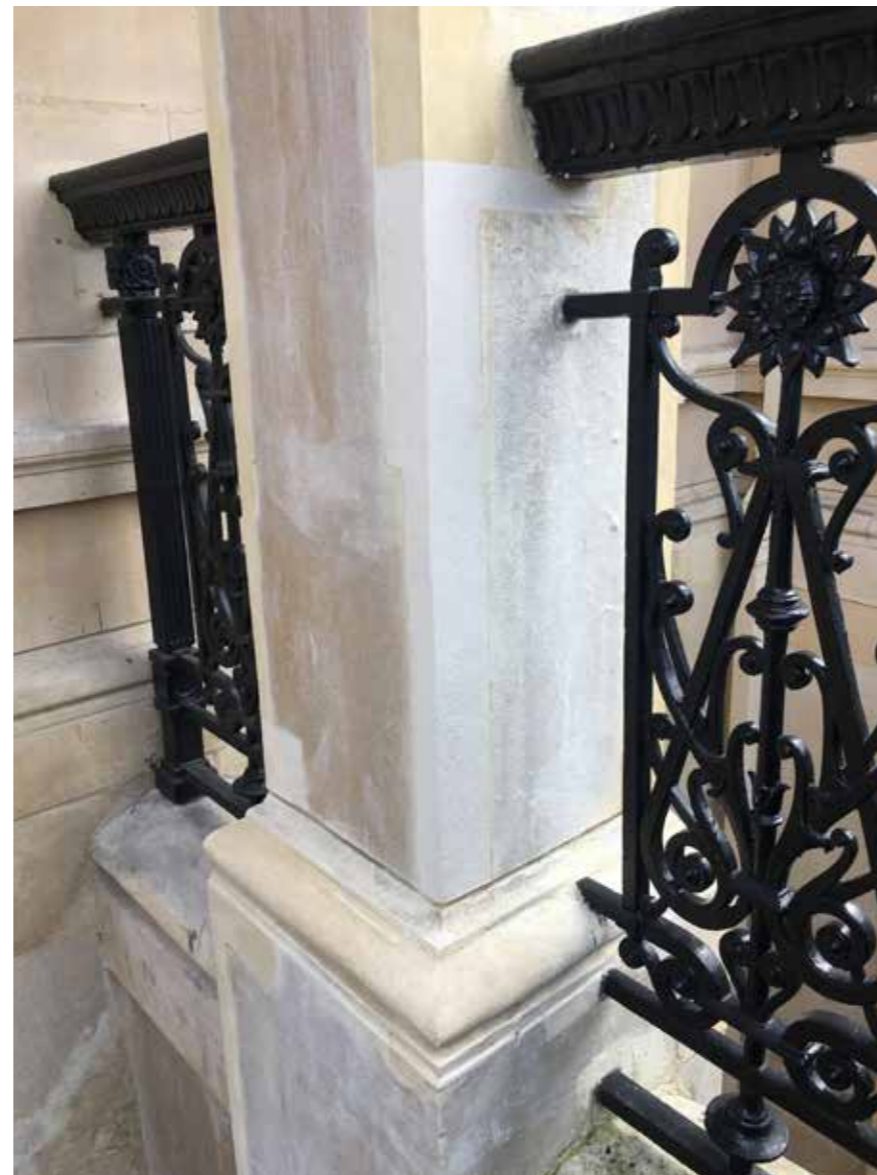
D.3.1 An partially successful repair to the corner base of the column between House 5 and House 4.

The corner repair after ten days on March 16. The side facing outwards is considered satisfactory, while the lateral face still has a strong contrast to the darker adjacent stone.

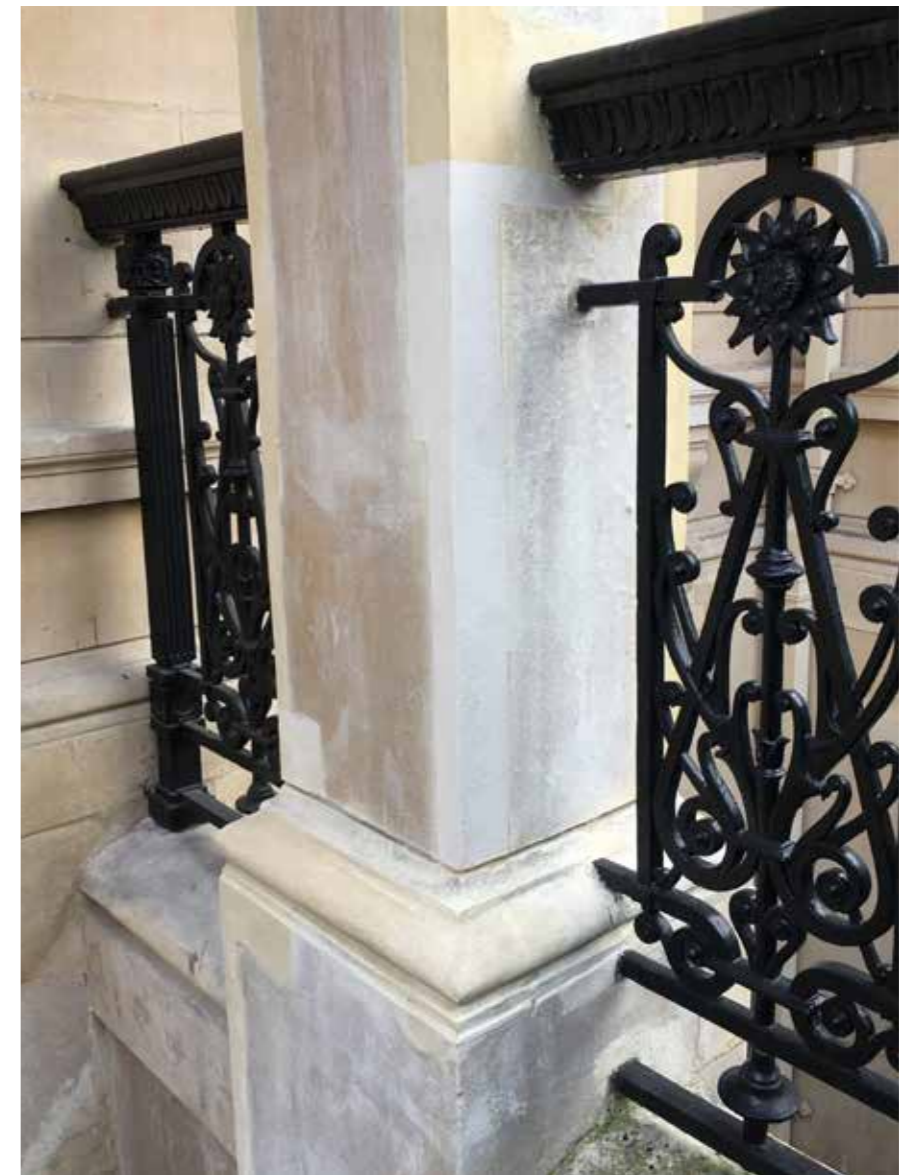
D.3.2 After seven and a half months there is no perceptable change to the repairs located to the lower corner of the pier.

Photo of tinting repair taken on October 23rd, 2024.

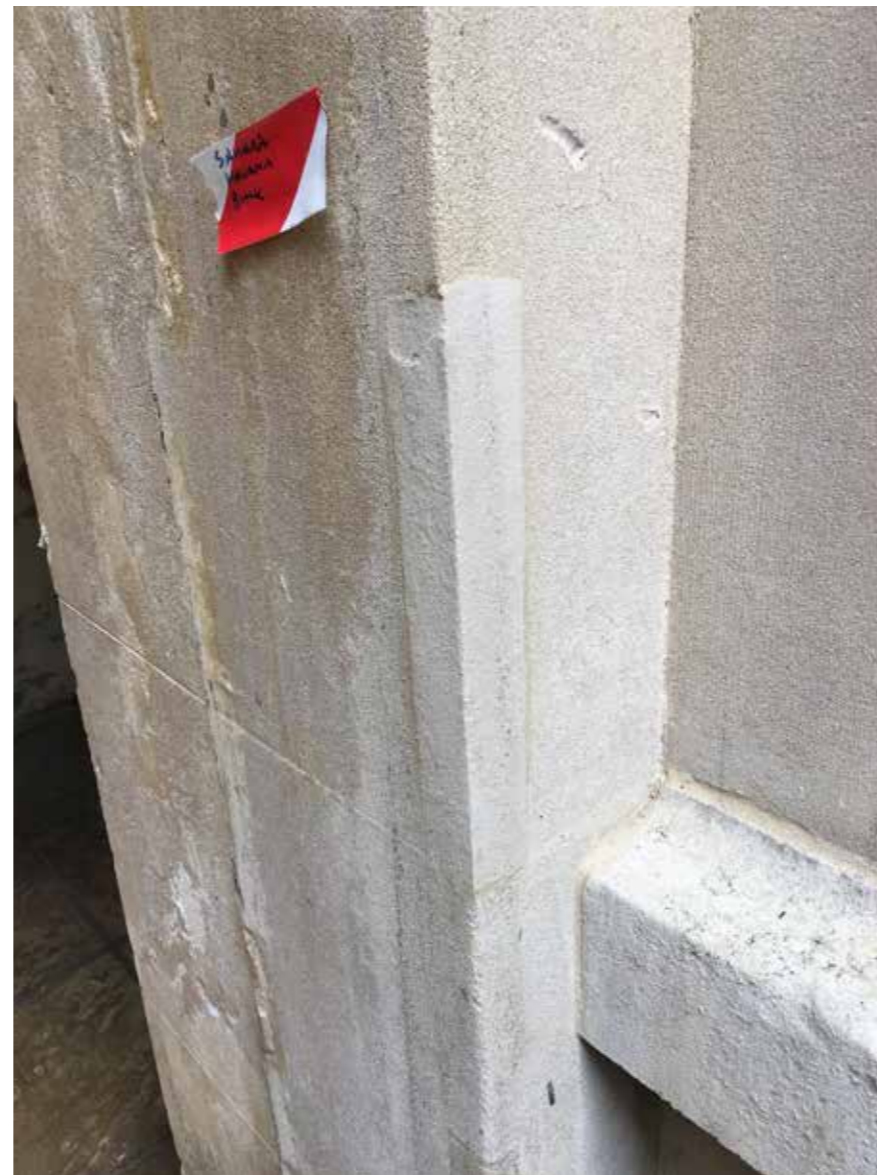
D.4.1 An successful repair to the corner pier in the basement area of House 5.

The corner repair after ten days. This repair is considered satisfactory.

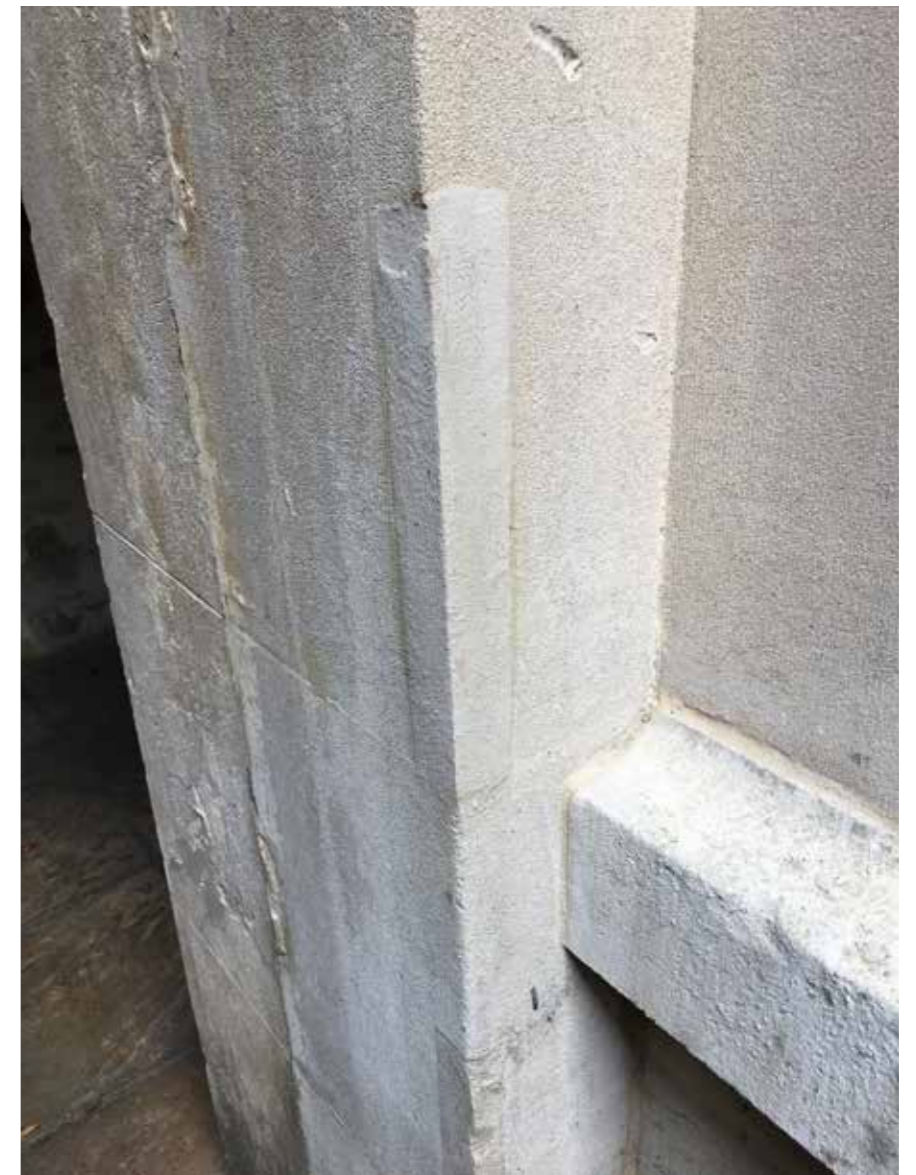
D.4.2 After seven and a half months there is no perceptible change to the repairs located on the corner of the basement pier.

Photo of tinting repair taken on October 23rd, 2024.

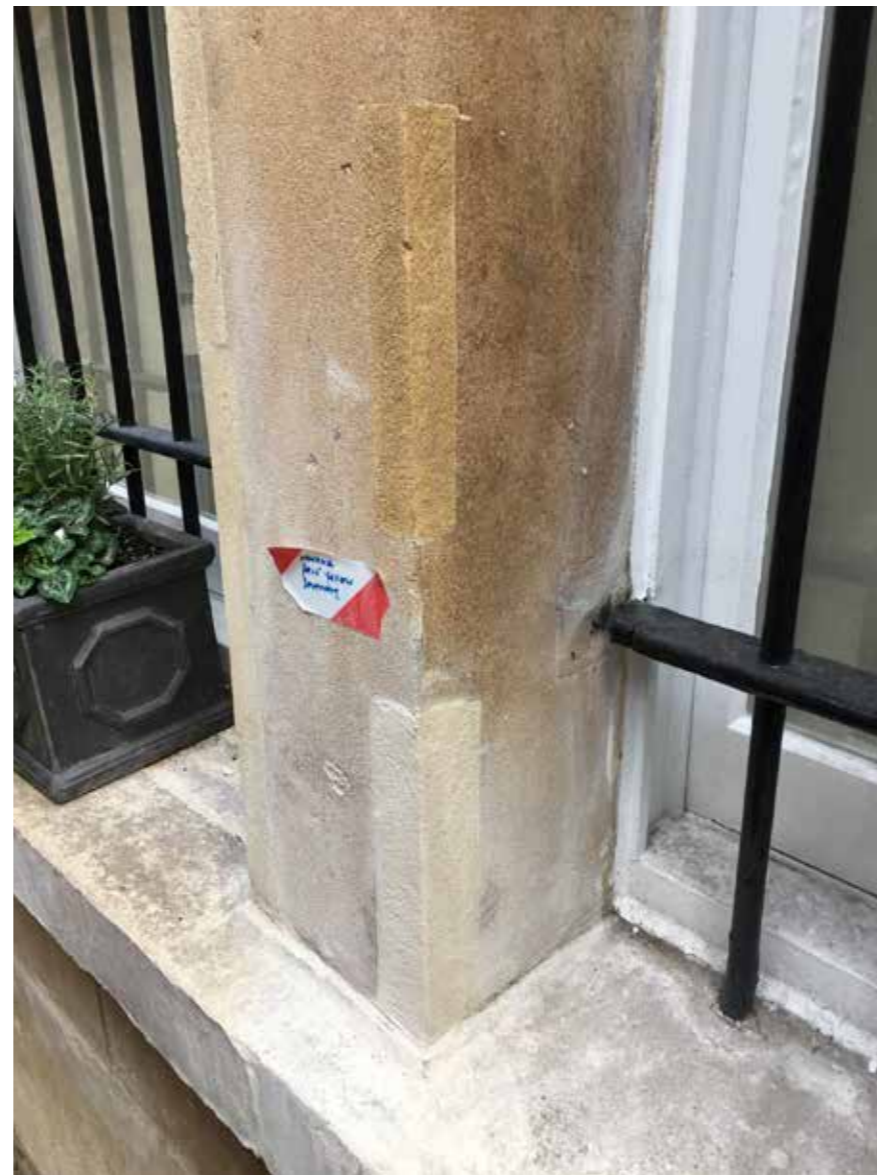
D.5.1 An successful repair to the corner of a pier in the basement area of House 5.

The corner repair after ten days. The repair is considered satisfactory.

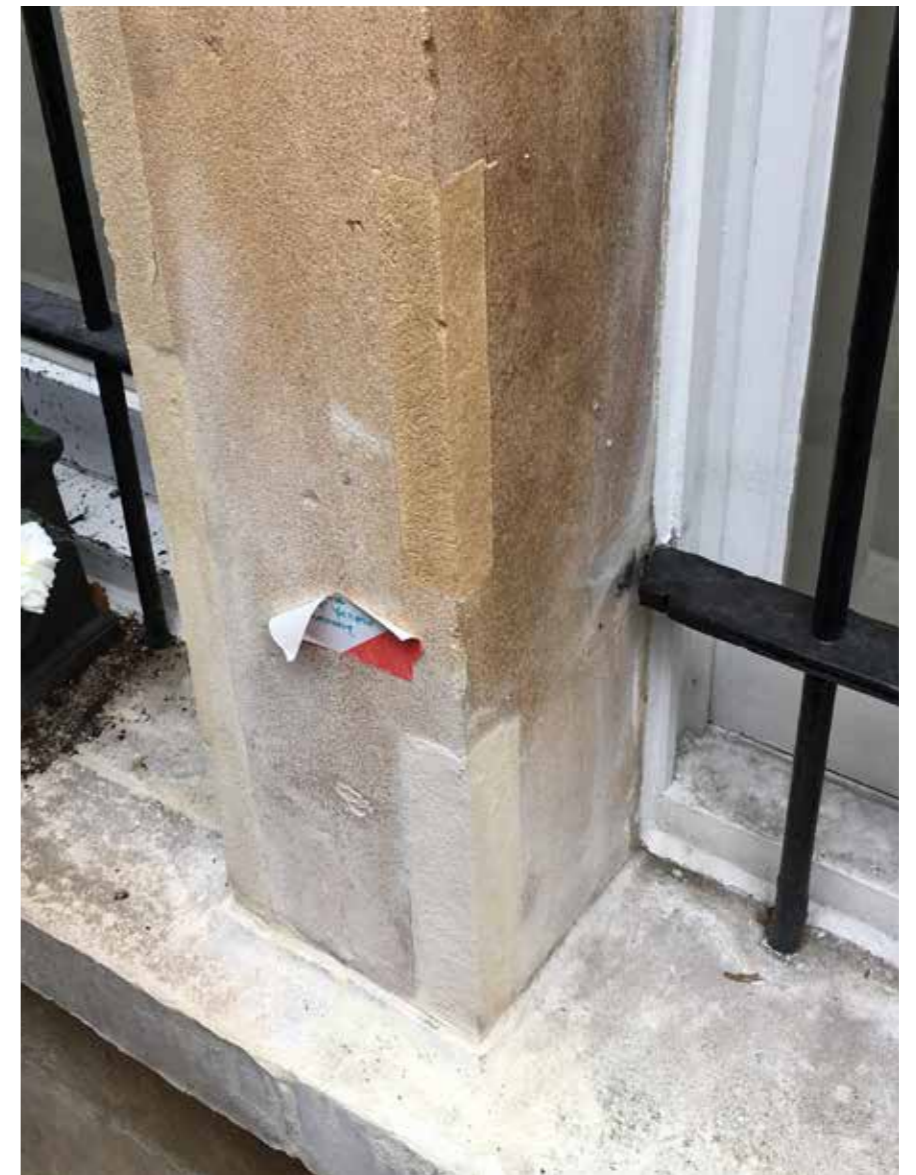
D.5.2 After seven and a half months there is no perceptible change to the repairs located on the corner of the basement window pier.

Photo of tinting repair taken on October 23rd, 2024. The repair identification label is still in place.
