40 Leighton Road, London, NW5 2QE

Arboricultural Report, Tree Constraints Plan  
&  
Impact Assessment

Surveyor: John Crawshaw M.Arbor.A.

Survey Date: Tuesday, 30 March 2021

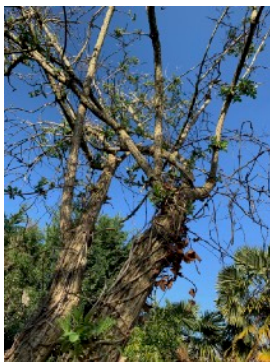
T3 snapped out stem

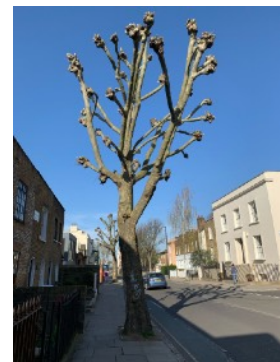
T5 Street tree

The proposed light well to the front of the property will require excavation within the RPA of T5. The RPA has been adjusted to represent the probable extent of root area given the current basement area.

The excavation represents a small area in terms of the overall RPA. Careful excavation by hand in this area, could ensure appropriate pruning back of any roots encountered.

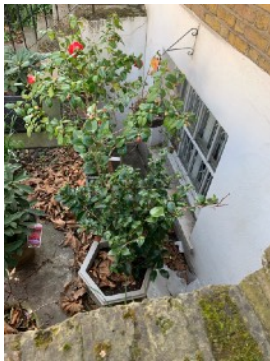
Neighbouring light well

The adjacent property has set a president, with a similar light well, with no apparent long term detriment to the tree.
