LEVEL MONITORING - RELATIVE SURVEY READINGS

Client: Crawford & Co Client Ref: SU1904991 Chart Scale 1:1000

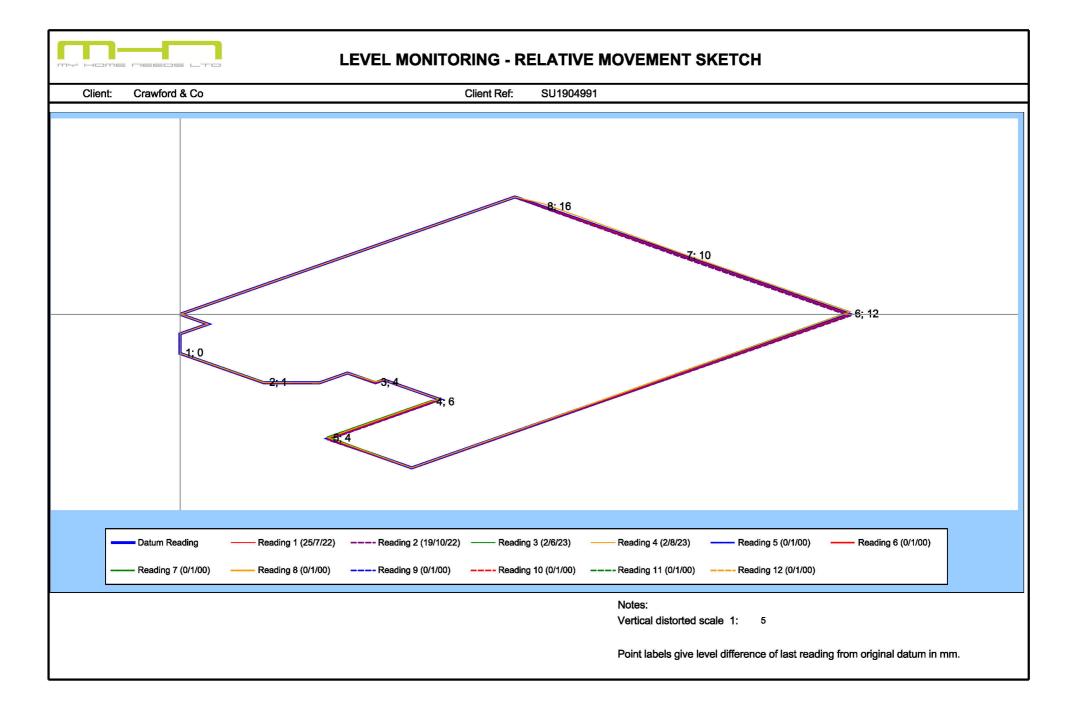
FRONT

- First visit since Oct 22. Trees have since been removed and points have been double checked to confirm movement.
- It was not possible to install all stations within a common brickcourse. Therefore initial readings cannot be interpretted as Distortion Data.
- Rear readings have been made relative to the deep datum. No secondary TBM available.

1 2 Further readings to be taken in Oct 23
