**161 ARLINGTON ROAD,
LONDON NW1 7ET**

Basement Impact Assessment

Project Ref: S 2930
Rev: 02
Issue Date: November 2024

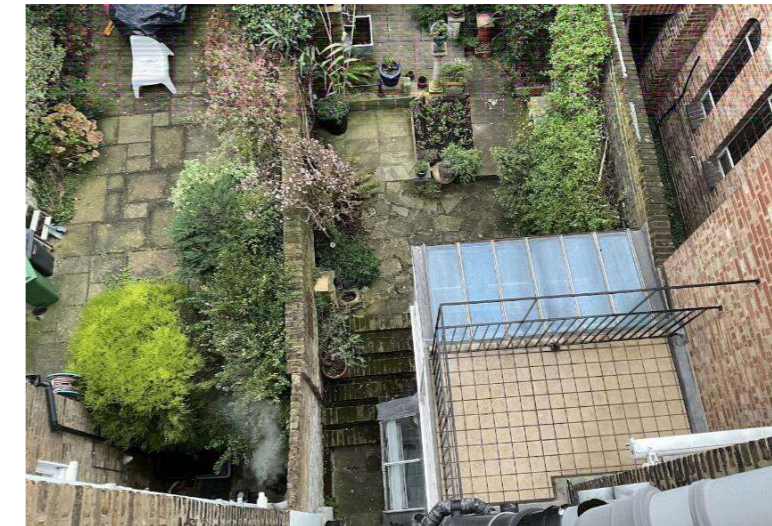
Figure 2: Existing Rear Gardens to Nos 159/ No161 Showing Hardstanding

The proposed scheme does not alter the permeability of the site with the new rear extension replacing being similar in size to the existing and the existing hardstanding retained. Any rainwater run-off will be collected and disposed via the sewer system as currently happens. The following photograph shows the existing rear garden around the extension.

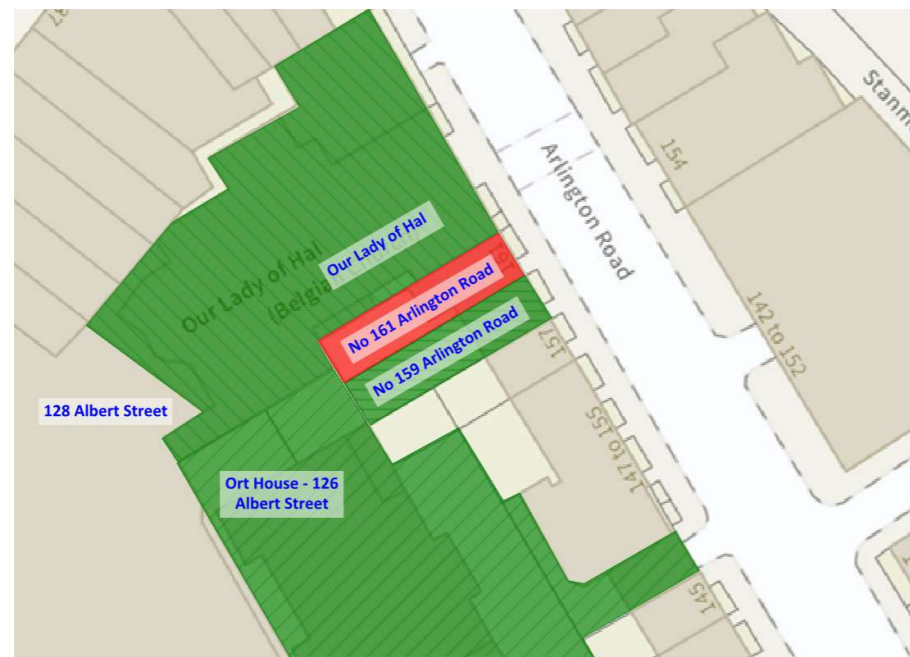
Figure 3: Site Plan showing Adjacent Properties

The site at No161 Arlington Road and its relation to the surrounding buildings is shown on the following plan, with each of the properties considered in more detail below.

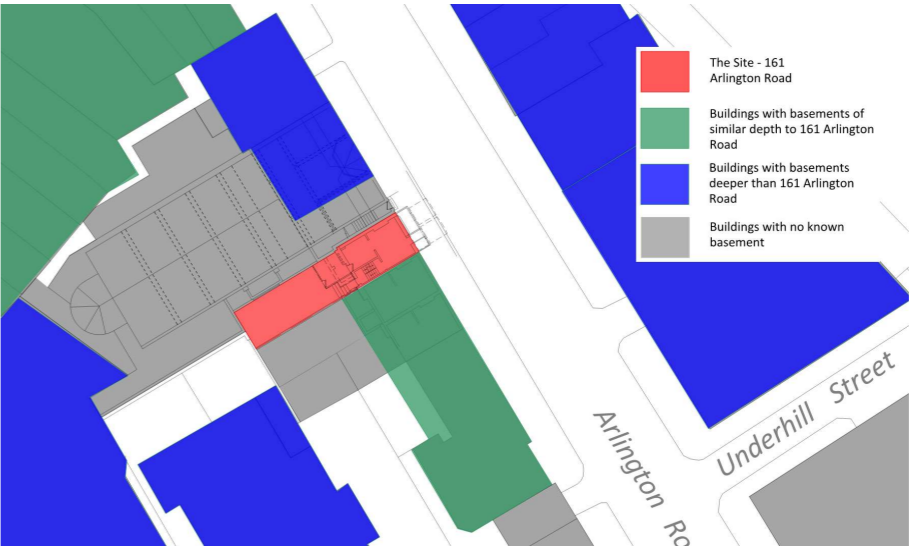
Figure 1: Summary of Surrounding Basements

The information on the surrounding basements is summarised in the Figure above. This shows that No161 is surrounded by basements which are similar or deeper than the proposed basement to No161. On this basis it is clear that the proposed basement works will have limited impact on the groundwater regime in the area.

Building	Description	Basement Depth
161 Arlington Road	Existing residential building	Existing basement 2210mm below ground floor/pavement Proposed basement 400mm bgf below existing, approx 2600mm below pavement level.
Our Lady of Hal	Church built c1933, Presbytery constructed later (1950s).	Built on site of No163-169, assumed to have basement similar to No161.
	Church - partial basement plantroom under centre of front 4 storey building to church.	Plantroom on northern side, approx. 3300mm below ground floor 2900mm below pavement (pavement on slight slope)
	Presbytery has full basement under building.	Full basement, assumed as church
159 Arlington Road	Existing residential building	As No161 existing
157 Arlington Road	Existing residential building	As No161 existing
147-155 Arlington Road	Five buildings refurbished c1996.	2600mm below ground floor
	Basement floor lowered.	2200mm below pavement
142-152 Arlington Road	Building converted from electricity sub-station to community c1979, converted to residential c2018.	Basement 3300mm below ground floor / pavement level

154-160 Arlington Road (building opposite)	Residential building rebuilt c2004	Basement 3000mm below ground floor / pavement
128 Albert Road (building behind)	Warehouse converted into mixed use A3 / residential c1994	Basement 30m from rear wall of No161, 2700mm below ground floor
Ort Centre/126 Albert Street	Offices built c1972	Basement 21m from rear wall of No161, basement lvl 28.3m, approx. 2.4m below Arlington Road pavement.

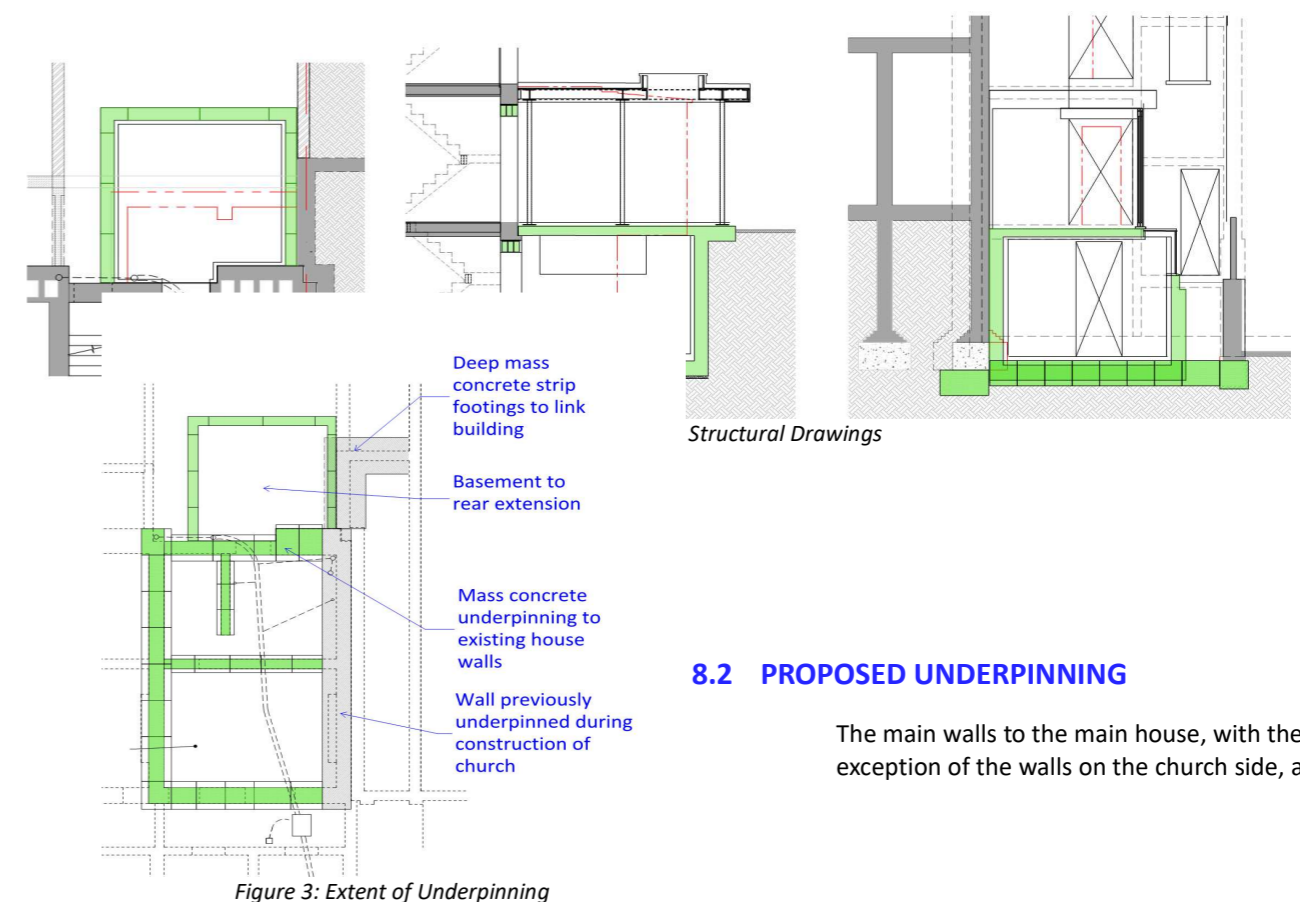
The proposed structure is shown on drawings S 2930 / S 001- S008 included in the appendices. Extracts from the structural drawings showing the basement arrangement are included below.

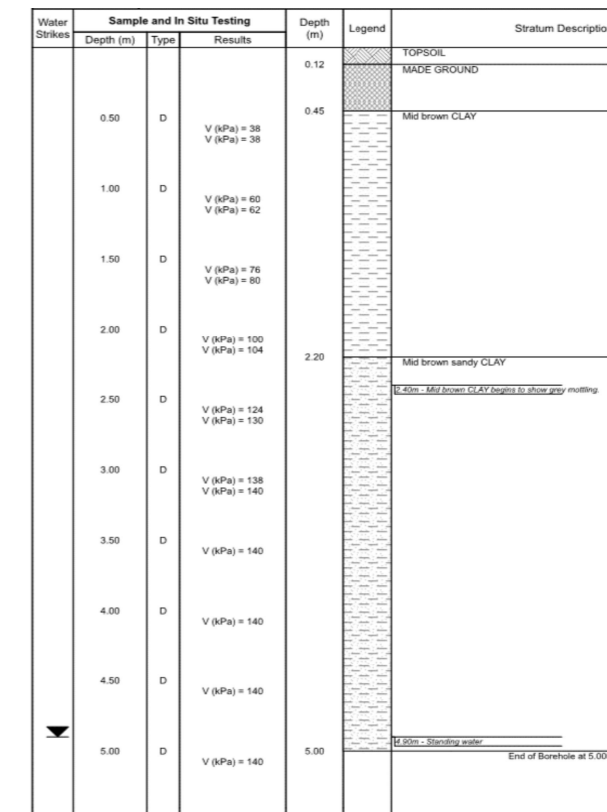
- The site is level.
- Made ground / topsoil to 0.45m depth below ground level(bgl) (rear garden).
- Mid brown Clay (weathered London Clay) to 5m bgl, beginning to show grey mottling from 2.2m bgl.
- Some water was encountered at 4.9m bgl. This is assumed to be percolation from the topsoil/made ground overlying the London Clay.
- Signiificant ground water is not expected to be encountered in the excavation but rainfall will need to be dealt with.
- The depth of the proposed basement excavation is taken as 3.5m below rear garden level and approximately 1.5m below this level.

Figure 4: Site Borehole

A borehole, carried out in the rear garden, confirmed the ground conditions to comprise topsoil/made ground over London Clay to depth with shear strengths of 124/130kPa at the proposed formation depth. The ground conditions confirm the geology maps and local boreholes referred to in the Desk Study.

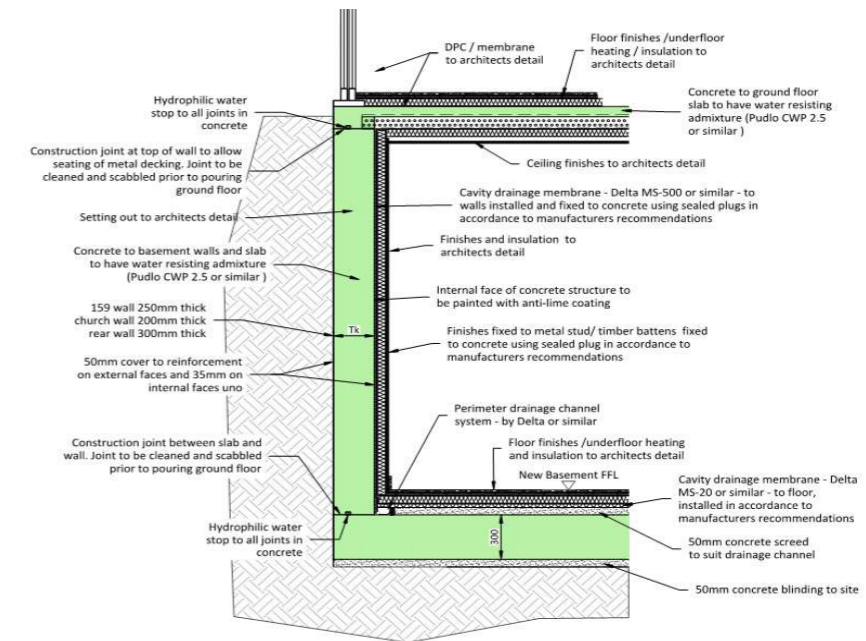
A typical arrangement is shown on the extract from the structural drawings below, refer to Appendix B for the proposed structural drawings.

Figure 5: Typical Basement Construction

Internally, the new basement will be lined with a cavity drainage membrane to act as a second line of protection, collecting any water which penetrates the concrete structure and acting as a vapour barrier to prevent moisture penetration. It is proposed to use Delta MS20 for the slab and Delta MS500 as the cavity membranes for the walls and ceiling respectively.

A secondary concrete floor screed, dry lining to the walls, and suspended ceiling will be constructed inside of the cavity membrane, incorporating insulation, giving protection to the waterproofing, and providing the finished face to the new space. The wall insulation will need to carry across the soffit of the ground floor slab to prevent cold bridging.

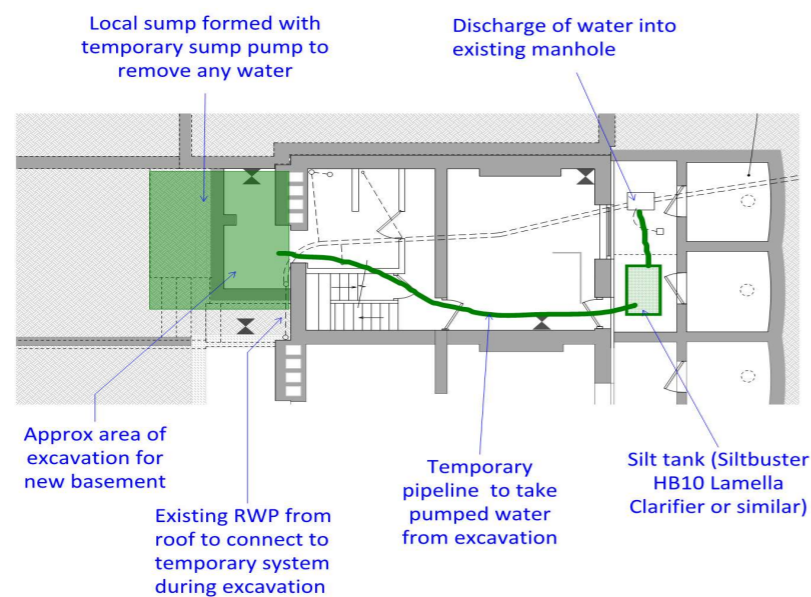
The arrangement envisaged is shown in the following sketch layout:

Figure 6: Proposed Dewatering Arrangement

- Locate a silt tank in the front lightwell. Silt tank to be Siltbuster HS Lamella Clarifier, or similar, to remove any silt or debris from water before discharge.
- Make a temporary connection to pick up existing rainwater pipe on back elevation and run to silt tank/manhole.
- Excavate a local sump within the excavation. Line sump with geotextile to limit loss of fines during pumping, form chamber to take a submersible pump, and back fill around chamber with suitable granular material to maintain stability.
- Pump water from the rear sump to the silt tank, where any fines will be removed from the water.
- Discharge the outflow from the silt tank into the existing manhole. Volume of water is less than the existing discharge, so is within capacity of the existing sewer connection.
