# LINCOLN'S INN NEW SQUARE LONDON

# **Architectural Paint Research Report**

# November 2023

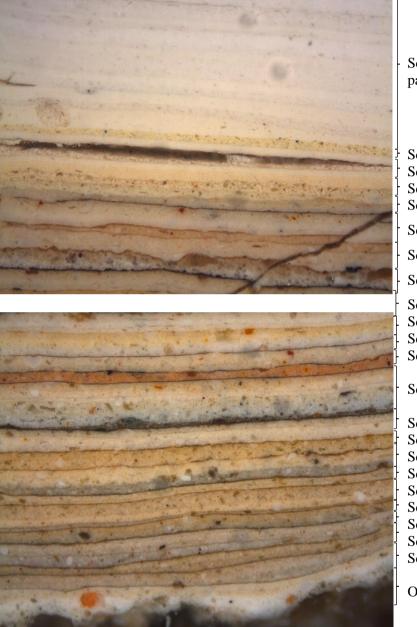
Photomicrograph illustrating sample 5 taken from the basement render at No. 4 New Square, showing its surviving decorative history. Photographed in cross-section in incident light using a 10X lens. Printed magnification not calculated.

Schemes 39-40 & 42-46: Titanium white paint X7

Scheme 37: Deep yellow paint Schemes 34-36: Titanium white X3 Scheme 33: Cream paint Scheme 32: Titanium white paint Scheme 31: Cream paint Scheme 30: Light brown paint Scheme 29: Brownish stone paint Scheme 27: Light stone paint Scheme 22: Warm yellow-stone paint Scheme 20: Light stone paint Scheme 18: Deep salmon pink paint Scheme 17: Warm stone paint Scheme 16: Light stone paint Scheme 15: Brown paint Scheme 11: Warm stone paint Scheme 10: Light warm stone paint Schemes 8-9: Light & Deep brown stone Scheme 7: Brown-stone paint Scheme 4: Warm stone paint Schemes 2-3: Deep stone paint Scheme 1: Brown stone paint Oil mastic render

Thirty-two separate phases of decoration survive on the basement wall over an oil mastic render substrate (see Table 1). However, comparison with other New Square samples suggests that a total of 47 decorative phases were preserved on the buildings overall, thereby indicating that No. 4 has lost numerous interim schemes. This loss was most likely the result of deterioration or sanding down in preparation for redecoration. Analysis highlighted that the 13 final decorations at No. 4 were executed at some point after c. 1960, suggesting that the basement render was repainted approximately every three to four years during this period. If a similar maintenance schedule was employed prior to c. 1960 there are a sufficient number of schemes remaining to date back to the mid-19<sup>th</sup> century.

Initially, the basement render at No. 5 was painted a brownish stone colour over a red lead primer. Two deep stone coloured decorations can then be seen before a warm shade of stone was applied in Scheme 4. Another 14 decorations executed in various shades of stone or brown followed. One exception to this colourway occurred in Scheme 18 when a distinctive deep salmon pink paint mixture was identified. In Scheme 31 the render was painted a more neutral cream colour.

From Scheme 32 onwards the basement render was decorated in a lighter palette consisting of mostly white painted finishes, although one cream and one deep yellow coating were also observed. This change in appearance coincided with the introduction of modern titanium-based paints from c. 1960 onwards and highlights the significant shift in taste which occurred in London in the years following World War II.
