**HIGHGATE CEMETERY:  
CHAPELS & ENTRANCE BUILDING, SOUTH LODGE**

**RIBA STAGE 3 SCHEDULE OF WORKS APPENDIX 3**

**MATERIALS ANALYSIS**

**Highgate Cemetery, London N6.  
Mortar Analysis. Results Summary - 5809/HC/01-06.**

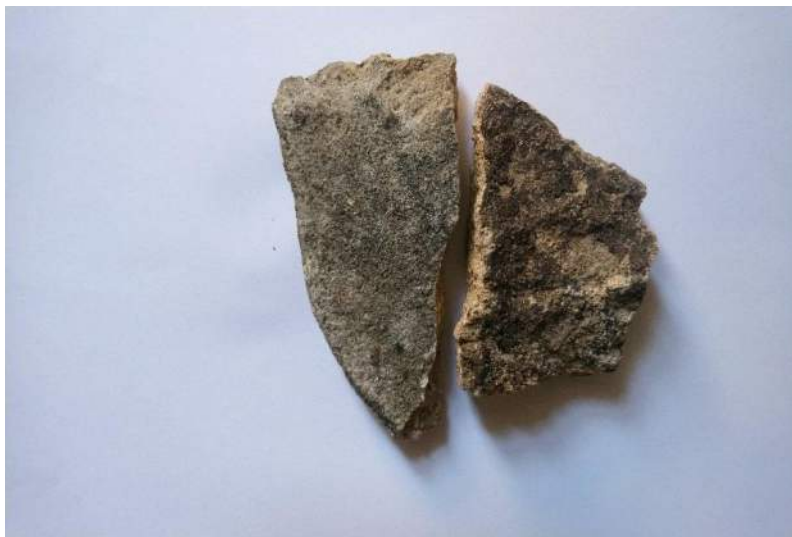
5809/HC/01  
Sample as tested

Thin (2mm-3mm) hard pale grey finish coat removed prior to analysis. Intact yellow-brown render fragments c.12mm thick. High strength (sample could not be broken by hand nor crumbled in fingers; disrupted using pestle with difficulty). Aggregate is principally yellow quartz with occasional particles of other geological types. Calcareous aggregate not positively determined. Kiln-fuel particles not found. Hair or fibre reinforcement not present.

**Sample 5/M4 (5809/HC/01).** This render sample from Vault 11 (Baxter) in the Cuttings catacombs comprises a thin pale grey finish coat applied to a yellow-brown backing coat. The finish coat has not been tested but it is almost certainly Portland cement mixed with fine sand probably at circa 1: 3. The backing coat has not fully carbonated and is Portland cement and washed yellow-brown quartz sand at circa 1 : 4 to 5. I understand this vault may date from circa 1850 and whilst it is possible that this render dates from then, I think it more likely to be later. Portland cement was not in common use in London until the 1860s and the lack of full carbonation and the washed sand may suggest a late 19<sup>th</sup> or early 20<sup>th</sup> century material.

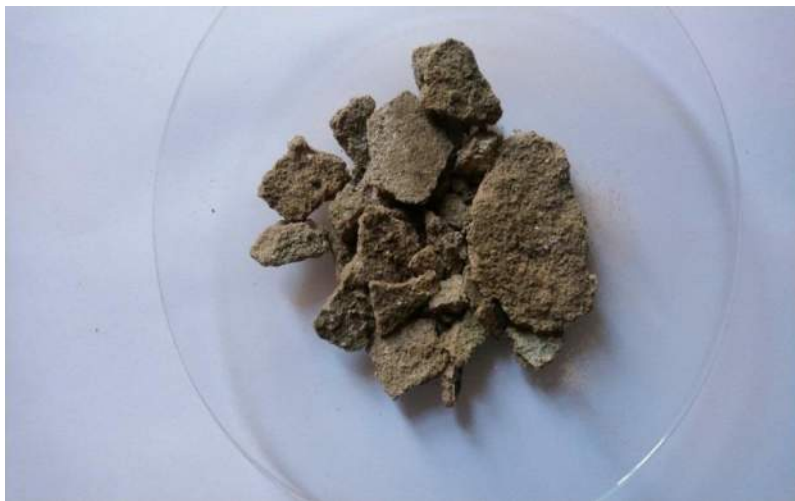
5809/HC/02  
Sample as tested

Intact brown render fragments c.15mm thick. Moderate strength (fragments could be broken by hand but not crumbled in fingers; disrupted using pestle with some difficulty). Aggregate is principally yellow-brown quartz and fine flint. Calcareous aggregate not positively determined. Kiln-fuel particles not found. Hair or fibre reinforcement not present.

Moist sample. Fully carbonated (phenolphthalein carbonation test).  
Apparent water permeability moderate/low (water droplet absorption on dried surface).  
Moderate effervescence on addition of dilute hydrochloric acid.

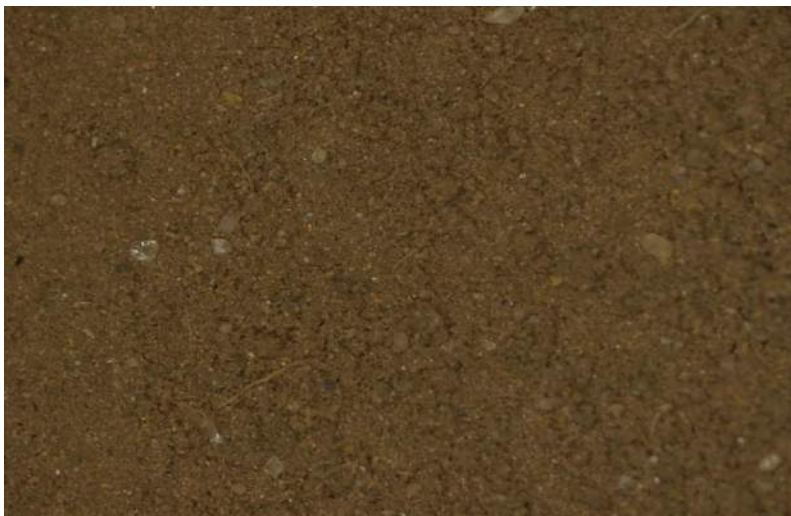
5809/HC/03  
Insoluble fines <45 $\mu$ m  
Stereomicroscope x20

Intact brown render fragments c.30mm thick applied in two coats. High/moderate strength (sample could not be broken by hand nor crumbled in fingers; disrupted using pestle with some difficulty). Aggregate is principally yellow-brown quartz. Calcareous aggregate not positively determined. Kiln-fuel particles not found. Hair or fibre reinforcement not present.

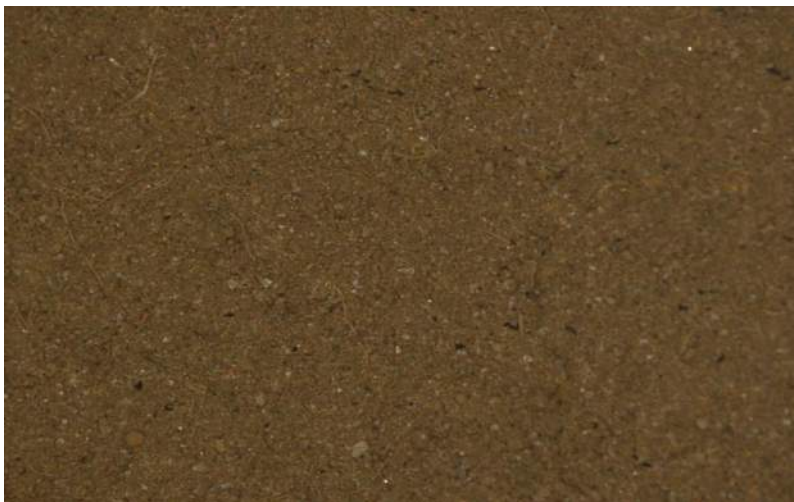
5809/HC/04  
Insoluble fines <45 $\mu$ m  
Stereomicroscope x20

Intact yellow-brown render fragments c.15mm thick. High strength (sample could not be broken by hand nor crumbled in fingers; disrupted using pestle with difficulty). Aggregate is principally yellow quartz with particles of flint and other geological types. Calcareous aggregate not positively determined. Kiln-fuel particles not found. Hair or fibre reinforcement not present.

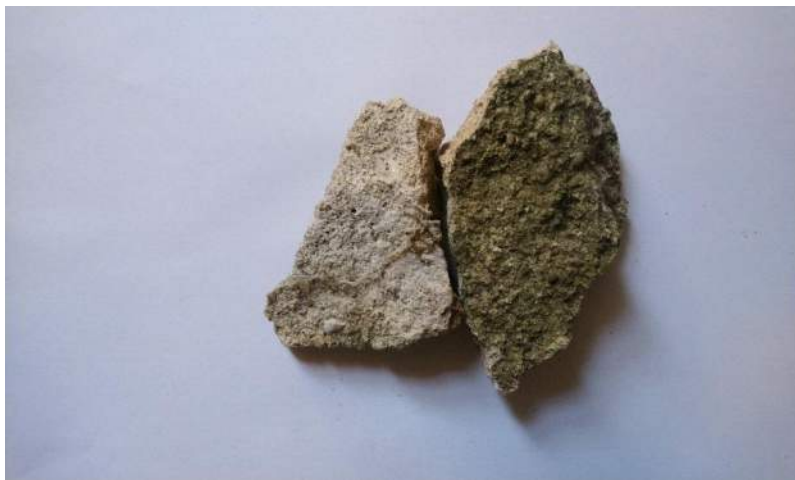
5809/HC/05  
Sample as tested

Intact pale grey-brown render fragments c.3mm thick. High strength (thin fragments could be snapped by hand with some difficulty but not crumbled in fingers; disrupted using pestle with difficulty). Aggregate is principally fine yellow quartz. Calcareous aggregate not positively determined. Kiln-fuel particles not found. Hair or fibre reinforcement not present.

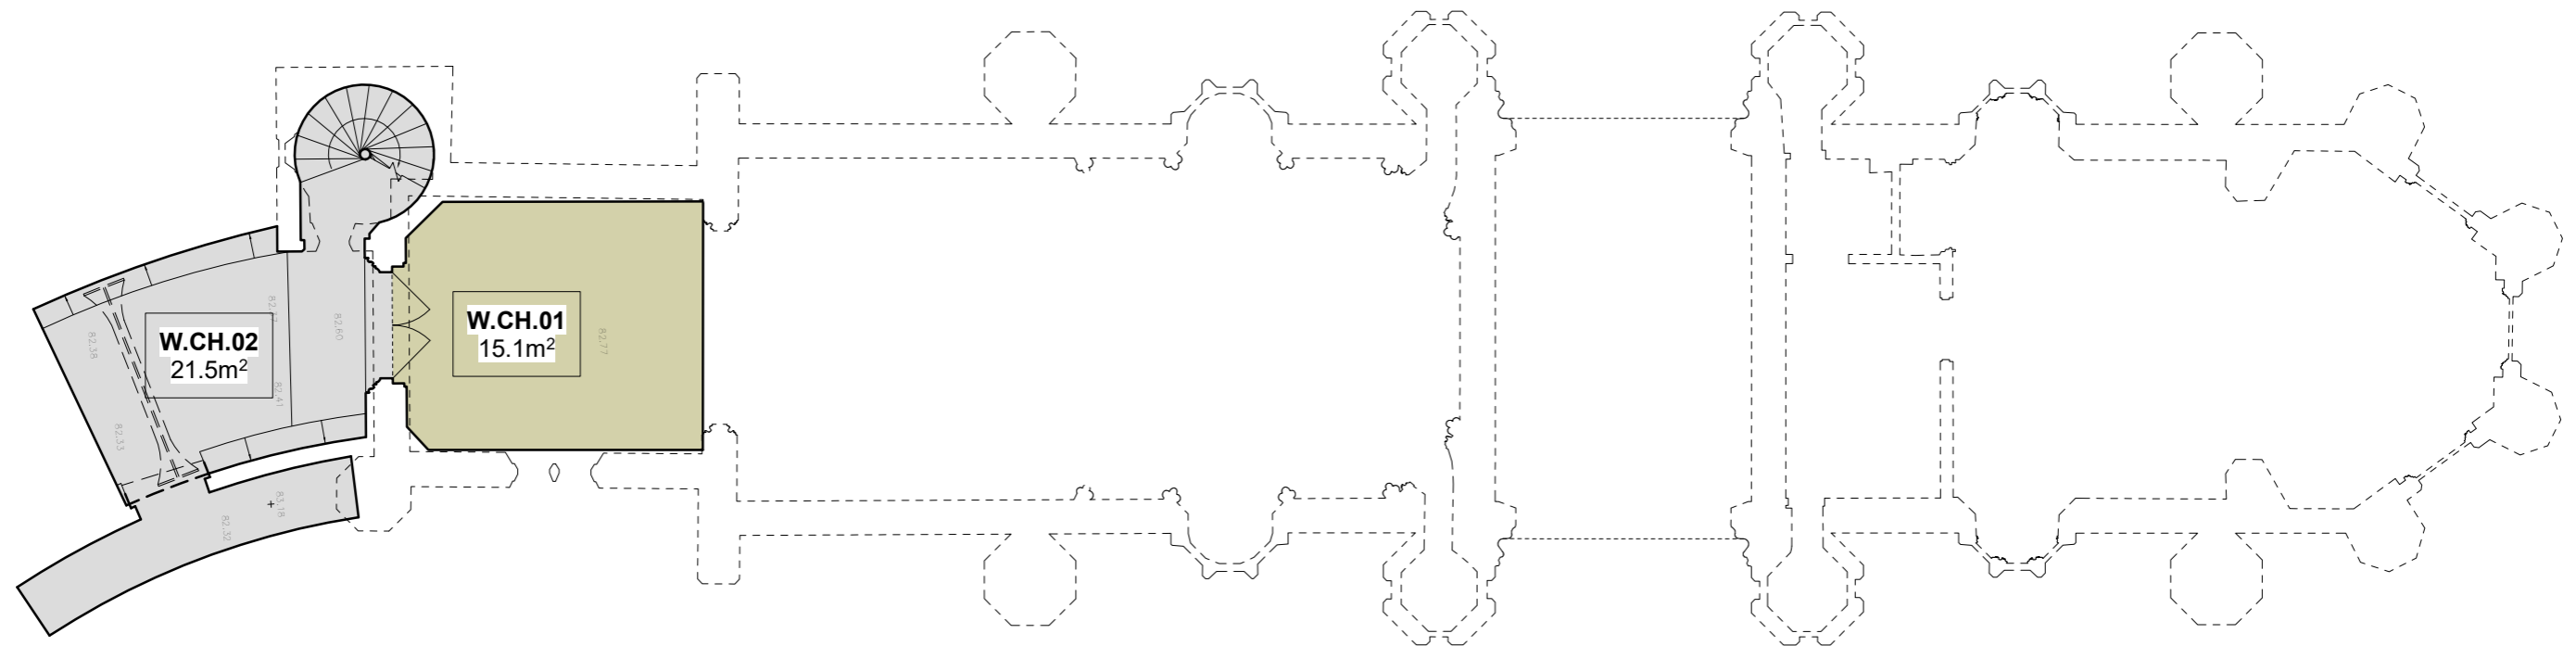
**1** Space Audit - Chapel - Basement Level  
 0101 1:100

Room ID.	Level	Space / Observations	Usable Area (m <sup>2</sup> )
W.CH.01	Basement	Gardeners Mess Gardener's welfare area (seating/kitchenette) Constrained access. Poor state of repair, damp. Intrinsic heritage value - former coffin-drop. Potential to form part of visitor experience.	15.1
W.CH.02	Basement	Tunnel Cutting / Turret Stair Stepped access to basement, constrained. External space not used. Intrinsic heritage value - former coffin passage. Potential to form part of visitor experience.	21.5
<b>Basement</b>		<b>Sub-total</b>	<b>36.6</b>

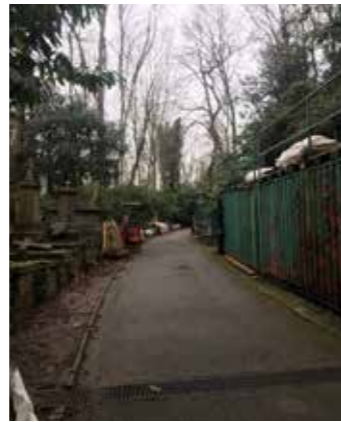
The containers are used as storage for vehicles and a small workshop area by the Gardening Team. They are in poor condition, inadequate and not fit-for-purpose.

Containers on path.

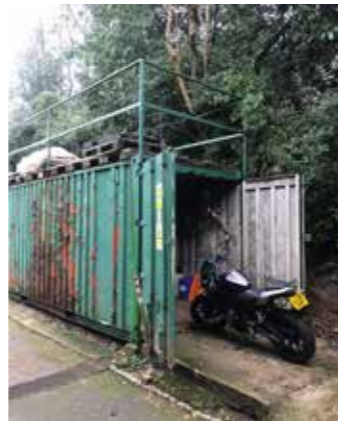
Vehicle Storage

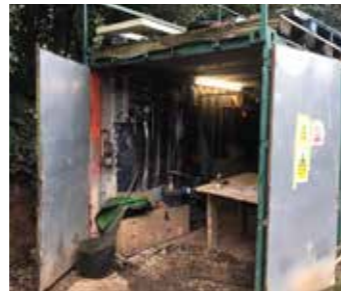
Container Workshop.

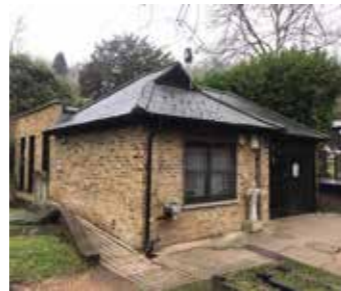
The Compound does not provide adequate space for the gardeners (notably WC provision) and their equipment and would not be fit to accommodate the Cemetery's aspirations for additional space for volunteers.

Exterior of East Compound.

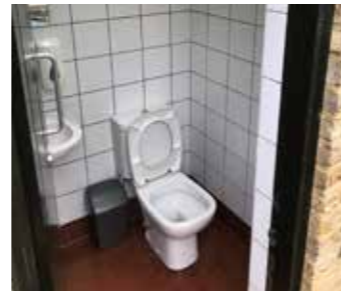
WC provision is inadequate for the visitor & staff numbers, with queue reported at peak times.

Visitor WC

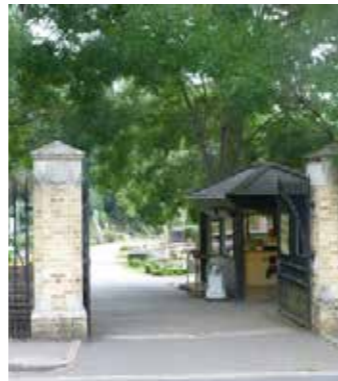
A small pre-fabricated unit sitting inside the East Cemetery entrance on Swain's Lane. Desk for a single staff / volunteer with a small gift shop area.

The building is not in-keeping and ill-suited with the Cemetery's architectural fabric.

Ticket Booth Exterior

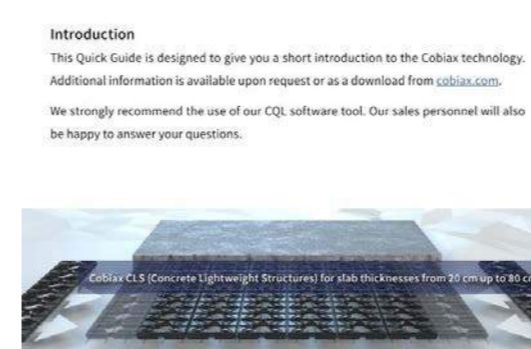
Cobiax Data Sheet Extract

One system we looked into for the raft slabs is Cobiax is a void former product which could be looked into for the raft slabs. This shows a reduction if effective carbon emissions of 29 kgCO<sub>2</sub>e/m<sup>2</sup> of slab area,

This accounts for loss of concrete volume and for the carbon footprint of the product itself. A quick volume calculation suggested that this would reduce the carbon rate of the raft slab concrete to about 95 kgCO<sub>2</sub>e/m<sup>3</sup>.

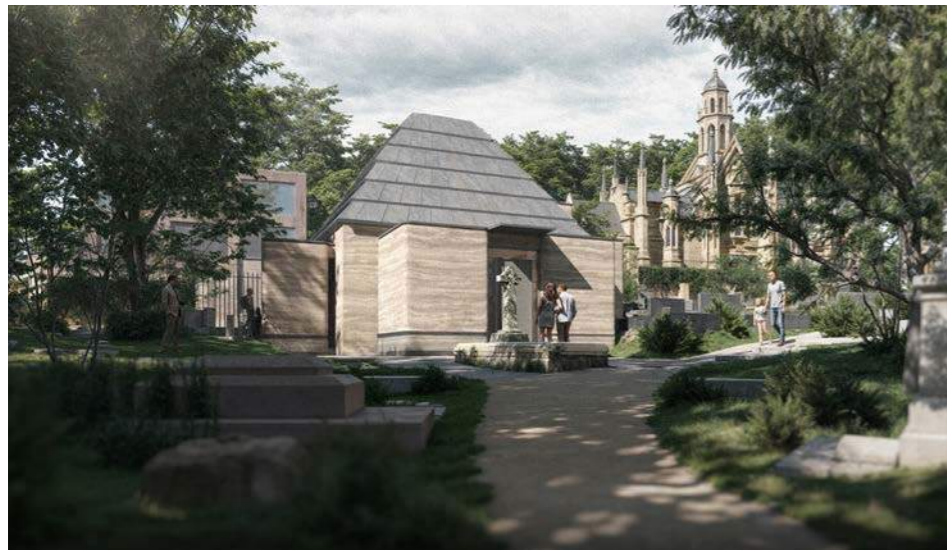
Below-ground construction requires large quantities of concrete and reinforcement, making it challenging to meet Upfront Carbon A1-A5 target. A conservative assumption of 25% cement replacement has been allowed for in the calculation; the impact of an aspirational 75% cement replacement has been indicated.

Visualisation of Proposed Education & Community Building

Assessment of Project 1:	
Category	Global Warming Potential Non-Decarbonised Scenario Kg CO <sub>2</sub> e/m <sup>2</sup> Life Cycle Stages
A1-A3 Product Stages (excl. Sequestered Carbon)	702.5
A4 Transport	82.9
A5 Construction	104.7
Total	890 (703.5 with 75% Cement Replace.)

Assessment of Project 2:	
Category	Global Warming Potential Non-Decarbonised Scenario Kg CO <sub>2</sub> e/m <sup>2</sup> Life Cycle Stages
A1-A3 Product Stages (excl. Sequestered Carbon)	702.5
A4 Transport	82.9
A5 Construction	104.7
B1 Use Phase	0.2
B2 Maintenance	12.1
B3 Repair	8.1
B4 Replacement	96.0
C1 Deconstruction/Demo	14.5
C2 Waste Transport	13.6
C3 Waste Processing	44.0
C4 Waste Disposal	0.1
Total	1079 (888.8 with 75% Cement Replace.)

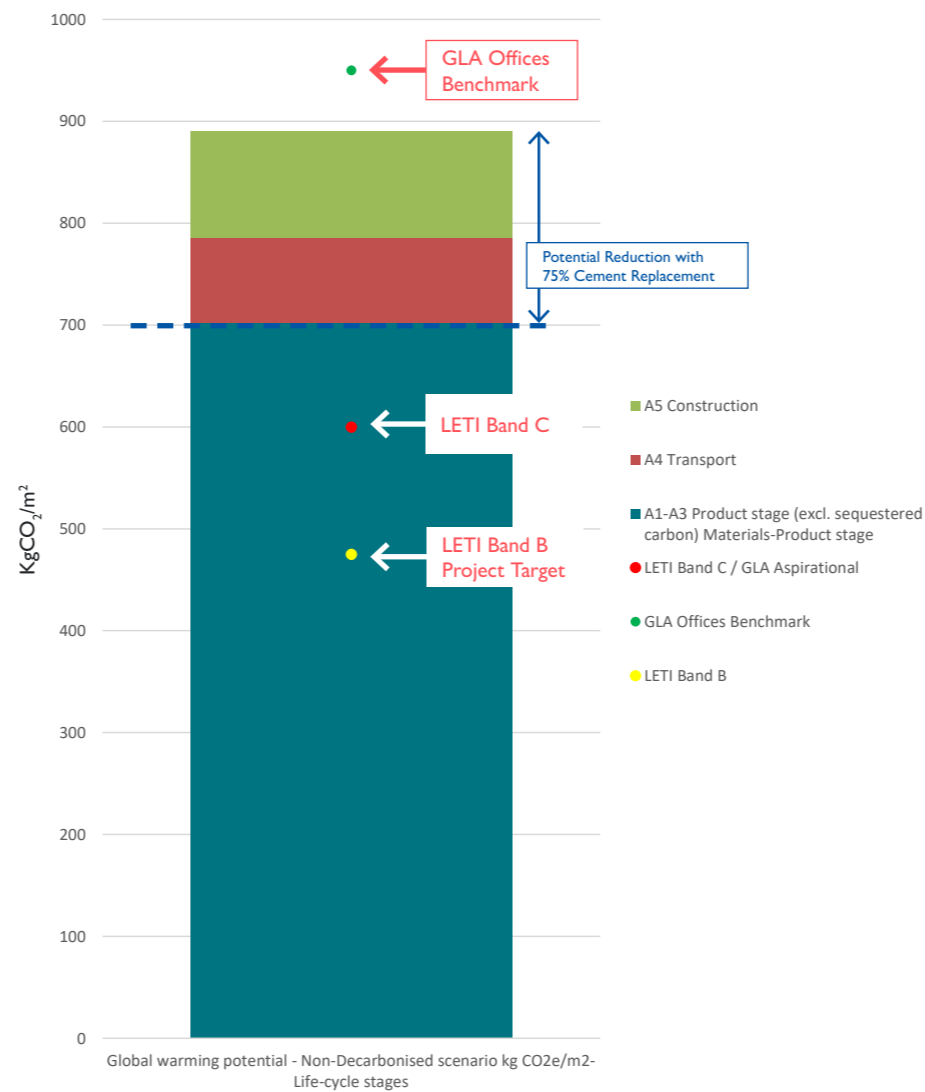
Global Warming Potential (Non-Decarbonised Scenario) Kg CO<sub>2</sub>e/m<sup>2</sup> (Stage A1 to A5)

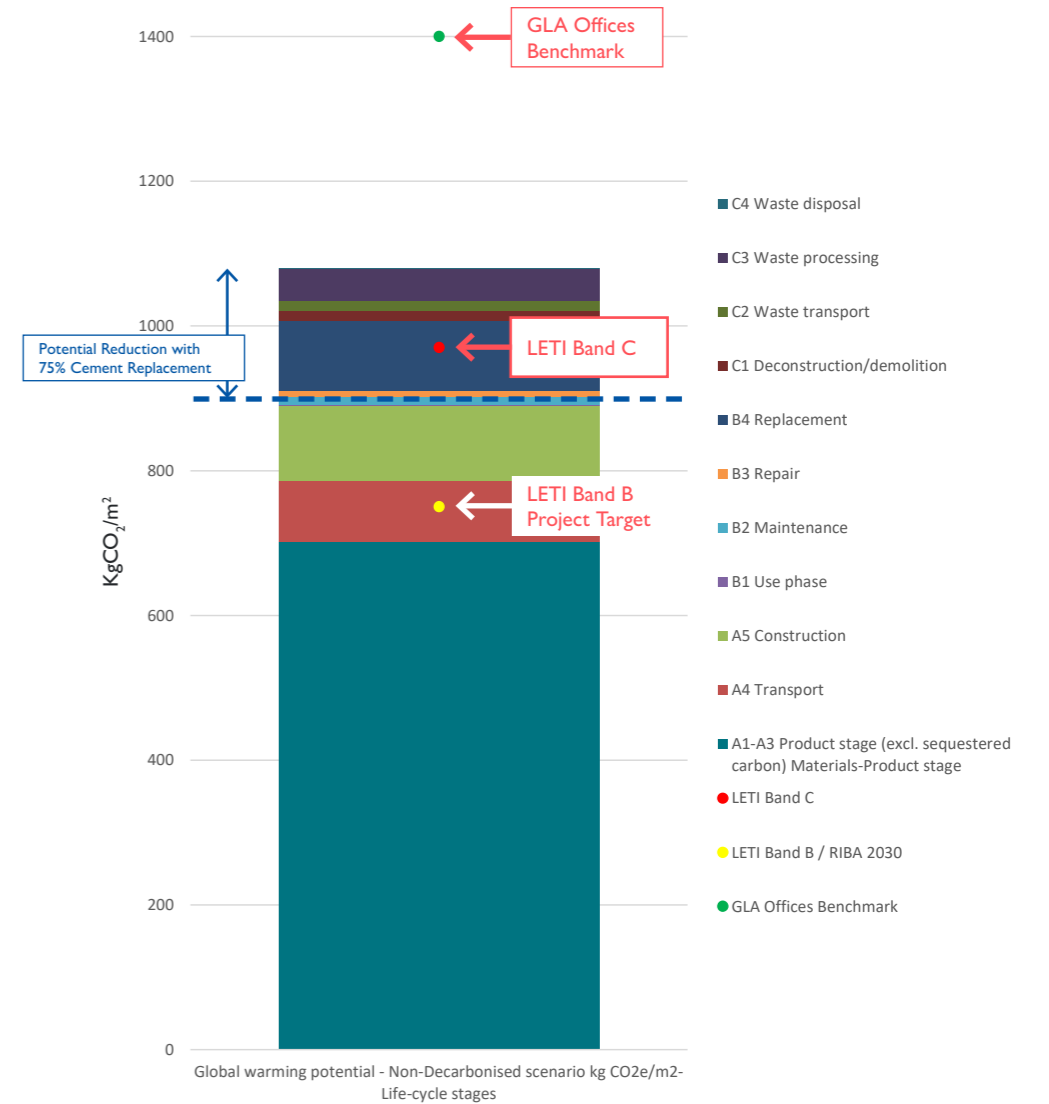
Global Warming Potential (Non-Decarbonised Scenario) Kg CO<sub>2</sub>e/m<sup>2</sup> (Stage A to C)

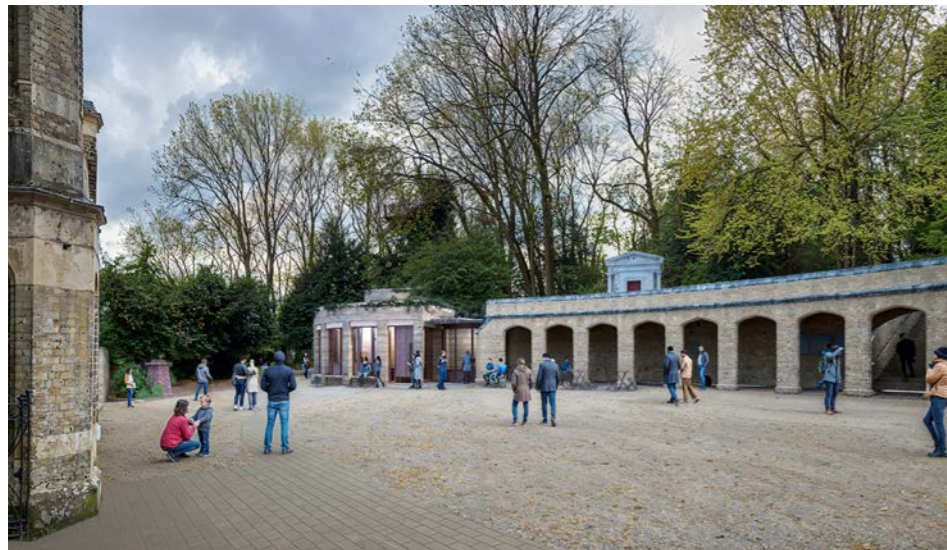
The considerable amount of concrete and reinforcement used for the layered concrete construction, additionally within the internal walls, further challenges the achievement of the Upfront Carbon A1-A5 targets.

Visualisation of Proposed Visitor & Operations Building

Assessment of Project 1:	
Category	Global Warming Potential Non-Decarbonised Scenario Kg CO <sub>2</sub> e/m <sup>2</sup> Life Cycle Stages
A1-A3 Product Stages (excl. Sequestered Carbon)	803.6
A4 Transport	81.9
A5 Construction	94.9
Total	980 (750 with 75% Cement Replace.)

Assessment of Project 3:	
Category	Global Warming Potential Non-Decarbonised Scenario Kg CO <sub>2</sub> e/m <sup>2</sup> Life Cycle Stages
A1-A3 Product Stages (excl. Sequestered Carbon)	803.6
A4 Transport	81.9
A5 Construction	94.9
B1 Use Phase	33.6
B2 Maintenance	13.6
B3 Repair	9.0
B4 Replacement	90.1
C1 Deconstruction/Demo	18.7
C2 Waste Transport	10.7
C3 Waste Processing	43.1
C4 Waste Disposal	0.1
Total	1199 (965 with 75% Cement Replace.)

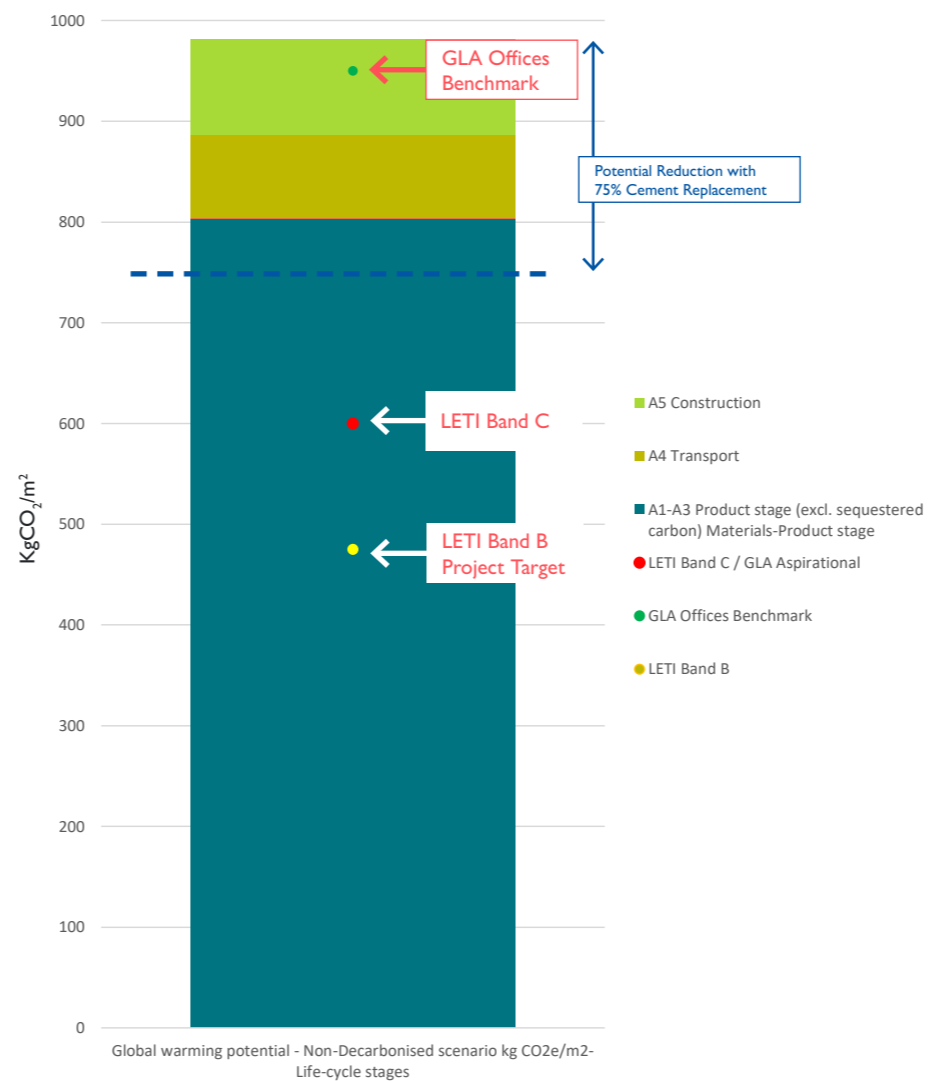
Global Warming Potential (Non-Decarbonised Scenario) Kg CO<sub>2</sub>e/m<sup>2</sup> (Stage A1 to A5)

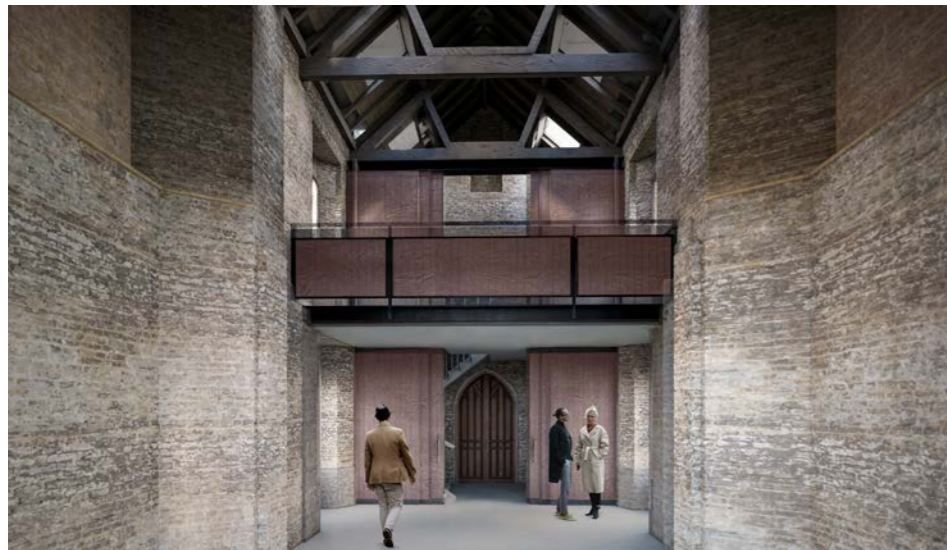
The project has significantly lower embodied carbon by comparison, as it is a refurbishment rather than a new build and meets targets. Assessment is for the interior refurbishment of Dissenters' Chapel only and excludes conservation repairs to the exterior of the Chapel Entrance Building.

Visualisation of Proposed Refurbishment to the interior of the Dissenters' Chapel

Assessment of Project 1:	
Category	Global Warming Potential Non-Decarbonised Scenario Kg CO <sub>2</sub> e/m <sup>2</sup> Life Cycle Stages
A1-A3 Product Stages (excl. Sequestered Carbon)	126.4
A4 Transport	6.6
A5 Construction	138.4
Total	271 (257 with 75% Cement Replace.)

Assessment of Project 1:	
Category	Global Warming Potential Non-Decarbonised Scenario Kg CO <sub>2</sub> e/m <sup>2</sup> Life Cycle Stages
A1-A3 Product Stages (excl. Sequestered Carbon)	126.4
A4 Transport	6.6
A5 Construction	138.4
B1 Use Phase	NA
B2 Maintenance	11.7
B3 Repair	4.3
B4 Replacement	13.8
C1 Deconstruction/Demo	14.0
C2 Waste Transport	2.1
C3 Waste Processing	7.7
C4 Waste Disposal	0.0
Total	325 (311 with 75% Cement Replace.)

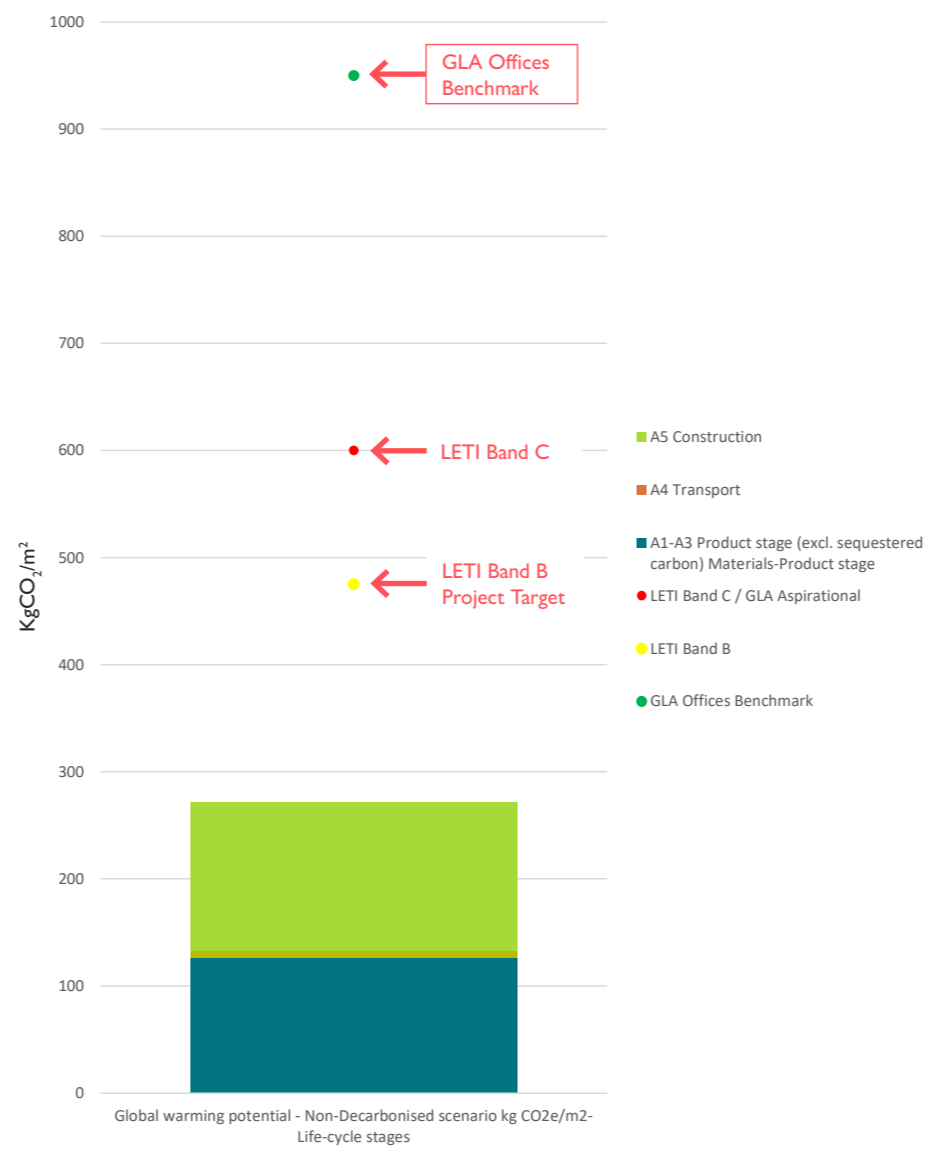
Global Warming Potential (Non-Decarbonised Scenario) Kg CO<sub>2</sub>e/m<sup>2</sup> (Stage A1 to A5)

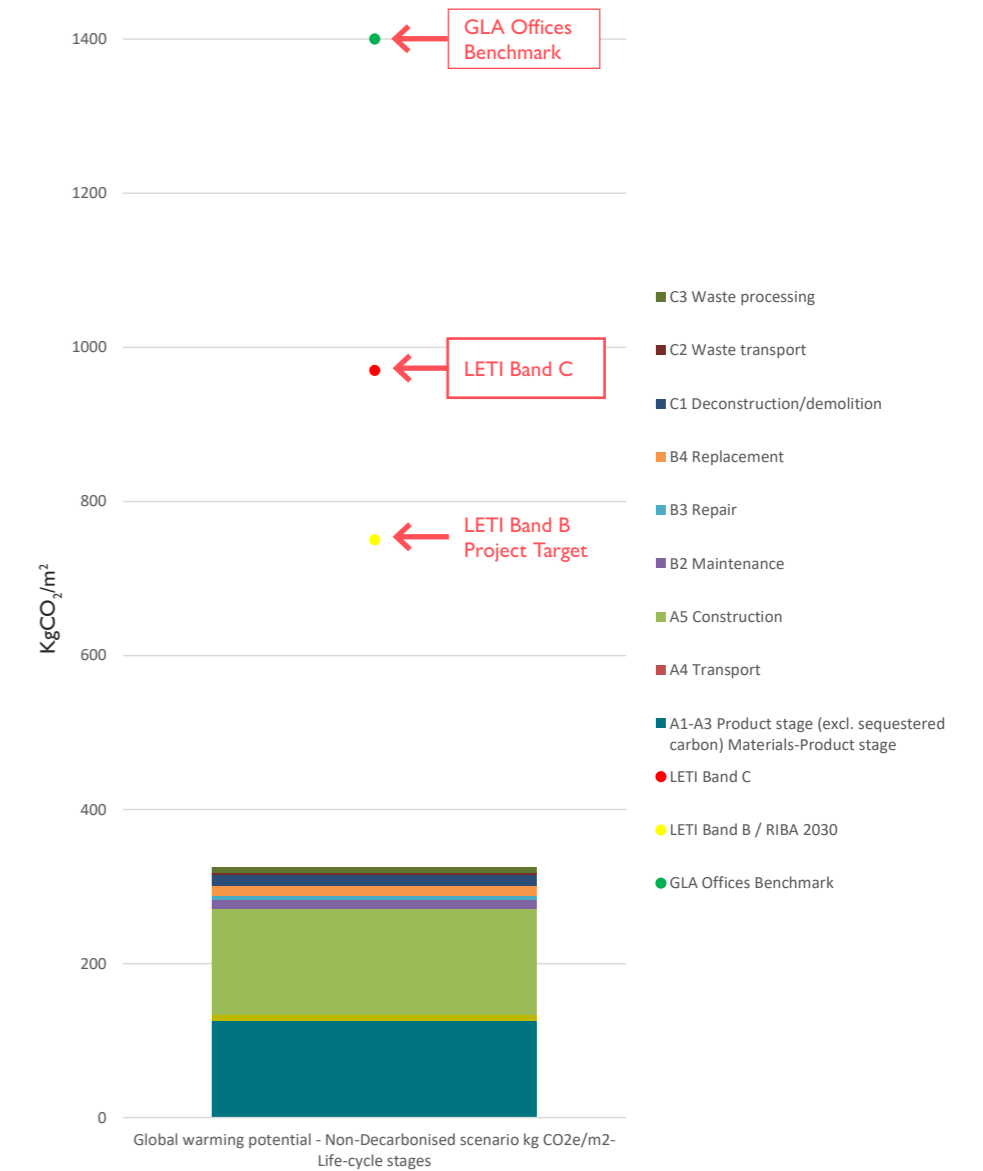
Global Warming Potential (Non-Decarbonised Scenario) Kg CO<sub>2</sub>e/m<sup>2</sup> (Stage A to C)

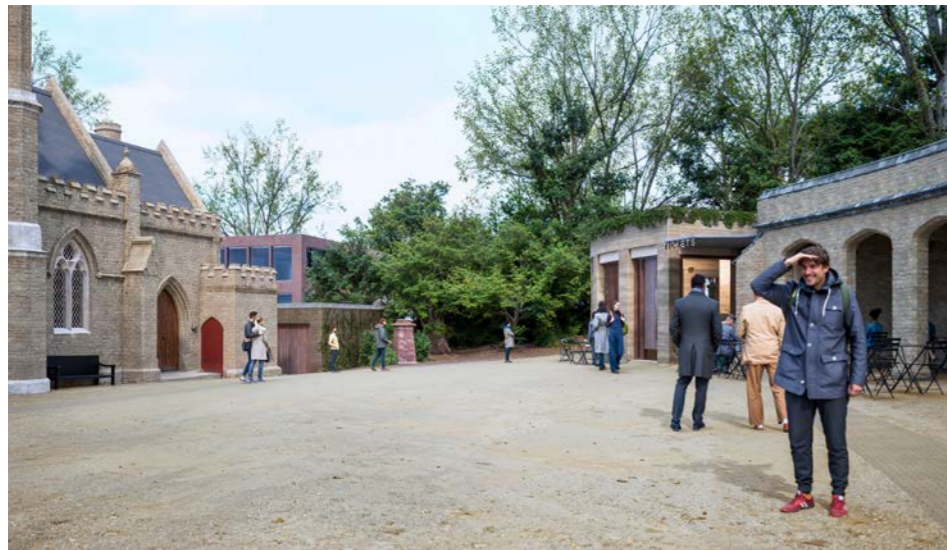
The embodied carbon is very low due to the reduced amount of materials and services required, given its function as a utility space. A lower embodied carbon could potentially be achievable if the flat roof build-up and finish are specified as gravel instead of aluminium.

Visualisation of Proposed Utility Block

Assessment of Project 1:	
Category	Global Warming Potential Non-Decarbonised Scenario Kg CO <sub>2</sub> e/m <sup>2</sup> Life Cycle Stages
A1-A3 Product Stages (excl. Sequestered Carbon)	329.6
A4 Transport	24.9
A5 Construction	88.6
Total	443 (401 with 75% Cement Replace.)

Assessment of Project 1:	
Category	Global Warming Potential Non-Decarbonised Scenario Kg CO <sub>2</sub> e/m <sup>2</sup> Life Cycle Stages
A1-A3 Product Stages (excl. Sequestered Carbon)	329.6
A4 Transport	24.9
A5 Construction	88.6
B1 Use Phase	NA
B2 Maintenance	11.7
B3 Repair	4.1
B4 Replacement	52.9
C1 Deconstruction/Demo	14.0
C2 Waste Transport	6.4
C3 Waste Processing	51.7
C4 Waste Disposal	0.0
Total	584 (542 with 75% Cement Replace.)

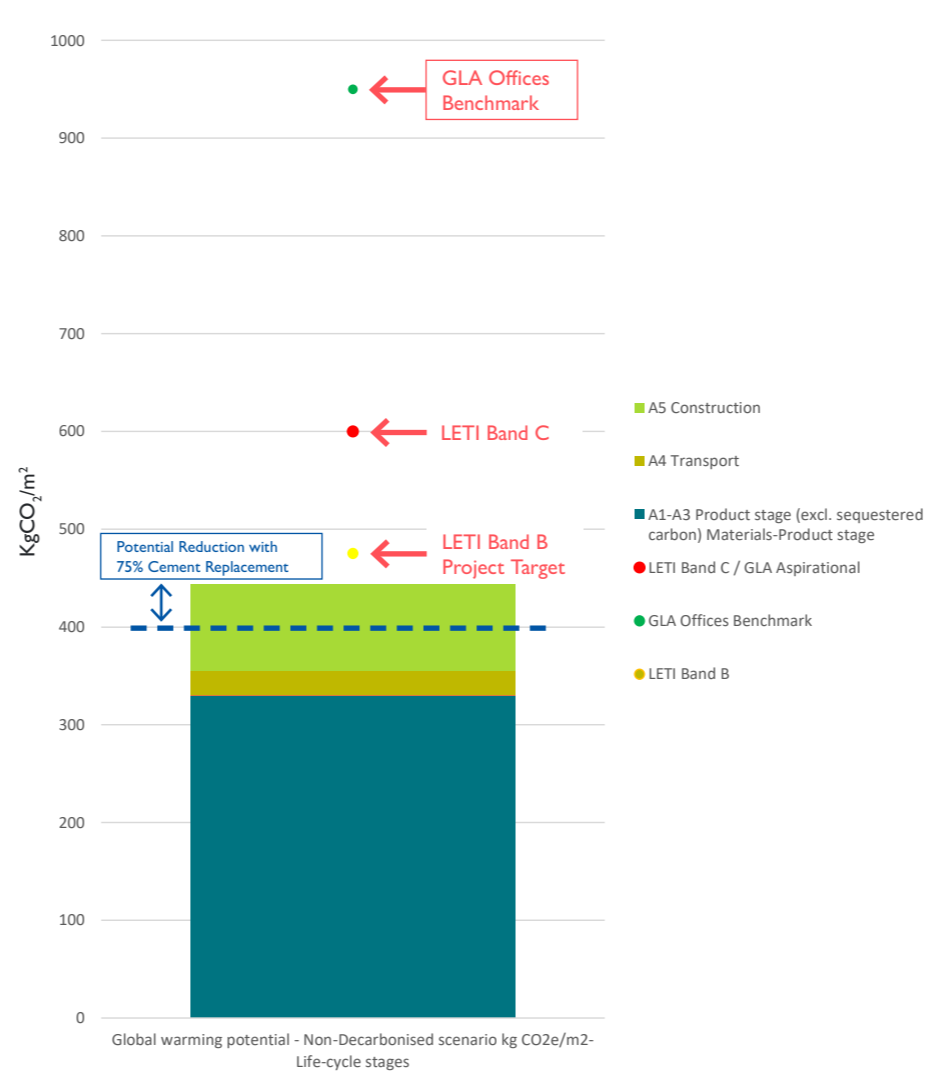
Global Warming Potential (Non-Decarbonised Scenario) Kg CO<sub>2</sub>e/m<sup>2</sup> (Stage A1 to A5)

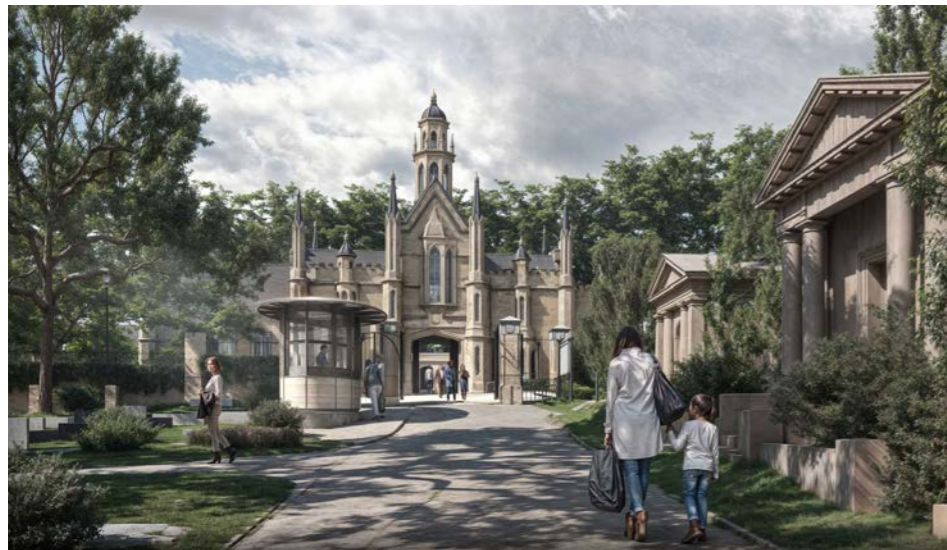
The A1-A5 target could potentially be achievable if the roof build-up and finish are specified as alternatives with lower embodied carbon. The model will be reviewed in the next stage to assess this adjustment.

Visualisation of Proposed Utility Block

Assessment of Project 1:	
Category	Global Warming Potential Non-Decarbonised Scenario Kg CO <sub>2</sub> e/m <sup>2</sup> Life Cycle Stages
A1-A3 Product Stages (excl. Sequestered Carbon)	674.1
A4 Transport	24.0
A5 Construction	77.9
Total	776 (658 with 75% Cement Replace.)

Assessment of Project 1:	
Category	Global Warming Potential Non-Decarbonised Scenario Kg CO <sub>2</sub> e/m <sup>2</sup> Life Cycle Stages
A1-A3 Product Stages (excl. Sequestered Carbon)	674.1
A4 Transport	24.0
A5 Construction	77.9
B1 Use Phase	NA
B2 Maintenance	11.7
B3 Repair	3.7
B4 Replacement	60.1
C1 Deconstruction/Demo	14.0
C2 Waste Transport	10.6
C3 Waste Processing	34.2
C4 Waste Disposal	0.0
Total	910 (792 with 75% Cement Replace.)

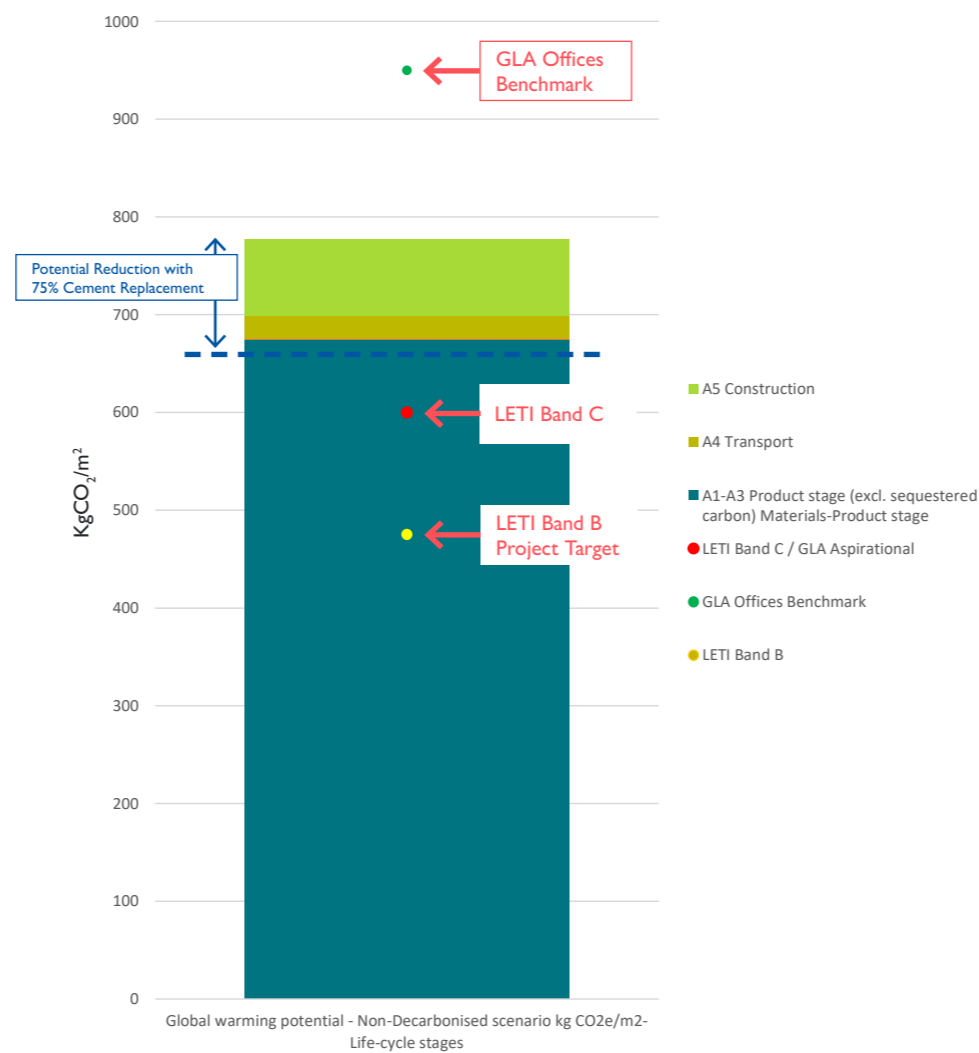
Global Warming Potential (Non-Decarbonised Scenario) Kg CO<sub>2</sub>e/m<sup>2</sup> (Stage A1 to A5)

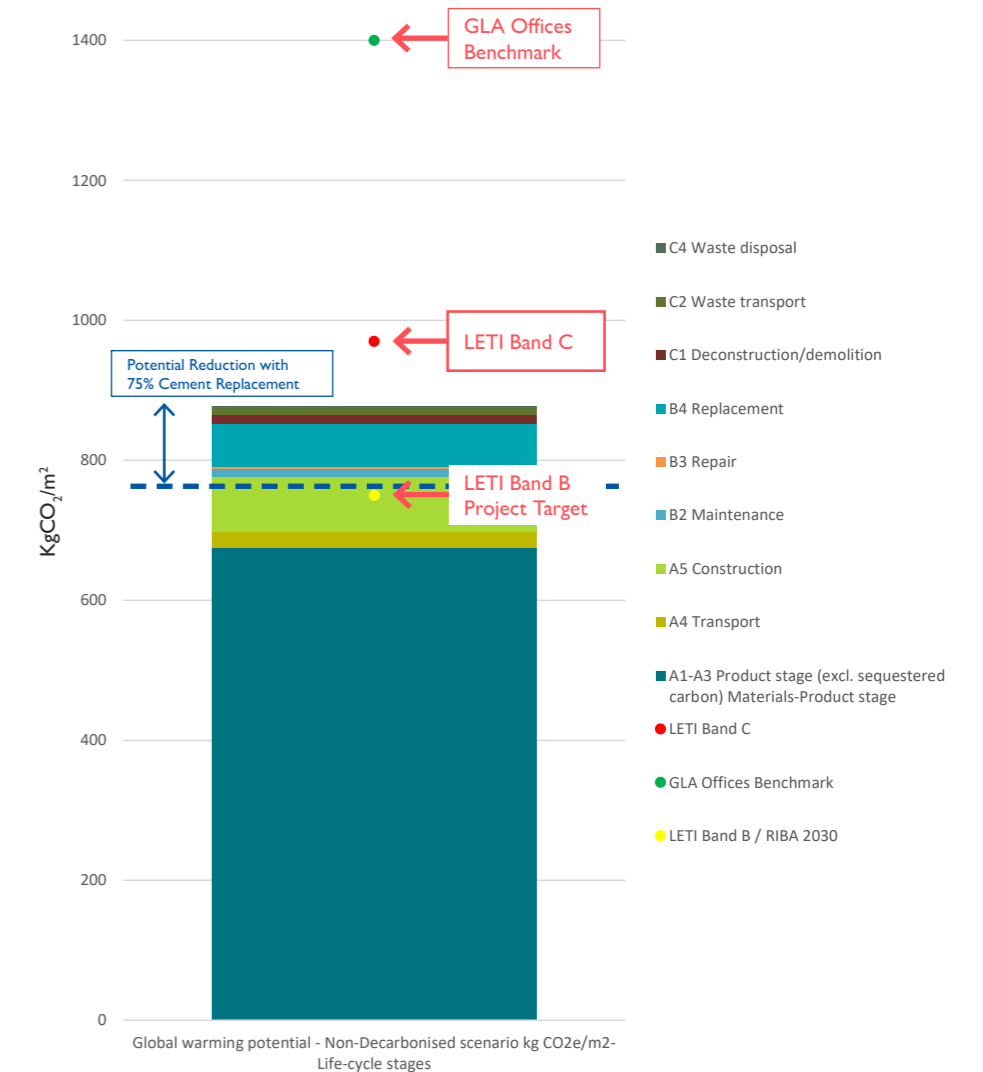
Global Warming Potential (Non-Decarbonised Scenario) Kg CO<sub>2</sub>e/m<sup>2</sup> (Stage A to C)

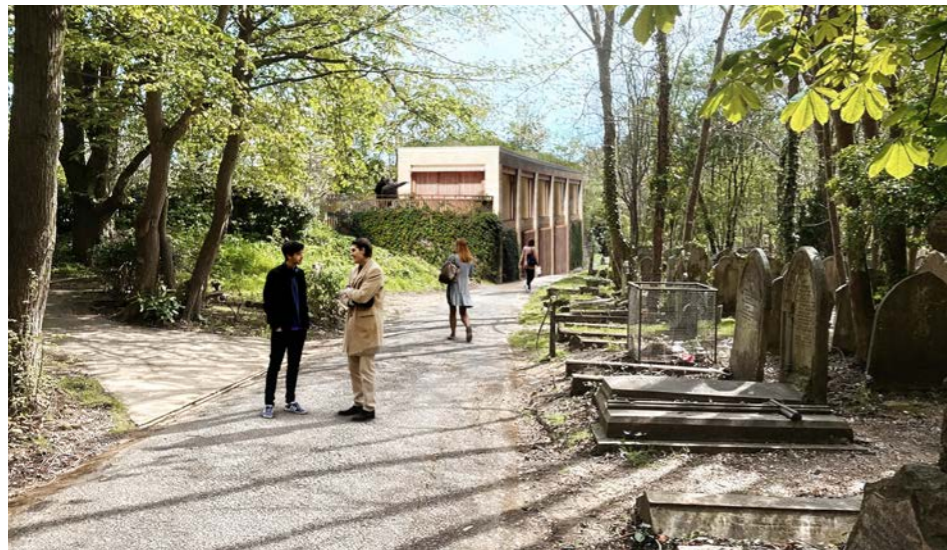
The high amount of concrete and reinforcement required for the retained walls, along with the use of steel for the gates and stair railings, presents challenges in meeting the targets. This is because the model already includes favourable assumptions, such as accounting for the steel in the gates and railings being modelled with 80% recycled content.

Visualisation of Proposed Utility Block

Assessment of Project 1:	
Category	Global Warming Potential Non-Decarbonised Scenario Kg CO <sub>2</sub> e/m <sup>2</sup> Life Cycle Stages
A1-A3 Product Stages (excl. Sequestered Carbon)	713.1
A4 Transport	65.7
A5 Construction	89.8
Total	869 (684 with 75% Cement Replace.)

Assessment of Project 1:	
Category	Global Warming Potential Non-Decarbonised Scenario Kg CO <sub>2</sub> e/m <sup>2</sup> Life Cycle Stages
A1-A3 Product Stages (excl. Sequestered Carbon)	713.1
A4 Transport	65.7
A5 Construction	89.8
B1 Use Phase	19.8
B2 Maintenance	13.4
B3 Repair	9.7
B4 Replacement	88.1
C1 Deconstruction/Demo	17.5
C2 Waste Transport	12.6
C3 Waste Processing	9.4
C4 Waste Disposal	0.1
Total	1030 (842 with 75% Cement Replace.)

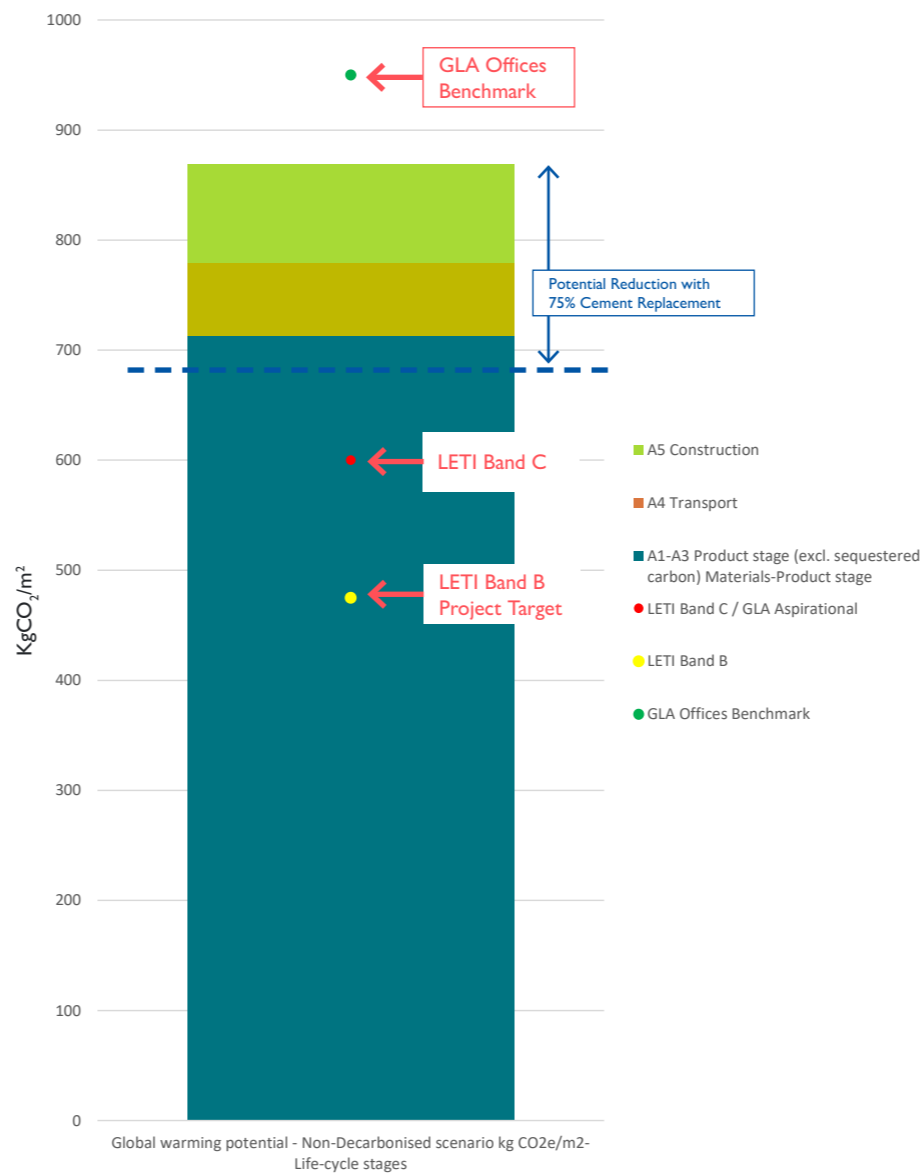
Global Warming Potential (Non-Decarbonised Scenario) Kg CO<sub>2</sub>e/m<sup>2</sup> (Stage A1 to A5)

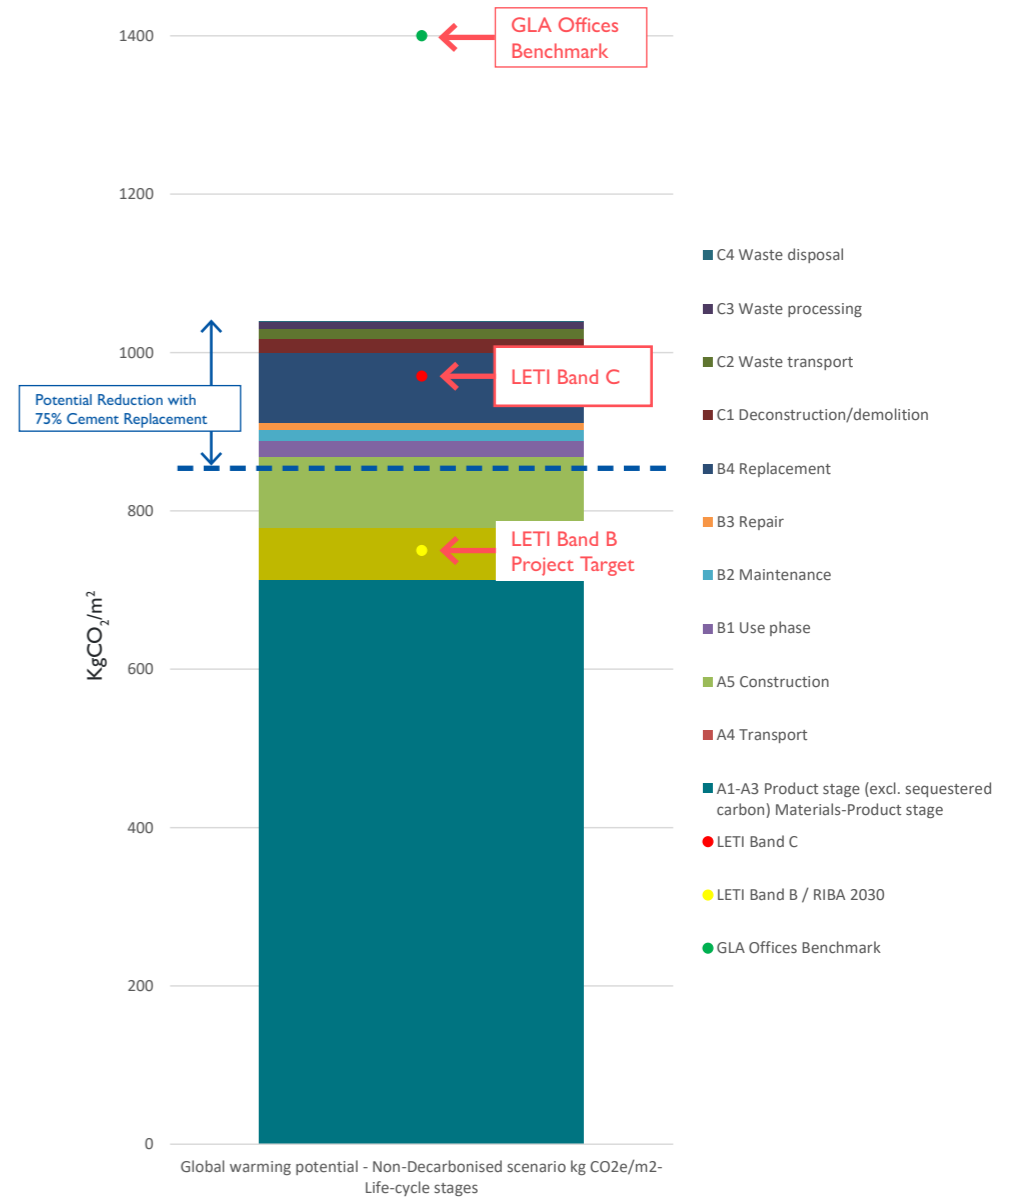
Global Warming Potential (Non-Decarbonised Scenario) Kg CO<sub>2</sub>e/m<sup>2</sup> (Stage A to C)

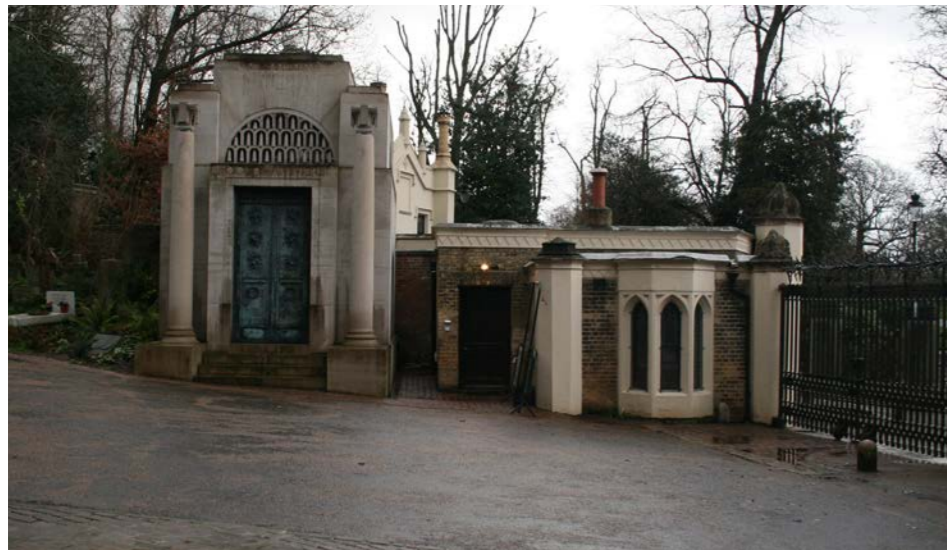
The embodied carbon is very low since this is a refurbishment project rather than a new build, allowing it to meet the targets. Please note that assessment excludes conservation repairs to the exterior of the building.

Visualisation of Proposed Utility Block

Assessment of Project 1:	
Category	Global Warming Potential Non-Decarbonised Scenario Kg CO <sub>2</sub> e/m <sup>2</sup> Life Cycle Stages
A1-A3 Product Stages (excl. Sequestered Carbon)	118.4
A4 Transport	9.8
A5 Construction	117.4
B1 Use Phase	NA
B2 Maintenance	11.6
B3 Repair	6.7
B4 Replacement	75.0
C1 Deconstruction/Demo	13.9
C2 Waste Transport	1.5
C3 Waste Processing	8.5
C4 Waste Disposal	0.0
Total	363
