**HIGHGATE CEMETERY:  
CHAPELS & ENTRANCE BUILDING, SOUTH LODGE**

**RIBA STAGE 3 SCHEDULE OF WORKS APPENDIX 3**

**MATERIALS ANALYSIS**

**Highgate Cemetery, London N6.  
Mortar Analysis. Results Summary - 5809/HC/01-06.**

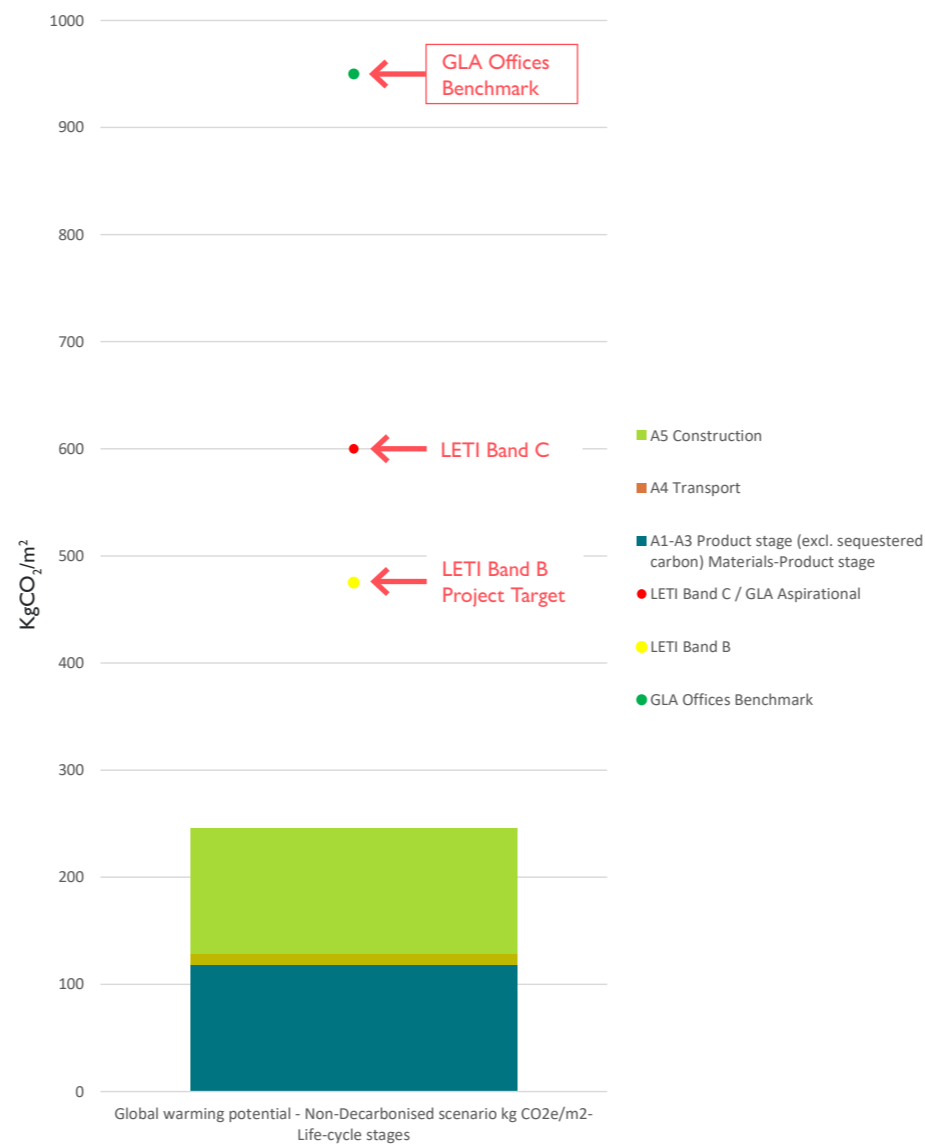
Global Warming Potential (Non-Decarbonised Scenario) Kg CO<sub>2</sub>e/m<sup>2</sup> (Stage A1 to A5)

The embodied carbon is very low since this is a refurbishment project rather than a new build, allowing it to meet the targets. Please note that assessment excludes conservation repairs to the exterior of the building.

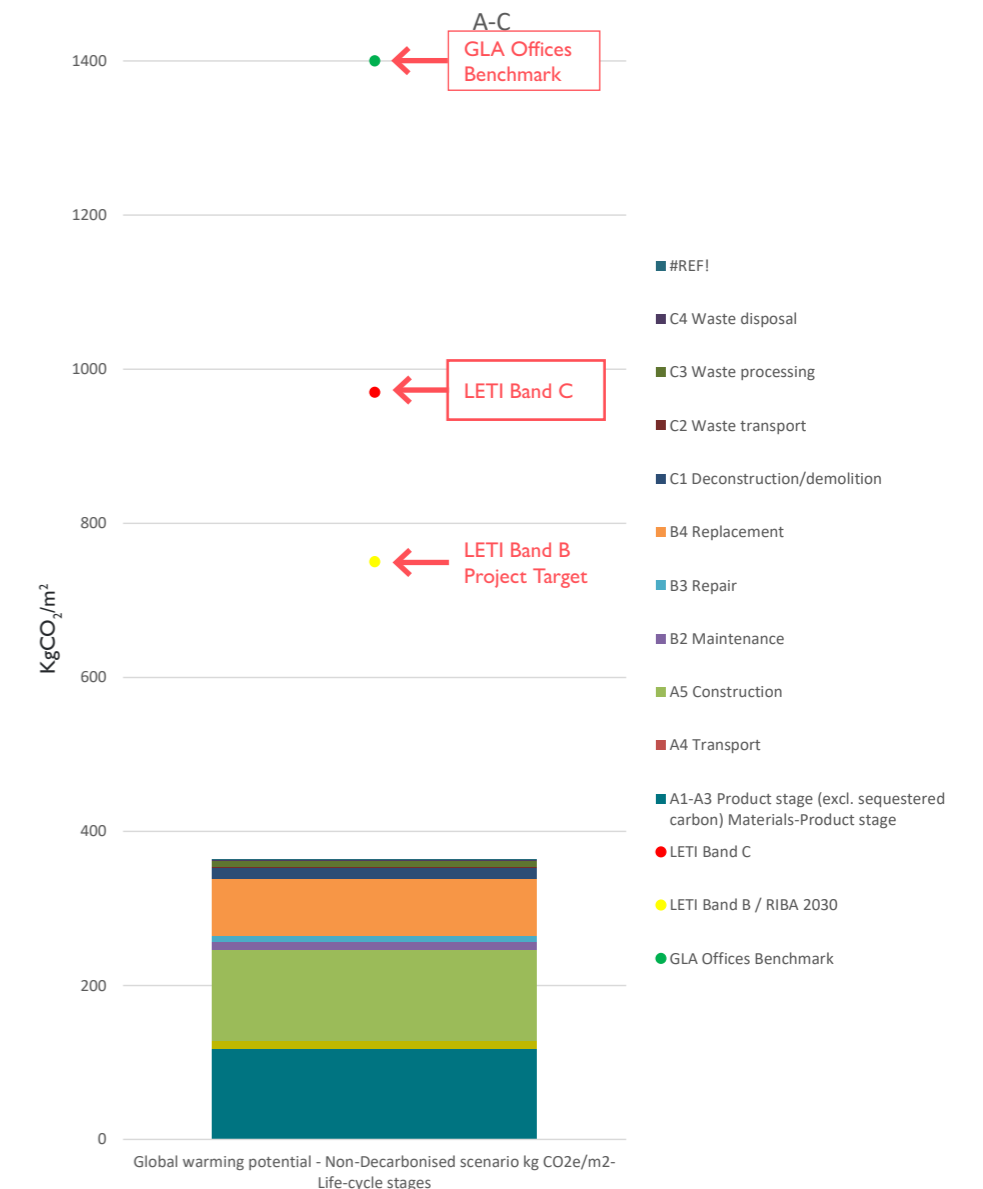
Global Warming Potential (Non-Decarbonised Scenario) Kg CO<sub>2</sub>e/m<sup>2</sup> (Stage A to C)
