## Building 4: THE COLONNADE

*West Scott Architects  
The Studio, 3A Bath Road  
London W4 1LL*

*Issue:  
22<sup>nd</sup> October 2024 Draft Final Stage 3.*

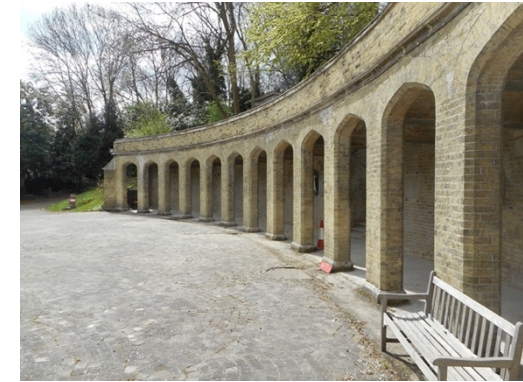
Figure 8. Colonnade

Original floor levels have been reliably established by excavation to reveal buried construction, supported by archive photo showing stone thresholds between arches.

Excavation of the late 20<sup>th</sup> century floor and reinstatement of historic floor levels in appropriate materials will enhance the setting, the appearance and the performance of the historic fabric.

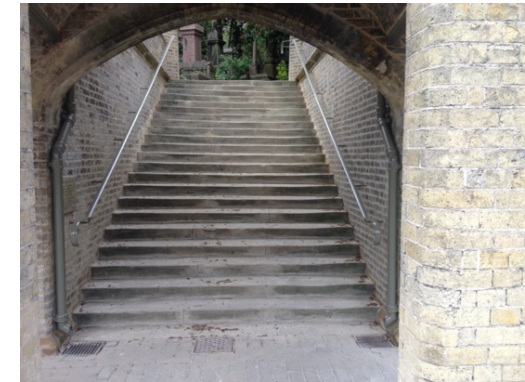
*Figure 9. Colonnade steps*

Use of the Colonnade is principally for access to the upper levels via the central stair. In the context of that the introduction of a minimal threshold between the arcade piers is not a significant matter, and it is recommended that the correct treatment of the historic fabric has precedence in this case.

The central staircase has already been provided with bilateral handrails (2016).

It is required for visitor management that a control line is established at the top of the central steps. This is proposed by a gated enclosure of railings at the top of the step flight. Visitor control policy is defined in documentation elsewhere.

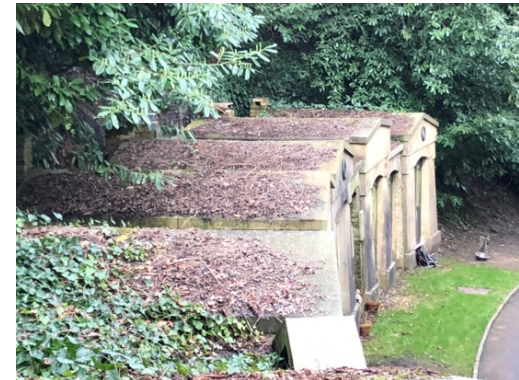
Figure 10. Roofs of Cuttings Catacombs

- Specify enhanced drainage at the rear of the catacomb structures to mitigate the degree of water penetration of the rear retaining wall. This will involve coordination with landscape management (CMP 6.18.3) both in advance of, during and following works.
- Enhance the drainage through the rear retaining wall in both the gaps in catacomb structures and the particularly wet vaults themselves, and organise the run-off to minimise impact on adjacent structures.
- Further review, and specify repairs with minor interventions to enhance the performance of the roofs in respect of shedding water, and disposal of the water that is shed.
- Carry out continued cyclical repair to address emerging defects. Examples are the repair of small areas of failed render to facades, and extensive repair and repointing of the brick

retaining walls in the gaps. Cyclical maintenance of ironwork such as gates will be included but will also require a long-term commitment outside the scope of Project 3.

It should be noted that the ongoing sustainability of the Catacombs structures will be dependent of management of the landscape AND general care of the structures including regular removal of vegetation from roofs and clearing of drains and channels. This falls outside the scope of this project, but will be critical to its success in the long term.

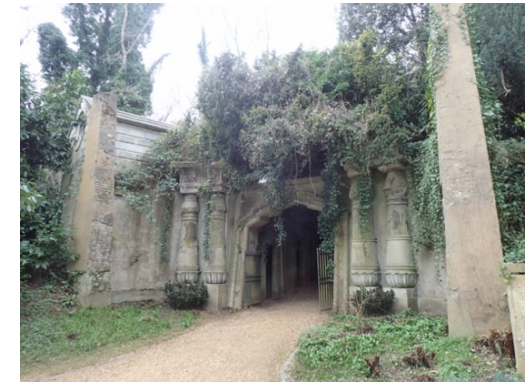
Figure 11. Egyptian Avenue lower portal

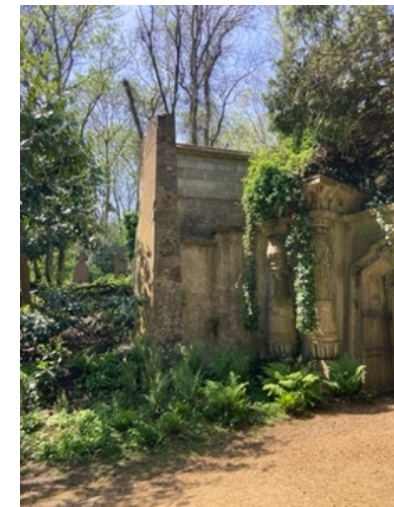
Figure 12. Lower portal broken obelisk

The scope of works is therefore to address the cyclical maintenance using the same ‘curated ruin’ philosophy, and to carry out what localised repairs are needed to sustain it in its 1998 condition. However to this we now add the reinstatement of the missing obelisk head and some of the missing render to the same elements deemed essential to the architectural appreciation of the composition.

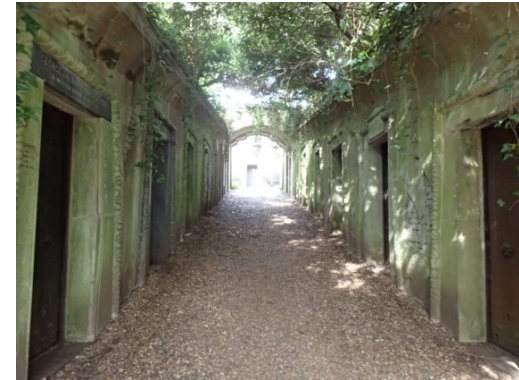
*Figure 13. Egyptian Avenue*

Guarding to the upper path where it crosses the sunken Egyptian Avenue is at present inadequate and relies on planting, management and signage for safety. Proposals to replace this with 1100mm high compliant guarding are included.

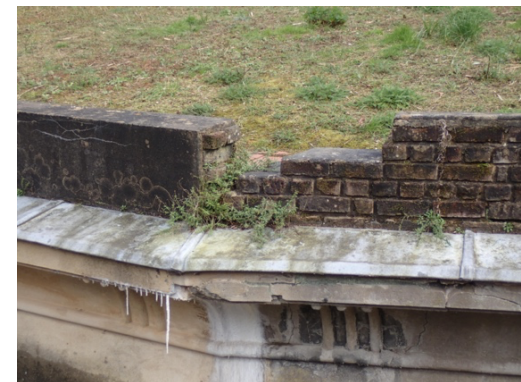
Figure 16. Evidence of previous repairs from 1990's works.

success, and the repairs required now to walls and surfaces to sustain the status quo is in many places no more onerous than it would be were the structure conventionally maintained. However there are some parts of the fabric that have deteriorated since 1998 to a substantial degree largely as a result of water ingress, and where there is a case for a different suite of construction details directed to the same aesthetic and philosophical outcome. The investigations and consideration in RIBA Stage 3 have concluded that the progressive deterioration of localised areas of wall surfaces and the accelerated corrosion of the door frames replaced in 1990-98 can and should be mitigated by improvement of the parapet wall-head detailing, and that the aesthetic impact of the resulting works (which will rapidly patinate) are an appropriate price to pay for this.

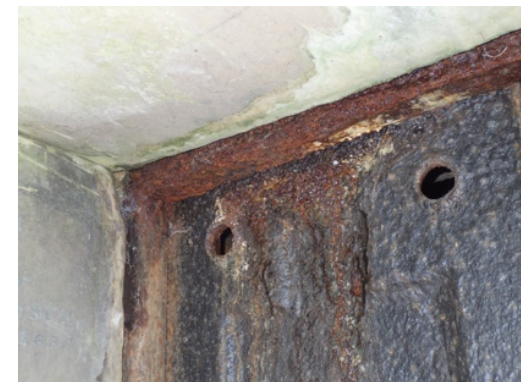
Figure 17. Rust-jacked frames have made access to some vaults difficult

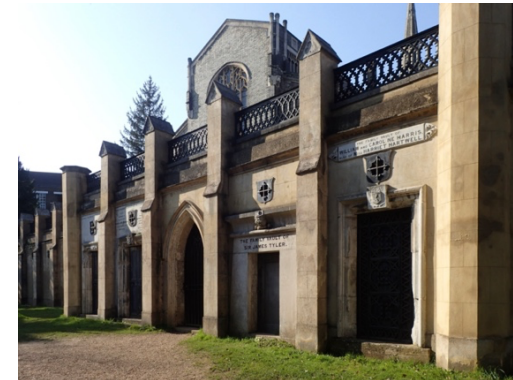
Figure 18. Terrace Catacombs approach elevation

To the end returns, where the vault structures are integrated with ramped and stepped approaches to the terrace, there are more significant issues, with substantial structural cracking and consequential render and other defects. Vegetation is involved in the ongoing decay, but above all the steps and ramps themselves have fallen into dereliction, and repairs to the facades need to be integrated with repairs to the steps and ramps. This is inevitably linked to the access strategy for the terrace and the wider site, which involves alterations.

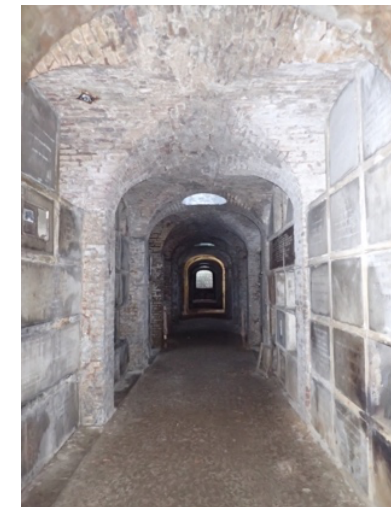
Figure 19. Terrace Catacombs internal vaults

The original asphalt covering to the flat terrace forming the waterproof roof membrane of the catacombs had failed and was removed, replaced by a tarmac surface which despite an underlying sheathing felt layer has proved to be water permeable. The general potential for water to penetrate is enhanced by the degradation of joints where the tarmac was patched following later drainage works and the water penetration into the vaults below is now at a level that gives serious concern.
