**HIGHGATE CEMETERY:
CHAPELS & ENTRANCE BUILDING, SOUTH LODGE**

RIBA STAGE 3 SCHEDULE OF WORKS APPENDIX 3

MATERIALS ANALYSIS

**Highgate Cemetery, London N6.
Mortar Analysis. Results Summary - 5809/HC/01-06.**

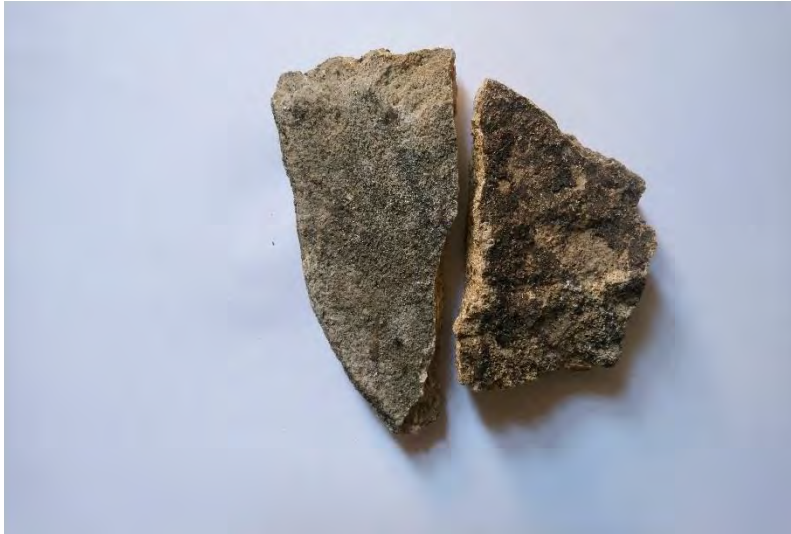
5809/HC/01
Sample as tested

Sample 5/M4 (5809/HC/01). This render sample from Vault 11 (Baxter) in the Cuttings catacombs comprises a thin pale grey finish coat applied to a yellow-brown backing coat. The finish coat has not been tested but it is almost certainly Portland cement mixed with fine sand probably at circa 1: 3. The backing coat has not fully carbonated and is Portland cement and washed yellow-brown quartz sand at circa 1 : 4 to 5. I understand this vault may date from circa 1850 and whilst it is possible that this render dates from then, I think it more likely to be later. Portland cement was not in common use in London until the 1860s and the lack of full carbonation and the washed sand may suggest a late 19th or early 20th century material.

Thin (2mm-3mm) hard pale grey finish coat removed prior to analysis. Intact yellow-brown render fragments c.12mm thick. High strength (sample could not be broken by hand nor crumbled in fingers; disrupted using pestle with difficulty). Aggregate is principally yellow quartz with occasional particles of other geological types. Calcareous aggregate not positively determined. Kiln-fuel particles not found. Hair or fibre reinforcement not present.

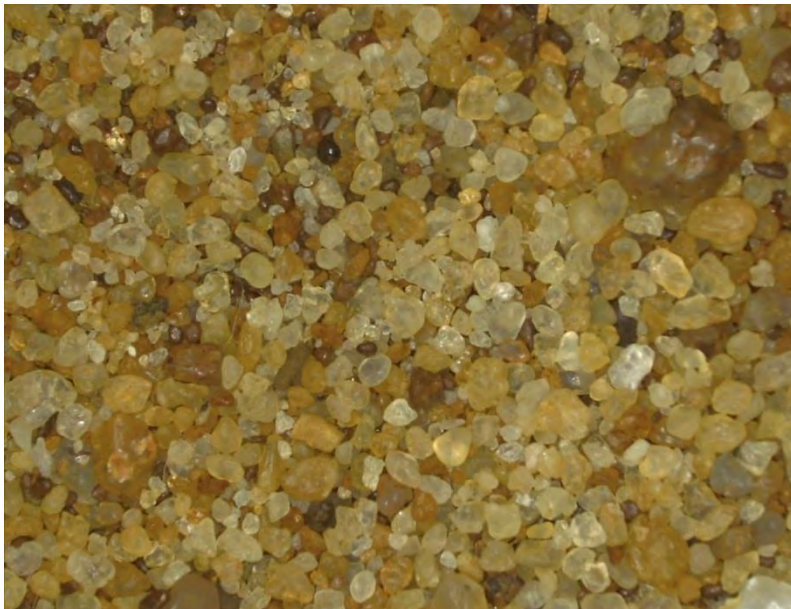
5809/HC/01
Insolubles >45 μ m
Stereomicroscope x10

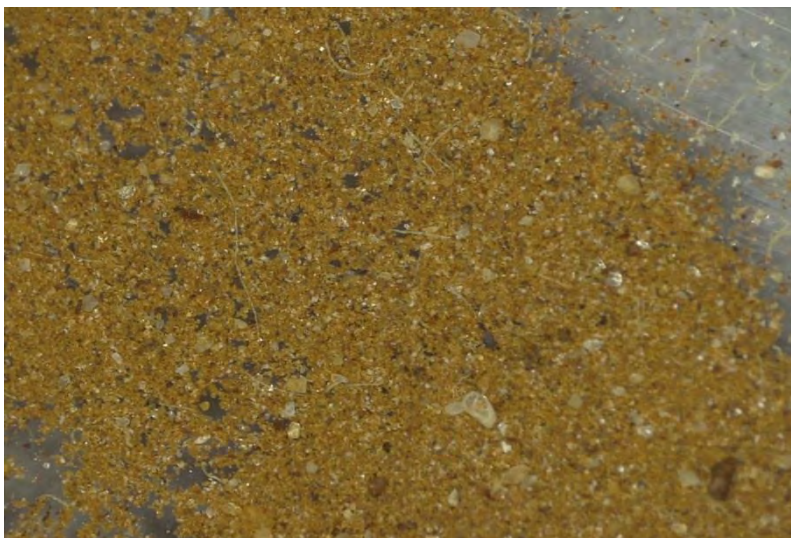
5809/HC/01
Insoluble fines <45 μ m
Stereomicroscope x20

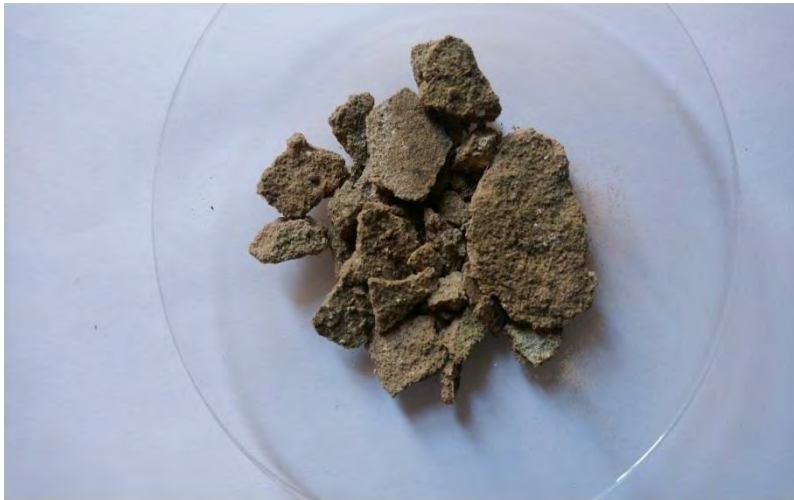
5809/HC/02
Sample as tested

Sample 6/M2 (5809/HC/02). This render sample from the RH Obelisk in Egyptian Avenue is a Roman cement binder and fine quartz sand at circa 1: 2. Roman cement was patented in 1796 and produced by calcining natural concretions known as septaria. It was a fast-setting material used primarily for external renders and run mouldings. It was gradually superseded by early Portland cements in the 2nd half of the 19th century. This is likely to be the original 1839 material.

Intact brown render fragments c.15mm thick. High/moderate (variable) strength (fragments could not be broken by hand nor crumbled in fingers; disrupted using pestle with some difficulty). Aggregate is principally fine yellow-brown quartz. Calcareous aggregate not positively determined. Kiln-fuel particles not found. Hair or fibre reinforcement not present.

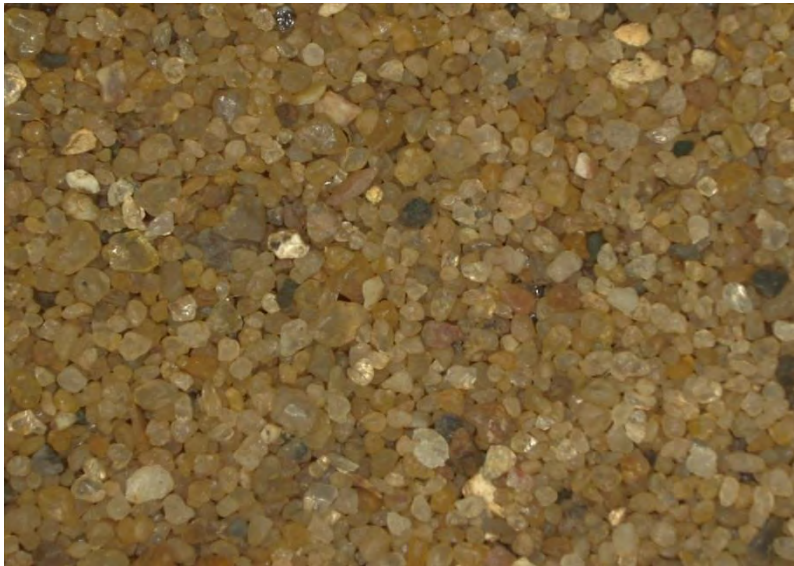
5809/HC/02
Insolubles >45 μ m
Stereomicroscope x10

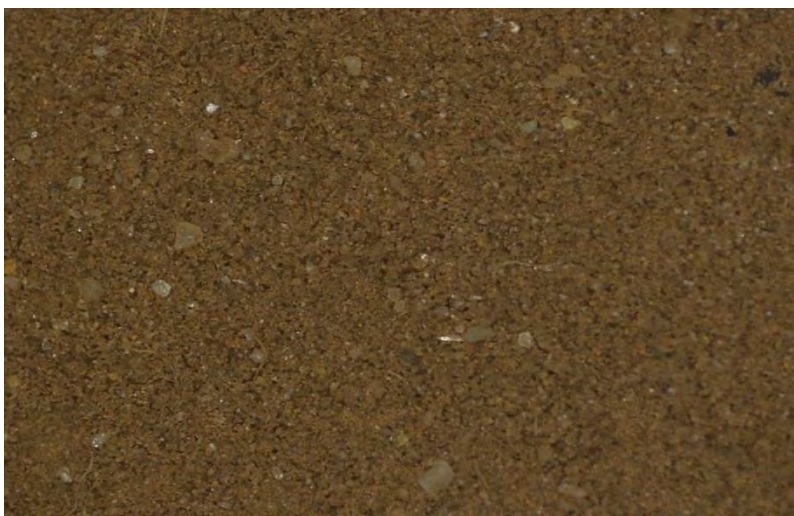
5809/HC/02
Insoluble fines <45 μ m
Stereomicroscope x20

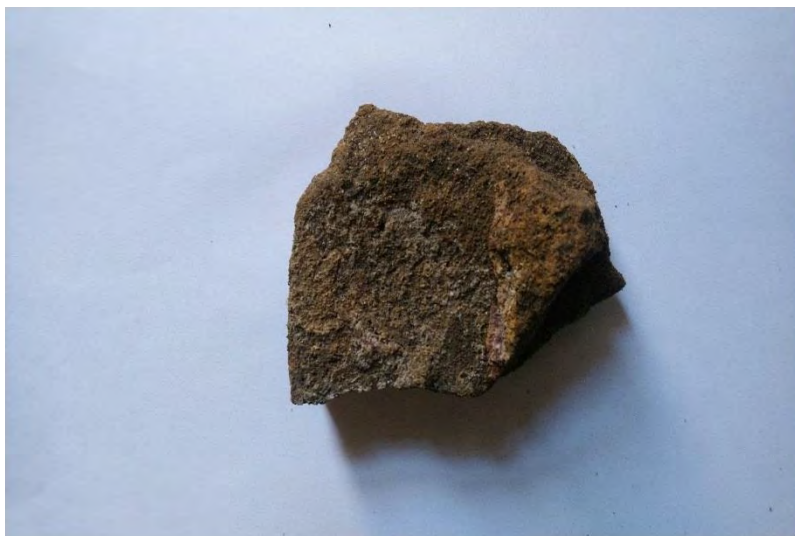
5809/HC/03
Sample as tested

Sample 6/M3 (5809/HC/03). This render sample from the LH Obelisk in Egyptian Avenue is also a Roman cement binder and fine quartz sand at circa 1: 2. It is similar to Sample 6/M2 and likely to be the original 1839 material.

Intact brown render fragments c.15mm thick. Moderate strength (fragments could be broken by hand but not crumbled in fingers; disrupted using pestle with some difficulty). Aggregate is principally yellow-brown quartz and fine flint. Calcareous aggregate not positively determined. Kiln-fuel particles not found. Hair or fibre reinforcement not present.

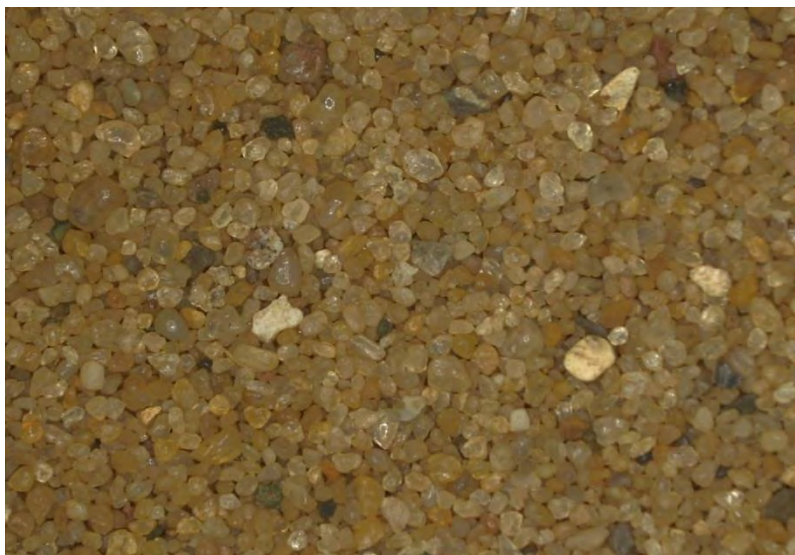
5809/HC/03
Insolubles >45 μ m
Stereomicroscope x10

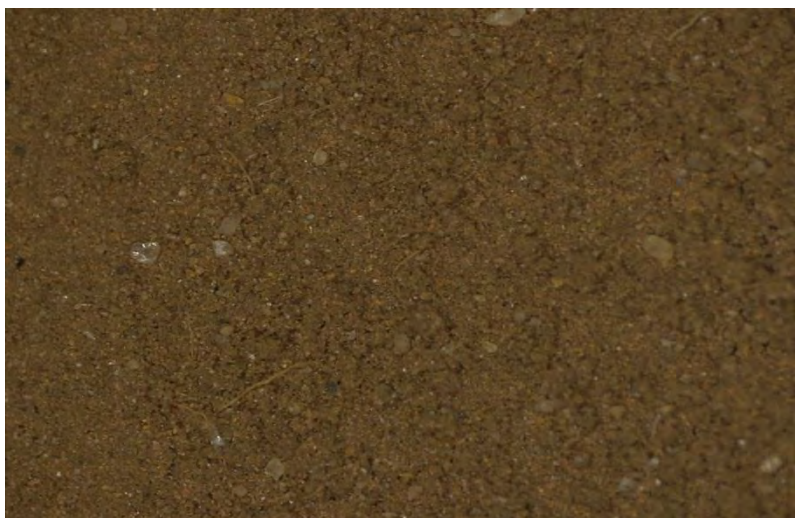
5809/HC/03
Insoluble fines <45 μ m
Stereomicroscope x20

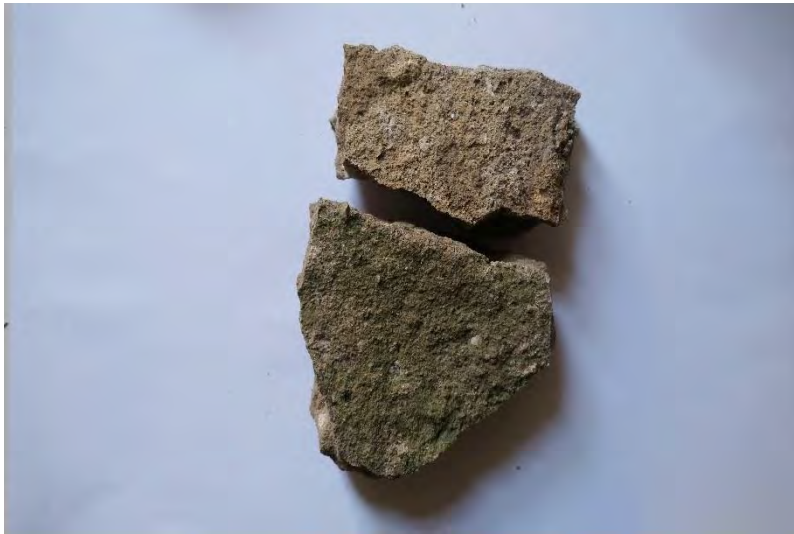
5809/HC/04
Sample as tested

Intact brown render fragments c.30mm thick applied in two coats. High/moderate strength (sample could not be broken by hand nor crumbled in fingers; disrupted using pestle with some difficulty). Aggregate is principally yellow-brown quartz. Calcareous aggregate not positively determined. Kiln-fuel particles not found. Hair or fibre reinforcement not present.

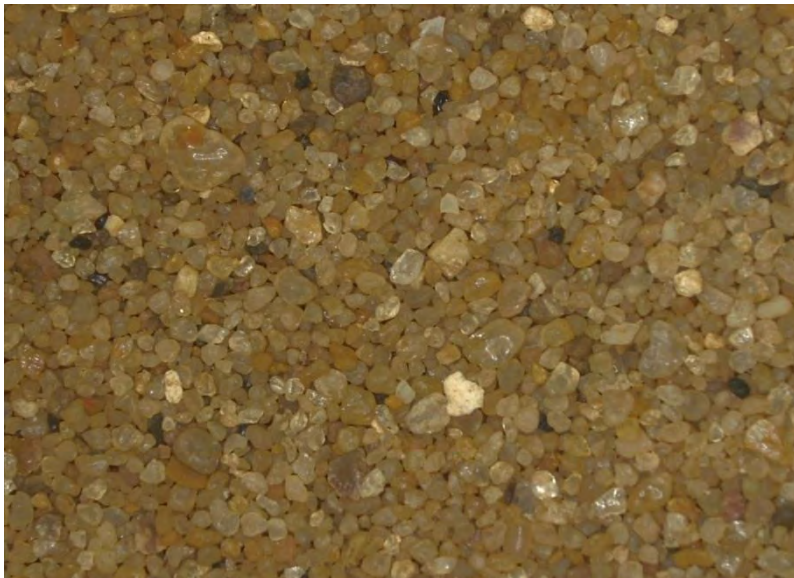
5809/HC/04
Insolubles >45 μ m
Stereomicroscope x10

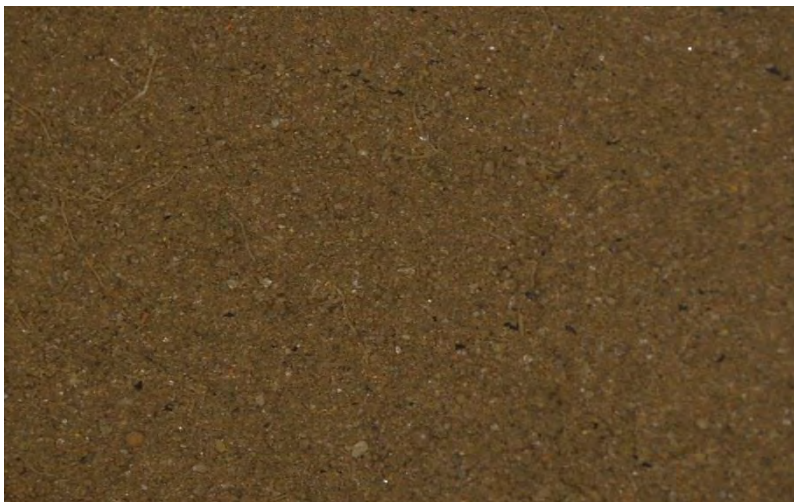
5809/HC/04
Insoluble fines <45 μ m
Stereomicroscope x20

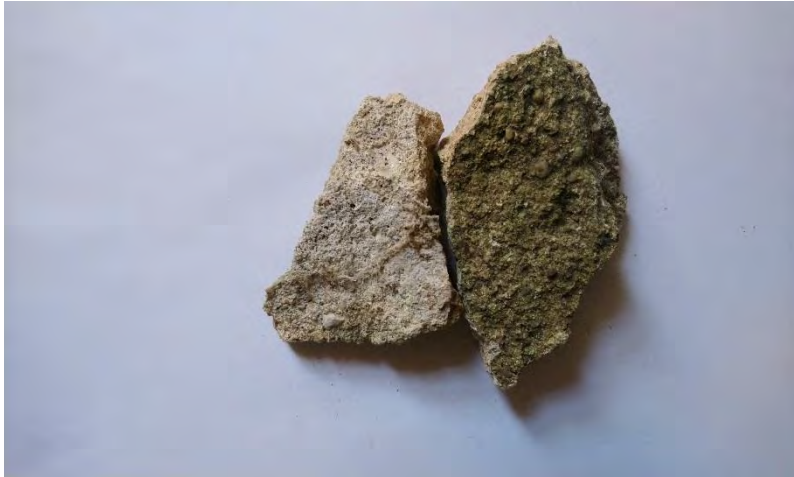
5809/HC/05
Sample as tested

Intact yellow-brown render fragments c.15mm thick. High strength (sample could not be broken by hand nor crumbled in fingers; disrupted using pestle with difficulty). Aggregate is principally yellow quartz with particles of flint and other geological types. Calcareous aggregate not positively determined. Kiln-fuel particles not found. Hair or fibre reinforcement not present.

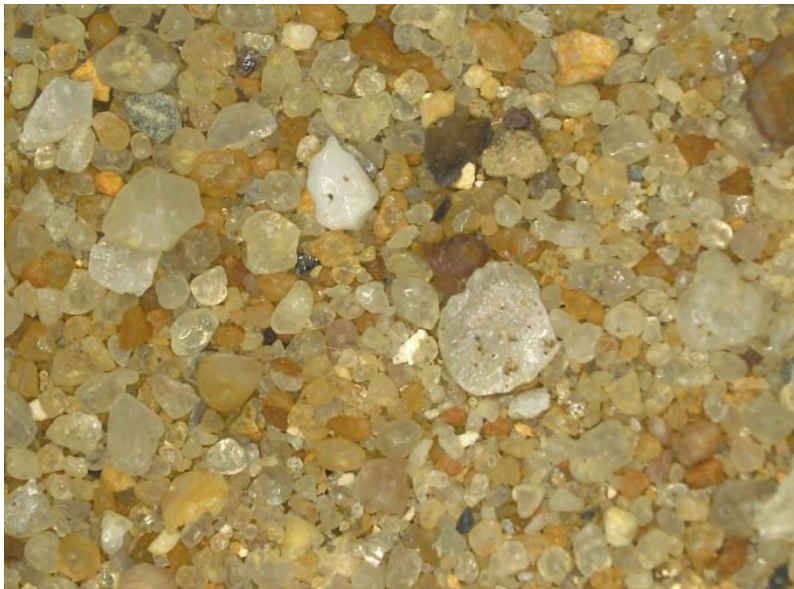
5809/HC/05
Insolubles >45 μ m
Stereomicroscope x10

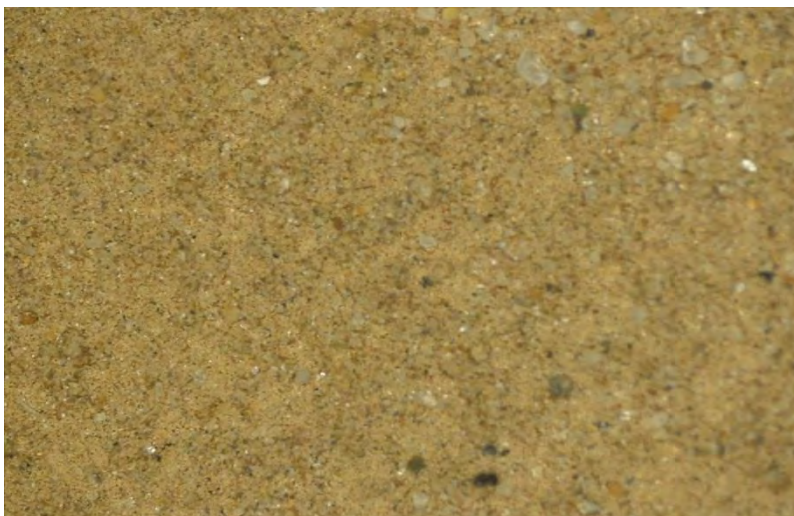
5809/HC/05
Insoluble fines <45 μ m
Stereomicroscope x20

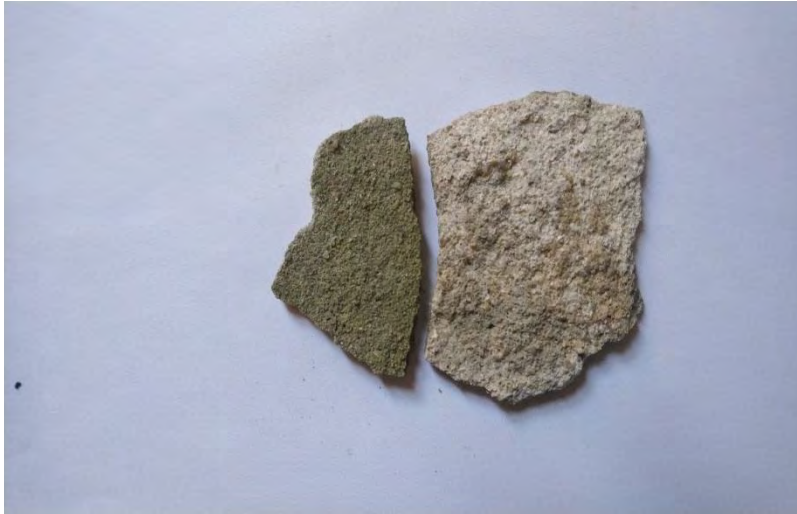
5809/HC/06
Sample as tested

Intact pale grey-brown render fragments c.3mm thick. High strength (thin fragments could be snapped by hand with some difficulty but not crumbled in fingers; disrupted using pestle with difficulty). Aggregate is principally fine yellow quartz. Calcareous aggregate not positively determined. Kiln-fuel particles not found. Hair or fibre reinforcement not present.

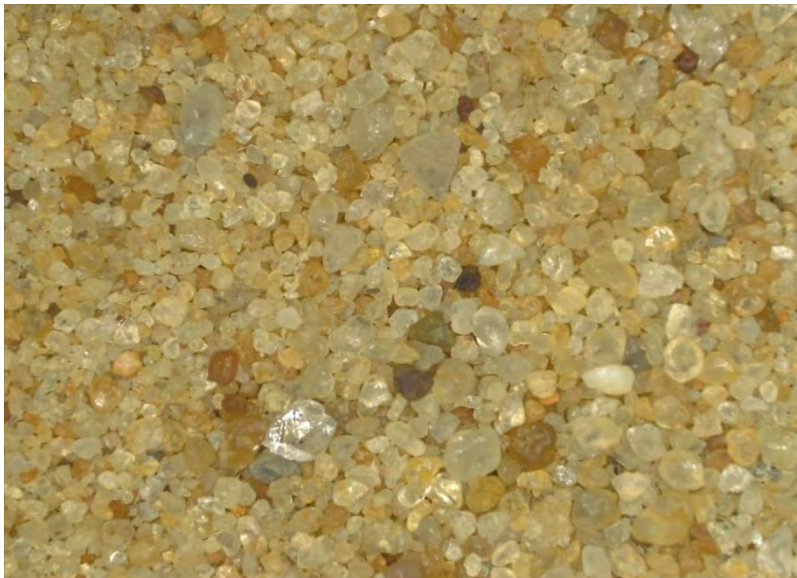
5809/HC/06
Insolubles >45µm
Stereomicroscope x10

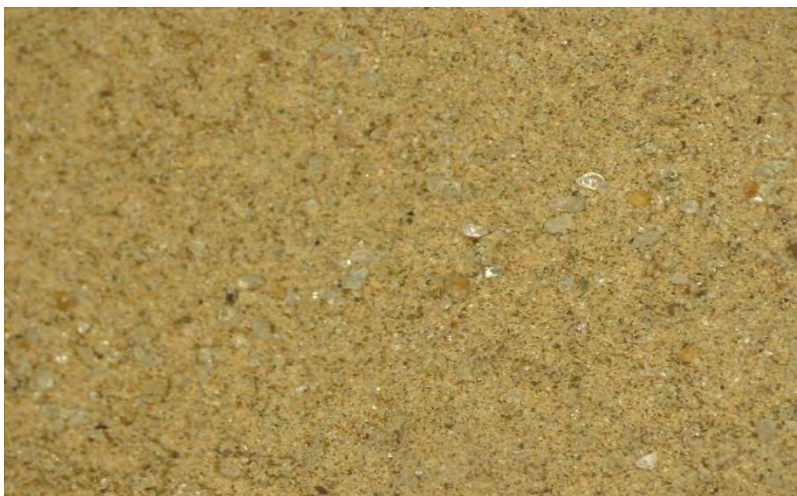
5809/HC/06
Insoluble fines <45µm
Stereomicroscope x20
