# Highgate Cemetery Conservation Philosophy

Prepared for the Friends of  
Highgate Cemetery Trust  
November 2024

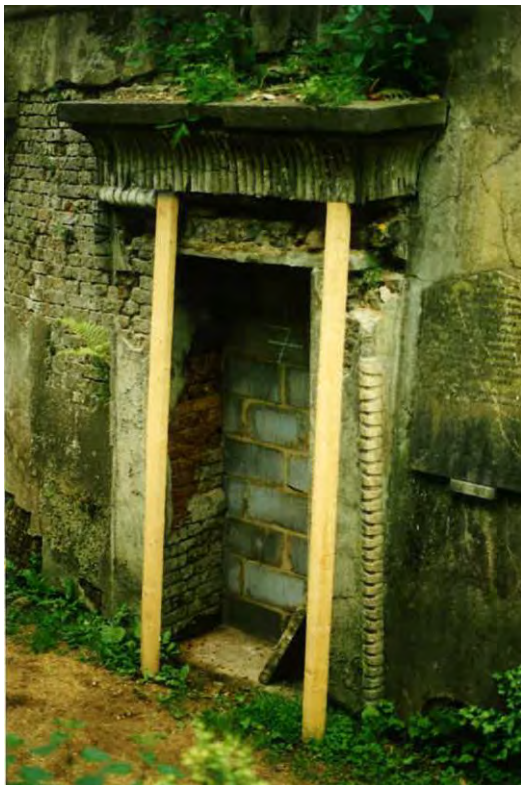
Figure 4: Portal to Vault 7 prior to conservation, cornice supported by timber posts.

Vegetation had grown in many of the monument's cracks and voids, and particularly between the cornice and wall of Vault 7 where a plant had pushed the cornice above the doorway away from the wall. This was worsened by the deteriorated brick core above the cornice which was no longer properly supporting it. The cornice was instead being held up by temporary timber posts (Figure 2).

Other condition defects to Vault 7 included missing mouldings to the entablature and jambs, detached render, remaining render in very poor condition, and exposed brickwork of varying levels of condition.

New render was applied to three specific areas: the section of the left-hand inner reveal where the render had fallen but its outline clearly legible; areas of the top of the cornice that had been cut out to insert the steel straps; and the vertical wall above the cornice.

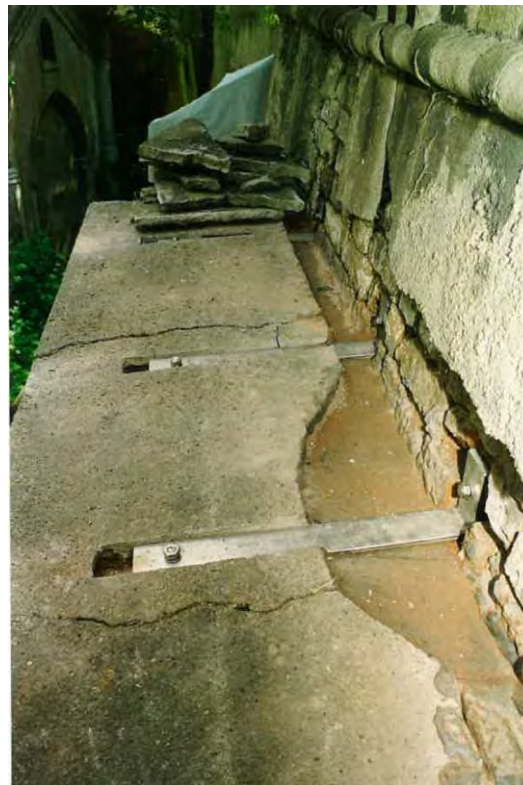
Figure 5: Inserted steel straps to fix the cornice to the wall

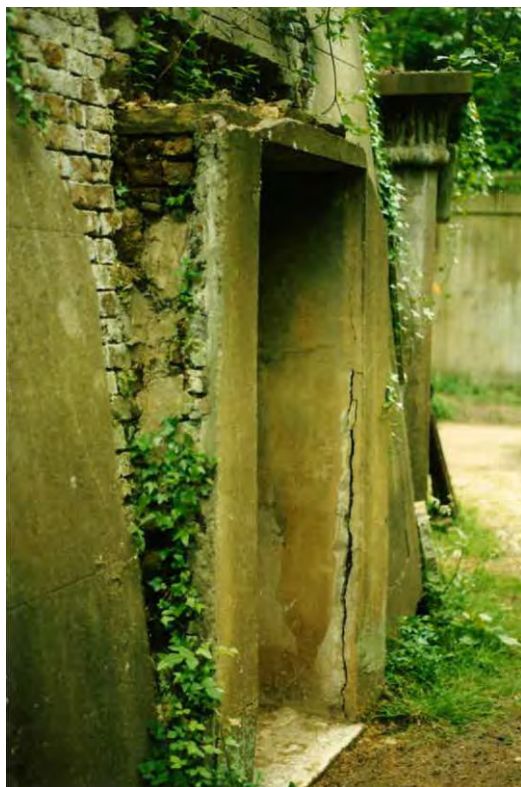
**Figure 6: Decayed state of Vault 13 doorway prior to conservation**

The entrance to this vault was in very poor condition, with all construction above lintel level missing (Figure 4) and the exposed brickwork badly decayed and overgrown. There was uncertainty whether the dressings to the entrance were original.

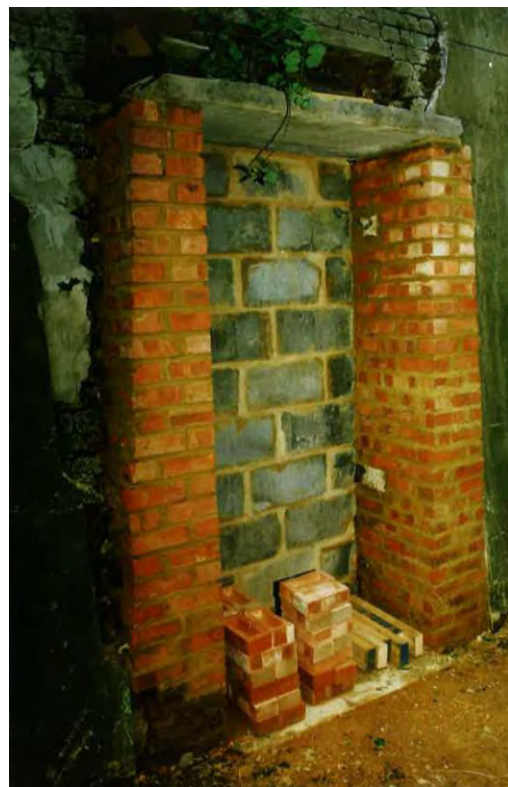
**Figure 7: Rebuilt doorway to Vault 13 in 1994**

Given its high level of decay, it was decided to renew the entrance to the vault in marble, to the same design as Vault 16 overleaf. The remaining render was removed, the structurally unstable brickwork demolished, and the original York stone lintel carefully retained.

The brick core was rebuilt (Figure 5), Carrara marble with a honed rather than polished finish was fixed to the doorway, and lightweight blocks inserted into the cornice to support it. All areas of brickwork were re-rendered, with a groove marked out to show the boundary between new and old render.

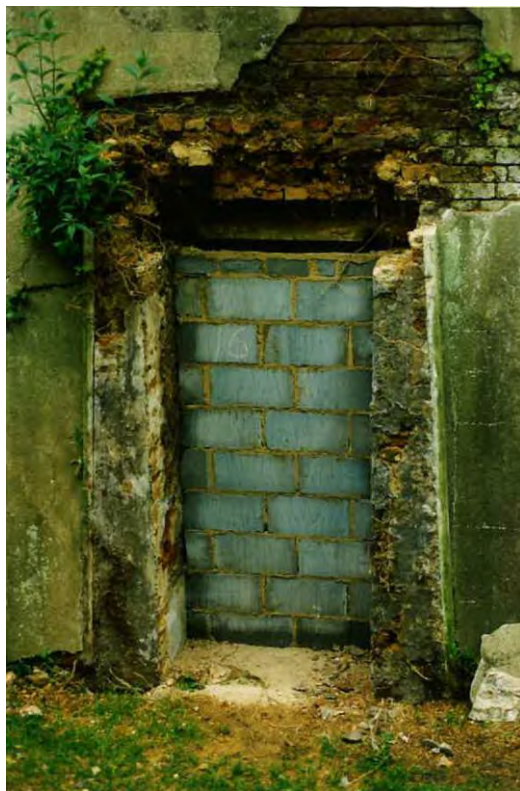
**Figure 8: Doorcase to Vault 16 with the marble surrounds removed, 1994**

The cornice and surrounding render to the doorway was very poor; the marble was stained; root growth had disturbed joints between the marble; and there were large deposits of cement where the vault had historically been blocked. The cornice was missing but retained some of its roll moulding, though its brick core was severely decayed and overgrown. Render was in similarly poor condition with significant cracks, lifting by plant growth, and complete detachment.

The brick core and York stone lintel of the cornice were removed, as were the marble facings to the doorway. The brick core underneath was in good condition and was simply repointed. The marble was cleaned off-site at the Nimbus workshop.

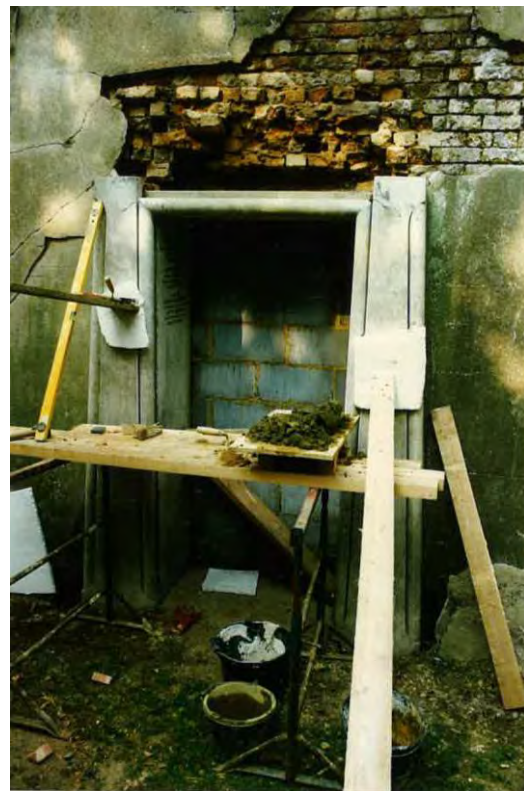
**Figure 9: New marble dressings being applied to the doorcase, 1994**

A new roll-moulded cornice was cast and built of bricks in honeycomb formation, a bed of slate, and surmounted by lead coping as on the other vault entrances.

Many areas of detached render were removed and marked up. This was then repaired in the same way as Vault 7, comprising both new render and consolidating chunks of detached render.

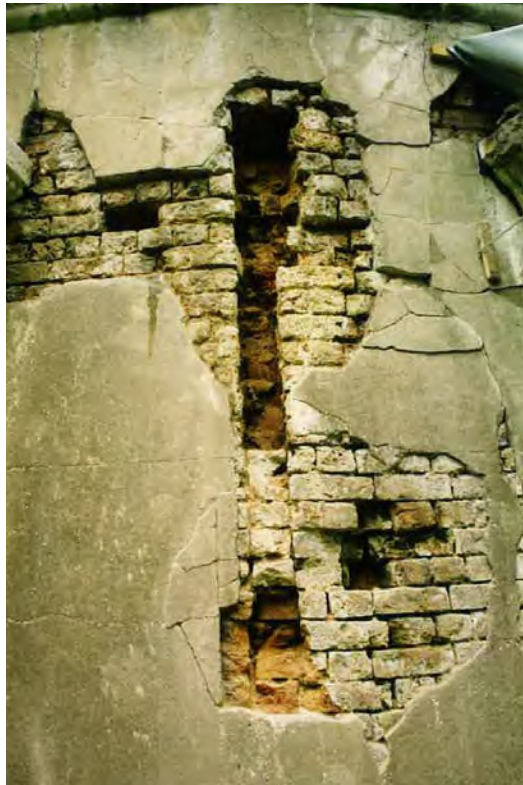
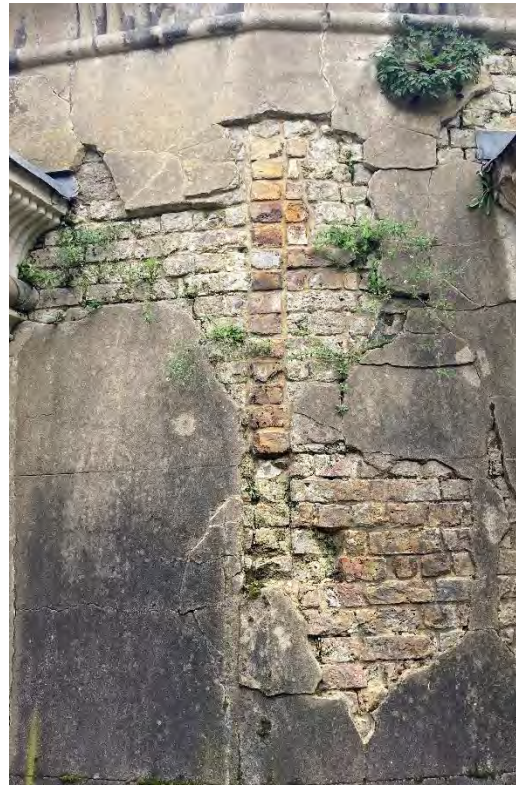
**Figure 10: Exposed drainpipe trench at corner of monument**

The trench of a previous drainpipe was infilled with stock brick (Figures 8 and 9).

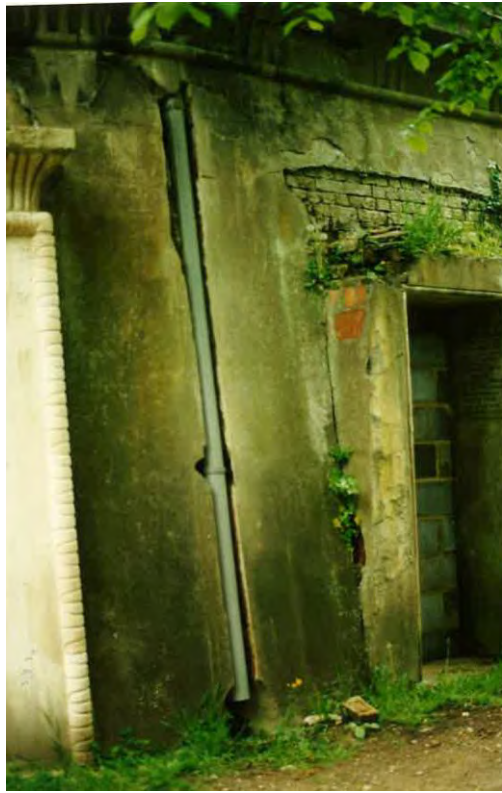
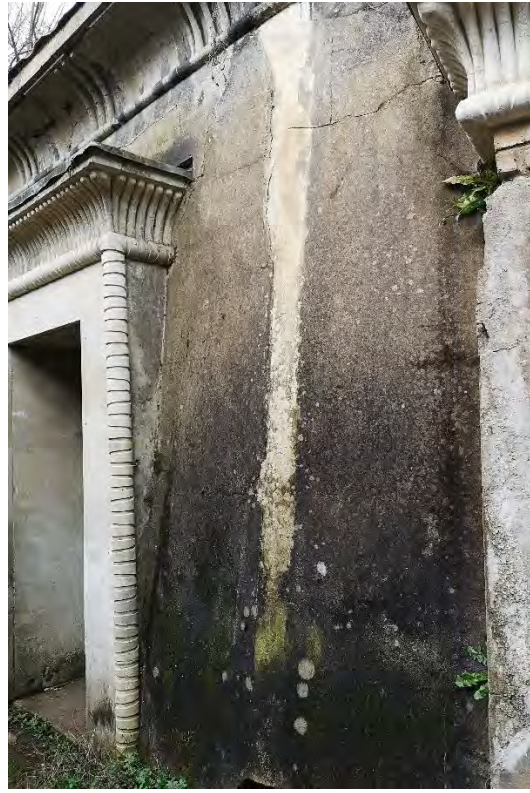
Figure 12: Exposed drainpipe

Further work to Vault 10 in 1994 entailed the re-rendering immediately above the doorway, re-rendering over the new downpipe installed to the right of the doorway (Figures 10 and 11), and installing a lead tray on top of the entablature.

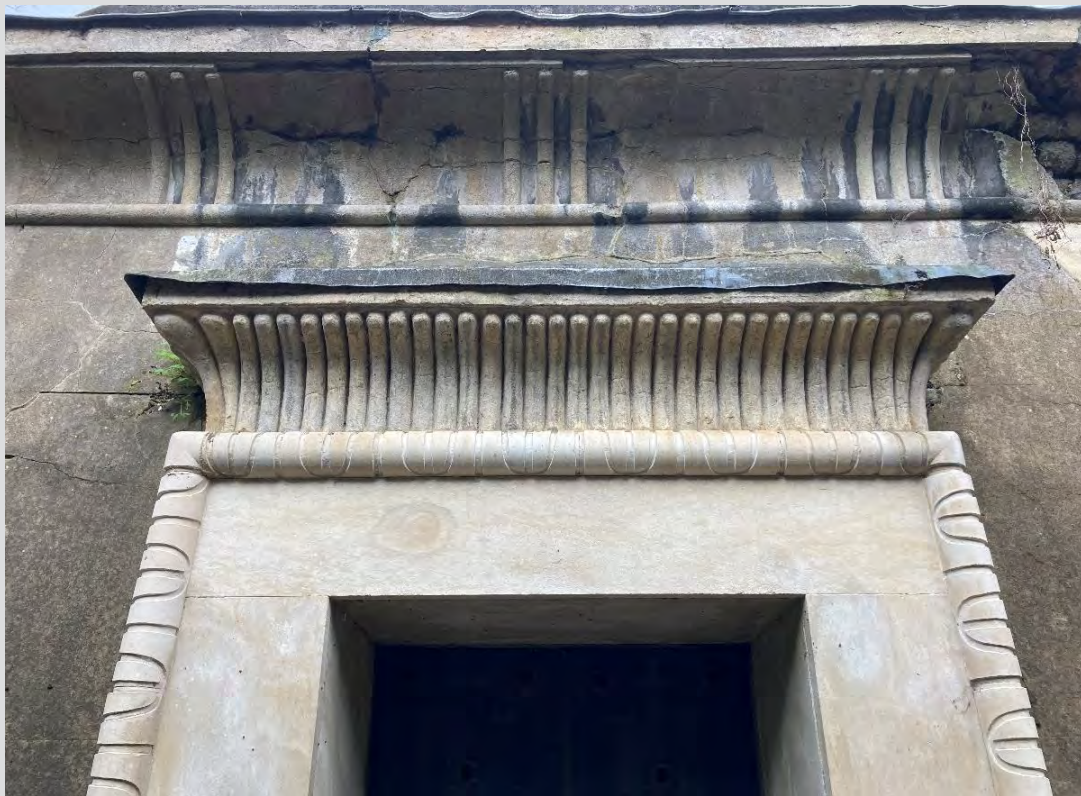
**Figure 14: Restored doorcase and cornice to the Circle of Lebanon**

It is therefore an unhelpful description of these works because more was done than simply fixing elements in the state they had been found upon intervention. For example, many of the surrounds and entablatures to the Circle of Lebanon doorcases were reinstated. Fluting details were restored in jesmonite, while doorways were reinstated with new render or marble.

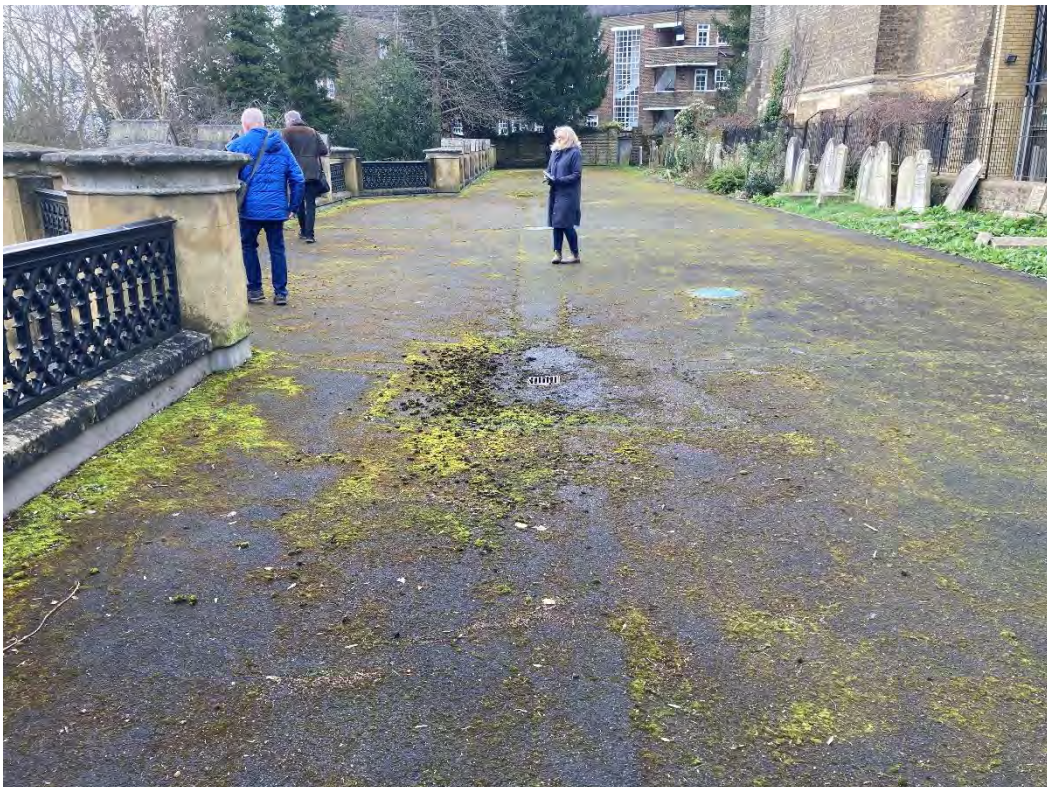
Figure 15: Modern tarmac over the Terrace Catacombs

The Victorian asphalt roof was removed in 1986-88 and replaced with tarmac, incorporating a surface water drainage system. However, this has caused problems of water ingress into the vaults below.

The roof of the Catacombs was again repaired in 2002, however, water ingress problems continue.

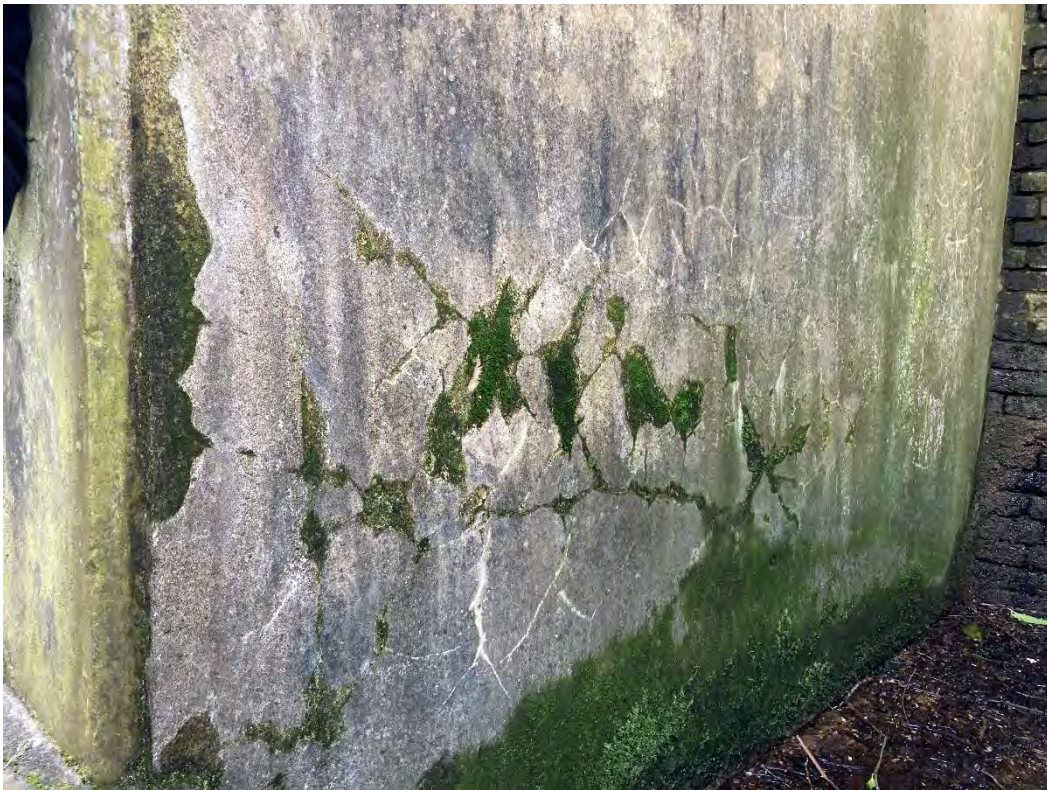
Figure 16: Flank wall of one of the vaults in the Cuttings Catacombs

The Cuttings Catacombs have continually suffered structural defects. Historic interventions have included building stepped buttresses to support the exposed flank walls of the vaults, and in 2008, a modern steel armature was inserted inside many of the vaults to support the pitched masonry roofs.

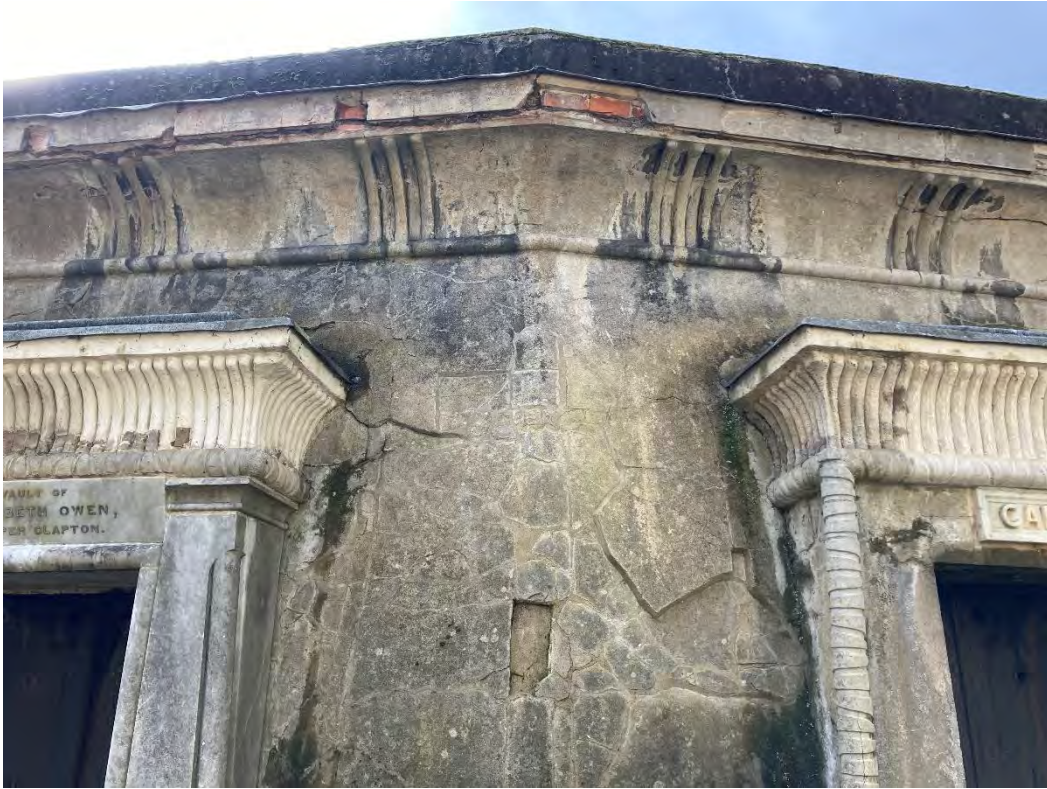
**Figure 17: Original render has been pinned back to the walls of the monument. Grooves incised into the grout differentiate between old and new.**

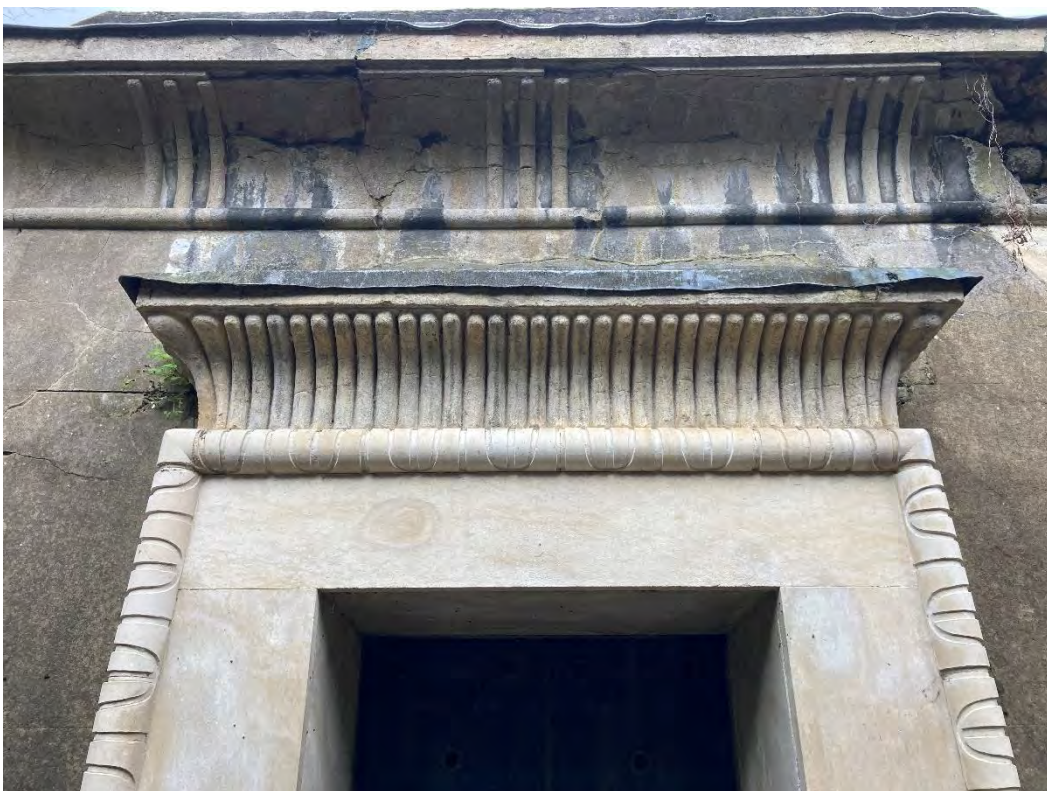
**Figure 18: Varying degrees of restoration were employed at the Circle of Lebanon, from maintaining its ruined appearance to reinstating lost features.**

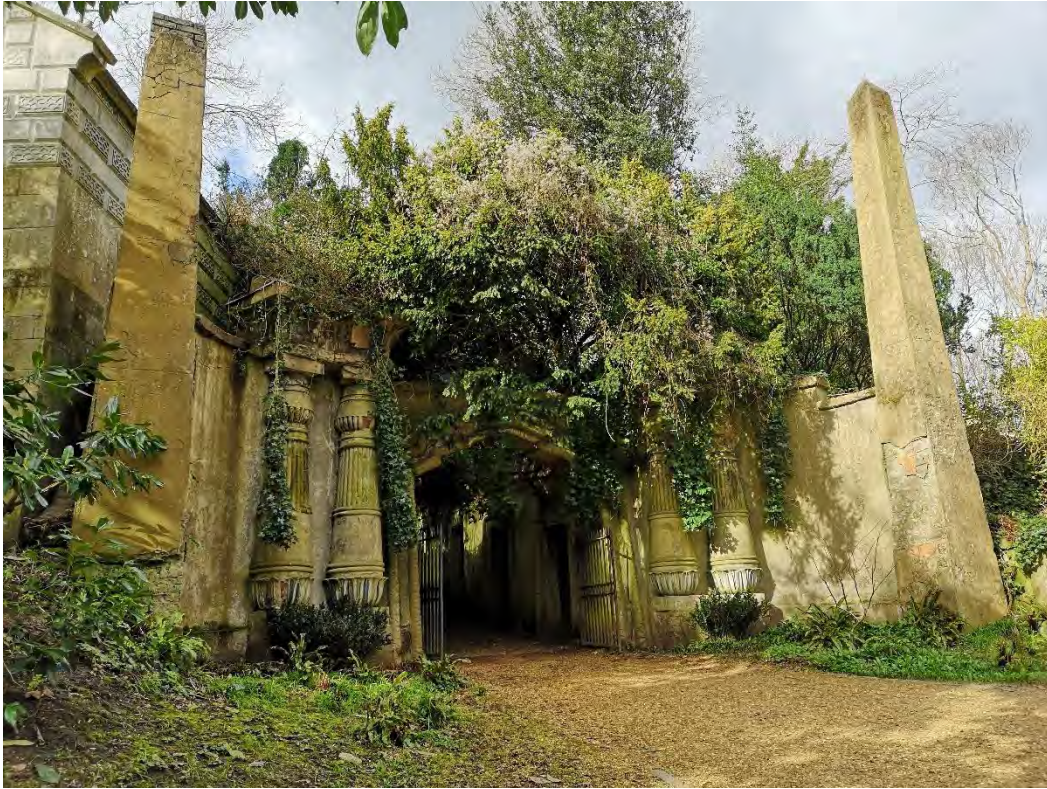
**Figure 19: The Egyptian Avenue is of aesthetic value as a grand and unique monument within the cemetery. However, the imbalance caused by losing the left-hand obelisk head and the cornice has diminished this architectural interest because its original design has been made less legible.**

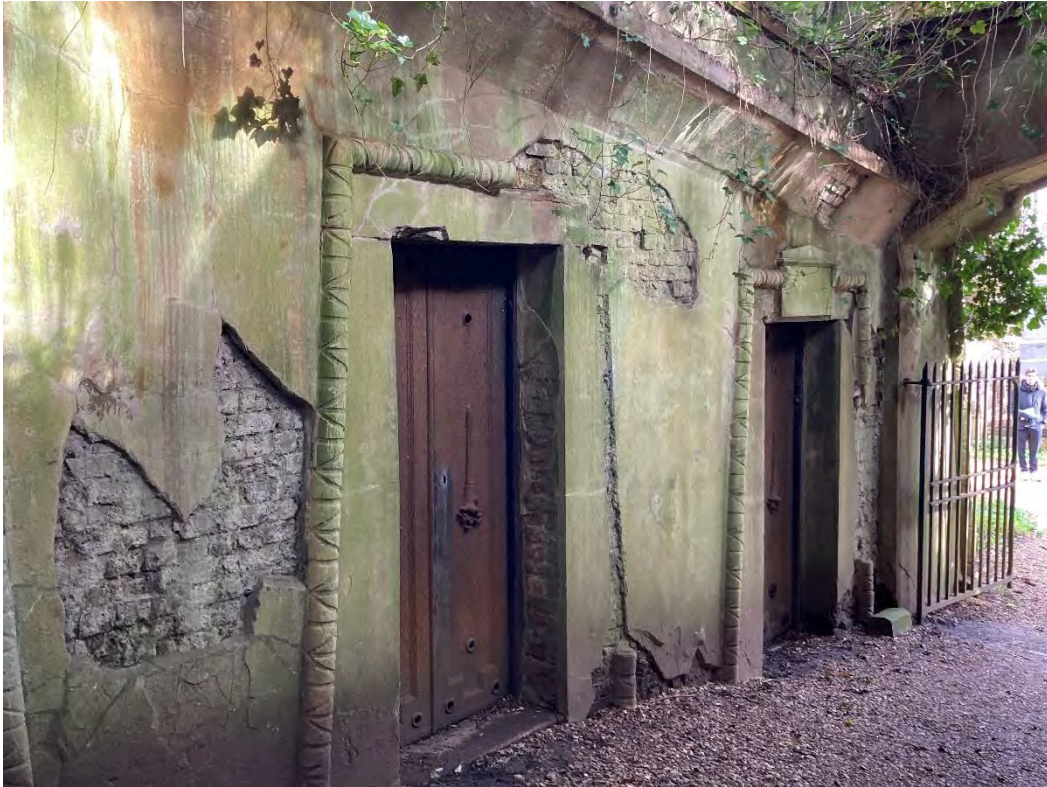
**Figure 20: Exposure of the monument's brick core contributes to the aesthetic value of the Egyptian Avenue as an expression of romantic ruination. This has mostly not diminished its aesthetic value because decorative details, like its door surrounds, are still clearly legible.**

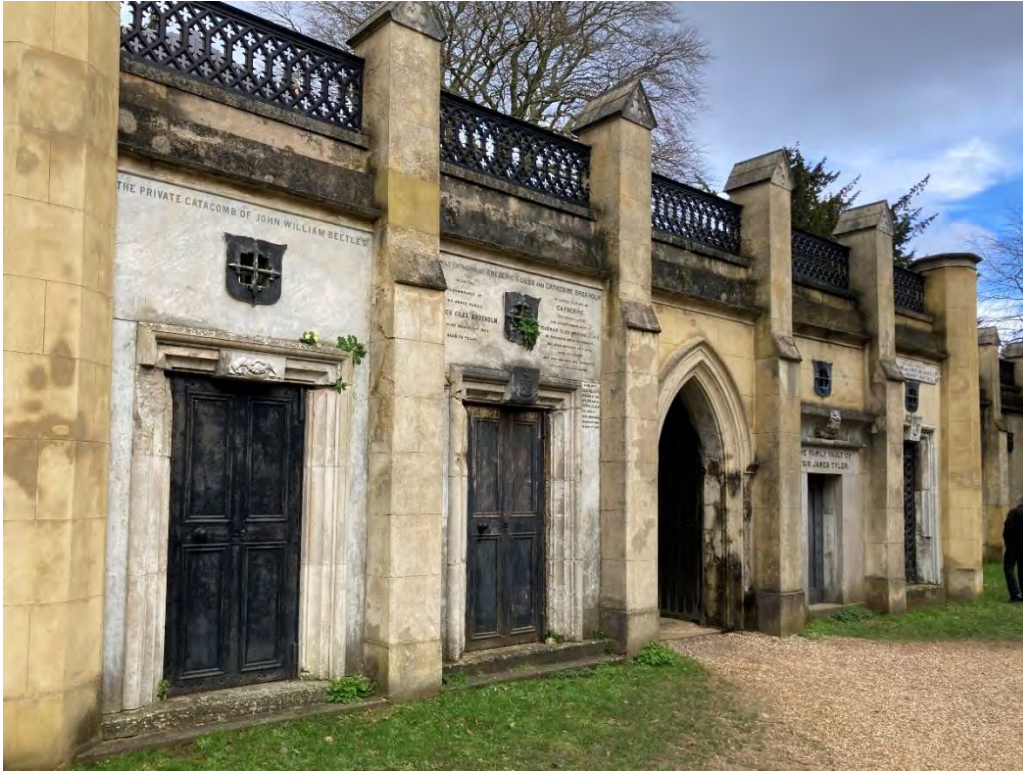
**Figure 21:** Modern render repairs have consolidated the Terrace Catacombs' external elevations and partly restored its original appearance. However, this is at odds with the less upkept masonry portals.

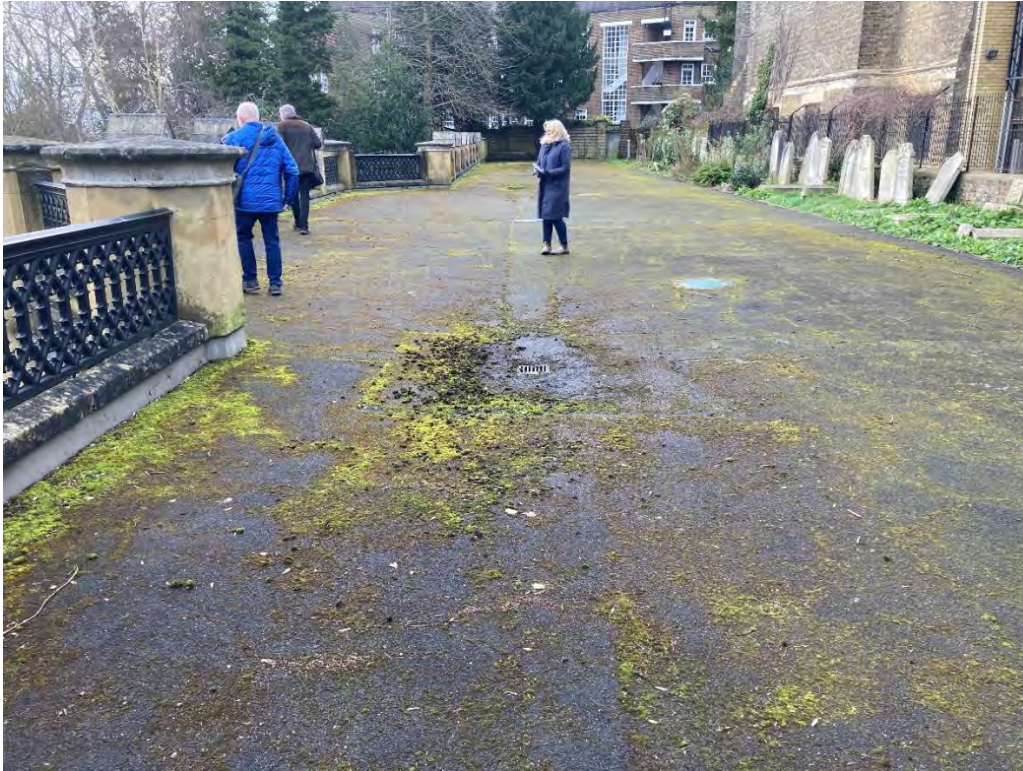
**Figure 22:** The modern tarmac on the roof of the Terrace Catacombs detracts from its aesthetic and evidential values because it is unsightly and presently causes water ingress problems inside the monument.

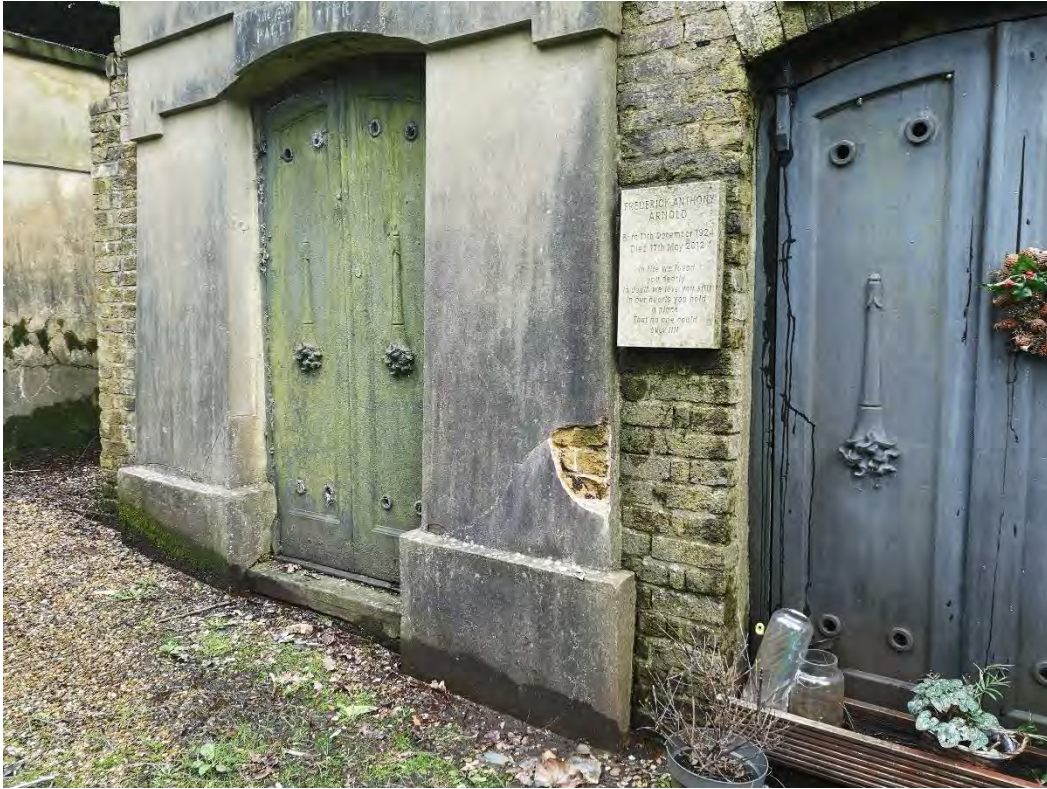
**Figure 23:** The exposure of underlying brickwork beneath the Cuttings Catacombs' rendered portals detracts from the illusion of masonry and gives the monument a neglected appearance. This is because the aesthetic value of the Cuttings Catacombs' original design outweighs the aesthetic value of their ruination.

Compared to the other monuments discussed in this report, the aesthetic value of the Cuttings Catacombs has been diminished by areas of render that have fallen off the temple fronts, revealing their brick core and spoiling their illusion. Unlike the Circle of Lebanon, where ruination has exposed brickwork to the aesthetic advantage of the monument, the Cuttings Catacombs instead look neglected rather than romantically ruined. This has been worsened by water ingress and moisture which, aside from causing various condition- and structure-related issues, have diminished the external appearance of the monument.

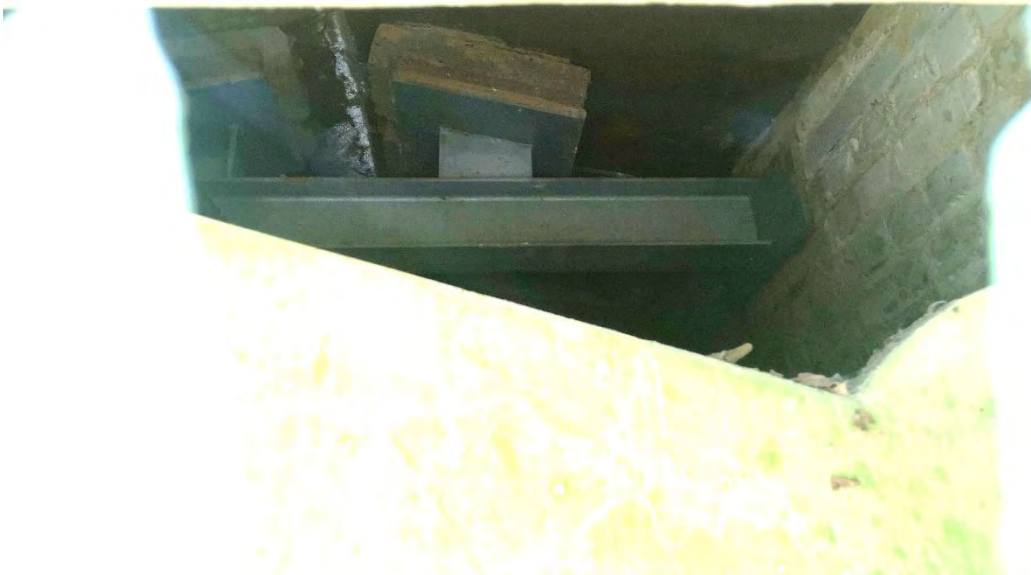
**Figure 24:** Steel armatures inserted in the Cuttings Catacombs have conserved their exterior aesthetic value by supporting their pitched masonry roofs. This is an instance where intrusive modern fabric of no intrinsic significance has improved the condition and aesthetic value of the monument.
