THE MORTUARY CHAPELS (MAP REF. 37)

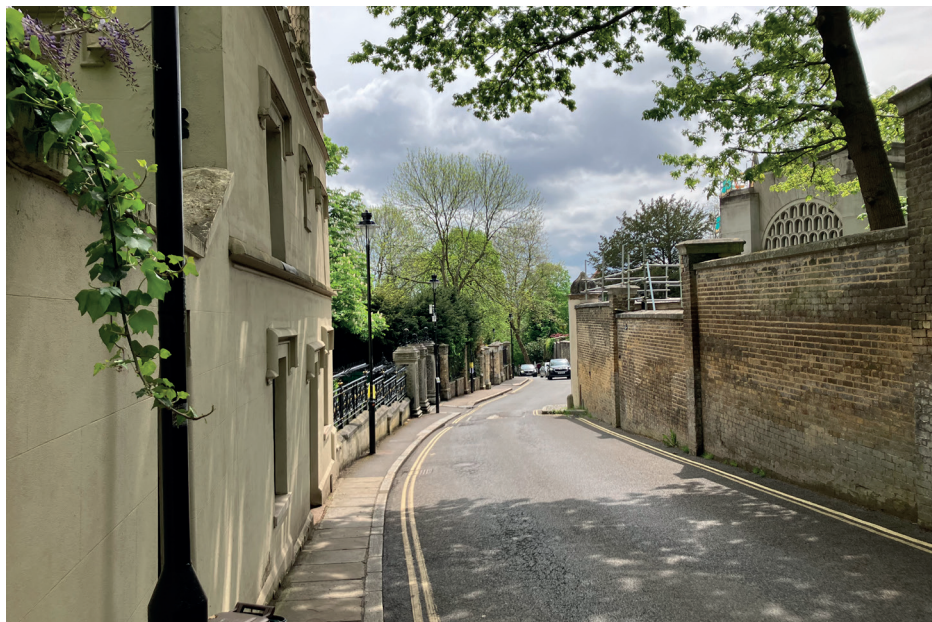
**Figure 7.8** View of the approach to Highgate Cemetery from the north on Swain's Lane. This corresponds with View 7 in the View Location Plan

7.24 While some views are afforded into the Cemetery, these are limited due to extensive vegetation growth. Nonetheless, the atmosphere evoked by the gothic entrance buildings and verdant spaces beyond contributes positively to the conservation area as one of the open spaces located on undulating ground, that provides relief to the urban environments around.

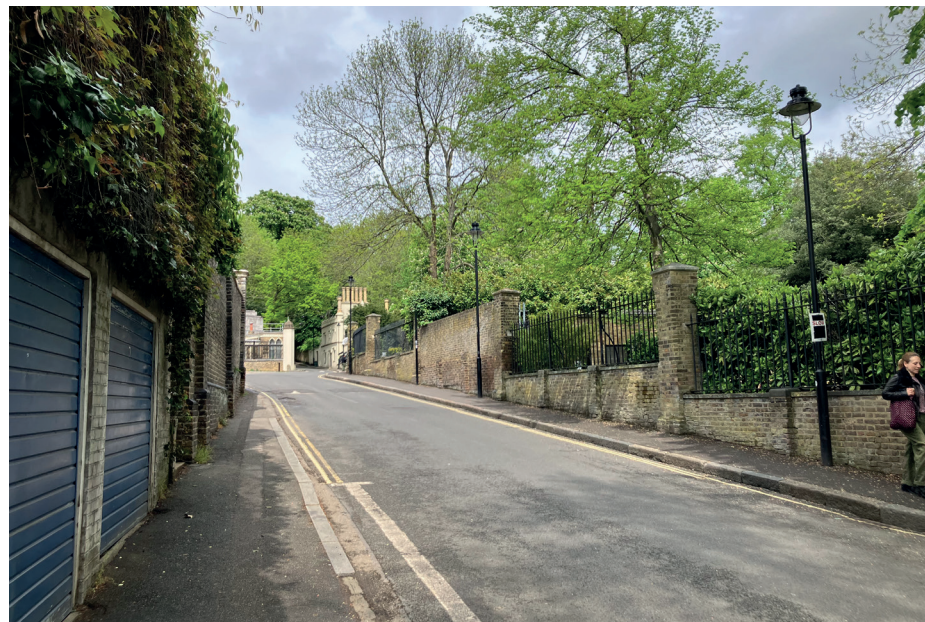
**Figure 7.9** View of the approach to Highgate Cemetery from the south on Swain's Lane, showing the East Side of the Cemetery. This corresponds with View 1 in the View Location Plan

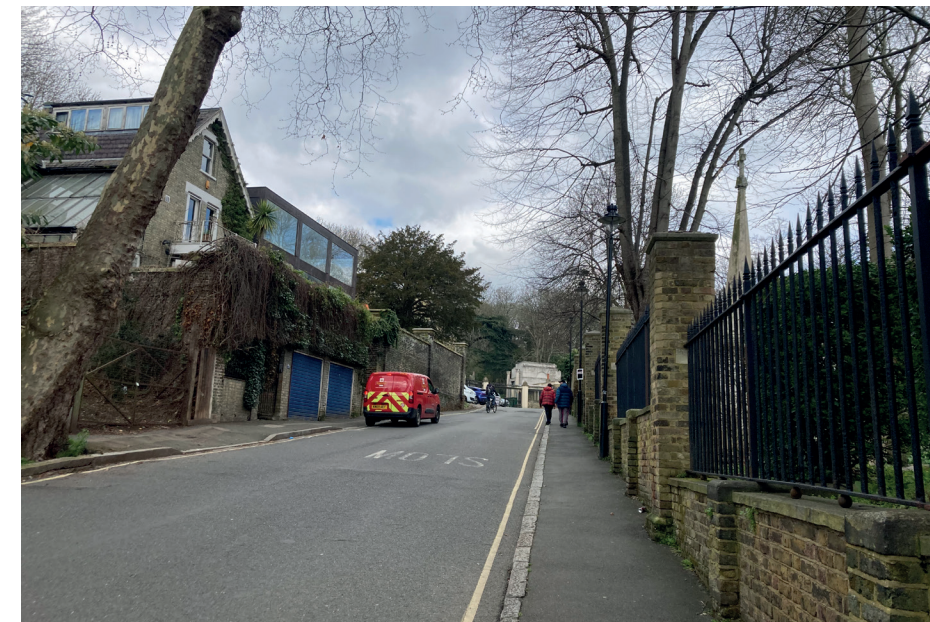
**Figure 7.10** View of the approach to Highgate Cemetery from the south, showing the Winter House against the backdrop of the Cemetery

7.25 The HCAAMS describes the cluster of houses on the west side of Swain's Lane, in particular the Winter House (grade II\* listed), noting that, in relation to the Cemetery, *"It is framed by Cor-ten steel which has weathered to a rust finish in harmony with the woodland character of the surroundings. The facades are highly glazed, giving the house a transparency which contrasts with the verdure of the Cemetery."* The modern and linear, minimalist aesthetic of the Winter House contrasts pleasingly with the gothic forms of the adjacent buildings. See **Figure 7.10**.

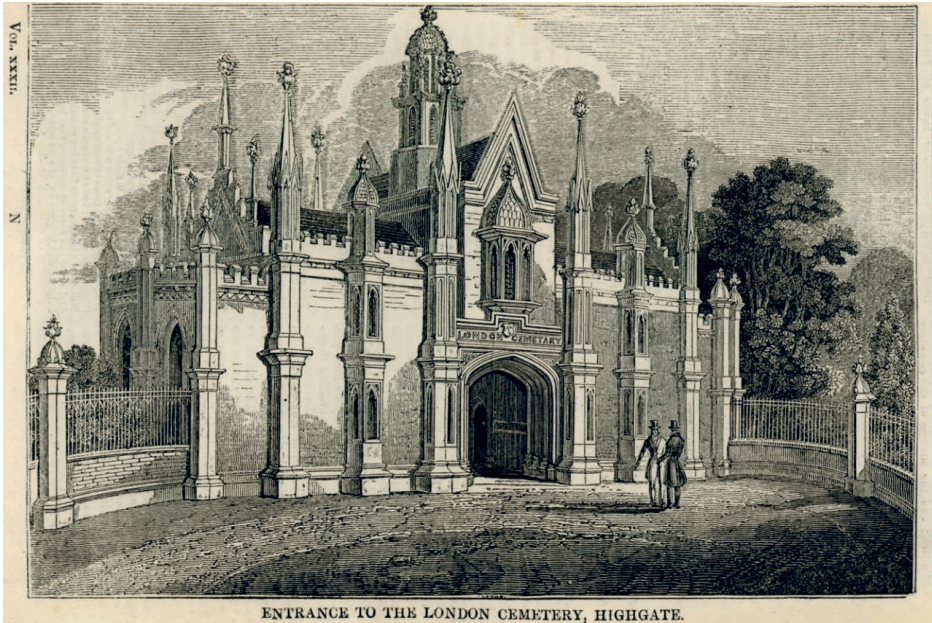
Figure 7.11 Illustration of ‘Highgate Cemetery Chapel’ published in the *Mirror*, September 15th 1838 (source: FoHCT Archive)

- 7.37
- An illustration in the *Mirror* of September 1838 shows the Chapel as seen from the entrance on Swain’s Lane (see **Figure 7.11**). The bell-tower cupola, is shown as part of the original design in 1838 and was formerly located atop the central archway between the two Chapels. An objection was made by St Michael’s Church to the erection of a cupola within 300 yards of their own, although it is not clear when this complaint was made.

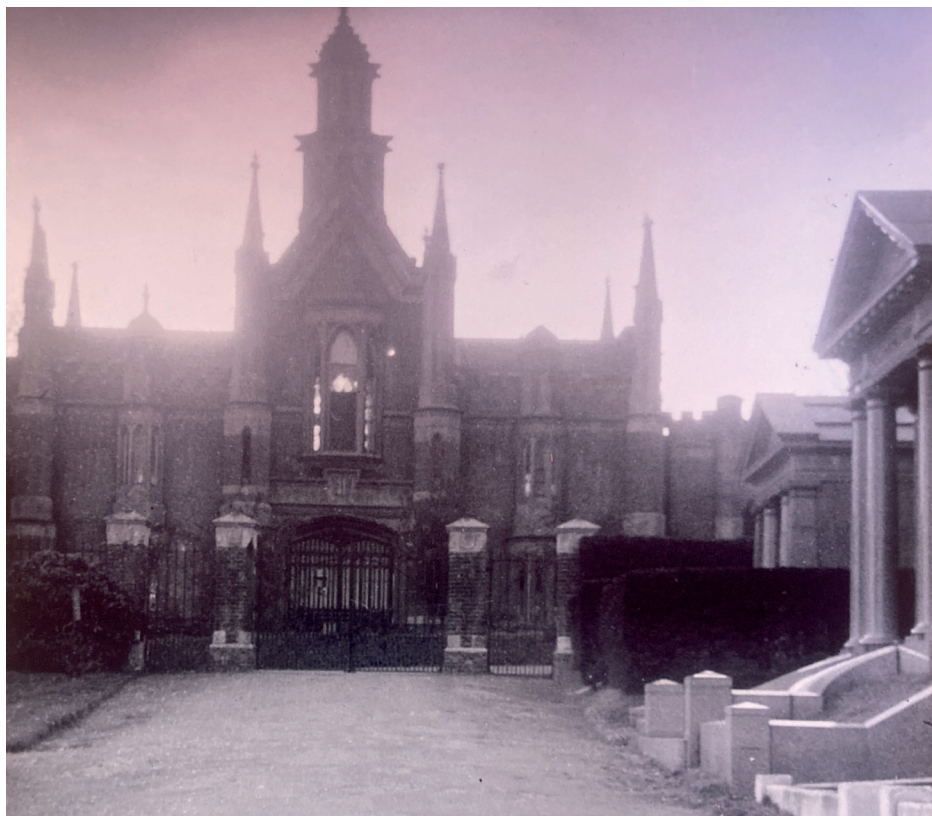
**Figure 7.12** Photograph showing the east elevation of the Chapels complete with pinnacles and steeple, post 1930 (source: FoHCT Archives)

- 7.41 It is not clear exactly when the pinnacles and cupola were removed but it is most likely a result of the disrepair of the building following wartime neglect, and the perceived hazard posed by these unstable parts of the building. When the bell-tower was removed, alterations were also made to the roof structure, including the alterations to the timber structure and installation of some steelwork for structural support. The internal portion of the chimney structure which previously separated the main body of the Dissenters' Chapel from the apse at the north end was probably removed at the same time, with the retained chimney stack (incorporated into the gable) being supported on steelwork.

- 7.43 John Gay (1909–1999), who documented the Cemetery in his books *Prospect of Highgate & Hampstead* (1967) and *Highgate Cemetery* (1984) took many photographs of the Cemetery during the post-war years, documenting its neglect and subsequent restoration in the 1980s. An earlier photograph, which is undated but likely to date from the mid-20th century, shows the east elevation of the Chapels complete with pinnacles and central tiered cupola (see **Figure 7.12**).

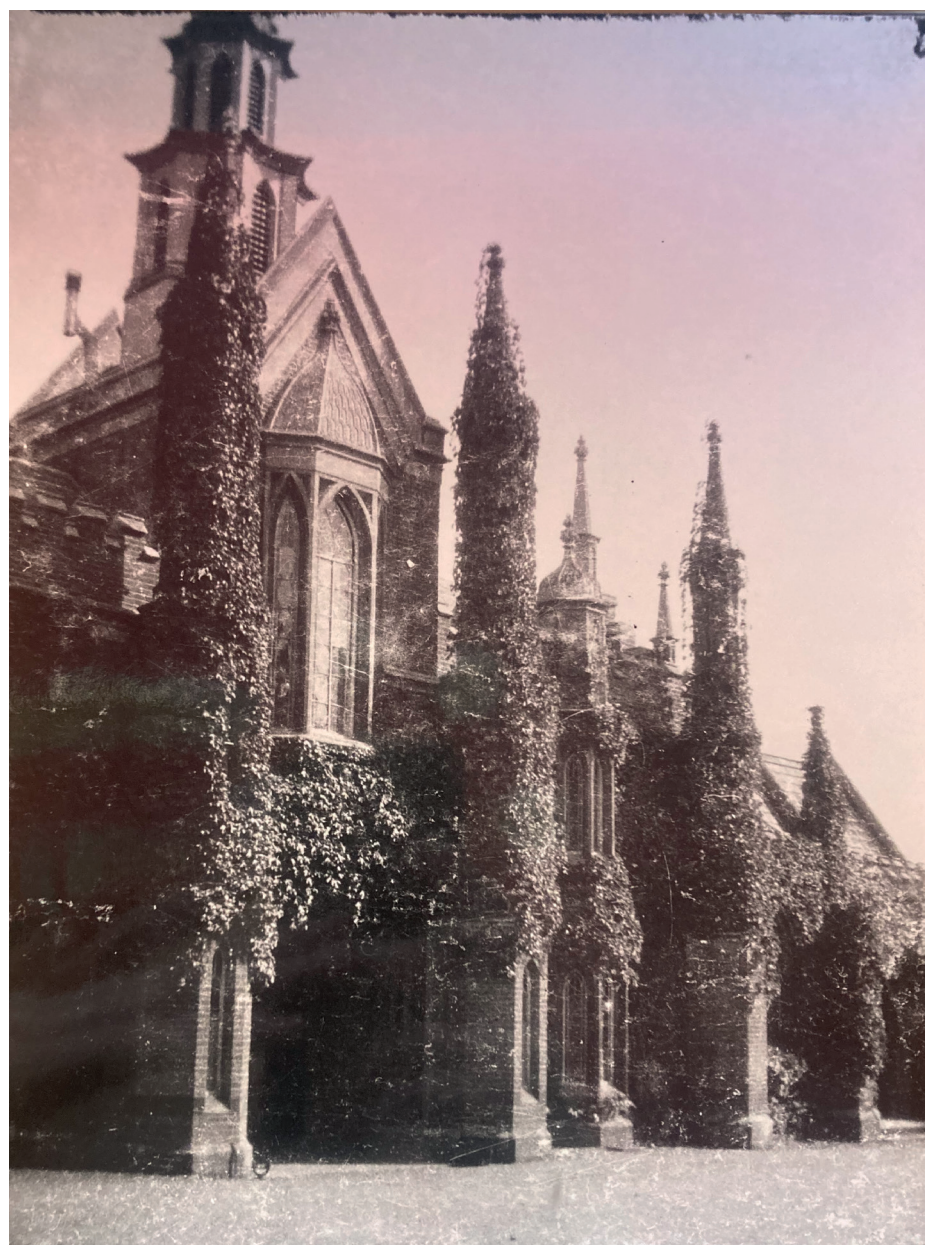
**Figure 7.13** Early photograph, possibly early 20th century, showing the west elevation of the Chapels. The Chapels are complete with its pinnacles and steeple (source: FoHCT Archives)

- 7.44 Another photograph which is likely to be earlier, photographer unknown, shows the west elevation of the Chapels with pinnacles and bell-tower. The building looks in a reasonable state of repair albeit extensive ivy growth covers the turrets and pinnacles on the west elevation.

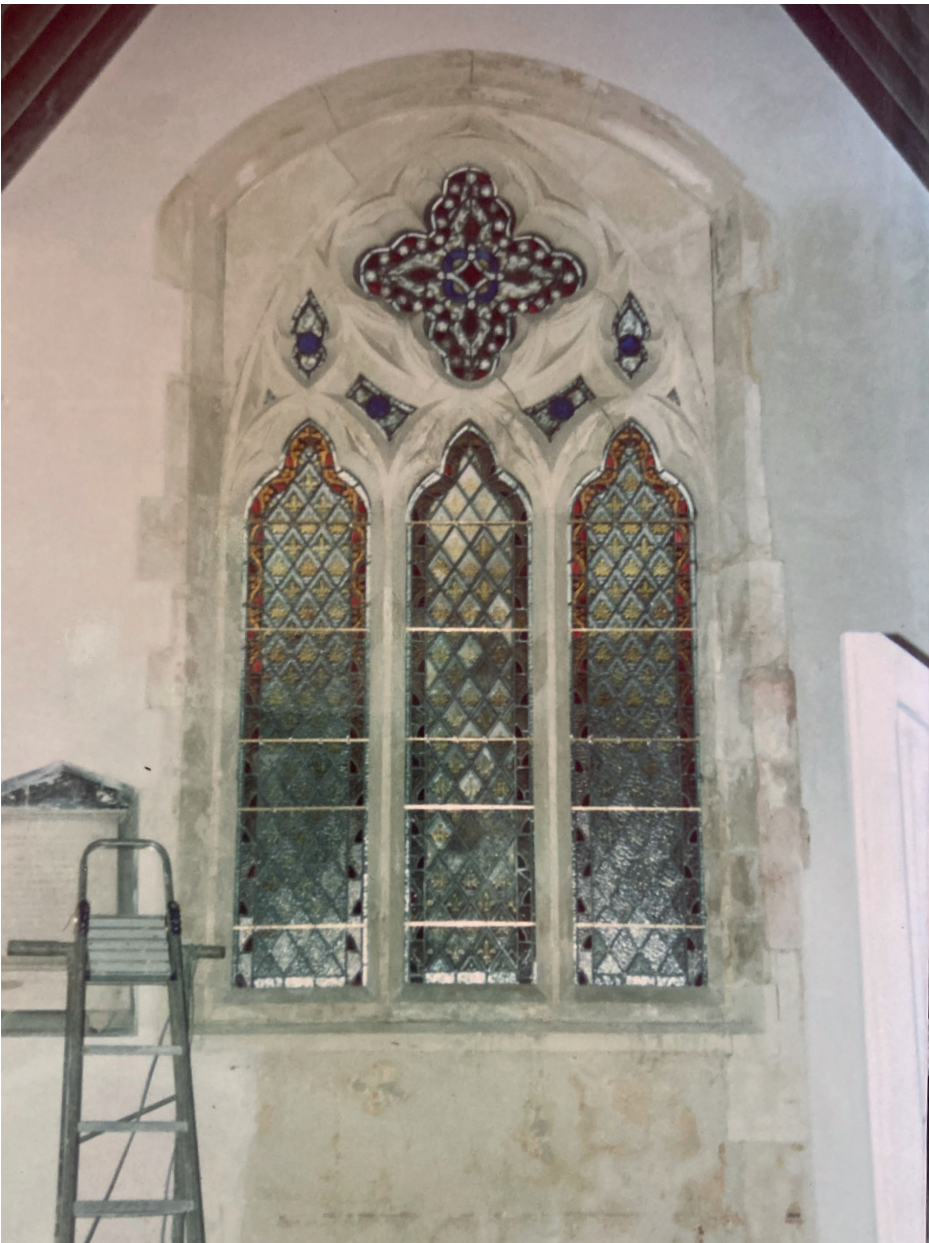
**Figure 7.14** Photograph of the stained glass south window just prior to its restoration in the 1980s (source: FoHCT Archives)

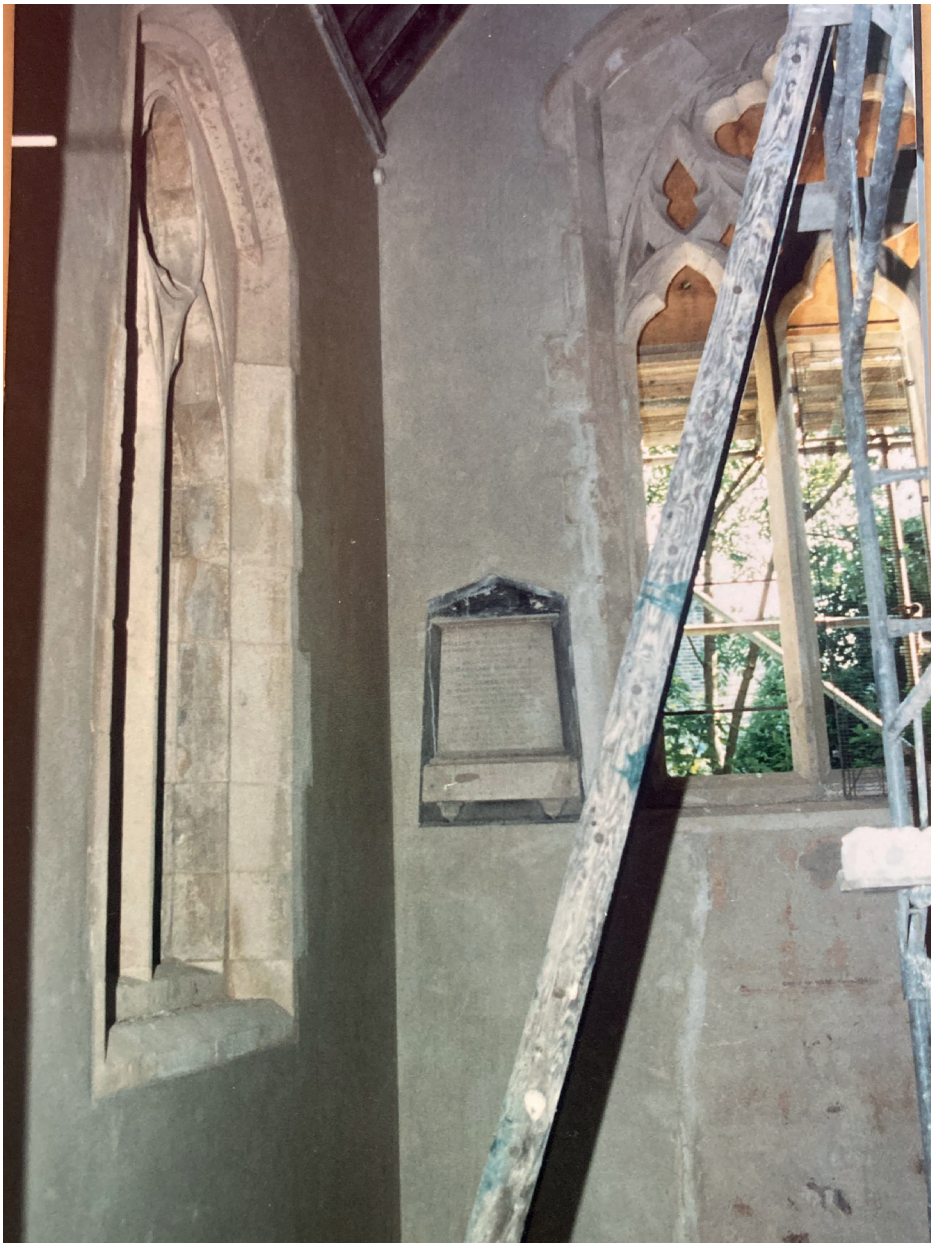
**Figure 7.15** Photograph of the window during restoration in the 1980s (source: FoHCT Archives)

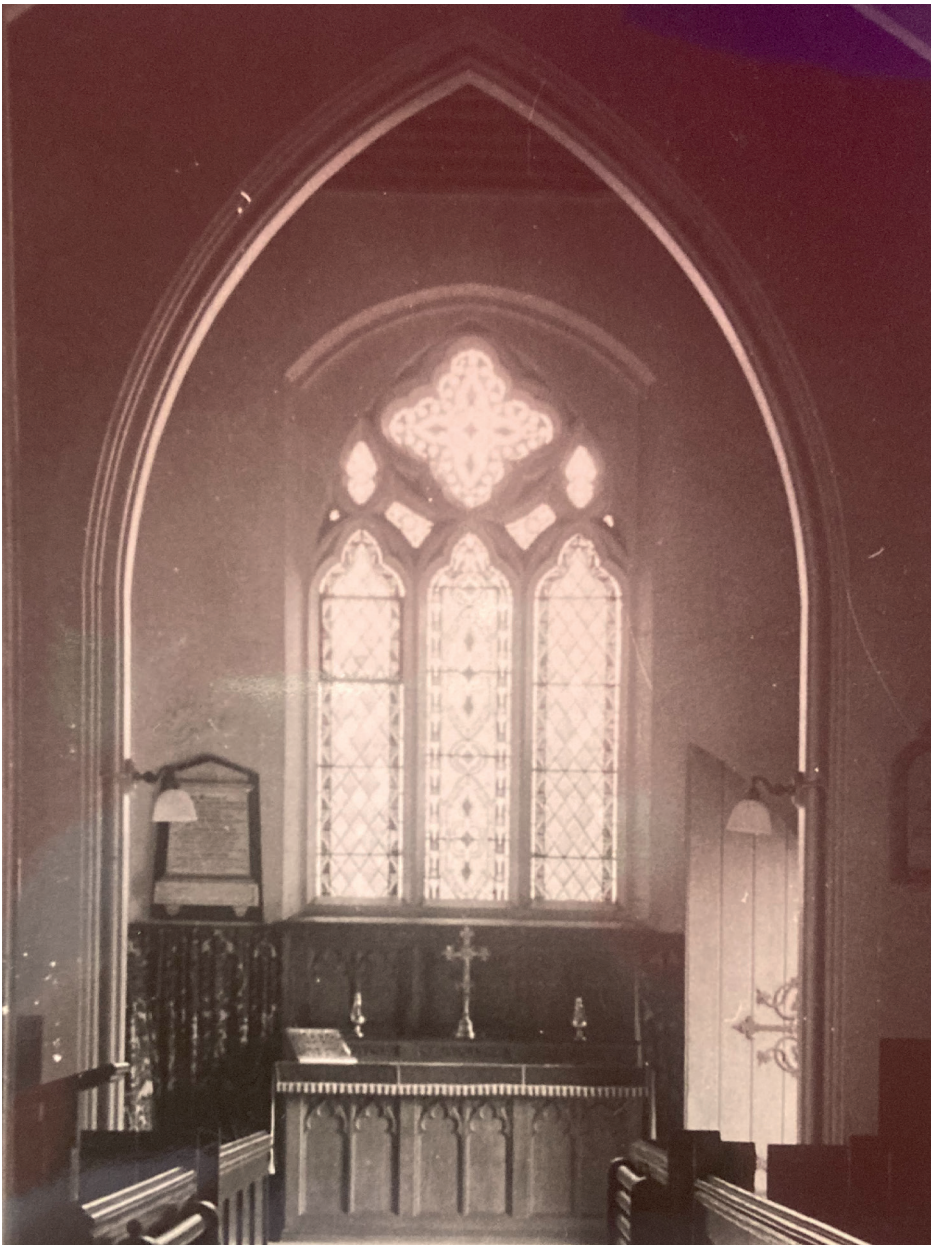
Figure 7.16 View of the Anglican Chapel prior to restoration works. Date unknown but estimated to be 1950s (source: FoHCT Archives)

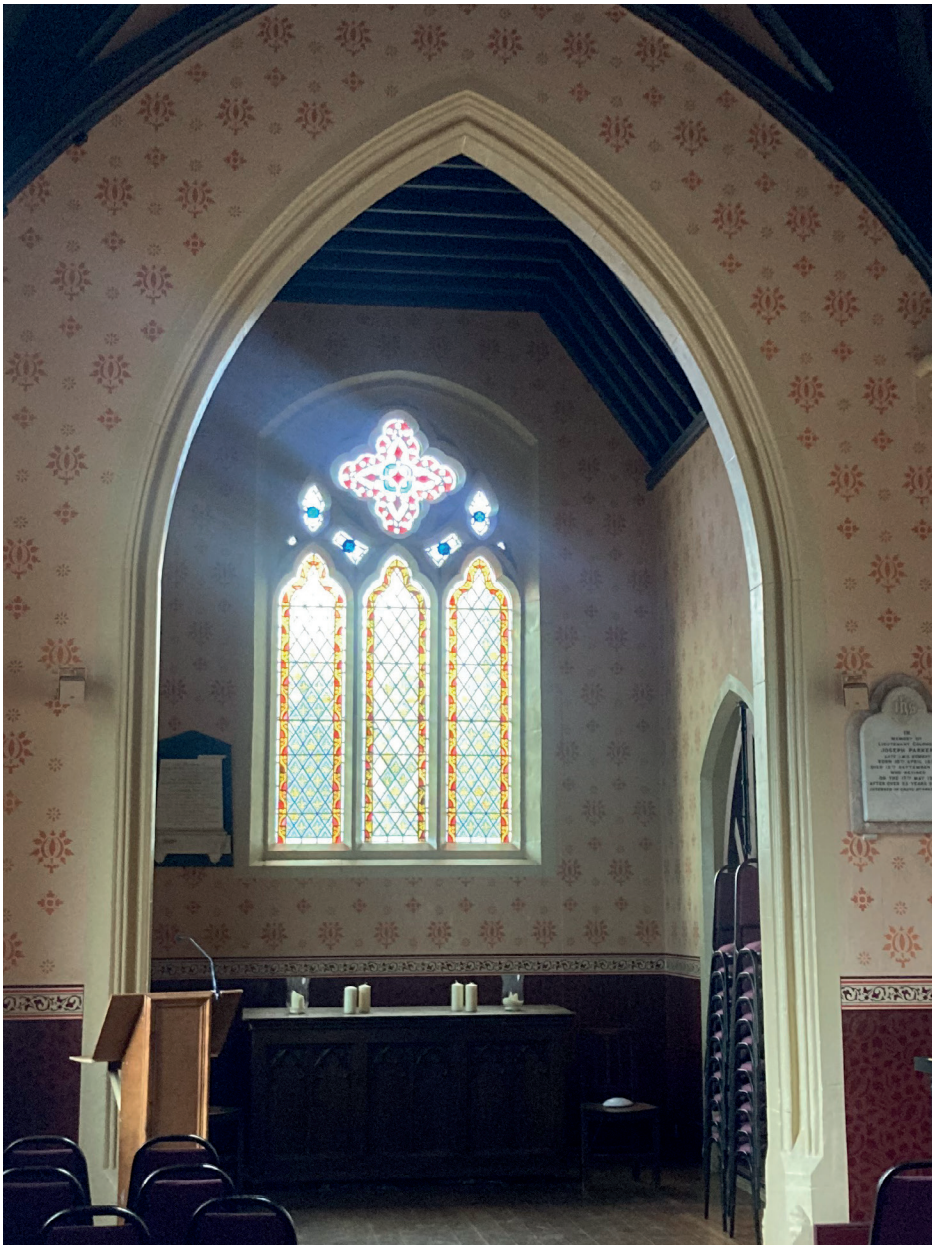
Figure 7.17 Recent view of Anglican Chapel. The paintwork was redone in the 1980s based on historic paint remains and stencil studies of the original design
