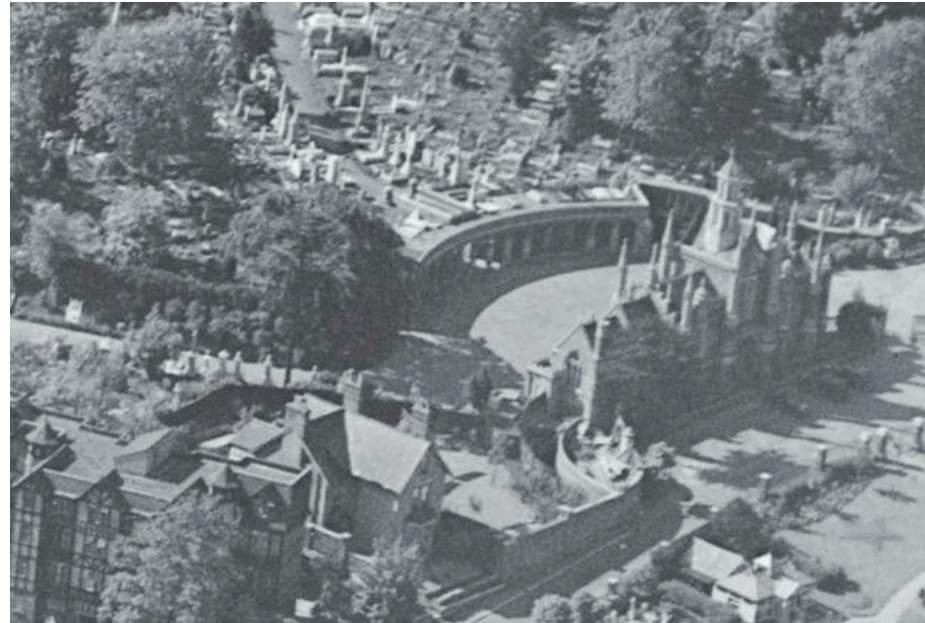
Figure 7.18 Aerial photograph from the early 20th century showing the Chapels with bell-tower and pinnacles. Part of the Cemetery is visible. (source: FoHCT Archives)

- 7.56 The loss of these parts of the building has been accentuated by tree growth and enclosure, which has served to reduce the visual scope of the Chapels to immediate views within the Cemetery and on Swain's Lane. **Figure 7.18** illustrates the main route through the West Side of the Cemetery as much more open at this time. Views of the Chapel would have been afforded on the approach along the path, whereas now it is largely obscured from view by tree and vegetation growth.

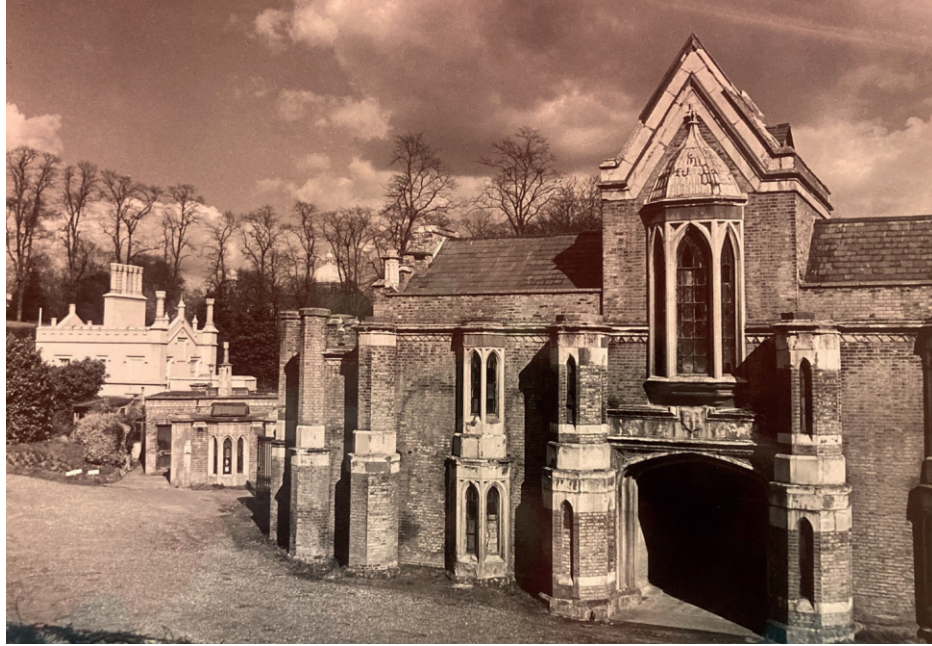
Figure 7.19 Photograph of the Chapel prior to repair works in the 1980s. Undated but likely taken by Gay in the 1970s / '80s (source: FoHCT Archives)

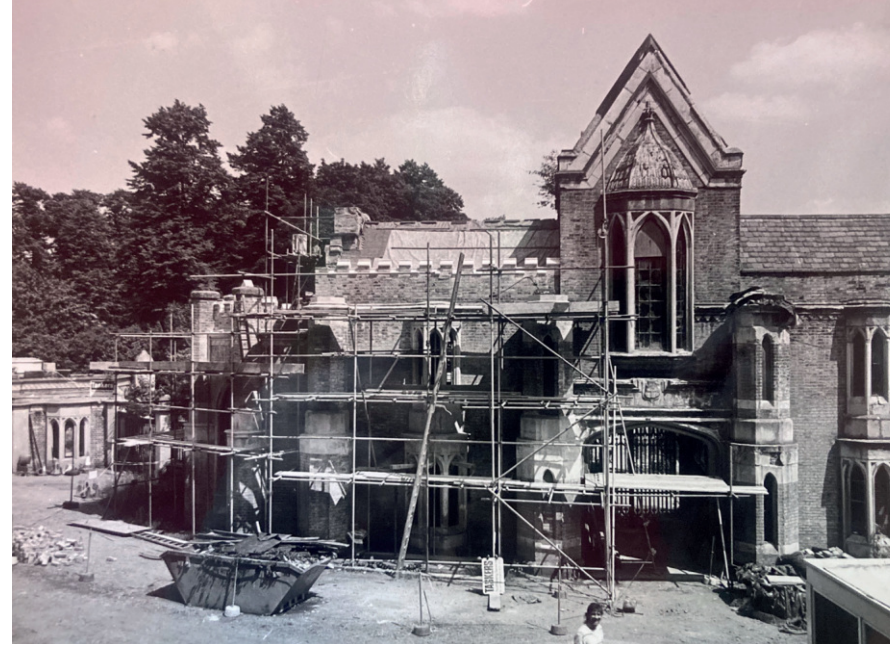
Figure 7.21 Photograph of the Chapel during repair works. Undated but likely taken by Gay in the 1980s (source: FoHCT Archives)

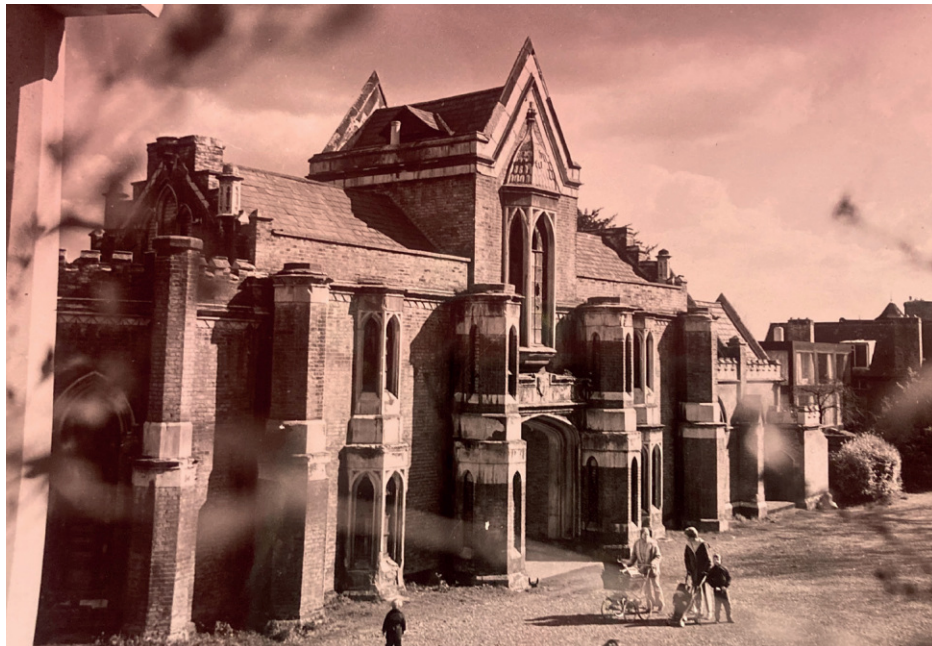
Figure 7.20 Photograph of the Chapel prior to repair works in the 1980s. Undated but likely taken by Gay in the 1970s / '80s (source: FoHCT Archives)

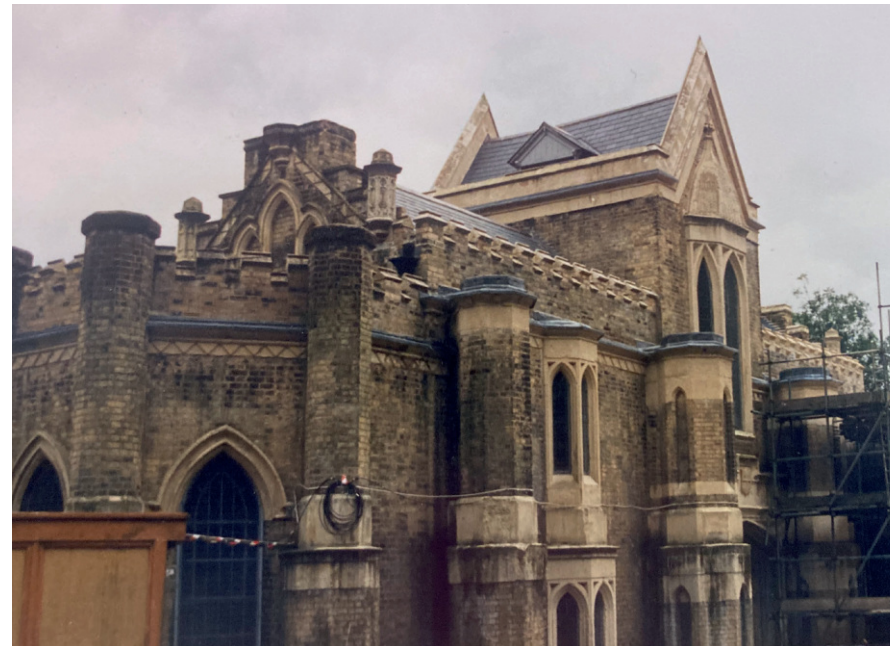
Figure 7.22 Photograph of the Chapel after restoration works in the 1980s. (source: FoHCT Archives)

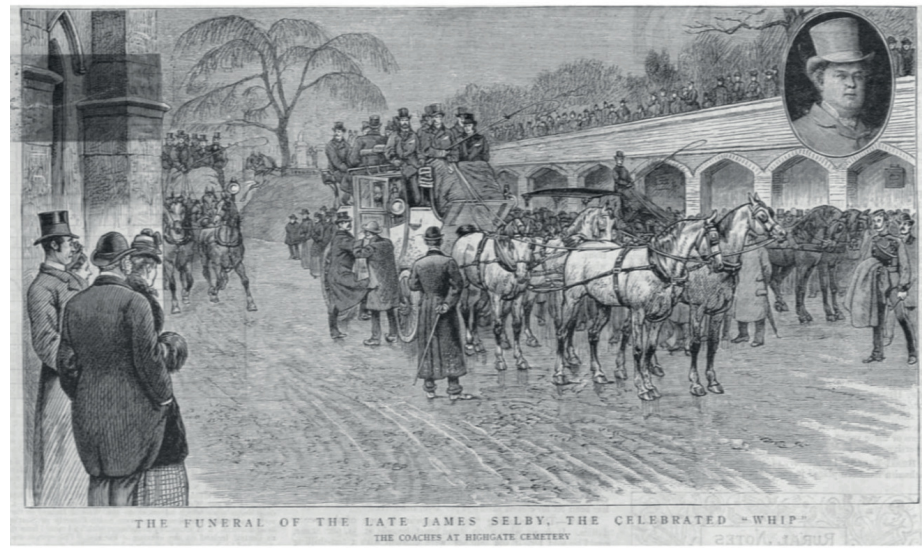
Figure 7.23 Illustration of The Funeral of The Late James Selby, showing the Courtyard and Colonnade beyond, from The Graphic, 29 December 1888 (source: The Graphic)

- 7.66 Furthermore, the Courtyard setts, which date to the 1980s, visually detract from the sense of arrival to the Cemetery and Chapels. Historically, the Courtyard was not surfaced (see illustration from 1888 at **Figure 7.23** and also 1980s photograph at **Figure 7.24**), and the laying of setts is not based on a historic precedent either at Highgate Cemetery or other cemeteries. The expansive hardstanding is indicative of vehicular movement and is not an appropriate visual introduction to the Cemetery.

- 7.72 There is little planning history relating directly to the Colonnade. However, we know from photographic evidence that minor repairs were undertaken in the 1980s (see before and after photographs taken by John Gay at **Figures 7.23 and 7.24**, and again at **7.25 and 7.26**), including removal of intrusive vegetation, and that the paving of the Courtyard in 1989, while not directly impacting the Colonnade structure, served to obscure the base of the arches and rear wall. In 2016, the Colonnade was repaired and conserved by West Scott Architects, including the reconstruction of subsided central steps, addition of handrails, and repointing of back wall in lime mortar (LBC ref. 2016/2806/L).

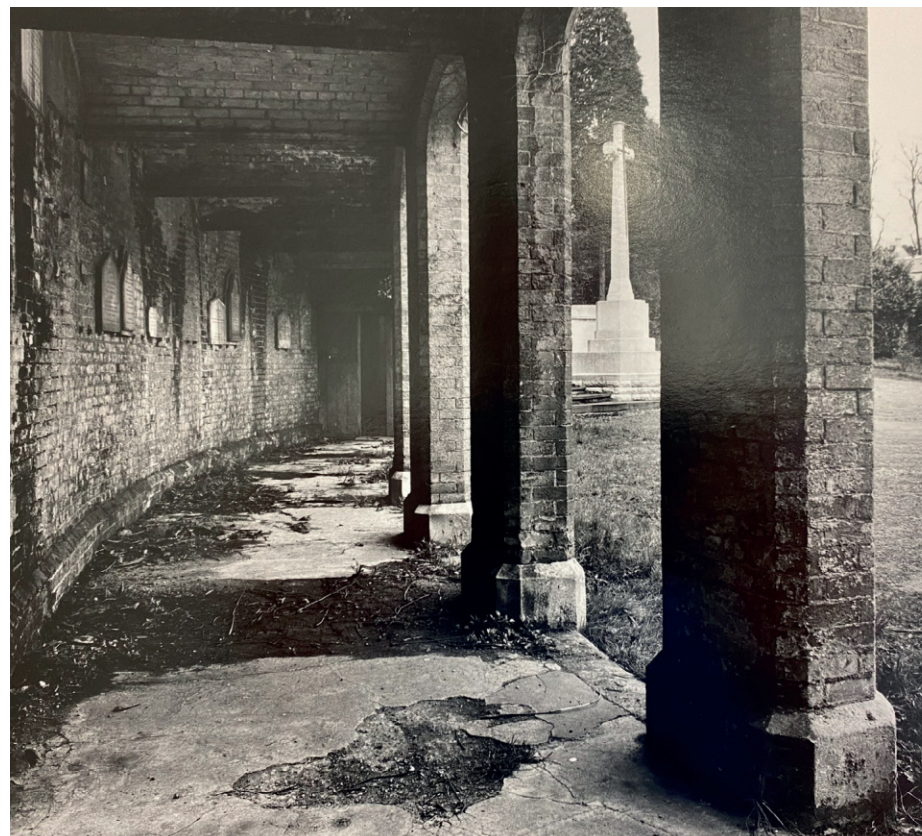
Figure 7.24 Photograph taken by John Gay of the Colonnade in the 1980s, prior to the Courtyard paving (source: FoHCT Archives)

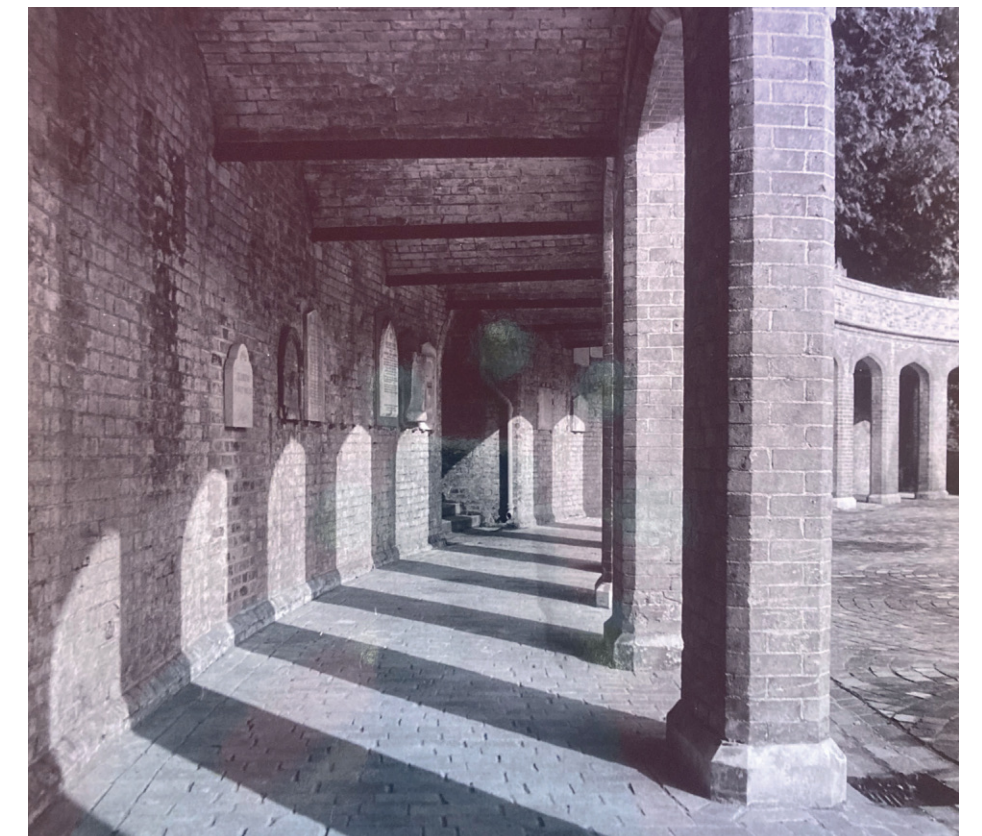
Figure 7.25 Photograph taken by John Gay c.1990 after the Courtyard paving and level change that obscured the base of the arches (source: FoHCT Archives)

- 7.73 The Colonnade is largely well-preserved and reflects its original form and appearance. However, during the 1980s, restoration works to the Courtyard involving the paving of cement setts was carried out and resulted in the base of the arches to be obscured due to the level change. See comparison photographs at **Figures 7.23 and 7.24**. This also served to obscure part of the brick skirting on the rear wall, with only the chamfered edge visible and two rows of brickwork obscured. This intervention has altered the proportions of the arches and space within the Colonnade. The cement setts also detract from an appreciation of the group value of the Colonnade and Chapels: though they are designed in an attractive fan layout, the cement materiality is unsympathetic to the context, especially in conjunction with the Cambridge brick and stone of the Chapels and Colonnade. The setts, while laid in an attractive fan-like pattern, are neither historically nor visually appropriate for this important entrance point into the Cemetery.

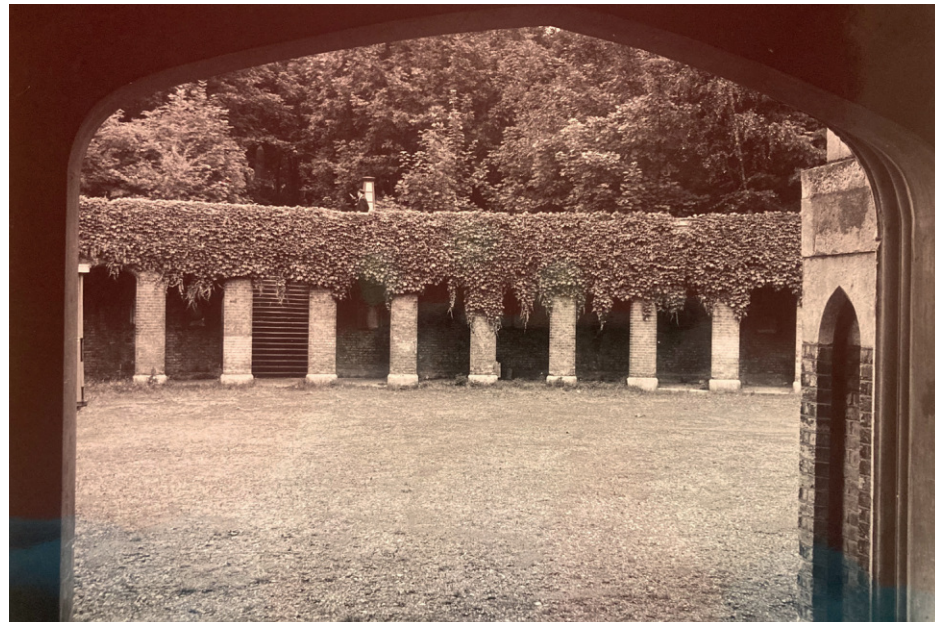
Figure 7.26 Photograph taken by John Gay of the Colonnade in the 1980s prior to the Courtyard paving (source: FoHCT Archives)

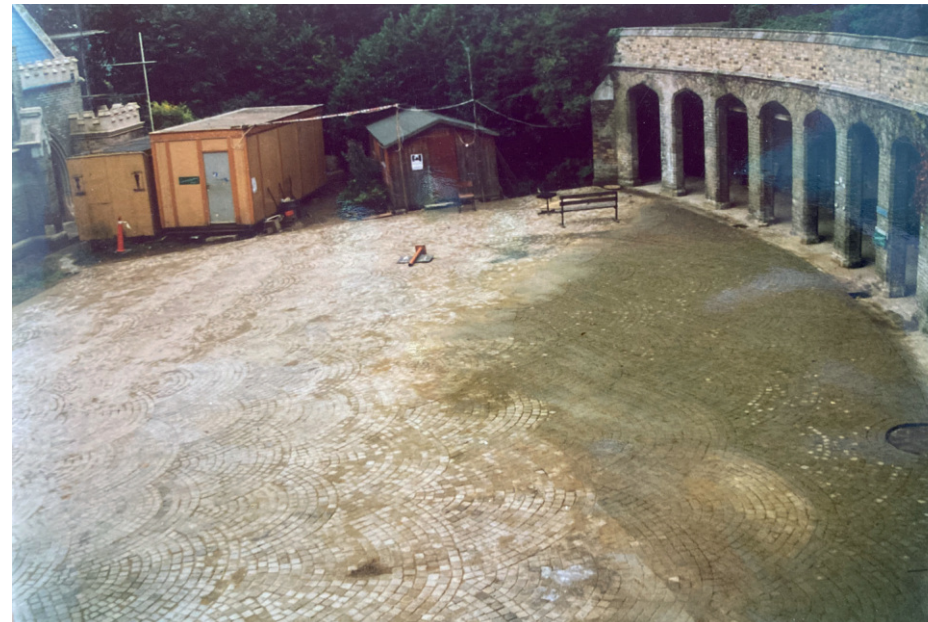
Figure 7.28 Photograph, undated but likely 1970s, showing Colonnade with temporary facilities buildings in the Courtyard (source: FoHCT Archives)

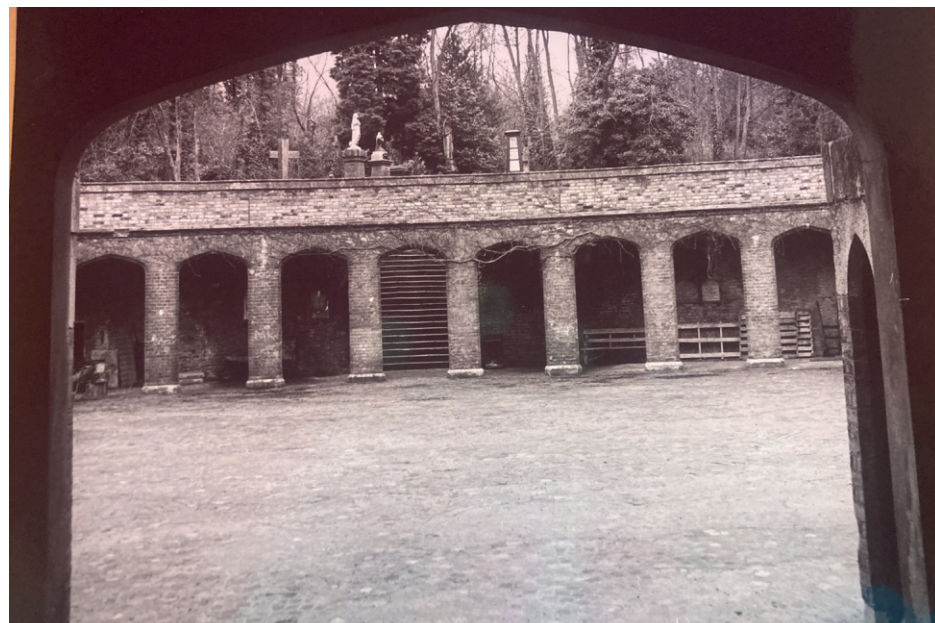
Figure 7.27 Photograph taken by John Gay c.1990 after the Courtyard paving and removal of vegetation from the Colonnade (source: FoHCT Archives)

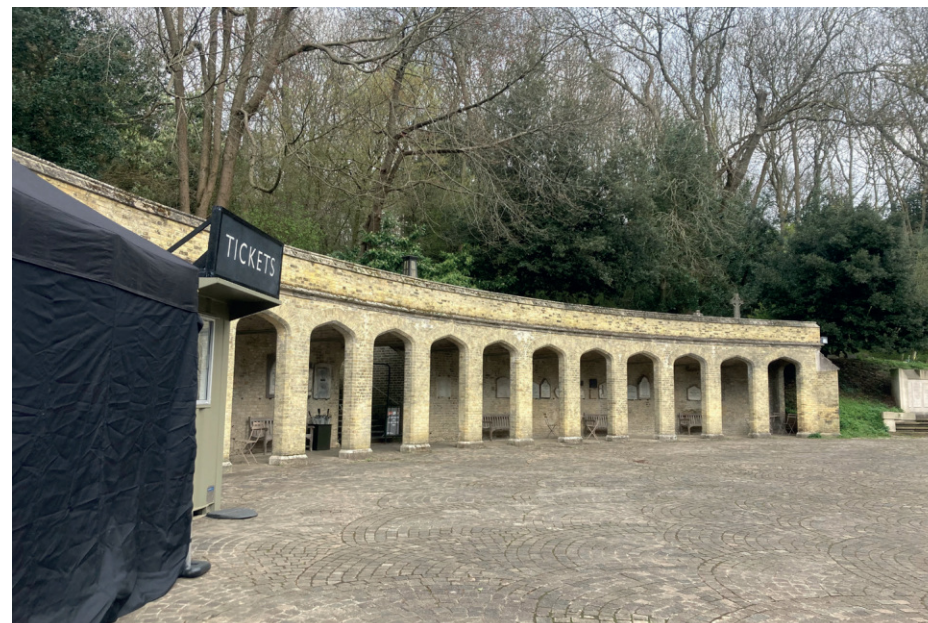
Figure 7.29 Recent photograph of the Colonnade. The temporary ticket office detracts from the Colonnade and its group value with the Chapels, as it obscures part of the Colonnade and interrupts the elliptical form of the Courtyard

7.74 In addition, modern temporary paraphernalia associated with the running of the Cemetery is currently obscuring the Colonnade and detracting from an appreciation of its elliptical form. See **Figure 7.29**. The temporary ticket office, located in front of the south part of the Colonnade, is a portacabin and detracts from the sense of occasion and arrival signified by the Colonnade and Courtyard. Similarly, the temporary metal gate at the base of the Colonnade steps detracts from the formal character of the Colonnade and gravity associated with funeral processions.

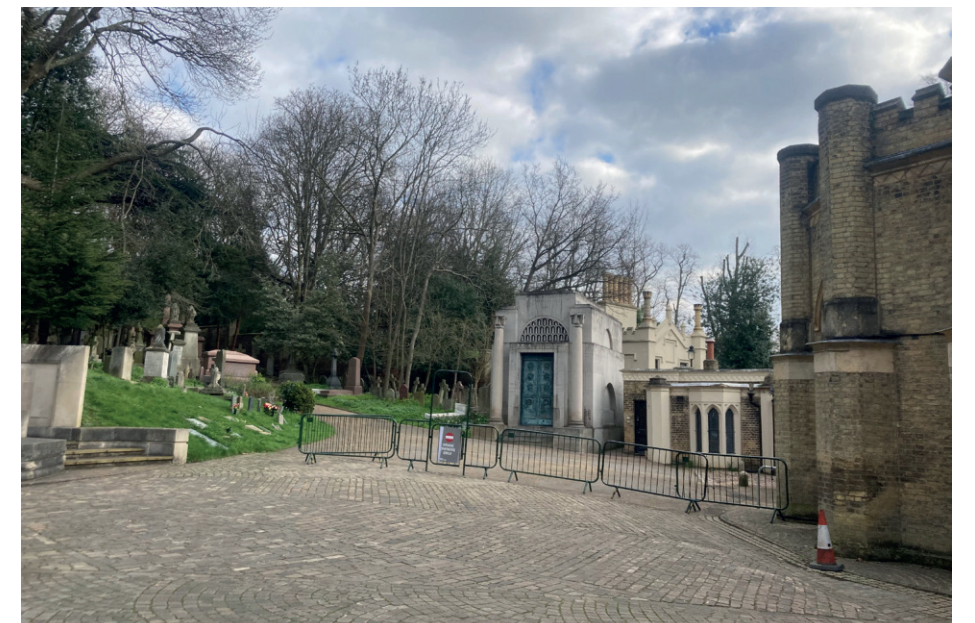
Figure 7.32 Recent photograph of the South Lodge. The Goldhammer Mausoleum, by Craig Hamilton, was built in 2017 and has changed the setting of the lodge
