Condition & Feasibility Study

125 Shaftesbury Avenue

Pre-Application Review

27th September 2024

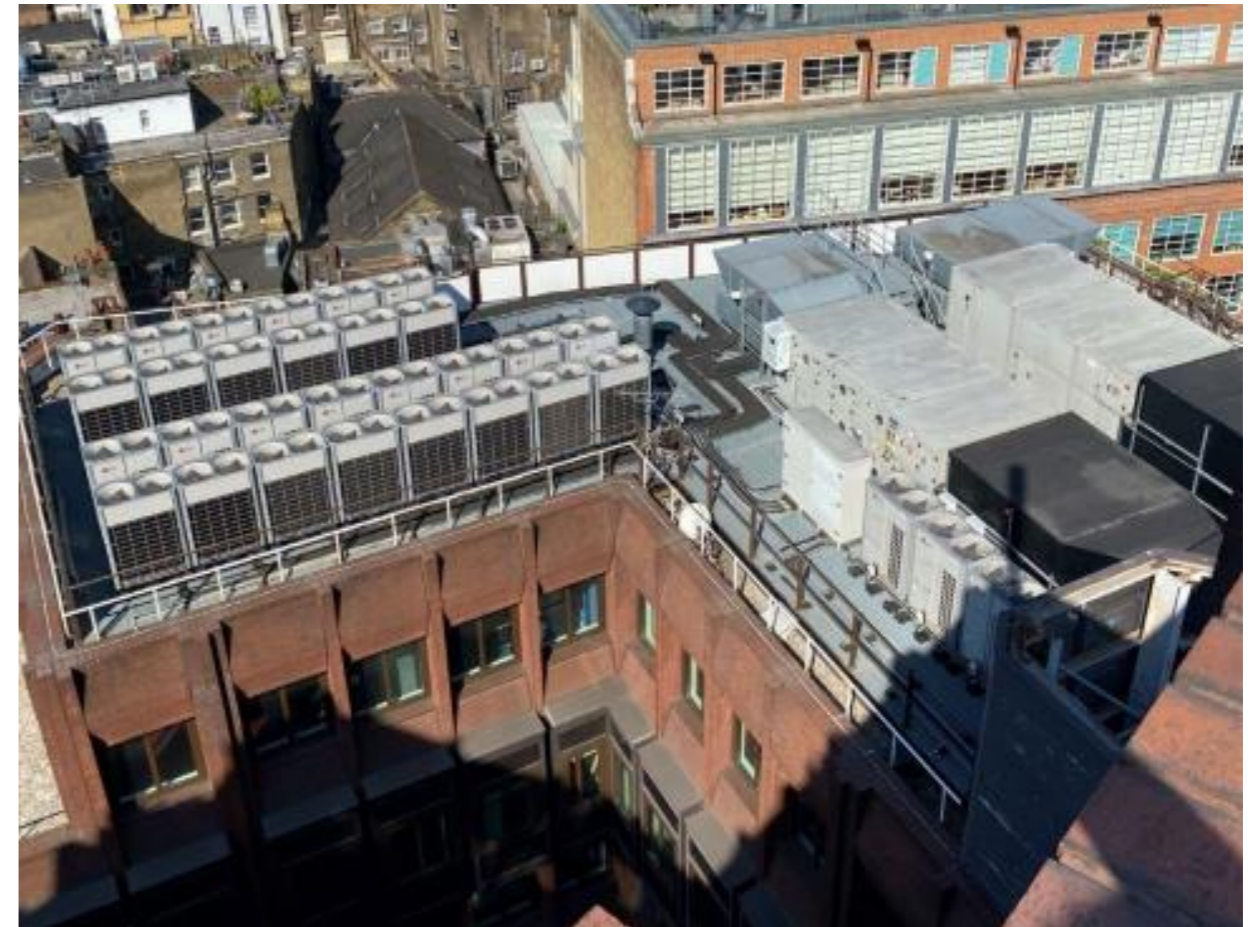
Figure 2.4.4: photograph showing external VRF and AHUs at roof level (L07), demonstrating the condensed and constrained spatial arrangements at roof levels with the current plant equipment and arrangements.

Building services systems are covered in detail in Section 4 and are therefore not detailed in full within this section. They are typically made up of a VRF-led all-electric HVAC solution, installed during the previous fit out. Most of the heating, cooling and ventilation plant can be found at roof levels (VRF units, AHUs etc.) across L10 and L07, with most of the central electrical equipment (HV/LV etc.) found at basement level across electrical plantrooms. There are no PV panels, water recycling or other such measures within the current building. Although the majority of the measured floor area achieves an EPC rating of B, the operational energy consumption of the existing building remains poor, even after the most recent fit out and services installations, suggesting a more fundamental change is required to achieve the kind of energy performance expected to meet today’s onerous energy efficiency and reporting standards.

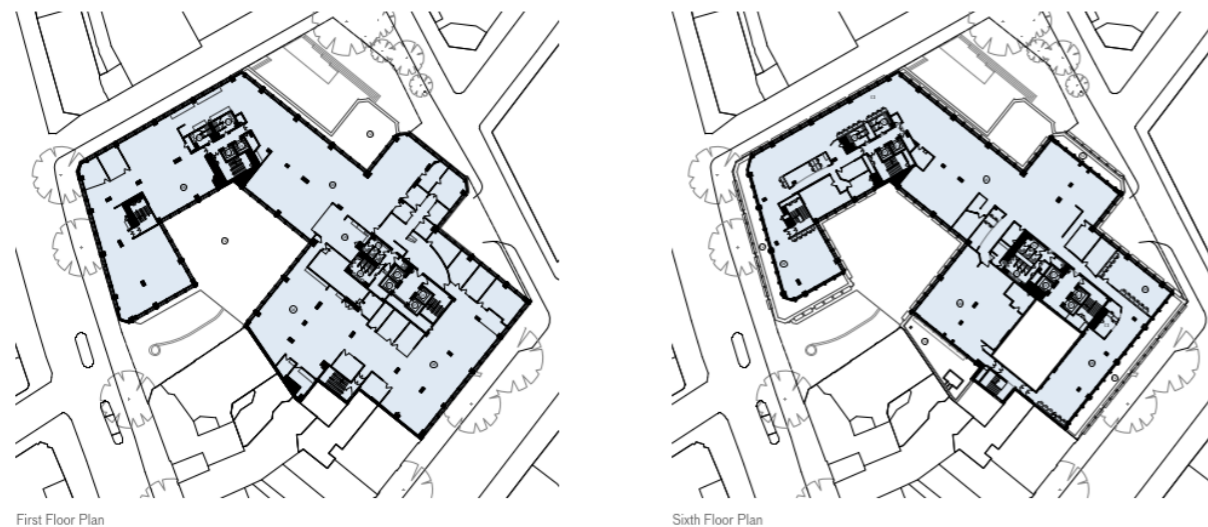
Figure 3.1.1: GA drawing showing L01 and L06 plan layouts of the existing building demonstrating narrow and inefficient existing floorplates (via DSDHA).

As described in Section 2.3, the quality of internal space is compromised by the narrow and inefficient floorplates which appear to be the same layouts as the original 1982 construction, which are not considered suitable for the modern office tenant. There may be opportunity to infill and laterally extend these floorplates to improve the spatial arrangements given the structural considerations set out in Section 5.3, and this has been explored by the project team.

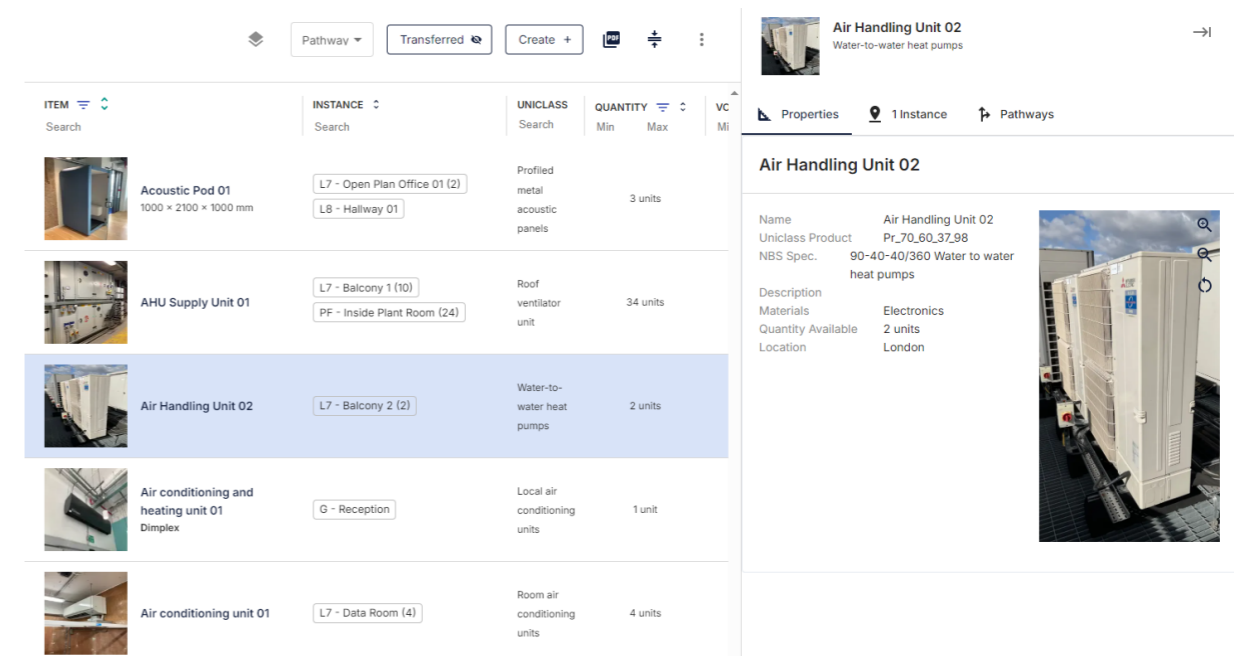
Figure 5.1.1: example of the MEPH section of the elemental detail for each building component within the MEP section, providing images and informative detail to support potential reuse.

The Materials Index audit goes beyond simply listing materials and quantifying mass, potential reuse and recycling metrics. The survey is completed on a collaborative and accessible online form which lists the details of all materials, allowing the design team to access this database like a ‘materials bank’ and review the potential for onsite or onwards reuse of all materials groups. An example of this element-by-element detail is shown below from the 125 Shaftesbury Avenue audit portal.

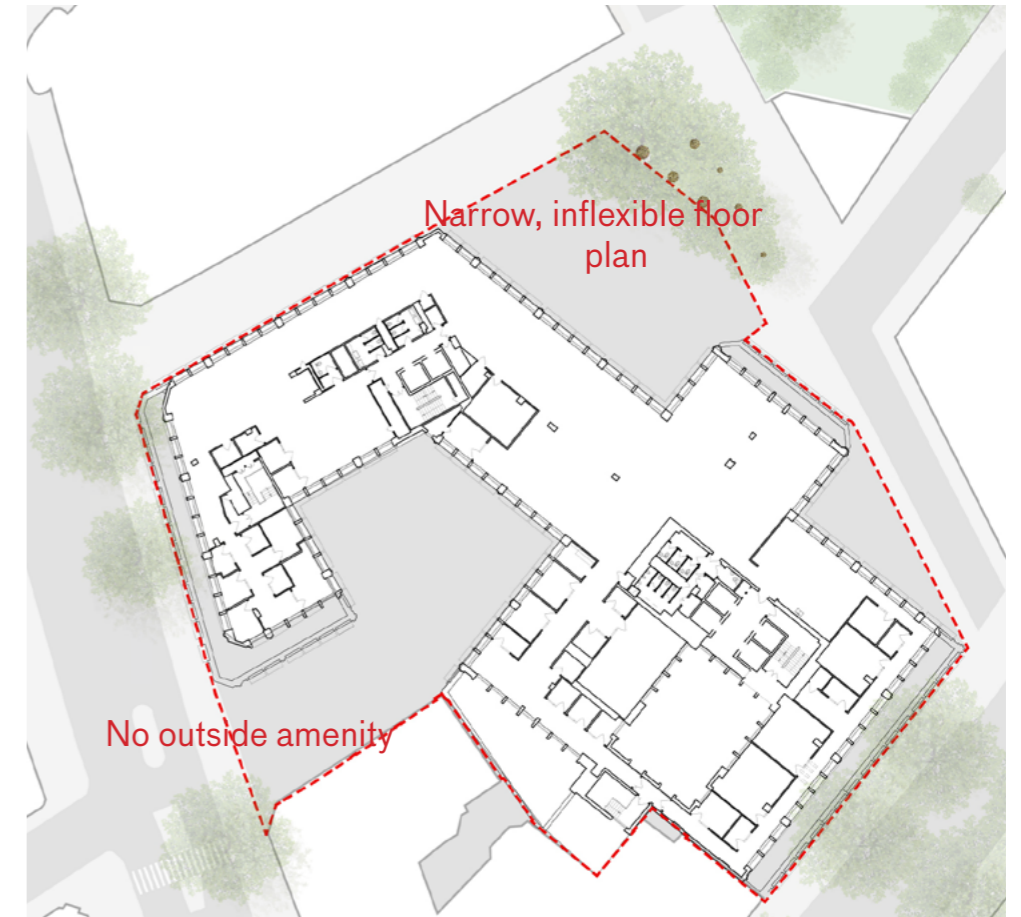
Typical Floor

● Despite low embodied carbon, operational carbon is high due to existing facade performance limitations and lack of space for sufficient MEP equipment at basement and roof level.

Although high on retention, a retrofit will provide poor quality of space for future users, does not address the fundamental issues of the site and not provide any public benefit at ground floor.
