125 Shaftesbury Avenue

Pre-Demolition Audit

Report Number: 2406_2706_/A

Issued: 28/11/2024

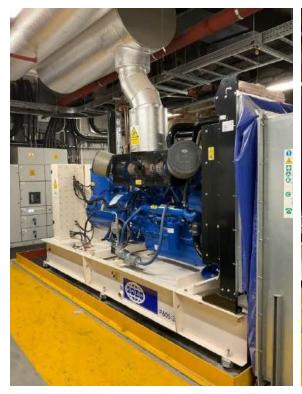
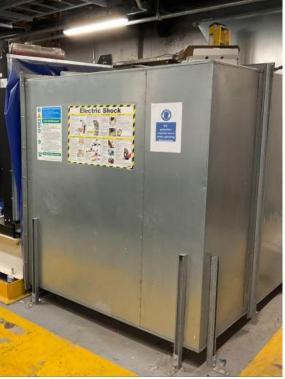
Interior: Top level and roof plant areas

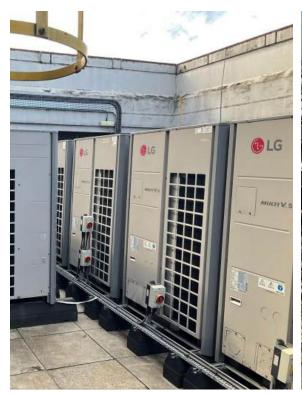
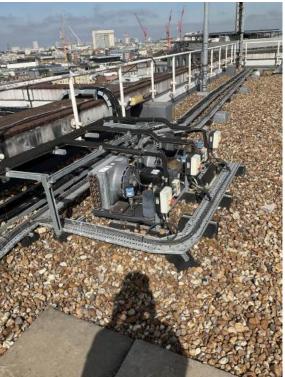
Exterior: Top level and roof plant areas

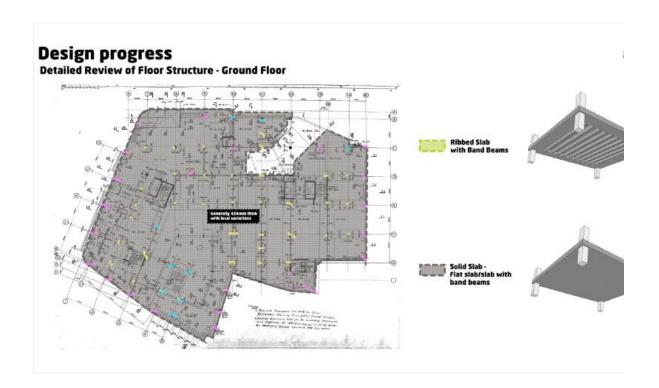
Review of Existing Floor Structure, Source: AKT II.

Analysis of the existing building structure by AKT II identifies a concrete framed building consisting of slabs and columns. Ribbed concrete slabs with band beams and typical reinforced concrete slabs of various thicknesses are present throughout the building. The ground floor and basement slabs have an increased thickness of 425mm to compensate for additional load. The concrete columns are distributed on a 7.8m X 7.8m grid within the floor plate. Preliminary drawings from DSDHA rationalises the demolition of cantilever slabs from Level 6 to Level 10.

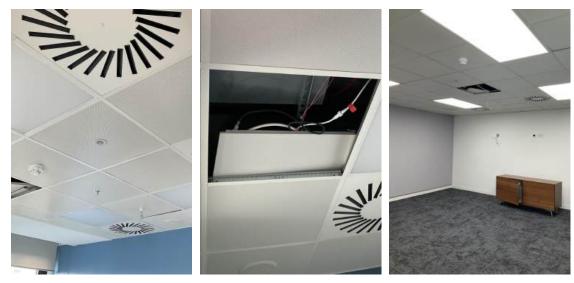
Examples of ceiling grid systems with integrated lighting and detectors.

Description: Square ceiling tiles were identified across some of the levels with

Comments: Material Index can explore resale opportunities for these items via

Removal & Storage When removing the ceiling tiles, each module should be

deconstructed carefully ensuring minimal damage and breakage; they should be stored on-site where possible, stacking them vertically, on

their edges to prevent bending/damage caused by stacking.

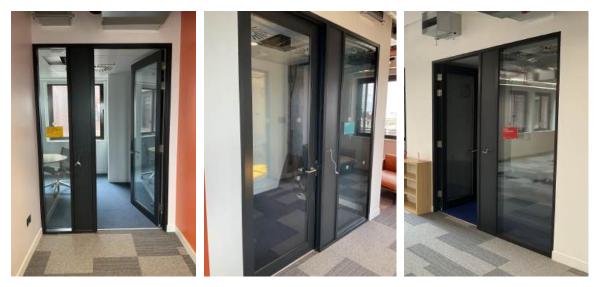
Glazed partitions with doors across 125 Shaftesbury Avenue.

Description: There are various types of fixed and swing glazed partition panel type

When removing the glass panels, each pane should be deconstructed carefully ensuring minimal damage and breakage. A specialist contractor is advised for this. Material Index has a network of such contractors that can be utilised. Once removed, materials should be labelled and stored on-site, arranging them on A-frame trolleys with protective measures in place between glass layers to prevent scratching and breakage. Material Index can advise on specialist deconstruction contractors for on-site reuse.

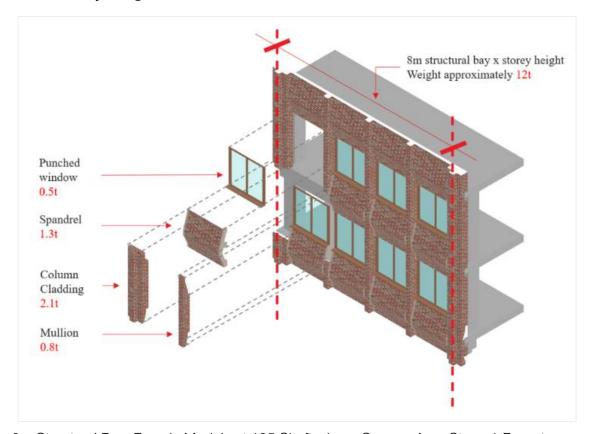
8m Structural Bay, Facade Module at 125 Shaftesbury. Source: Arup Stage 1 Report.
