125 Shaftesbury Avenue

Structural Statement

Prepared by AKT II

November 2024

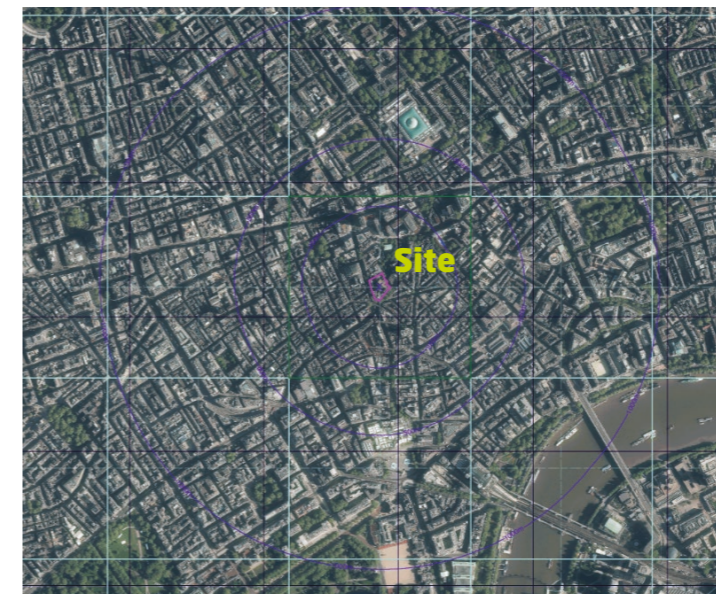
Figure 2.2 Aerial photo showing site location
