Initial 192 Goldhurst Terrace - TP1 NAME PIL Date 20/06/2022

DETERMINATION OF LIQUID AND PLASTIC LIMITS Tested in Accordance with:BS 1377-2:1990:Clause 4.4 and 5 i2 Analytical Ltd Unit 8 Harrowden Road Brackmills Industrial Estate Northampton NN4 7EB

Client: Client Address:	Milvum Engineering Services Ltd	Client Reference: 192GT
	71-75 Shelton Street, London, WC2H 9JQ	Job Number: 22-66623 Date Sampled: 20/06/2022 Date Received: 21/06/2022
Contact:	Graham Kite	Date Tested: 06/07/2022
Site Address:	192 Goldhurst Terrace	Sampled By: Client - Philip Lewis LMB
Testing carried out at	2 Analytical Limited, ul. Pionierow 39, 41-711 Ruda Slaska, Poland	
Test Results:		
Laboratory Reference:	2323612	Depth Top [m]: 1.18
Hole No.:	TP1	Depth Base [m]: Not Given
Sample Reference:	Not Given	Sample Type: D

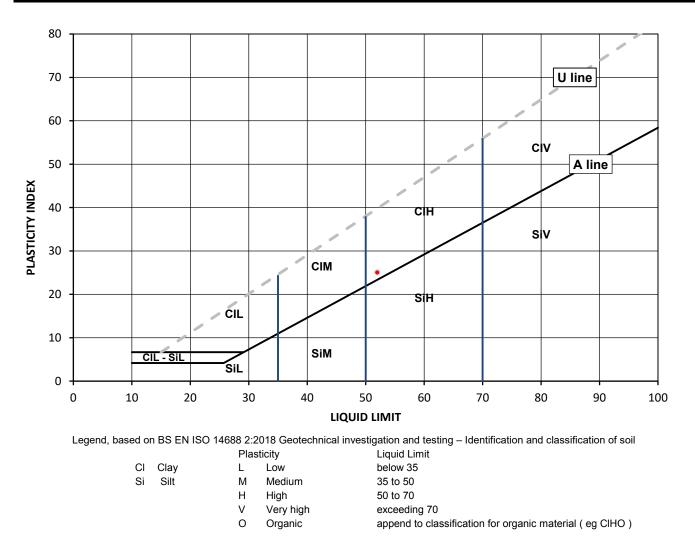
Brown slightly gravelly slightly sandy CLAY

As Received Water	Liquid Limit	Plastic Limit	Plasticity Index	% Passing 425μm
Content [W] %	[WL] %	[Wp] %	[lp]%	BS Test Sieve
20	52	27	25	73

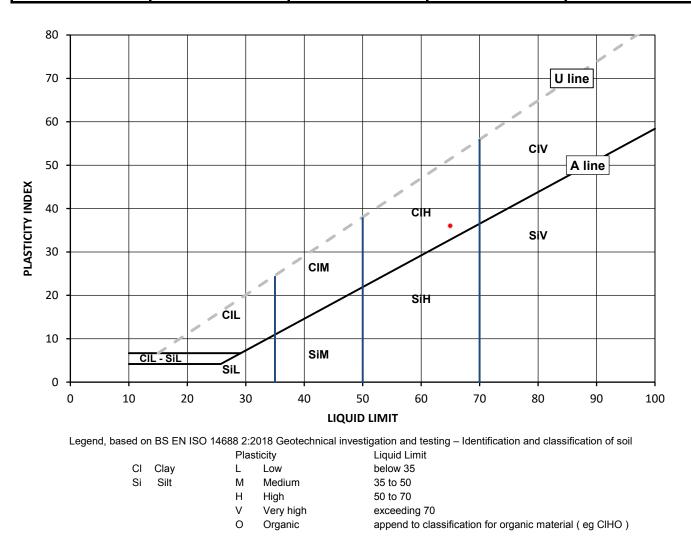
Sample Description: Brown slightly gravelly sandy CLAY

As Received Water	Liquid Limit	Plastic Limit	Plasticity Index	% Passing 425µm
Content [W] %	[WL]%	[Wp] %	[lp]%	BS Test Sieve
29	65	29	36	92

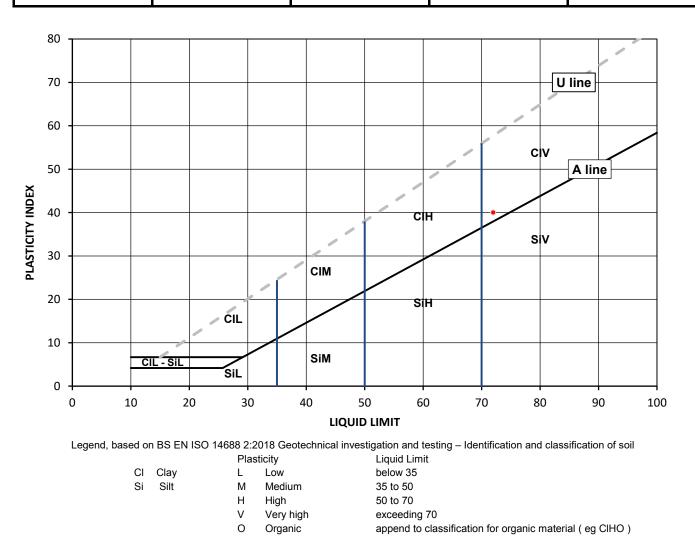
Laboratory Reference: 2323614 Hole No .: TP4 Sample Reference: Not Given Sample Description: Brown slightly gravelly CLAY

As Received Water Content [W] %	Liquid Limit [WL] %	Plastic Limit [Wp] %	Plasticity Index [lp] %	% Passing 425µm BS Test Sieve
	[112] //	["""	[.b] %	Bo rest blove
21	72	32	40	79
