DESIGN AND ACCESS STATEMENT

EXTERNAL STAIR NOSINGS

10 DUKE'S ROAD, LONDON, WC1H 9AD

UCL

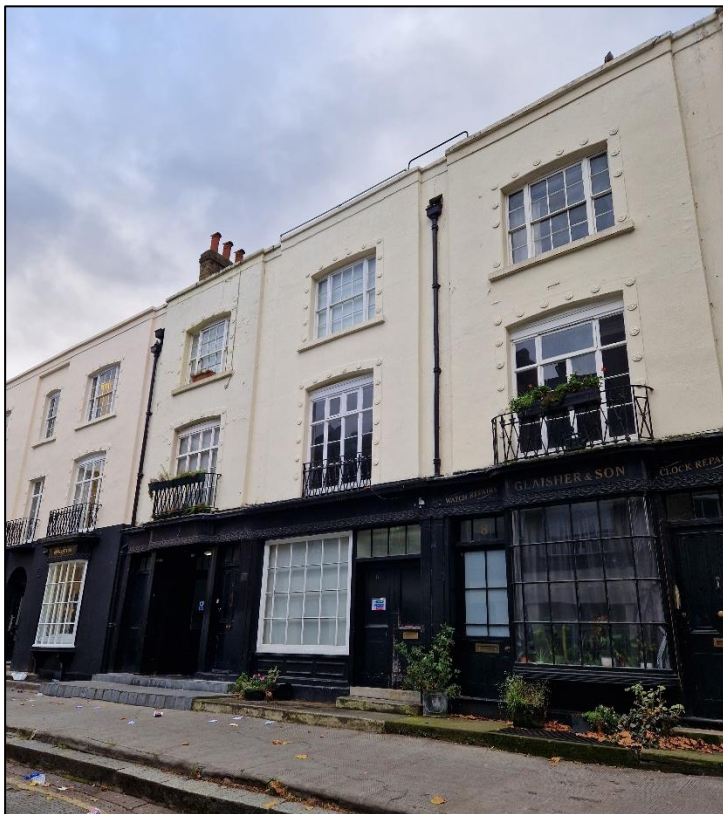
- Built: c.1822 and restored late c.20th century
- Grade: Grade II*
- Located within the Bloomsbury Conservation Area

The 10 Duke's Road building forms part of a terrace of 8 no shops (originally) with accommodation over (Nos.2-16 – Even), built in c.1822 comprising of 3 storeys with an attic and cellar.

The property is a Stucco fronted terrace property with the ground floors painted in black. The roof is a slate roof with dormers.

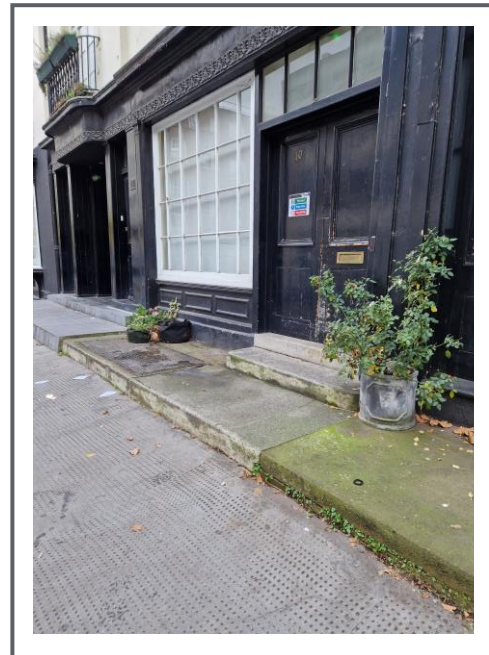
Photo 2 – Front external steps and hardstanding.

The main access into the building is via Dukes Street, at ground level. There are concrete steps to the entrance of the property and the front hardstanding detail.

External Concrete Steps: We propose a 55mm x 55mm x 6mm Anti-Slip GRP Stair Nosing, in Dark grey (RAL7043) with standard grit to all three steps as per the product data sheet appended to the planning

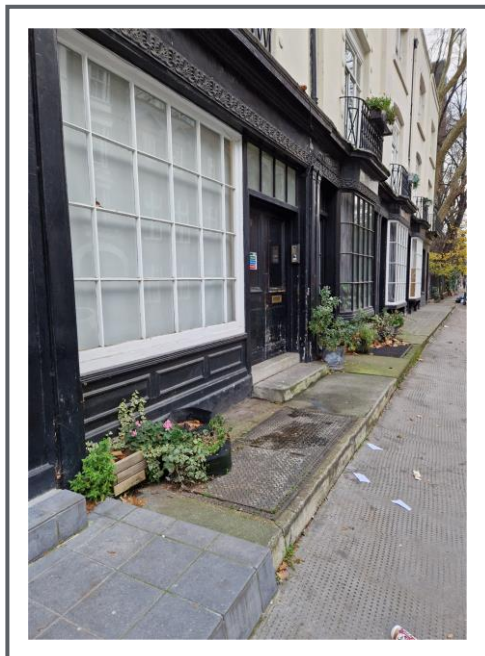
Photo 3 – Front external steps and hardstanding.

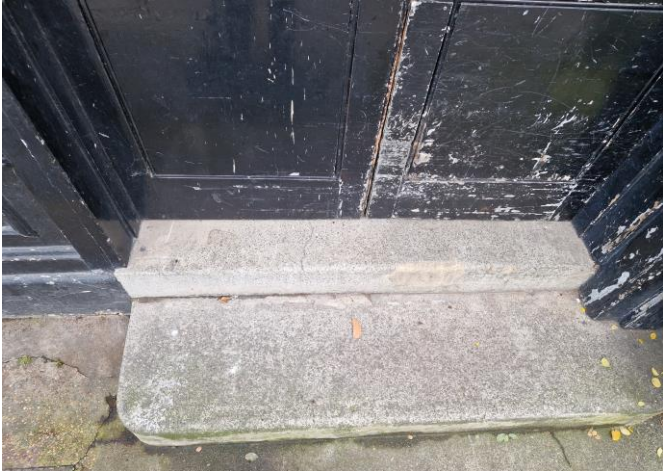
Photo 5 – Top view of the two steps directly in front of the entrance door.

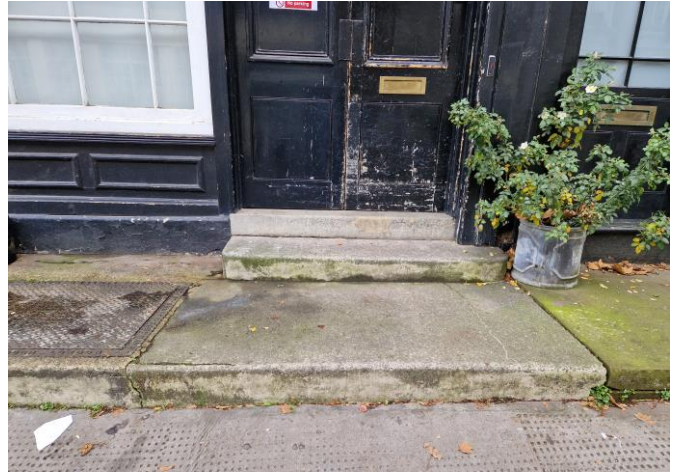
Photo 6 – Image of the two entrance steps and the one hardstanding step.
