Flood Risk Assessment and Drainage Strategy Report

Reference: L2845-REP-001 July 2024 Date:

Factual Report

Project Name	Netherhall Gardens
Project Number	50124
Client	Nedko Kyuchukov
Document Name	Factual Report

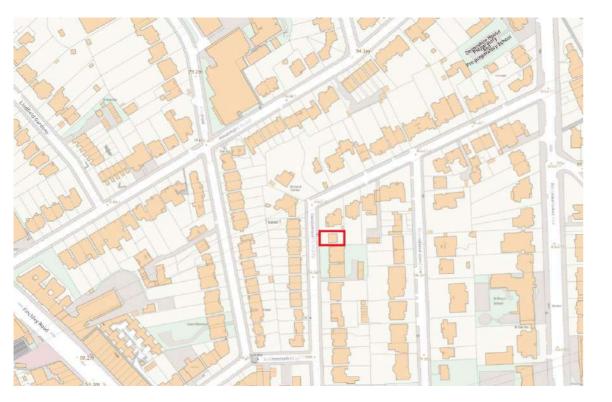
Figure 1 – Site Location Plan

This Flood Risk Assessment (FRA) and Drainage Strategy (DS) report has been produced by Pringuer-James 1.1.1 Consulting Engineers (PJCE) on behalf of Irena Kyuchukova & Nedko Kyuchukov to support a planning application for the development proposals at the site 34a Netherhall Gardens, London, NW3 5TP. Figure 1 below shows the location of the site.

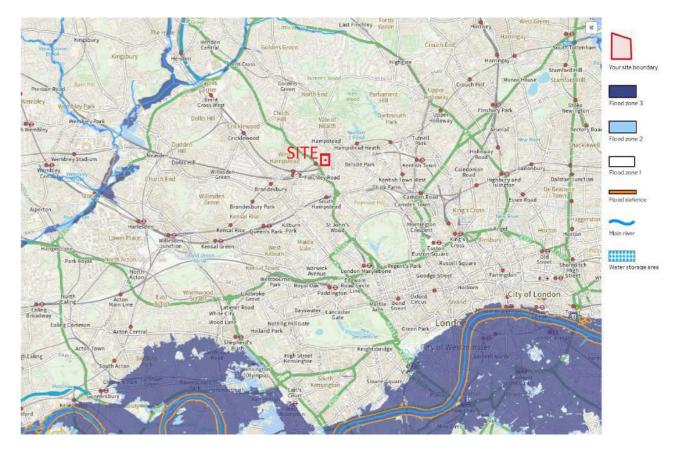
Figure 2 – EA Flood Map for Planning

- 4.1.2 Figure 2 below has been extracted from the EA's flood map for planning and shows the various flood zone extents in the area around the site.

4.1.3 As can be seen the site is shown to be located within Flood Zone 1, with the nearest areas of Flood Zone 3 near Embankment, emanating from the River Thames.

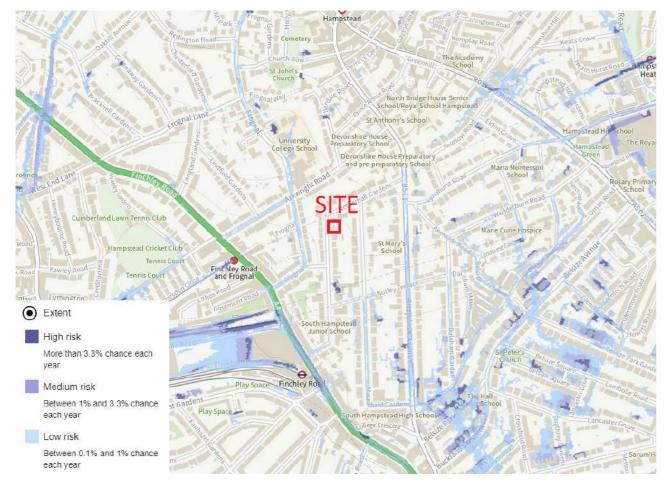
Figure 3 – EA Surface Water Flood Map

4.1.5 As can be seen, the site has a very low risk of surface water flooding as well as Netherhall Gardens and its surrounding area.

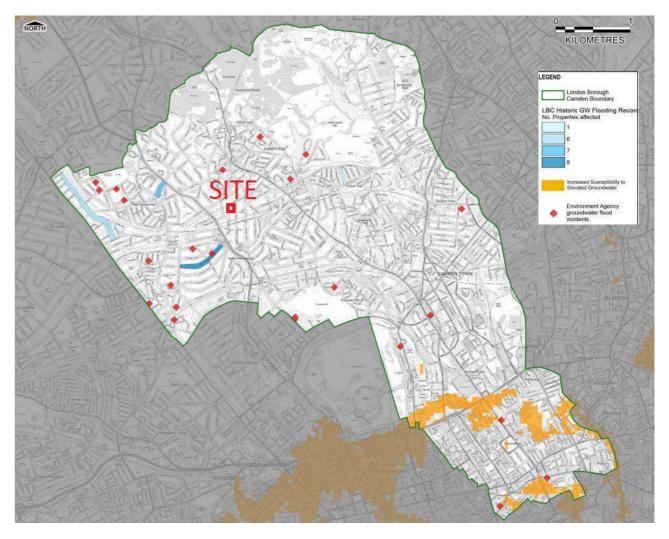
Figure 4 – LBoC SFRA Environment Agency Areas Susceptible to Groundwater Flooding

- 4.1.8 Figure 4 below have been extracted from the London Borough of Camden (LBoC) SFRA and shows the susceptibility of groundwater flooding within the borough.

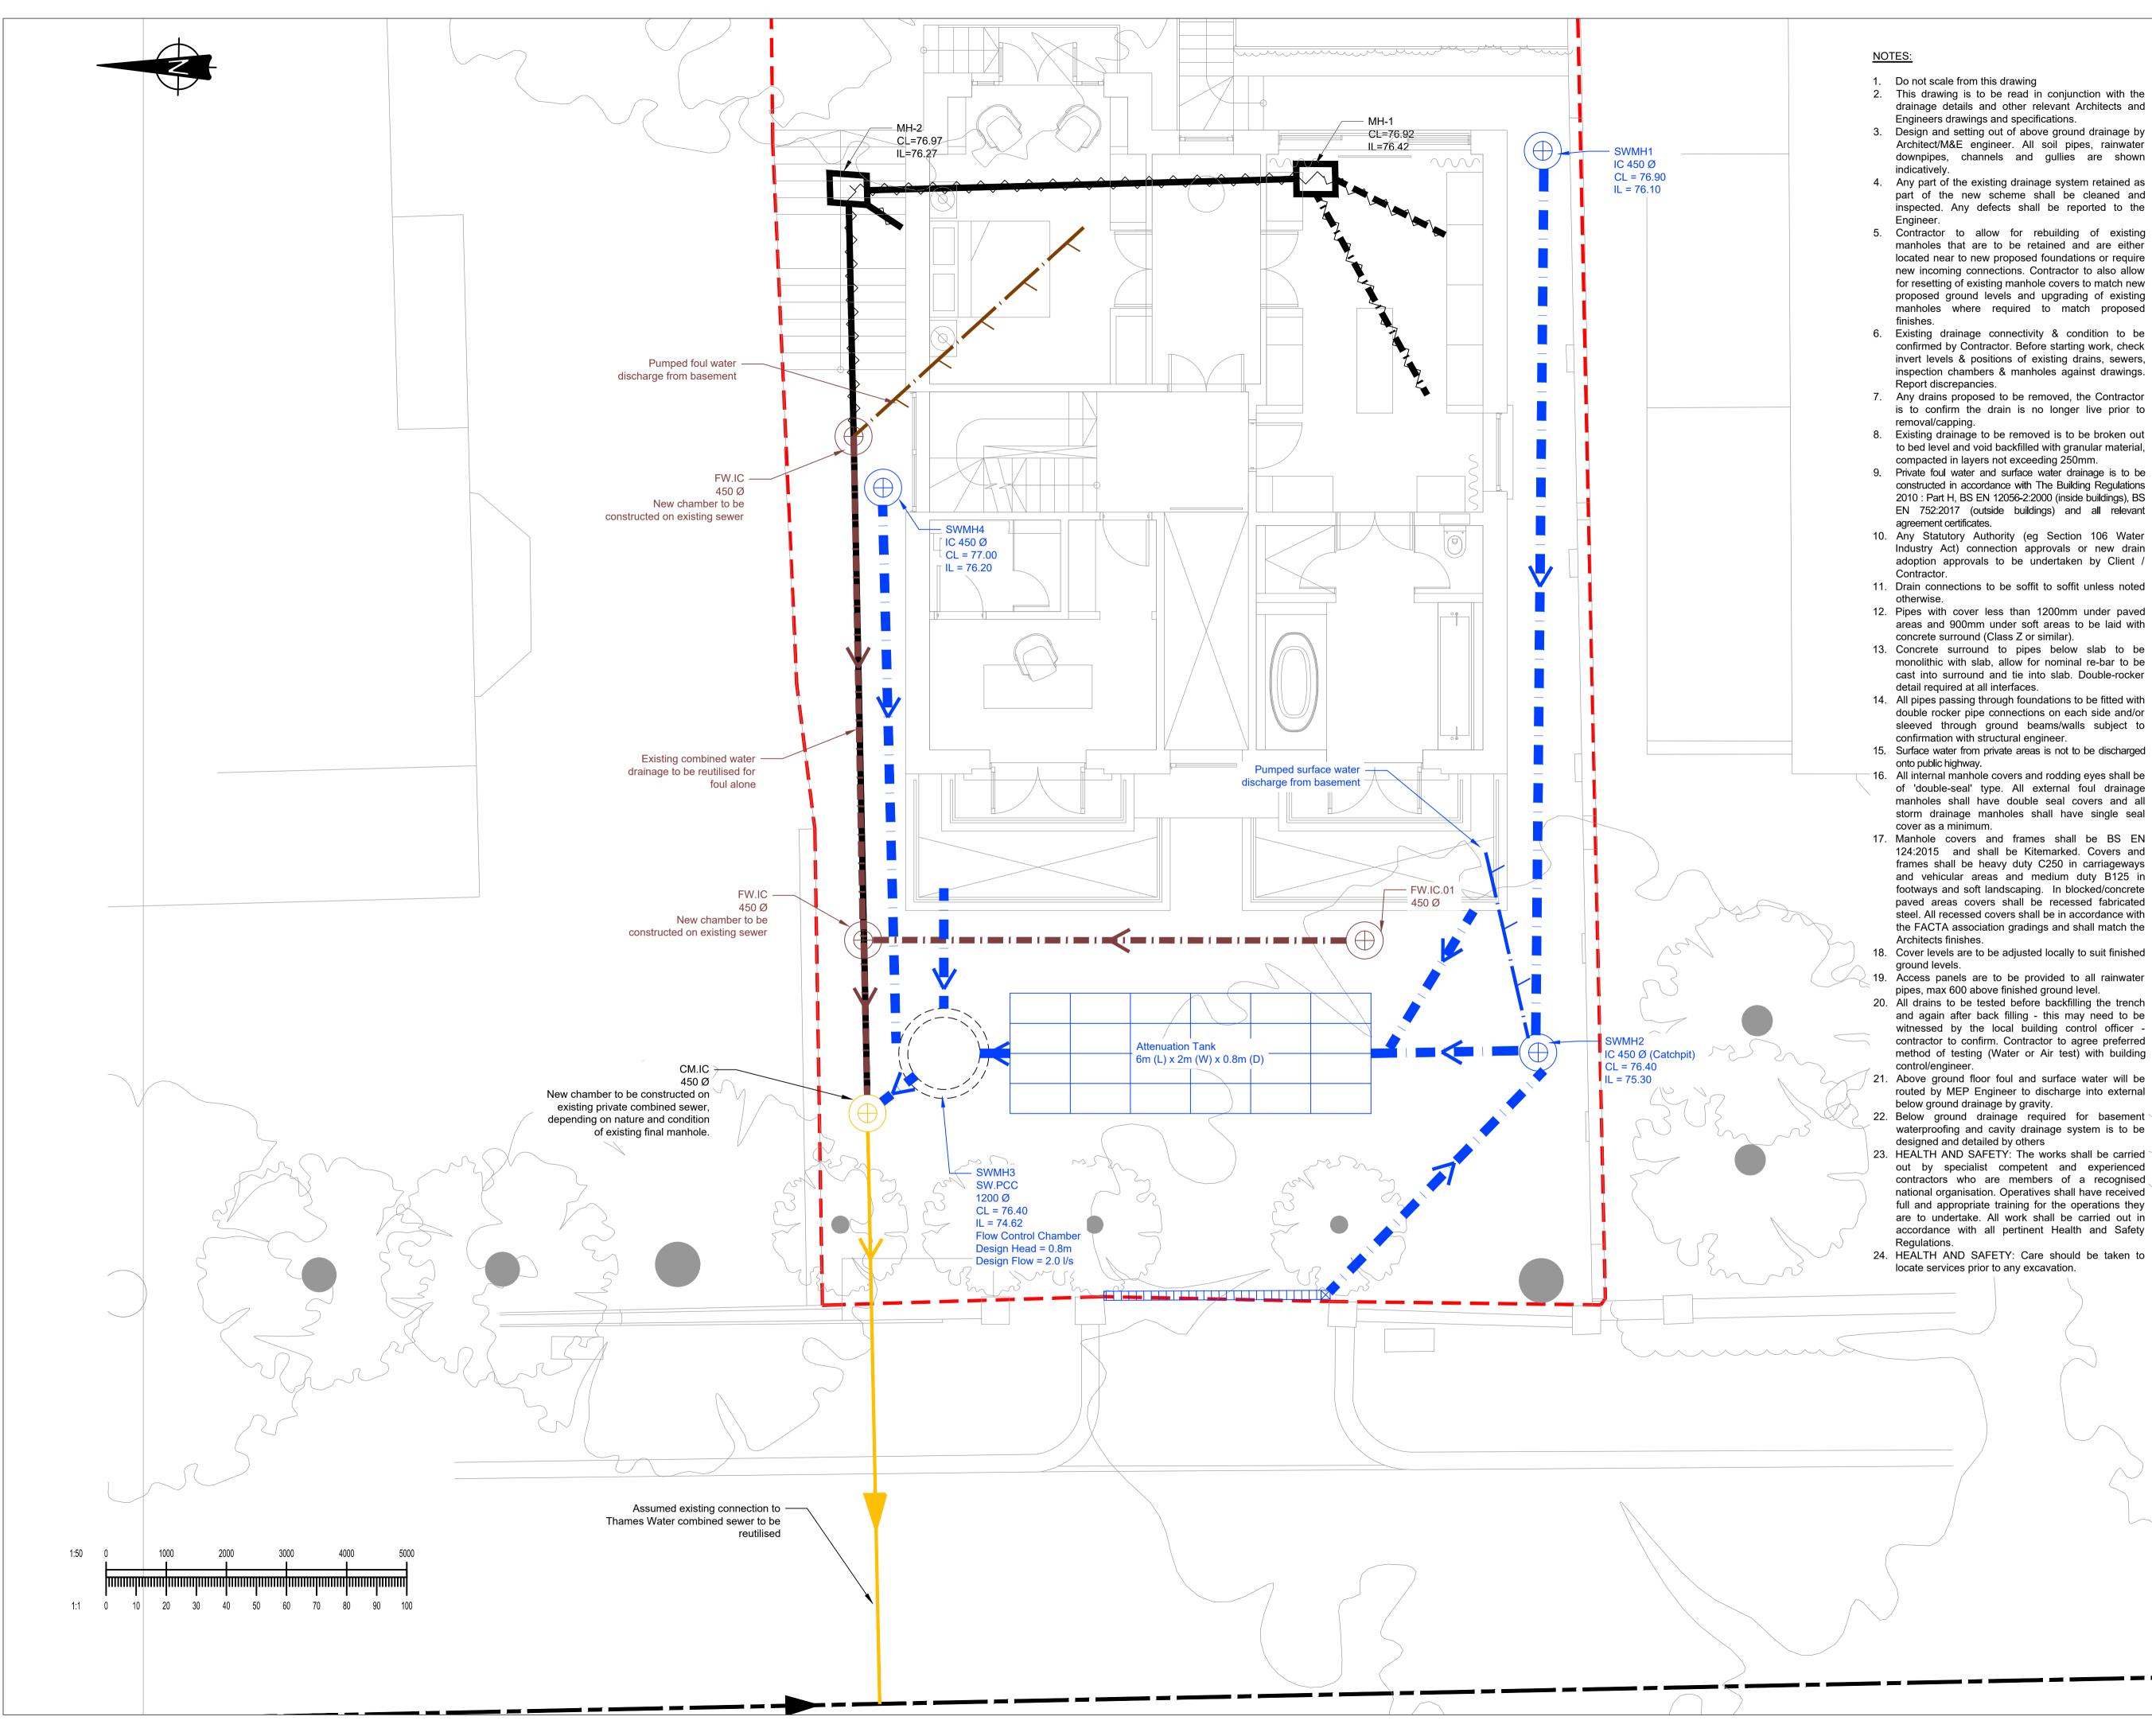
PROPOSED DRAINAGE STRATEGY LAYOUT

- confirmed by Contractor. Before starting work, check invert levels & positions of existing drains, sewers, inspection chambers & manholes against drawings.
- to bed level and void backfilled with granular material,

- routed by MEP Engineer to discharge into external
- out by specialist competent and experienced contractors who are members of a recognised national organisation. Operatives shall have received full and appropriate training for the operations they are to undertake. All work shall be carried out in P01 30.07.24 TS TM Issued For Information accordance with all pertinent Health and Safety

- 10.1.6 Surface water runoff from site is proposed to discharge at 2.0l/s, an improvement from the existing flow rates to blockages, that may cause flooding. The surface water will be restricted by a flow control unit.

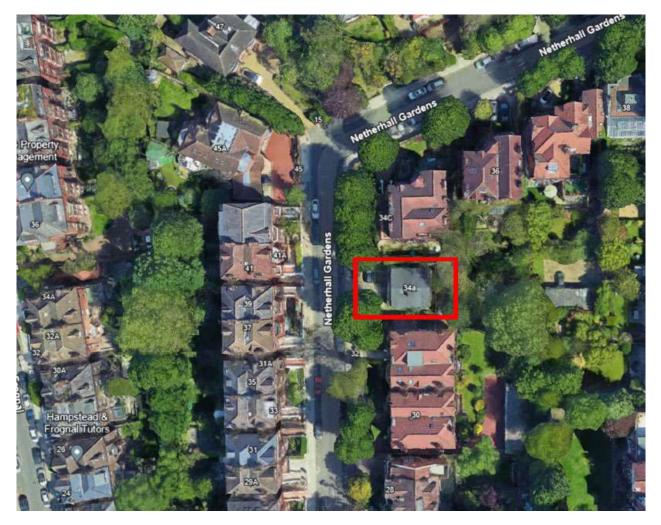
Figure 2.1 Site location and extent shown in red

The site is situated at 34a Netherhall Gardens, London, NW3 5TP, as presented in Figure 2.1. The site is located at National Grid Reference 526360, 185150. The site falls within the administrative boundaries of the London Borough of Camden and currently includes a 2-floor residential dwelling with a garage on ground floor.

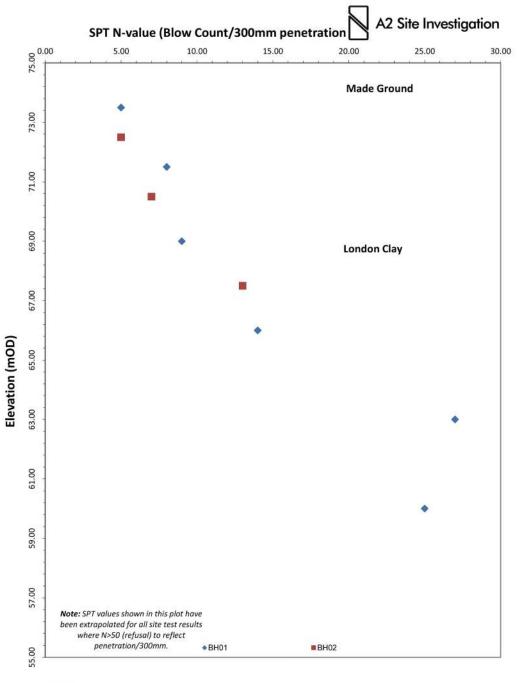
Figure 10.1 SPT/ Elevation plot

Standard Penetration Tests were completed in all cable percussion boreholes. The tests were completed in accordance with BS EN ISO 22476-3.

Figure 10.1 presents the SPT versus Elevation plot for the site. Detailed SPT results are presented in Appendix C.

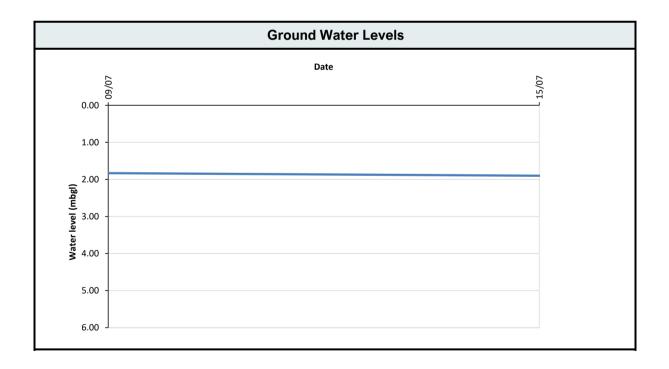
Visit	Date	Engineer	Atmospheric Pressure (mbar)	Weather condtion	Water level (m)	Base of Well (m)
1	09/07/2024	FA/AN/AR	1002.00	Rainy	1.83	9.20
2	15/07/2024	FA	1008.00	Overcast	1.90	9.20
3	22/07/2024	FA/AN/AR	1006.00	Sunny	1.96	9.20
4						
5						
6

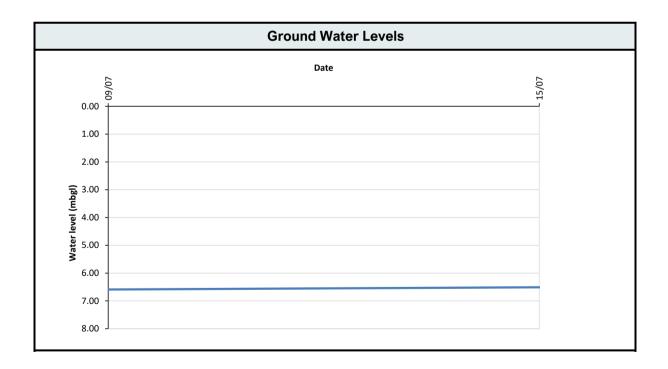
Visit	Date	Engineer	Atmospheric Pressure (mbar)	Weather condtion	Water level (m)	Base of Well (m)
1	09/07/2024	FA/AN/AR	1002.00	Rainy	6.59	7.56
2	15/07/2024	FA	1008.00	Overcast	6.51	7.56
3	22/07/2024	FA/AN/AR	1006.00	Sunny	3.68	7.56
4						
5						
6
