**King's Cross Methodist Church
58a Birkenhead Street
London
WC1H 8BW**

Ground Investigation &
Basement Impact Assessment

J24145
Rev 2

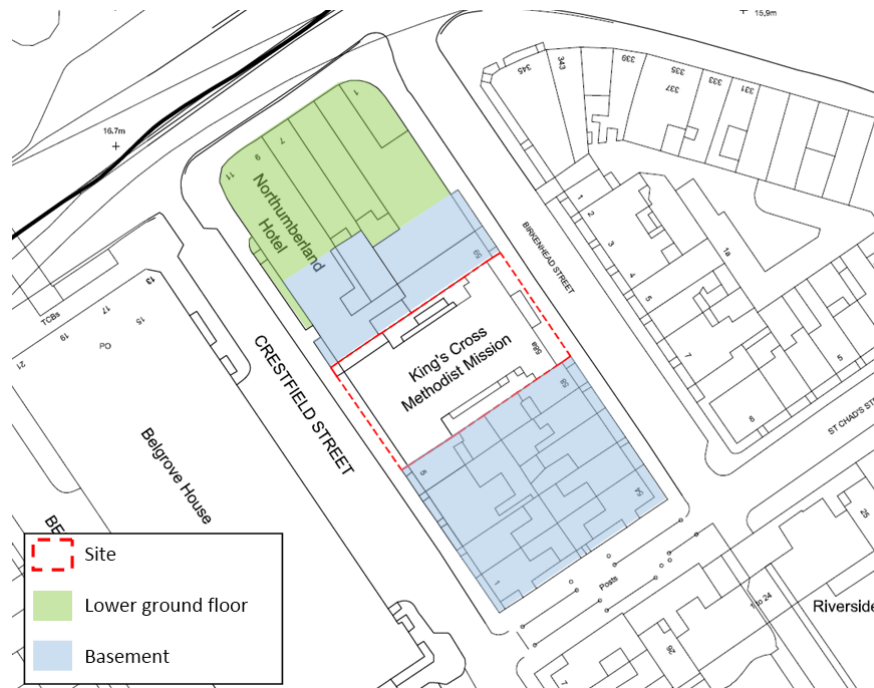
The plan below indicates lower ground floor and basement levels in the buildings neighbouring the site, which has been compiled using information from the site walkover and information available on the Local Authority planning portal.

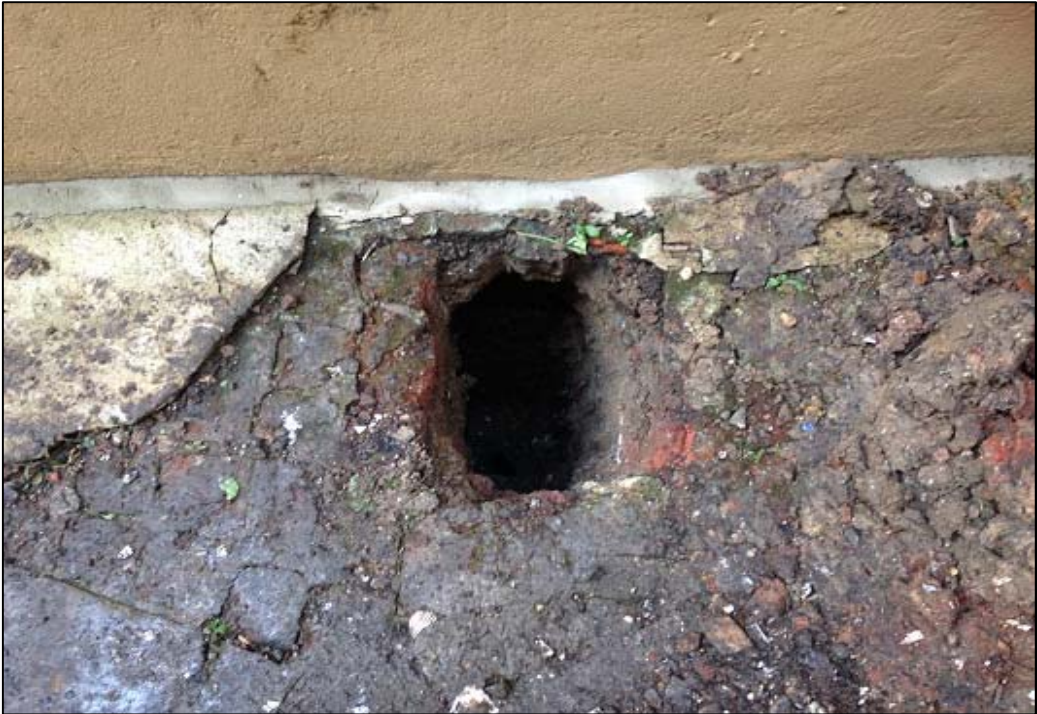
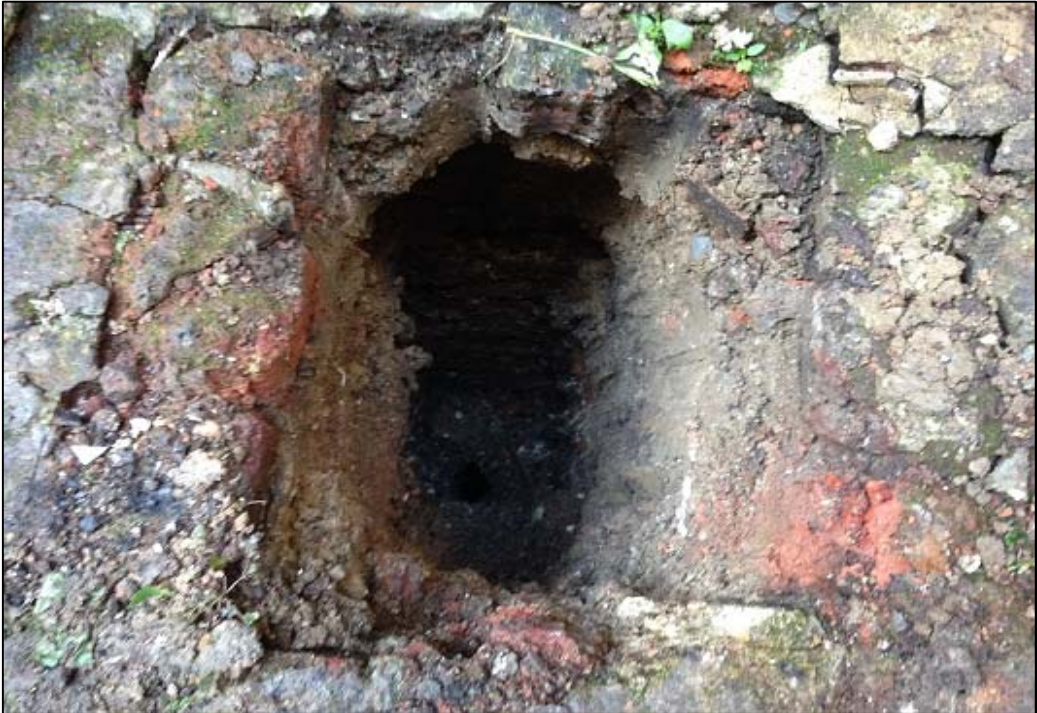
Remarks: All dimensions in millimetres Sides of trial pit remained stable during excavation Groundwater: Not encountered			Scale: 1:20
			Logged by: ML

Base of footing not proved.
 Borehole No 3 advanced through base of trial pit.

Trial Pit No 1 was excavated adjacent to the northwestern party wall, but the base of footing was not encountered at the maximum extent of the trial pit, at a depth of 1.30 m (16.41 m OD). Trial Pit Nos 2 and 6 were also excavated adjacent to this party wall, although from a lower level. The foundations were found to be bearing on London Clay at 0.30 m (14.58 m OD) and 0.60 m (14.51 m OD) respectively.

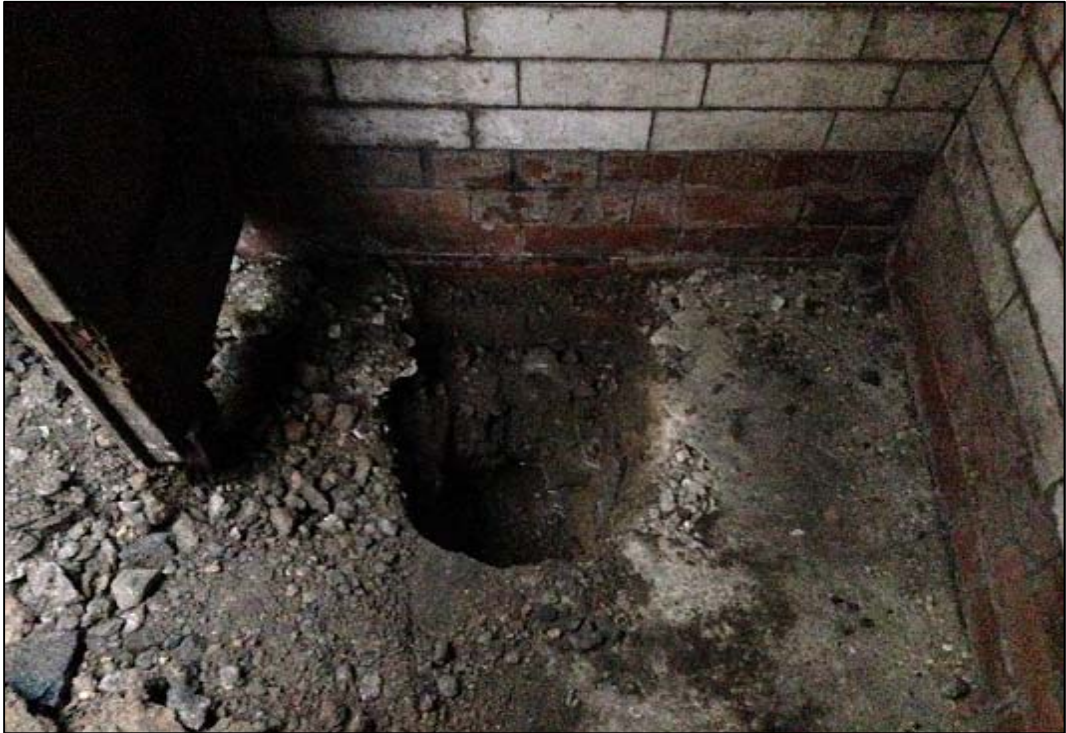
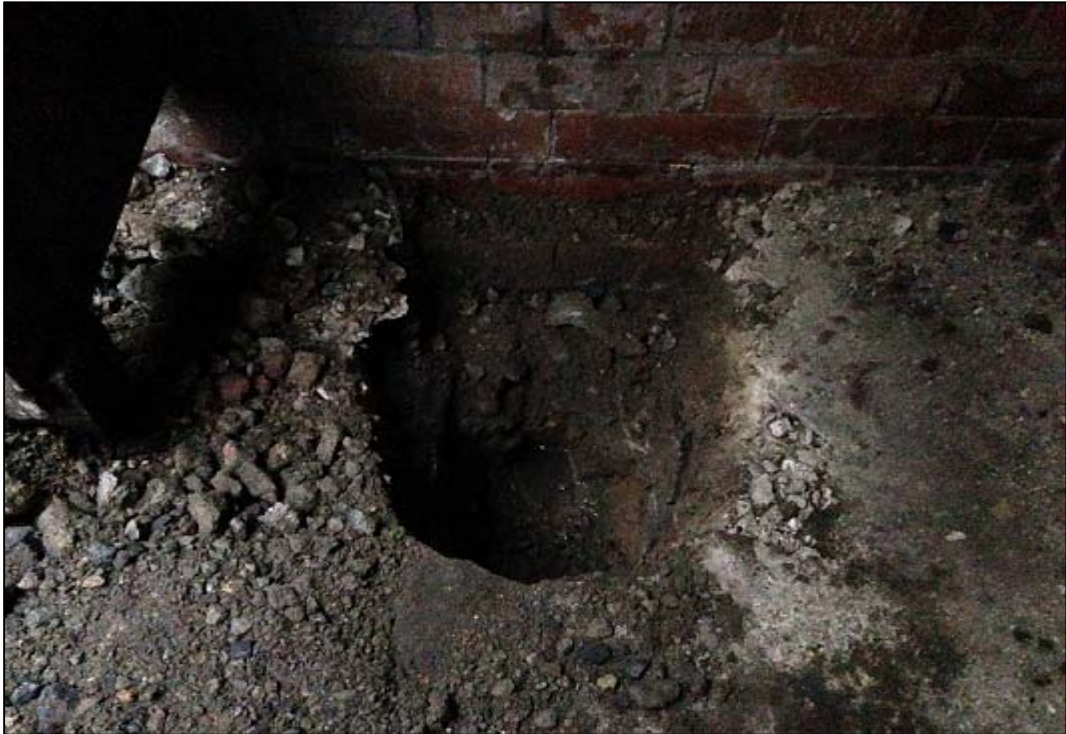
Remarks: All dimensions in millimetres Sides of trial pit remained stable during excavation Groundwater: Standing at 0.30 m	Scale: 1:20
	Logged by: ML

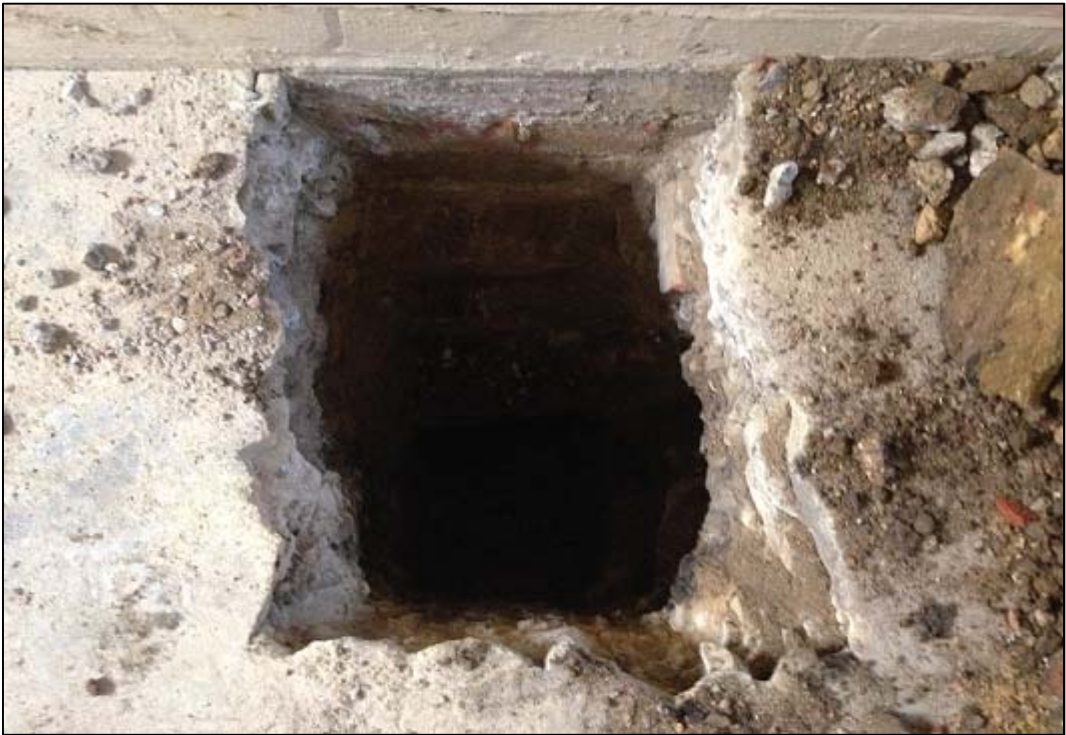
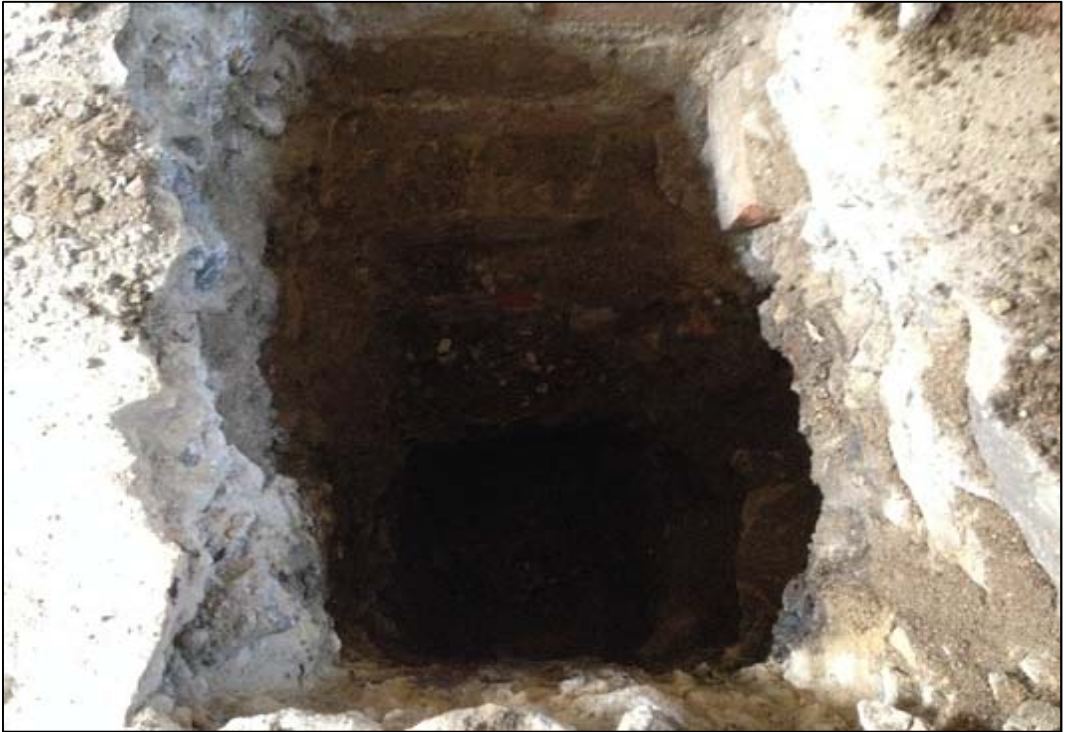
Remarks: All dimensions in millimetres Sides of trial pit remained stable during excavation Groundwater: Not encountered			Scale: 1:20
			Logged by: ML

Trial Pit No 3 was excavated adjacent to the northwestern elevation of the two-storey section of the church, which was found to be supported by a concrete footing bearing within the made ground at a depth of 0.70 m (16.33 m OD). Trial Pit No 4 was excavated at basement level, adjacent to the dividing wall between the two-storey section and the five-storey section of the church, which was found to be supported by brick footing bearing on the London Clay at a depth of 0.30 m (14.76 m OD).

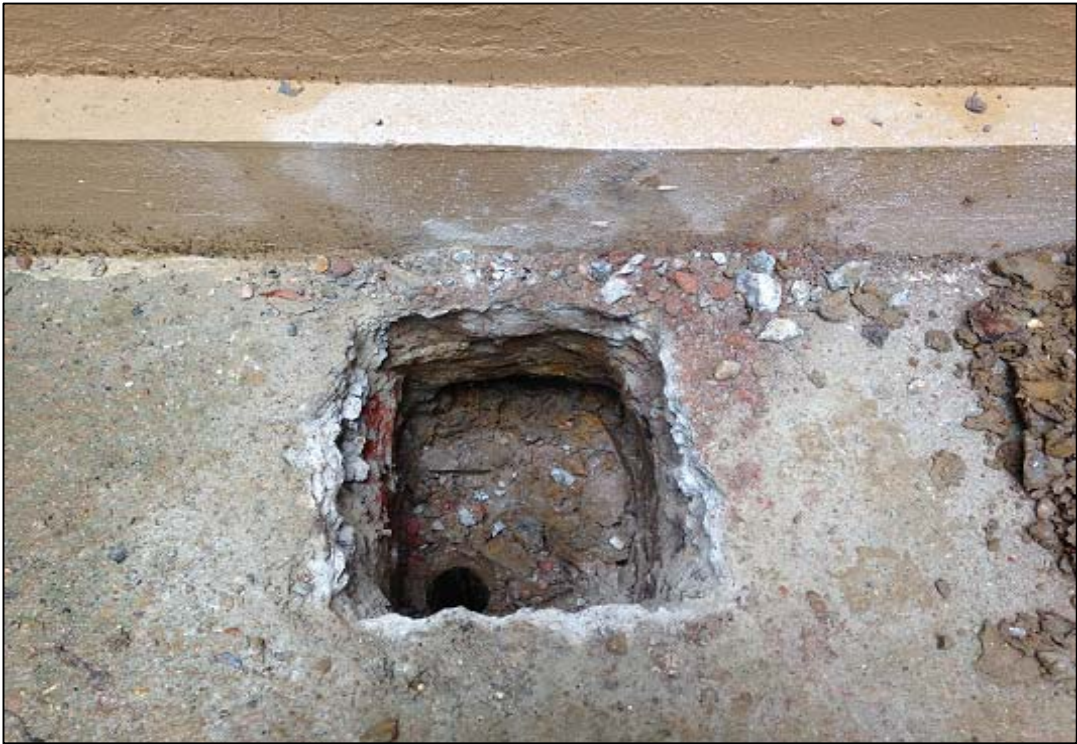
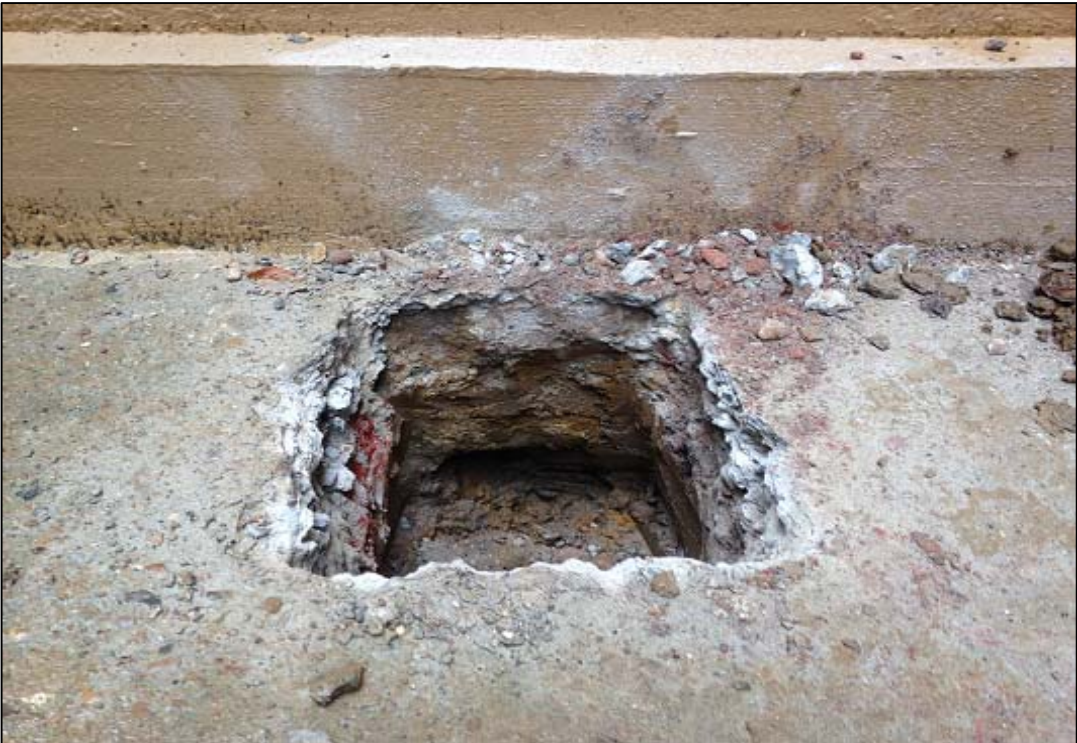
Remarks: All dimensions in millimetres Sides of trial pit remained stable during excavation Groundwater: Not encountered			Scale: 1:20
Sample:0.4 m			Logged by: ML

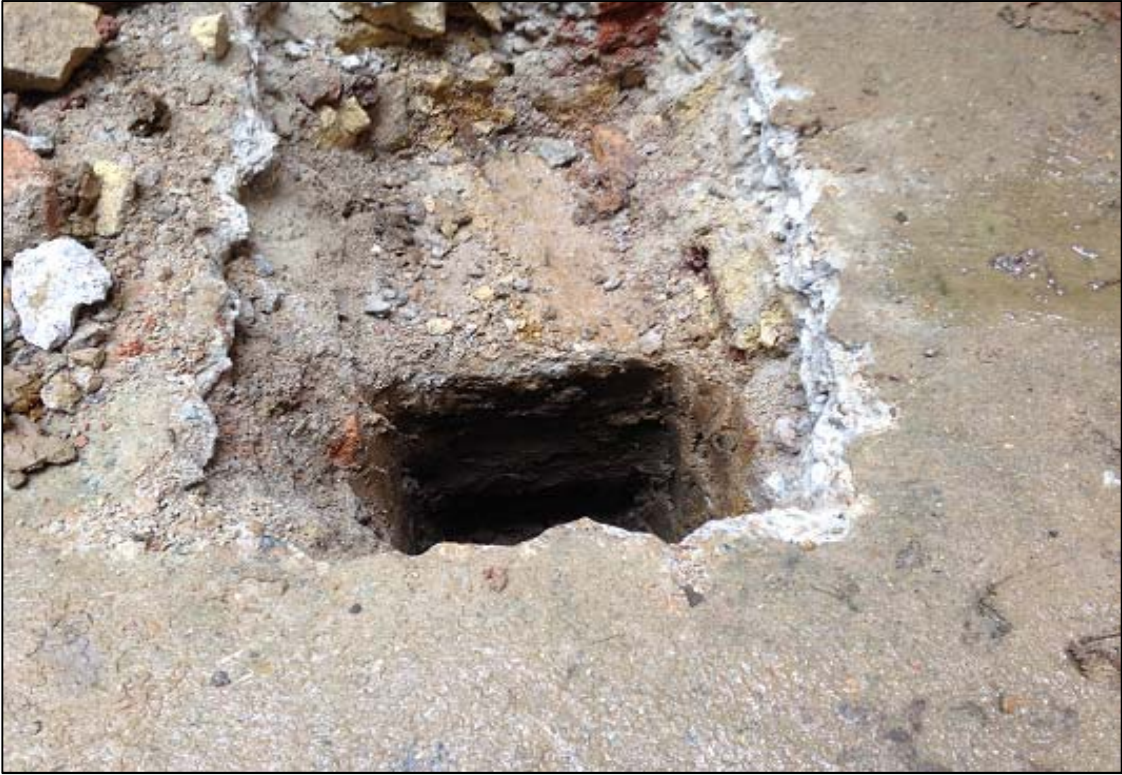
Remarks: All dimensions in millimetres Sides of trial pit remained stable during excavation Groundwater: Not encountered	Scale: 1:20
	Logged by: ML

The southeastern party wall was found to be supported by a concrete footing bearing within the London Clay at a depth of 0.60 m (14.45 m OD and 14.46 m OD), as indicated by Trial Pit Nos 5 and 7 respectively.

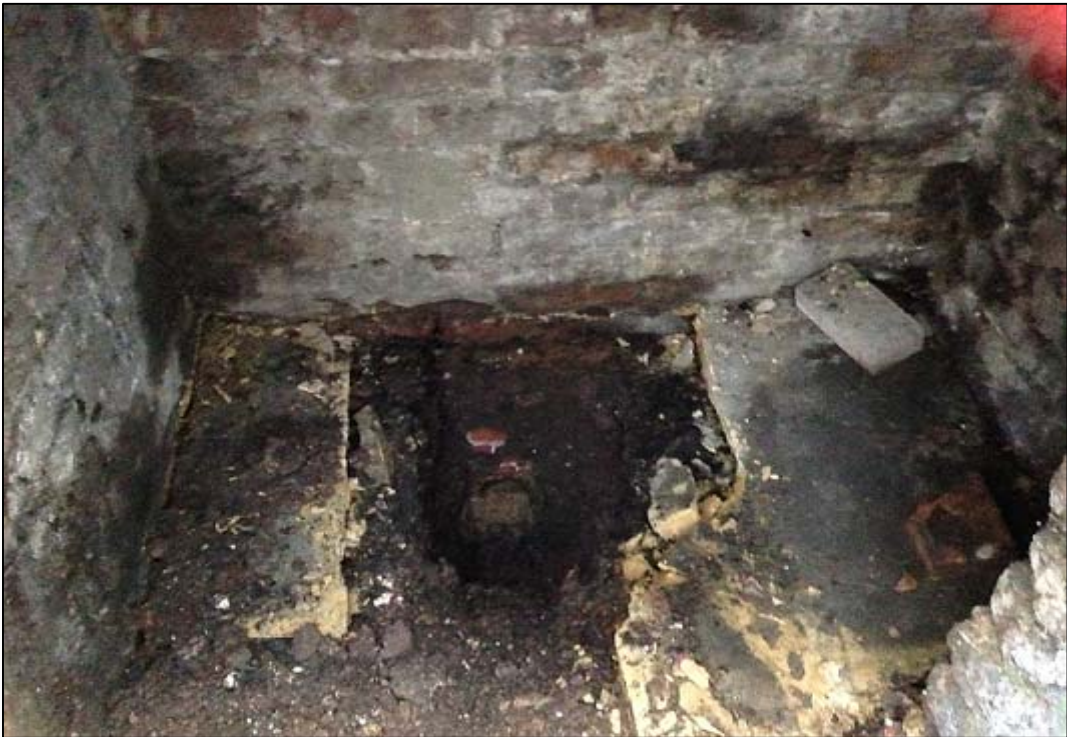
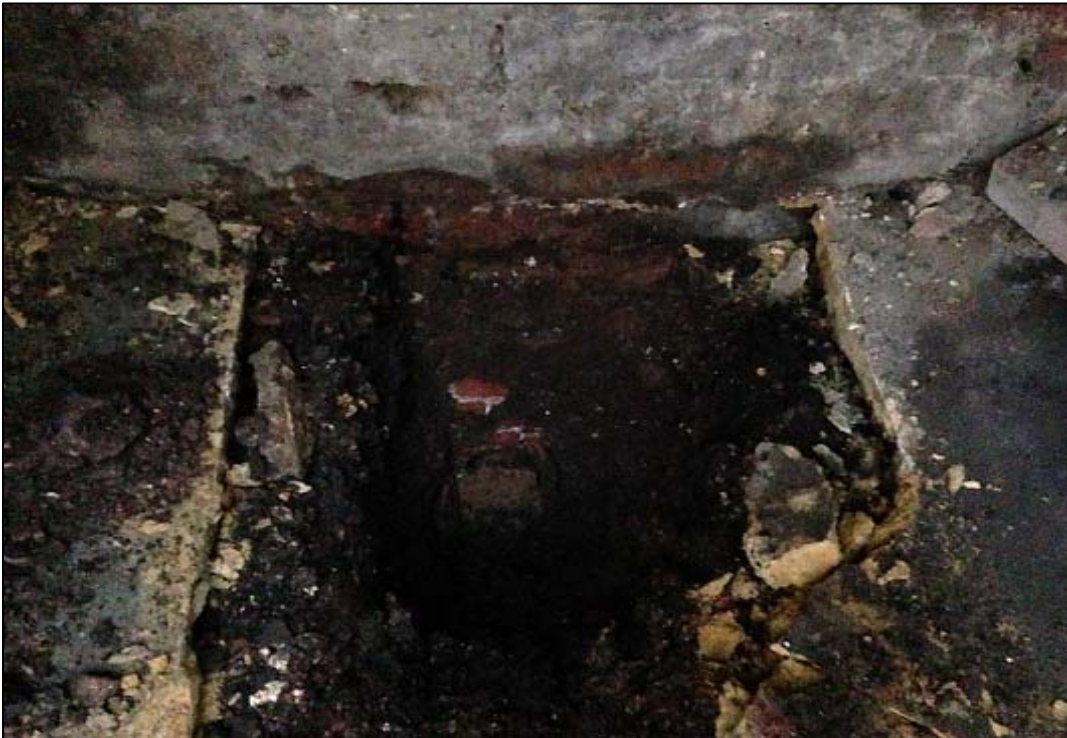
Remarks: All dimensions in millimetres Sides of trial pit remained stable during excavation Groundwater: Not encountered			Scale: 1:20
			Logged by: ML

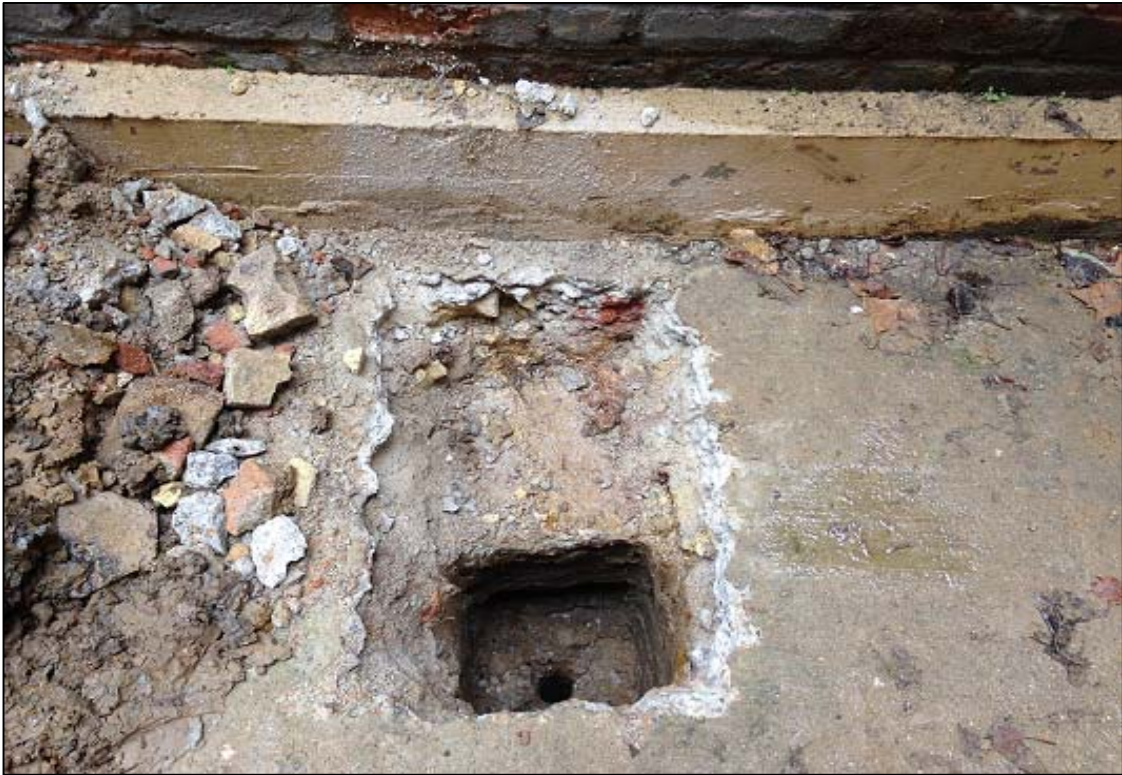
Remarks: All dimensions in millimetres Sides of trial pit remained stable during excavation Groundwater: not encountered			Scale: 1:20
			Logged by: ML
