Flat 1, 253 Goldhurst Terrace, London, NW6 3EP Nimbus Engineering Consultants Ltd Basement Impact Assessment March 2024

# BASEMENT IMPACT ASSESSMENT FOR FLAT 1, 253 GOLDHURST TERRACE, LONDON, NW6 3EP

**DOCUMENT NO: C3000-R1-REV-B**

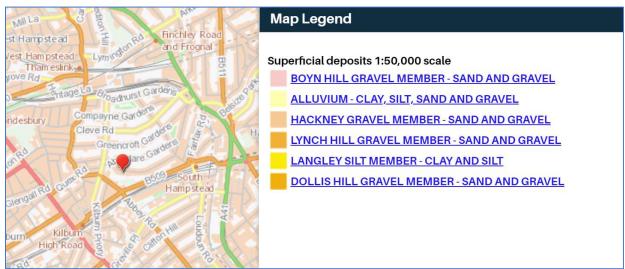
According to the British Geological Survey, the superficial deposits at the site are unknown, as shown in Figure 1, below. The bedrock at the area is of the London Clay Formation, shown in Figure 2, below.

Figure 1- Superficial deposits at the site. (Source: British Geological Society Website (contains British Geological Survey materials © NERC2023)).

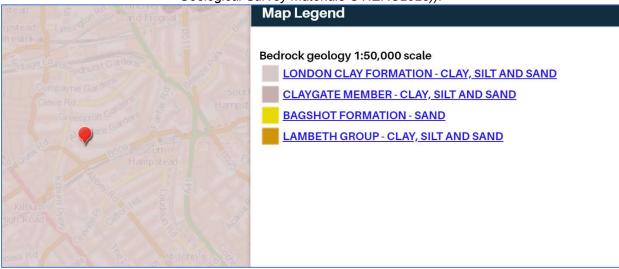
Figure 2 - Bedrock at the site. (Source: British Geological Society Website (contains British Geological Survey materials © NERC2023)).

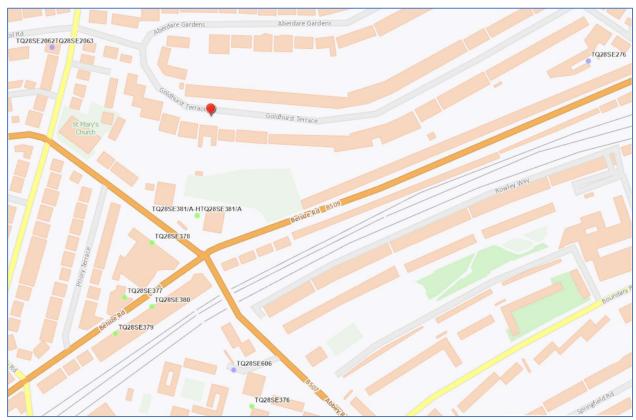
Historic boreholes within the vicinity of the site were consulted in order to determine groundwater levels within the vicinity of the site. The location of these boreholes can be found in figure 3 below, and the results of boreholes can be found in Appendix B.

Figure 3 - Historic Boreholes at the site. (Source: British Geological Society Website (Contains\_British Geological Survey materials © URKI [2023]. Base mapping is provided by ESRI)).

The results of these historic boreholes show that no groundwater was encountered, and the Groundwater vulnerability MAGIC maps from DEFRA shown overleaf, also show the site to be in an area of unproductive strata, with a soluble rock risk.

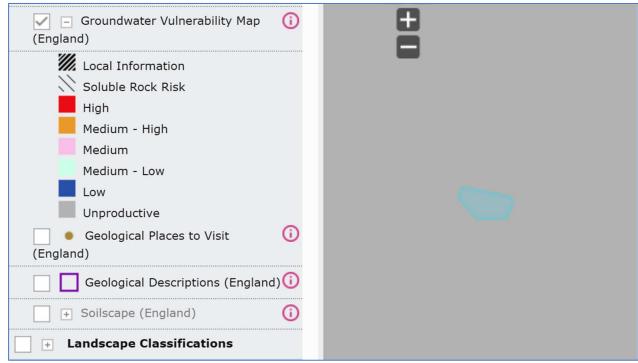
Figure 4 – Groundwater Vulnerability Map – Magic Maps (DEFRA)

We have consulted historic boreholes at the site and have also consulted the DEFRA

Magic Maps and both show that the groundwater is very low at this site and there is no

risk of groundwater flooding.

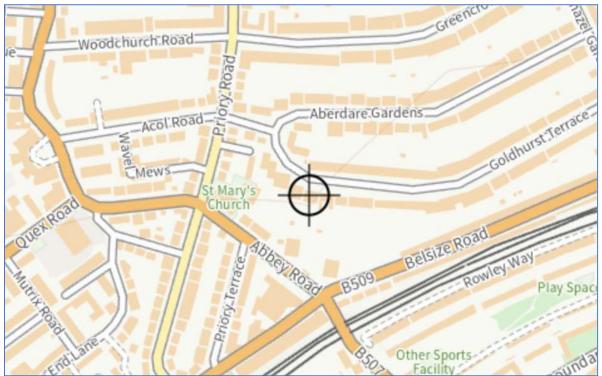
The Environment Agency's Flood Map for Planning (Rivers and Sea), shown below, indicates the site is in Flood Zone 1, and not at risk of flooding from rivers or the sea.

The site is also not at risk of tidal flooding, this can also be confirmed by the Environment Agency's Flood map, below.

Figure 5 – Environment Agency Flood Map (from Rivers and the Sea) for the proposed development

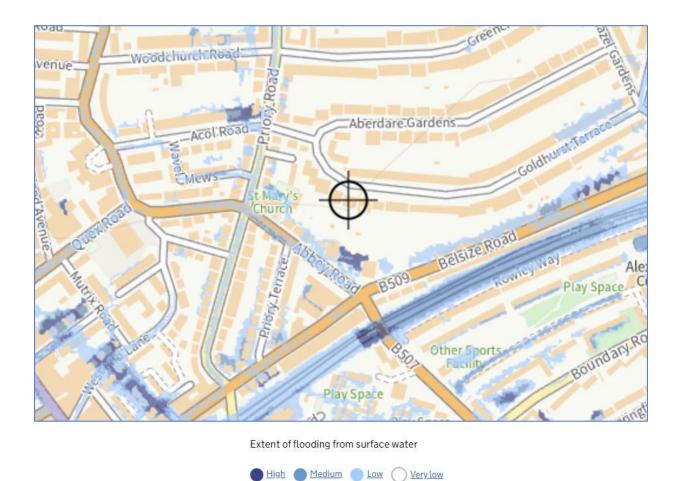
The proposed development site is not at risk of surface water flooding, this can be confirmed by the Environment Agency's Flood map shown below.

Figure 6 – Environment Agency Flood Map (from surface water) for the proposed development.

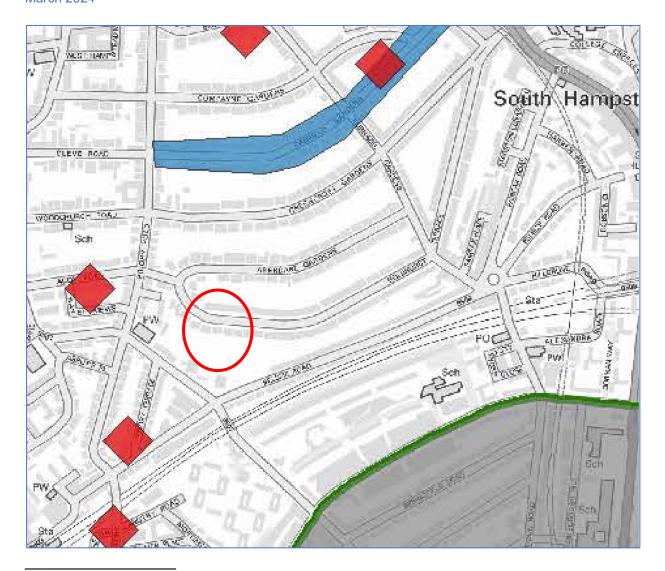
Furthermore, we have consulted the Camden Borough Council, Level 1, Strategic Flood

Risk Assessment's Geo Flood map, as shown in figure 7 overleaf, and this shows the

proposed development site to be in an area with no risk of groundwater flooding, therefore

there will be no risk of groundwater flooding to this proposed basement.

Figure 7 – Increased Susceptibility to Elevated Groundwater Map – Extracted from London Borough of Camden Level 1 Strategic Flood Risk Assessment Report

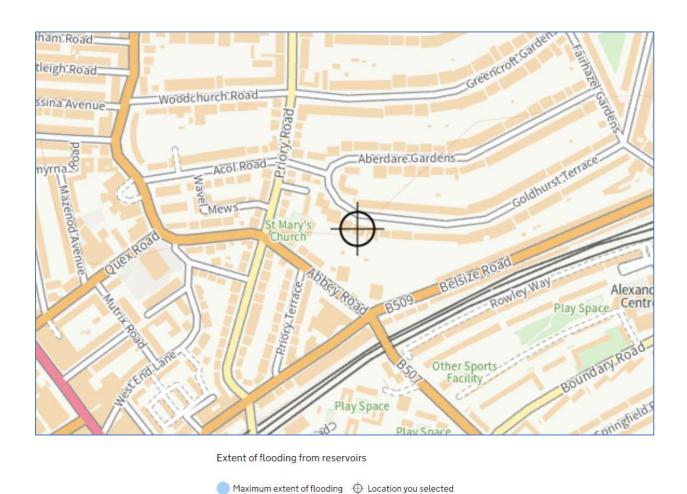
The Environment Agency's Flood map shown below, shows the site not to be at risk of reservoir flooding.

Figure 8 – Environment Agency Flood Map (from reservoirs) for the proposed development

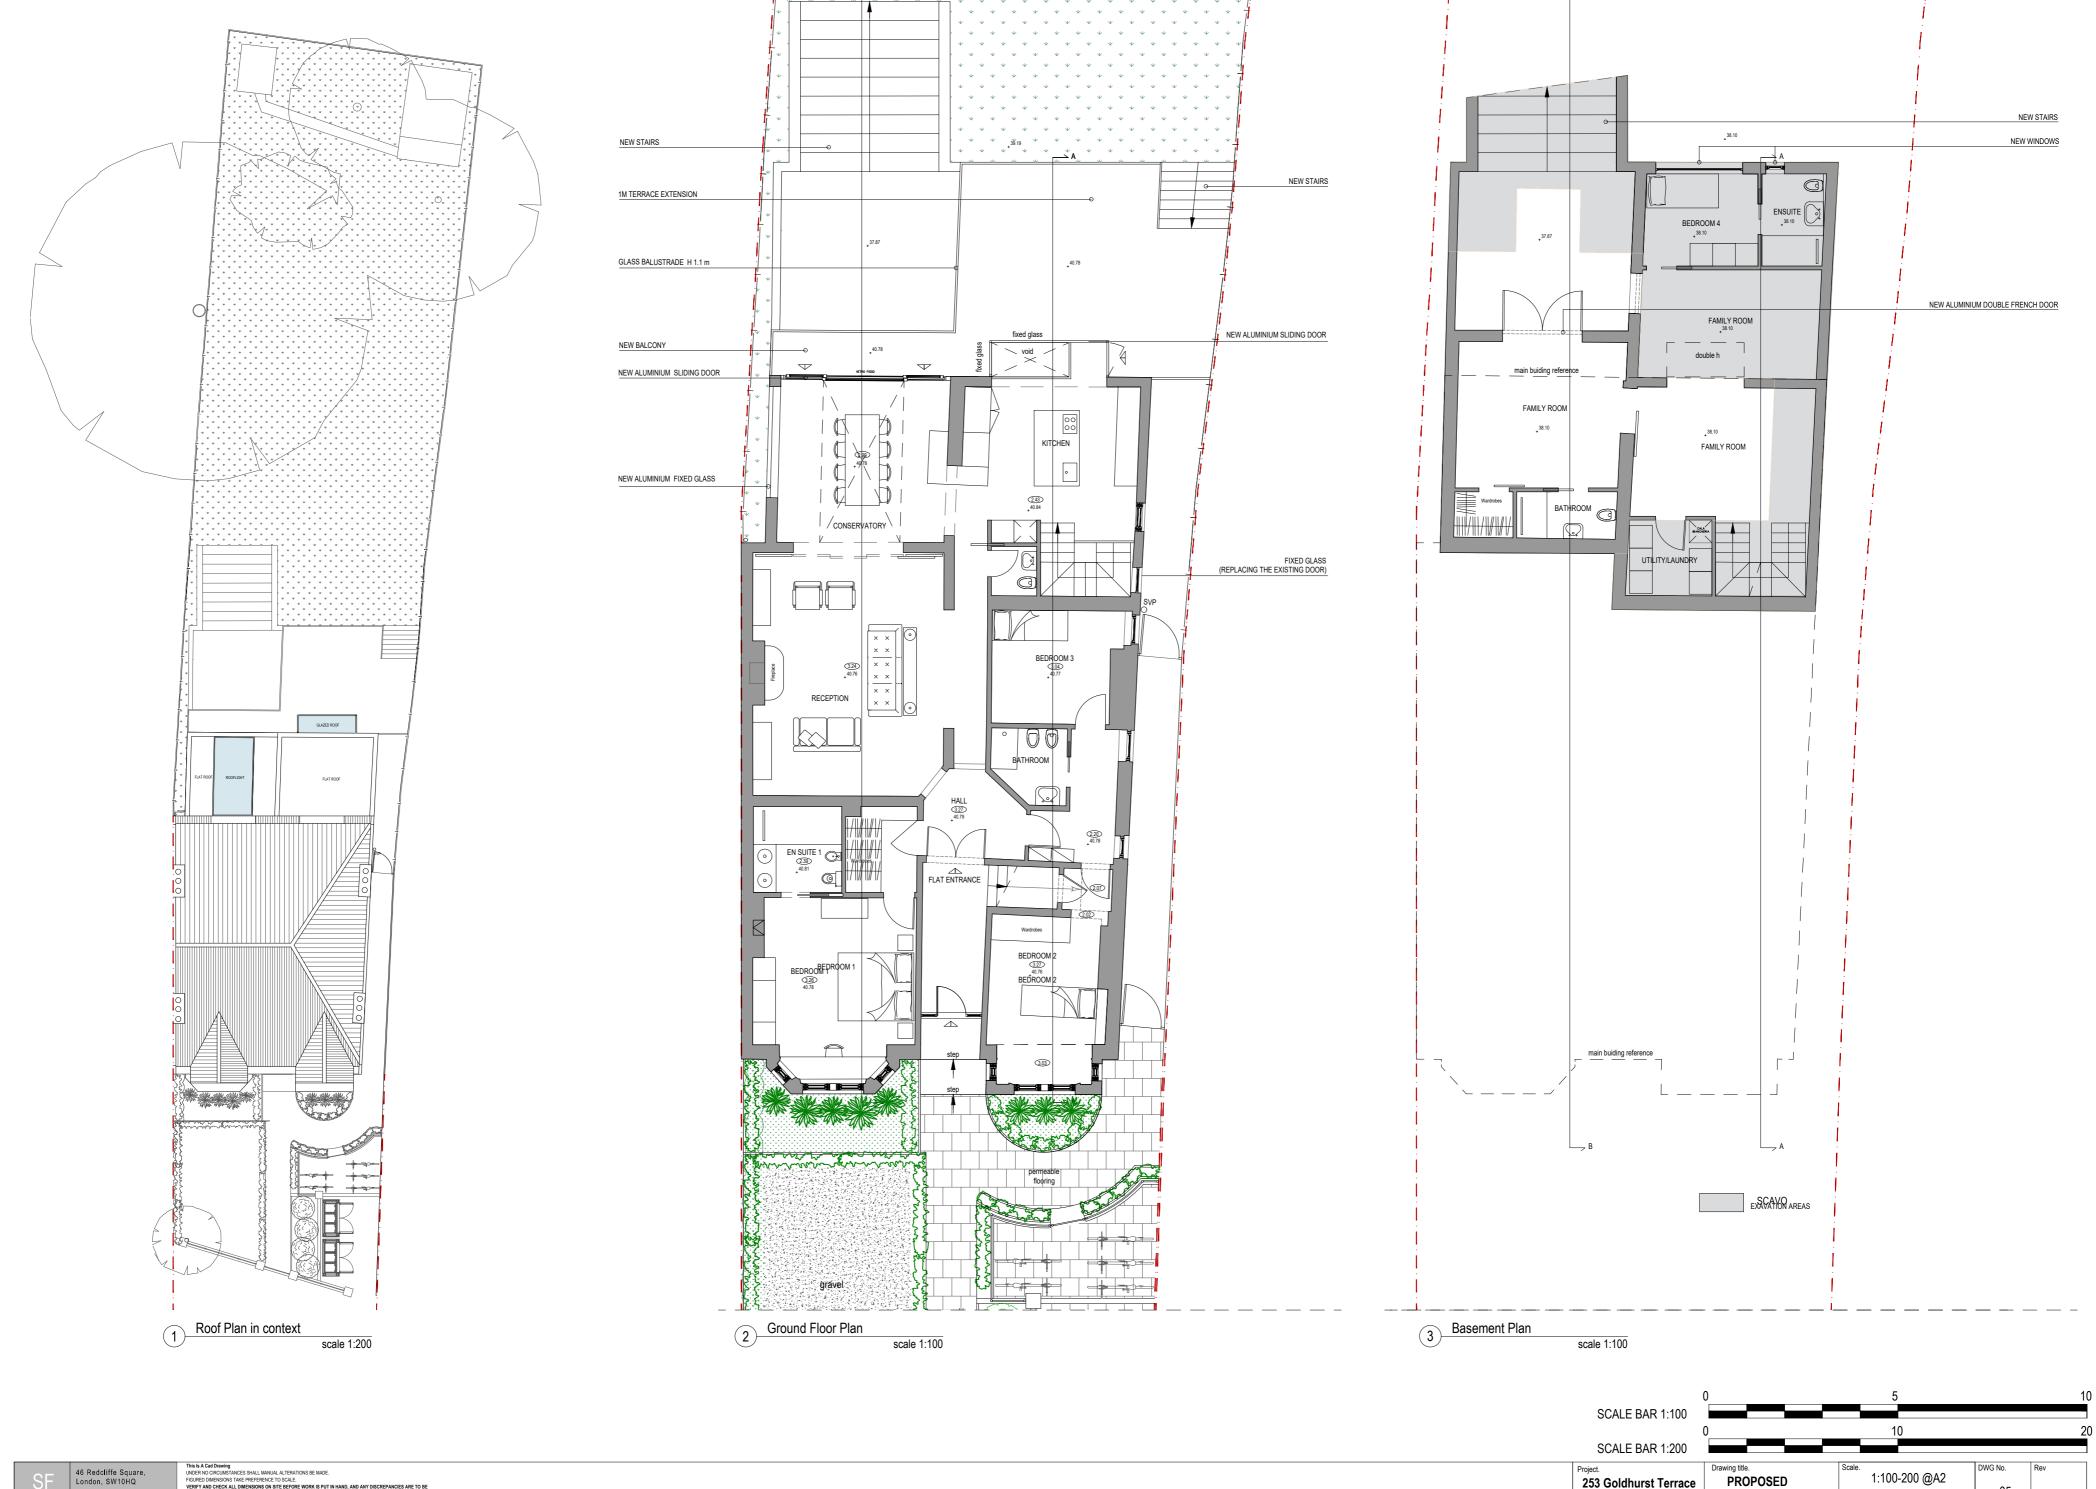
# APPENDIX A - DRAWINGS

A set of drawings showing the existing and proposed site layouts are included in Appendix

A. These show that the proposals are for a basement extension.

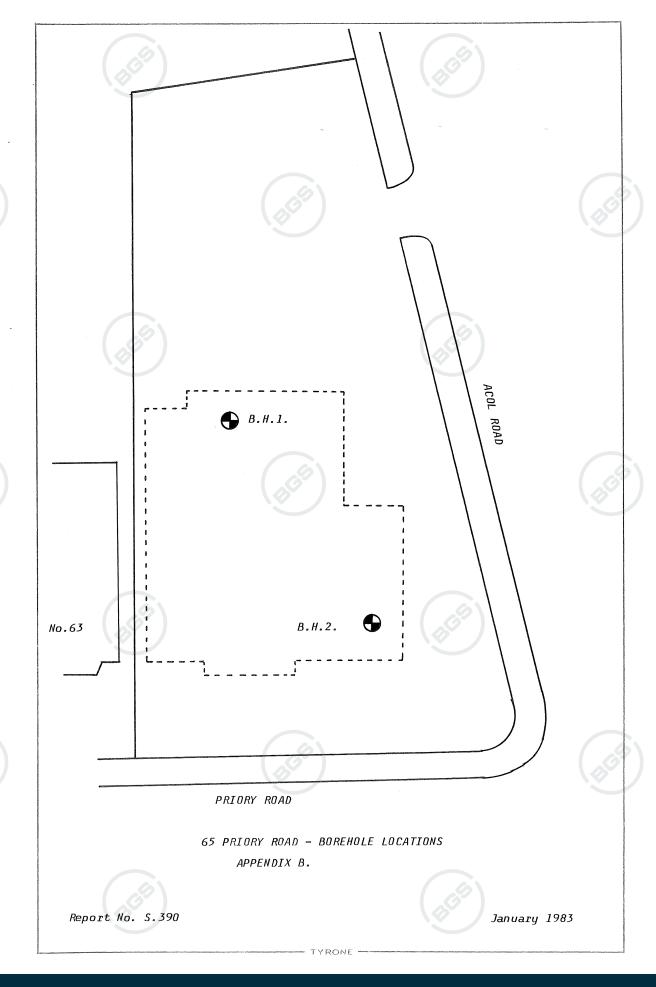
***************************************	MÄDE GROUND Soft to firm brown clay with many broken bricks and de-composed mortar	2 (A)	1.00						(0
	LONDON CLAY  Firm slightly silty brown  mottled grey CLAY with  extensive close fissuring.  Occassional clay stones.	*	2.00		SPT 5	1.50 2.50	J   U100		1.
	Becoming firm to stiff	X - X - X - X - X - X - X - X - X - X -	3.00			-2.95	0100		
	Very stiff slightly silty dark brown slightly mottled grey CLAY with some fissures and thin partings of grey fine silt	~\\\\\\\\\\\\\\\\\\\\\\\\\\\\\\\\\\\\\	4.00			3.50   -3.95   4.50	U100		(8
	Gypsum crystals from 5.00m	x x x x x x x x x x x x x x x x x x x	5.00		CDT27	-4.95	7

6.00		SPT27	6.00	J		
•	Very stiff to hard slightly silty blue-grey CLAY with	****** 	8.00		SPT33	7.50	J		(8
	many large fissures. Some silty and sandy partings		9.00			8.75 9.50	J	B.H. Dry	
		X-/-x				-9.95	U100	9
