British Museum – Energy Centre Programme

Discharge of Contamination Planning Condition

Document: Ground Investigation Report
Project: The British Museum (Proposed SWEC)
Reference No: GL25243_GI
Date: September 2024
Prepared for: Steadberry Restoration Limited

Document: Desk Study Report
Project: The British Museum (Proposed SWEC)
Reference No: GL25243
Date: December 2022
Prepared For: Steadberry Restoration Ltd

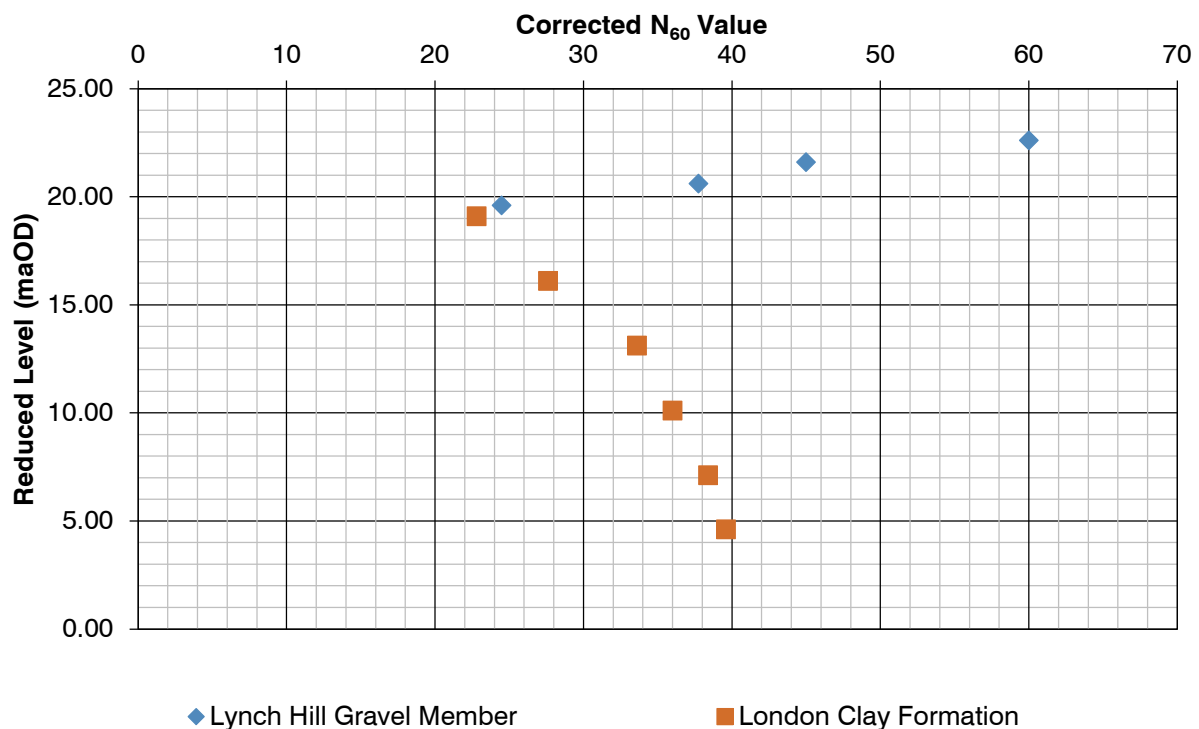
Figure 3.4.1 Corrected N₆₀ Values vs. Depth

Figure below provides the relationship between depth and N₆₀.

The above graph shows that all of the SPT N₆₀ values were above 20. Using these values, the majority of the Lynch Hill Gravel Member can be interpreted as being medium dense or better.
